**Suttieslea Road, Newtongrange,
Midlothian.
Archaeological Desk-Based Assessment
and Evaluation.**

**Data Structure Report,
No. 1630**

Author	Ian Suddaby MA FSA Scot MifA
Illustrator	Leeanne Whitelaw BSc MAAI&S
Editor	Melanie Johnson MA PhD FSA Scot MifA
Commissioned by	Cruden Homes (East) Ltd
Date issued	June 2009
Version	2
OASIS Reference	cfaarcha1-58842
Planning Application No	07/00002/FUL
Grid Ref	NT 3405 6465

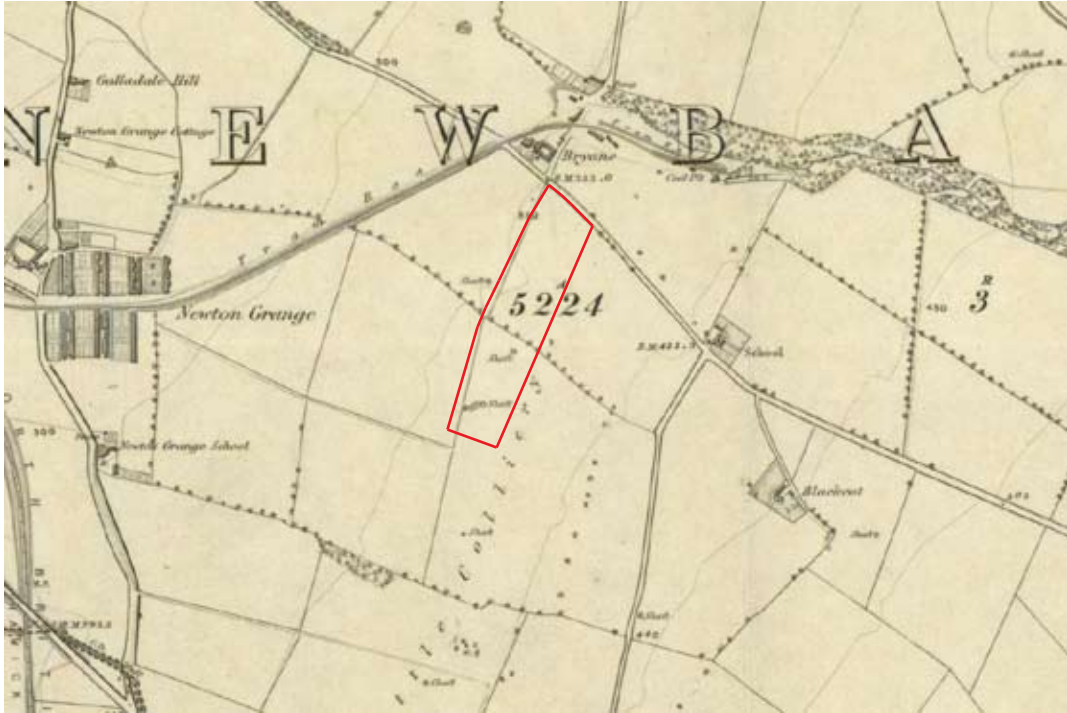
Fig. 2 - Extract from First Edition Ordnance Survey map 1854

- 3.1.6 The Ordnance Survey 1st Edition Map (Midlothian Sheet 13, 1854) also shows the proposed development area as lying within parts of two fields, separated by a hedged boundary, and two 'Shafts' are shown in the southern field (Fig. 2). The land to the south west of the development site (including part of the site) is covered by the annotation "Newbattle Colliery". There are no surface traces of this apart from "Shafts" which are presumably air shafts and the annotation may relate to the location of underground workings.

the feature conforms to that of one of the 'Shafts' first shown on the Ordnance Survey map in 1854 (Fig. 2).

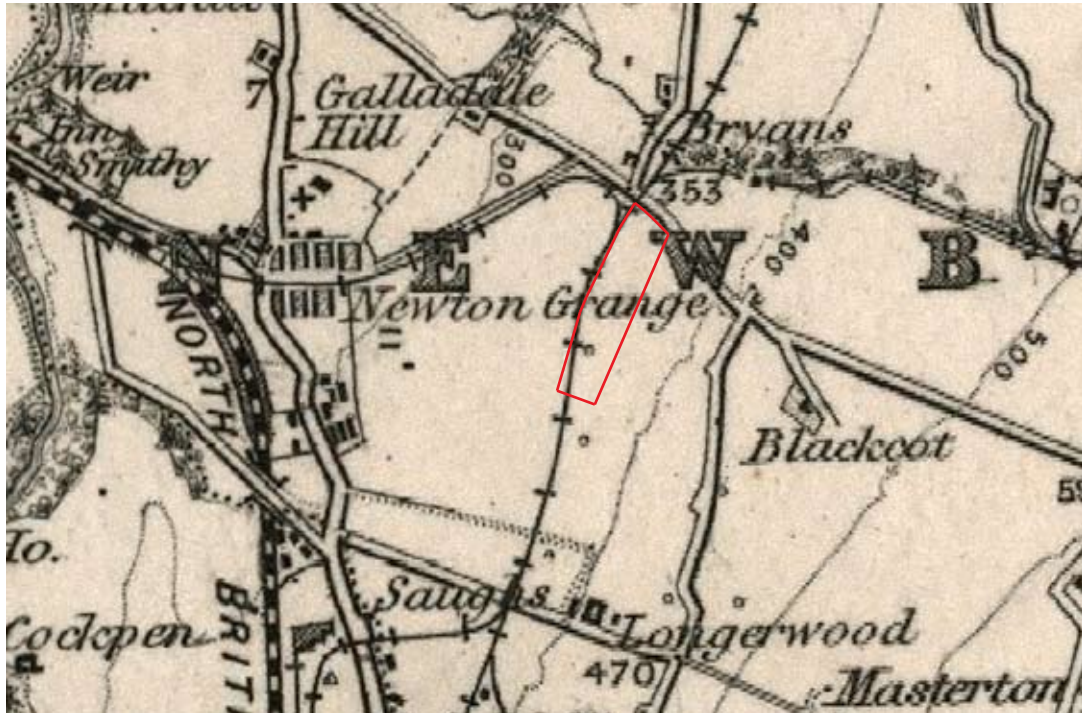
Fig. 3 - Extract from Second Edition Ordnance Survey map 1898

- 3.1.7 The Ordnance Survey Second Edition (Edinburgh Sheet 32, 1898) shows the shafts and by this time the railway to the west of the proposed development area has been constructed (Fig. 3).

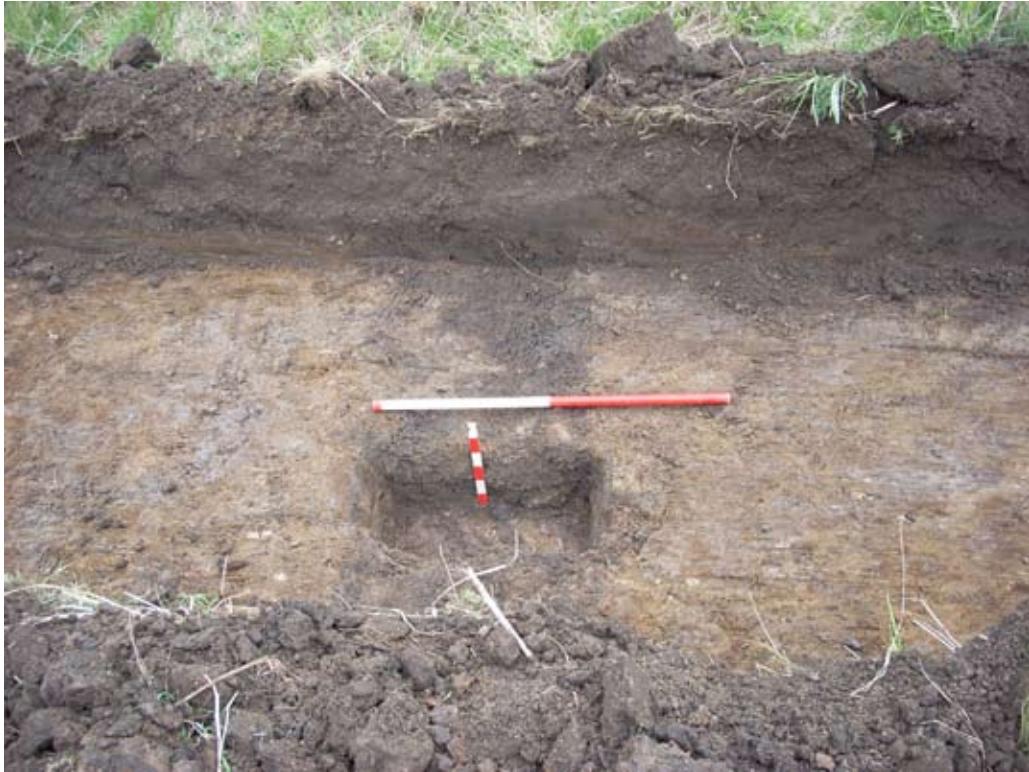
Fig. 4 - Trench 2, ditch 203 section

- 3.3.2 In Trench 2, a ditch (**203**) was recorded (Fig. 4) the cut of which was still faintly visible on the surface suggesting it to be of recent origin. This lay to the north-west of an airshaft (**201**) (see below). The ditch was 0.7m wide, 0.25m deep and had vertical sides with a flat base. No finds were recovered. Ditch **203** was aligned SSW - NNE.
- 3.3.3 A circular feature with a diameter of 3-4m was recorded in Trench 2 (**201**). A sondage with a depth of 0.6m was excavated into the feature and showed that the sides were unlined and vertical. The feature was filled with a coal-flecked grey clay and stones (**202**). No finds were recovered. The general location of

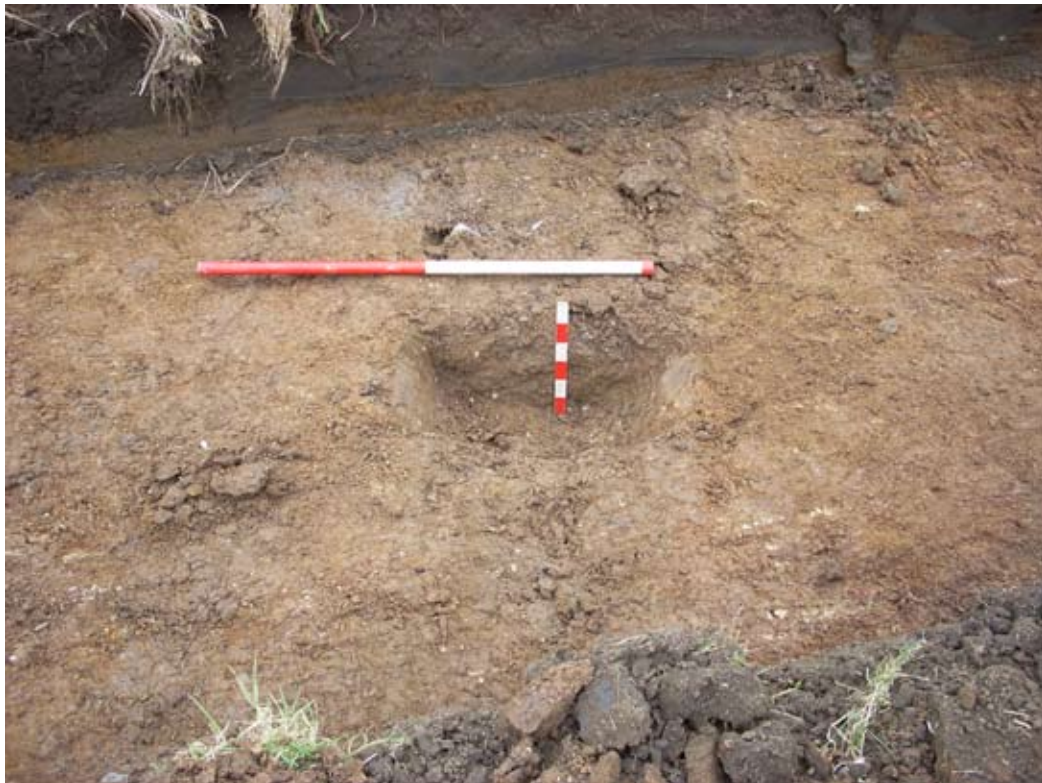
Fig. 5 - Trench 4, ditch 403 section

- 3.3.4 In Trench 4, N-S aligned ditch (**403**) was recorded (Fig. 5) the cut of which was still faintly visible on the surface suggesting it to be of recent origin. This ditch was 0.7m wide, 0.25m deep and had near vertical sides with a flat base. No finds were recovered.

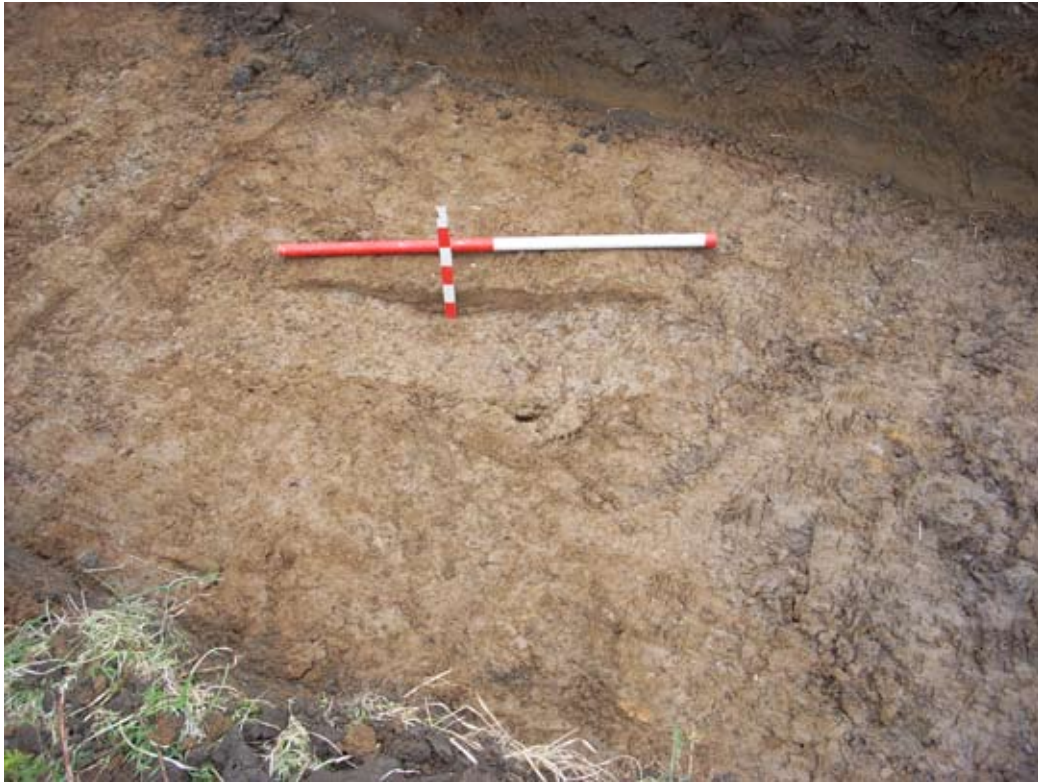
Fig. 6 - Trench 8, ditch 801 section

- 3.3.7 Trench 8 was located to investigate the field boundary identified in the desk-based assessment. A single ditch (**801**) was recorded at this location, aligned roughly NW-SE, with a width of 2.5m and surviving depth of 0.2m (Fig. 6). This contained a yellow-brown clay-silt (**802**). No finds were recovered.

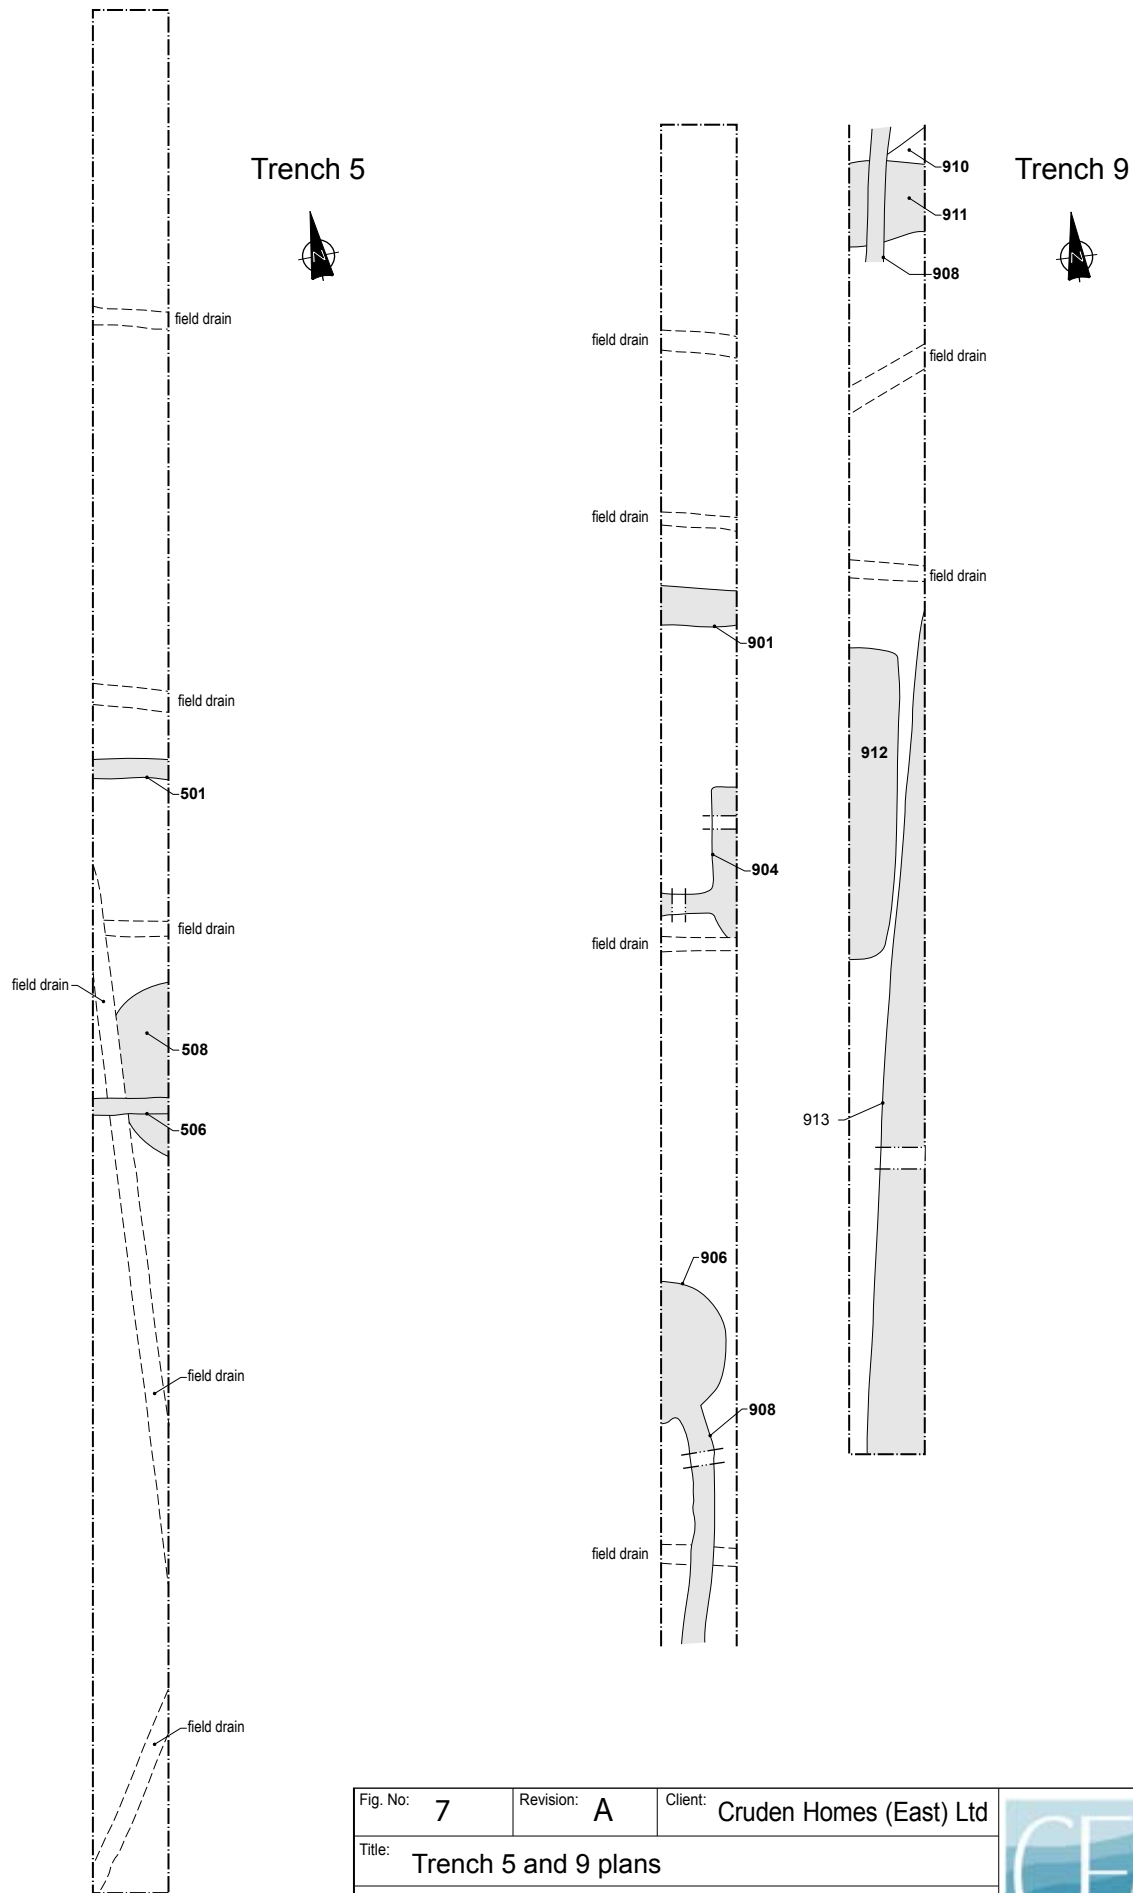
Fig. No: 7	Revision: A	Client: Cruden Homes (East) Ltd
Title: Trench 5 and 9 plans		
Project: Suttieslea Road, Newtongrange, Midlothian Archaeological Desk-Based Assessment and Evaluation

- 3.3.5 In Trench 5, a section of ditch (**501**) was recorded on a roughly E-W alignment. The ditch was V-profiled, had a width of 1.4m and a depth of 0.3m. It contained a significant coal content. The sequence of fills was a primary fill of coal chips and clay (**502**) and a secondary fill of coal-flecked orange-brown clay-silt (**503**). No finds were recovered.
- 3.3.6 A deposit of coal (**508**) within the trench had a width of 5m and a depth of 0.1m. It was cut by stone-filled field drains.

- 3.3.8 In Trench 9, a section of ditch (**901**) was recorded on a roughly E-W alignment in adjacent trenches and may be a continuation of the same feature as they were similar in size, profile and fills (Fig. 8). The ditch was V-profiled, had a width of 1.4m and a depth of 0.3m. The sequence of fills was a primary fill of coal chips and clay (**902**) and a secondary fill of coal-flecked orange-brown clay-silt (**903**), sealed by a buff subsoil (**002**). No finds were recovered. This ditch may be a continuation of ditch **501** in the adjacent Trench 5 as they were similar in size, profile and fills.

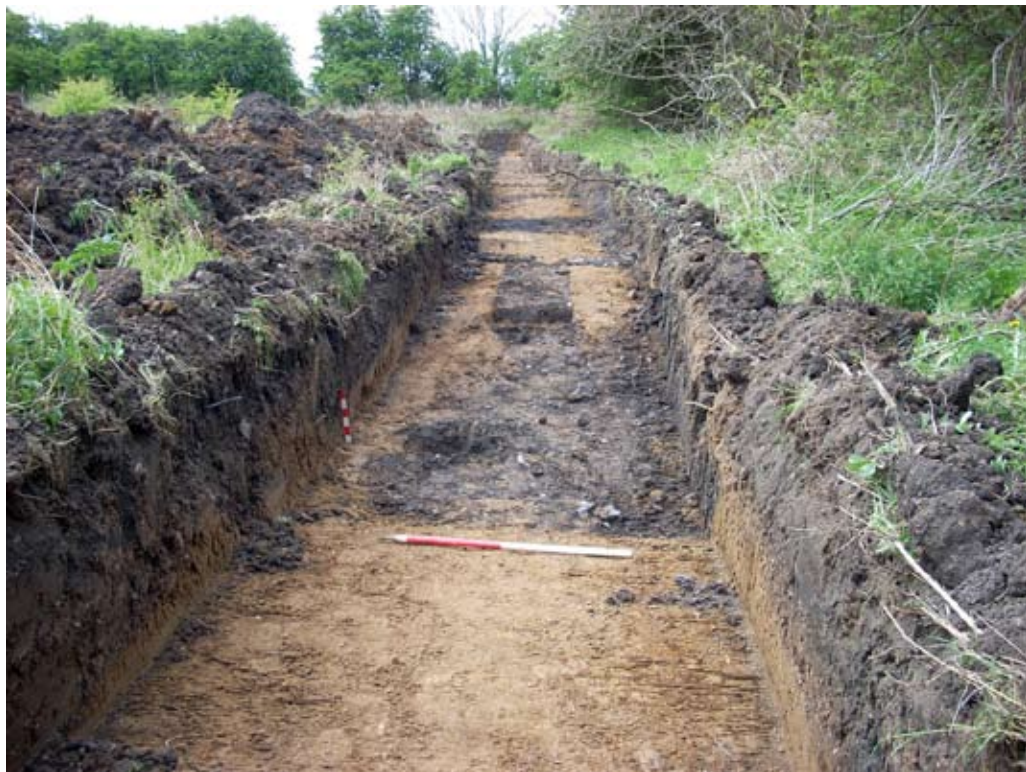
Fig. 9 - Trench 9, airshaft 906 in the foreground with ditches containing coal and soil fills beyond

- 3.3.12 A circular feature with a diameter of 3-4m was recorded in Trench 9 (**906**) (Fig. 9). A sondage with a depth of 0.6m was excavated into the feature and showed that the sides were unlined and vertical. The feature was filled with a coal-flecked grey clay and stones (**907**). No finds were recovered. This feature was very similar to one (**201**) recorded in Trench 2. The general location of the feature conforms to that of one of the coal 'Shafts' first shown on the Ordnance Survey map in 1854 (Fig. 4).

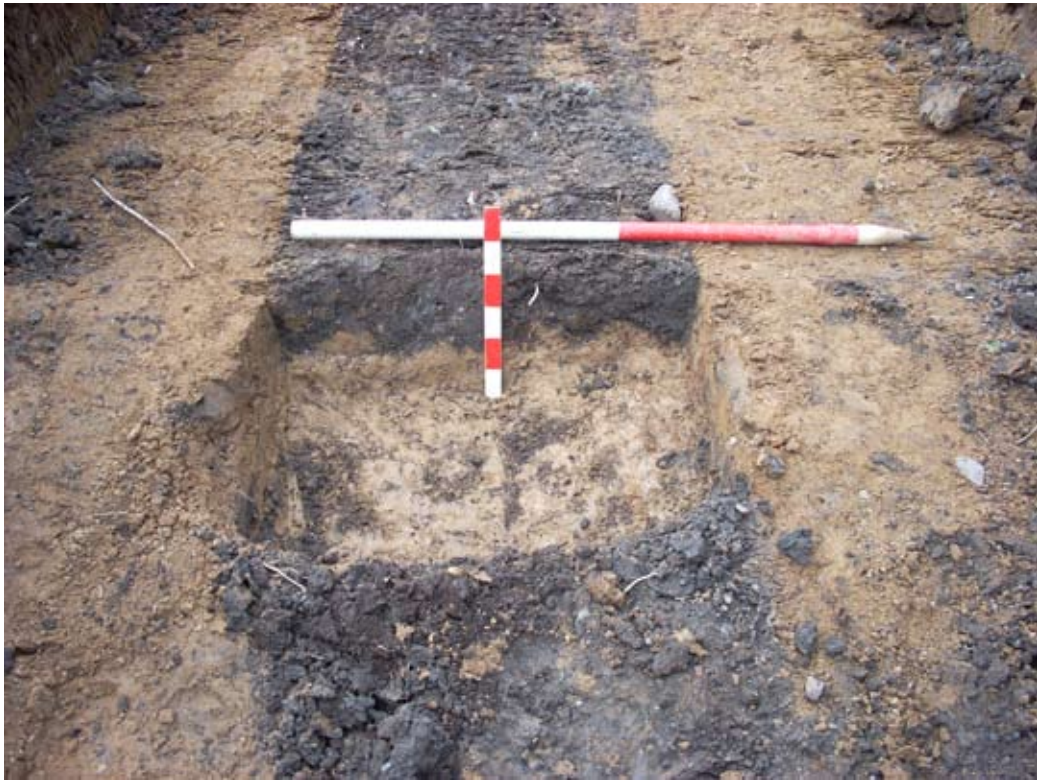
Fig. 10 - Trench 9, ditch 908 section

- 3.3.10 A further ditch (**908**) was recorded in Trench 9 (Fig. 10). This ditch (**908**) had similar dimensions and profile to the ditches recorded in Trenches 2 (**203**) and 4 (**403**), with vertical sides and a flat base. It was aligned roughly N-S and appeared to lead into the airshaft (**906**, Fig. 3). It cut a deposit of coal (**911**) and some field drains. It was 0.7m wide by 0.15m deep.

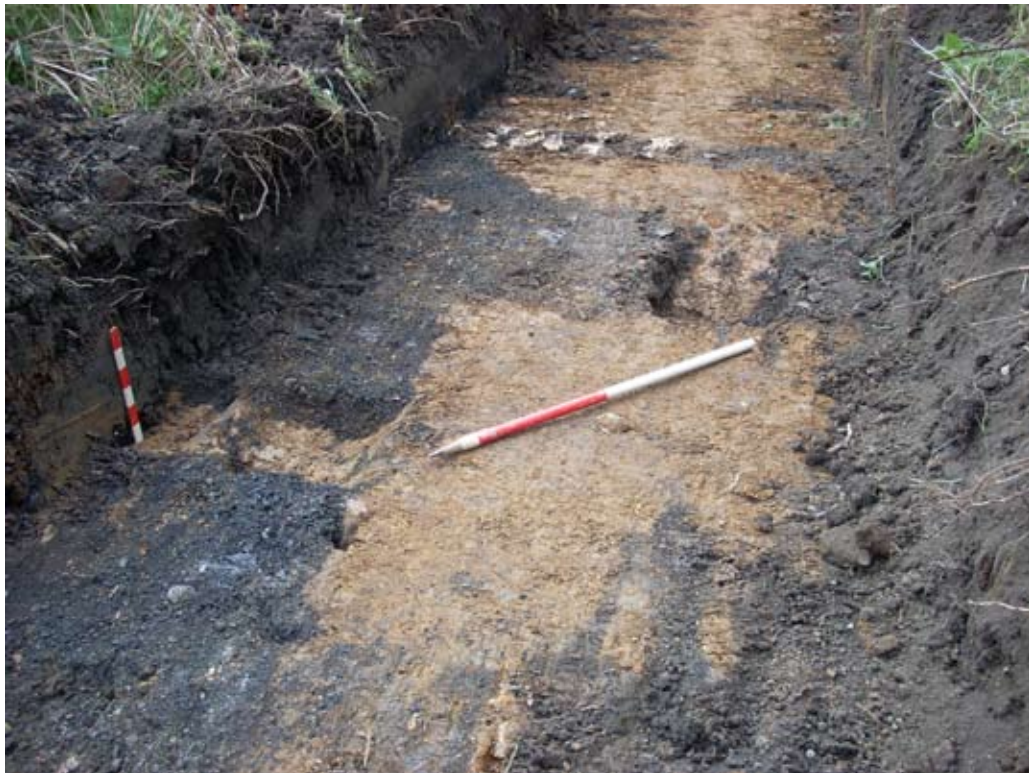
Fig. 11 - Trench 9, ditch 904 section

- 3.3.9 Also in Trench 9, and slightly to the south of ditch **901**, a shallow ditch (**904**) with an irregular plan and a V-profile was cut by a stone-filled field drain (Fig. 11). It measured up to 0.7m wide by 0.25m deep maximum.

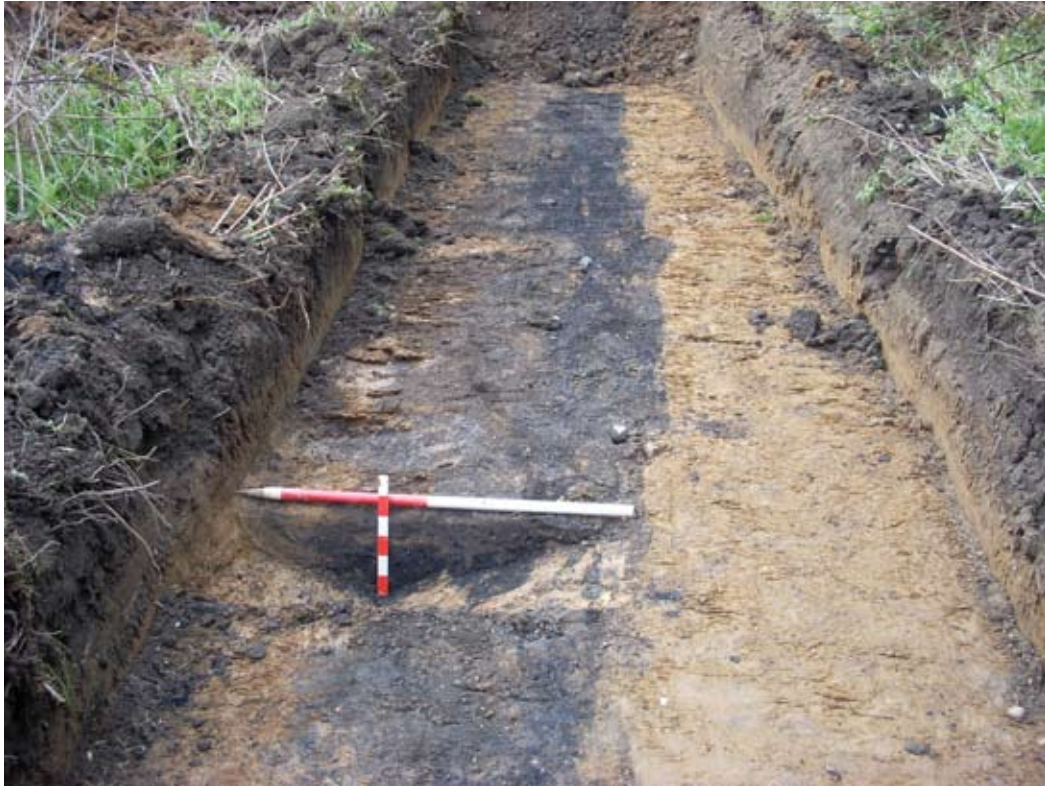
Fig. 12 - Trench 9, ditch 913 section

- 3.3.11 At the southern end of Trench 9, a V-profiled linear ditch (**913**) was recorded, aligned roughly N-S, containing coal-based lower fills (**914, 916**) with an upper fill of re-deposited clean yellow clay (**915**) (Fig. 12). It was 1.1m wide by 0.25m deep. This ditch was sealed by the buff subsoil (**002**). No finds were recovered.

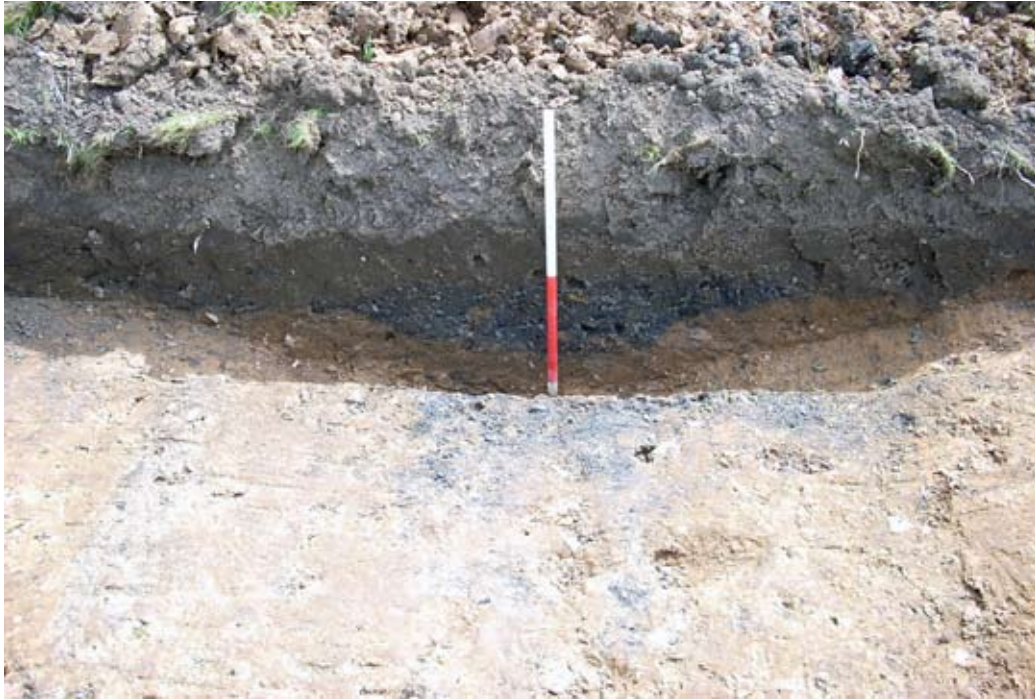
- 3.3.17 In Trench 17, a concentration of stones (**1710**) with a length of 5m and depth of 0.2m was recorded towards the northern end of the trench. These were distributed within a coal-flecked subsoil (**002**) and did not appear in the parallel Trench 18.

Fig. 13 - Trench 17, Section through furrow 1703 showing the primary fill of soil (1704) overlain by an upper fill of coal chips (1705)

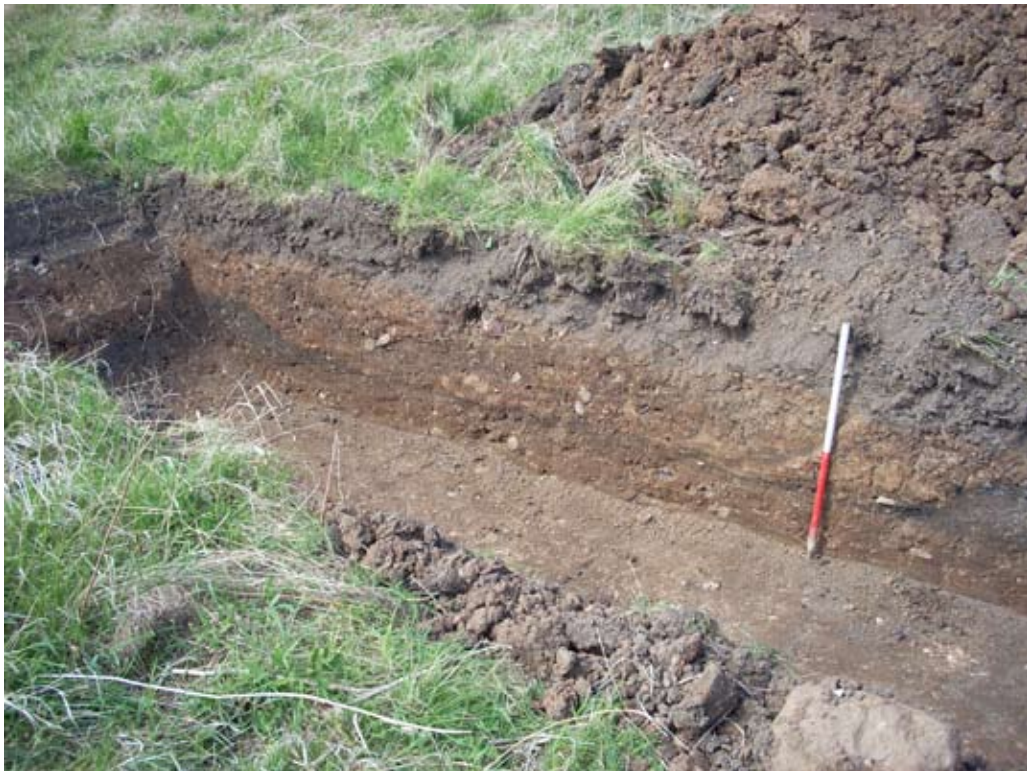
- 3.3.18 In Trench 21 made ground was recorded this may be the edge of the spread of made ground identified in Trench 16. It appeared that the made ground (**2101**) also filled a shallow cut (**2105**) (Fig. 14) at this point, however, the form and function of this cut was not identified, but it is not likely to be of any great antiquity as it cut subsoil and nineteenth century finds were present within the made ground and the subsoil.
- 3.3.19 A deposit of coal (**2106**) with a length of 2m and a depth of 0.1m overlay a subsoil (**2103**) and underlay made ground (**2101**).

Fig. 14 - Trench 21, made ground 2101 over subsoil 2103
