CFA ARCHAEOLOGY LTD

January 2009

**FRIARDYKES STEADING, CRYSTAL RIG,
SCOTTISH BORDERS,
STANDING BUILDING SURVEY**

Report No. 1582

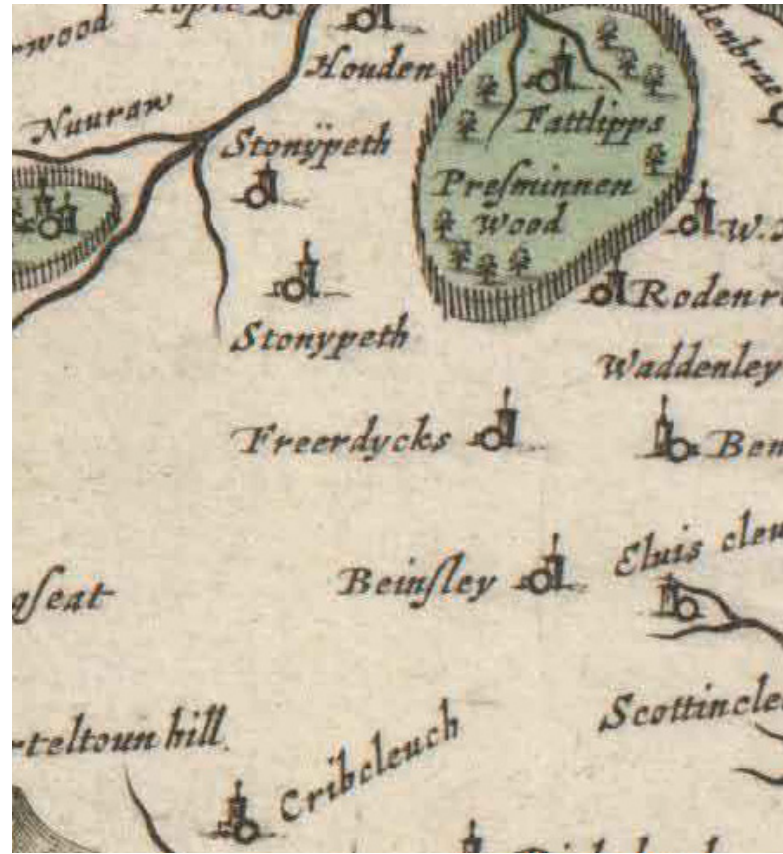
Fig 2a - Blaeu's 1654 Map

- 3.1.1 The cartographic sources examined are listed in Section 7. A settlement, annotated as 'Freerdycks' is first recorded on Blaeu's Atlas of Scotland (1654) (Fig. 2a). The settlement is also depicted on Adair's map (1682) annotated as 'frierdyks'(Fig. 2b).

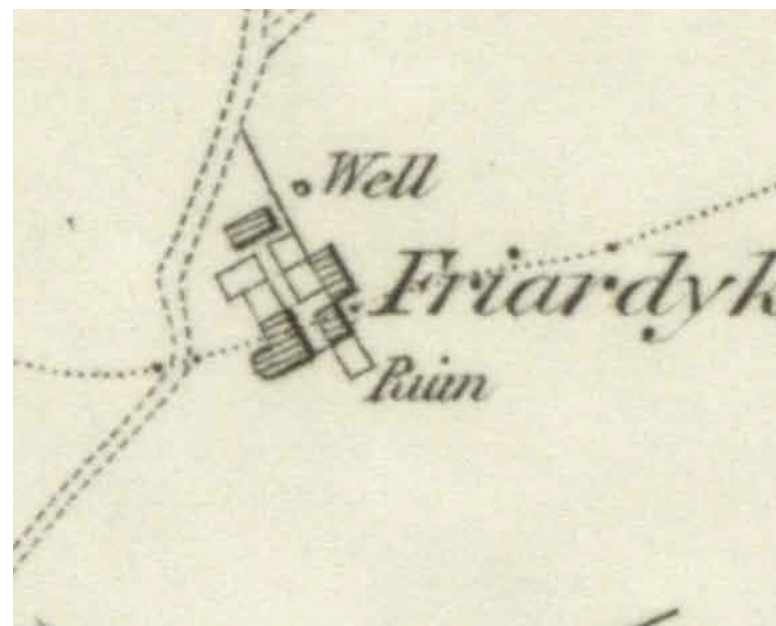
Fig 2d - 1855 First Edition

- 3.1.4 The 1855 First Edition Ordnance Survey map (Fig. 2d) shows Friardykes Steading comprising a single detached rectangular building situated on the north side of a rectangular range. The west side of the range is formed by an L-shaped structure, the short arm having a slightly curving wall. On the east side is a partially roofed building which is annotated as 'Ruin', and another roofed building offset from the other. Four small enclosures are depicted between the range and the detached building. In addition, a well is depicted immediately NE of the steading.

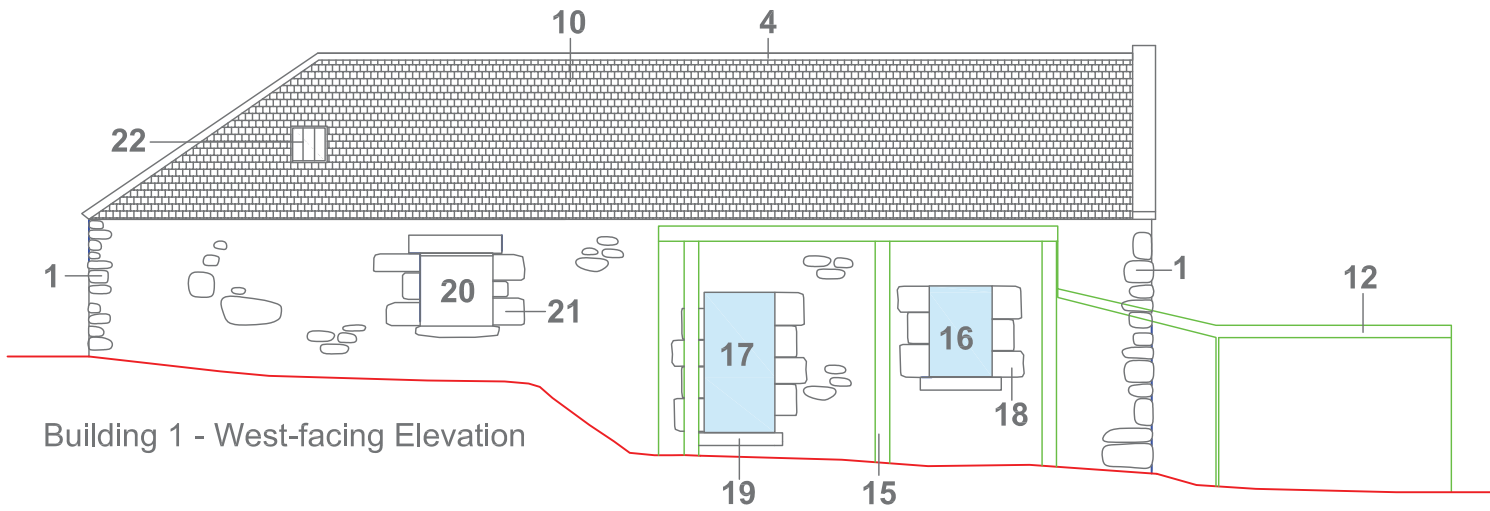
Building 1 - West-facing Elevation

- 4.3.4 The west-facing gable is partly masked by a timber-built shed (15) with corrugated sheet walls. At the south end of the west-facing elevation there is a blocked window (16) and doorway (17). The blocked window has sandstone long and short surrounds (18) and measures 1.7m wide and 0.78m high. The blocked doorway measures 2m high and 0.93m wide and has a worn sandstone step at its base (19). Both lintels above the door and window are missing. At the north end of the elevation there is rectangular opening (20); the window frame is missing. The window measures 1m wide and 0.95m high and has splayed ingos with droved surrounds (21). The slate roof (10) has a 9-paned skylight (22) at the north end.

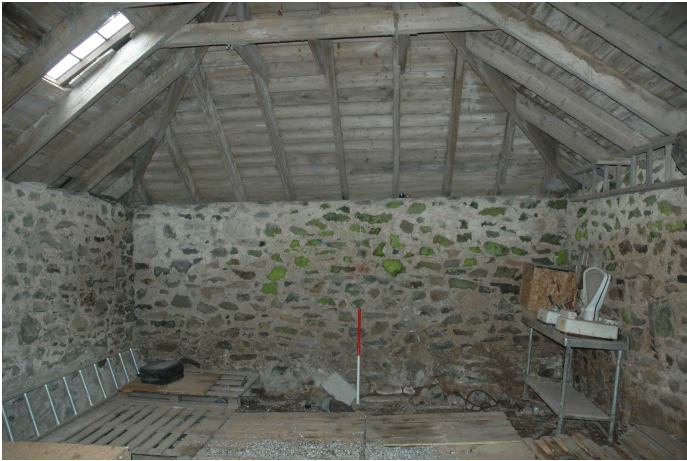
- 4.4.1 Unit 1, the former byre, measures 7.4m long and 4.8m wide and has an earth floor. All the walls are built of random rubble with no surface coatings. The north gable wall is featureless (Plate 1). The west wall has a single rectangular window opening. The opposite east wall has the two slit vents (6) and the doorway; the door opening has its original quoins (7) in situ but the lintel is missing. At the south end of the unit is the remains of a partition wall which has two entrances into Unit 2 (Plate 2).

Plate 1 - Building 1 interior shot of the north end of Unit 1, former byre

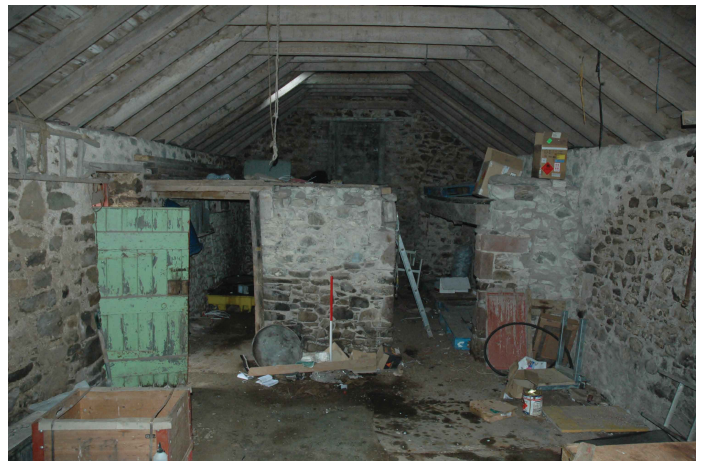
Plate 2 - Building 1 interior shot of the south end, of Unit 2, loft

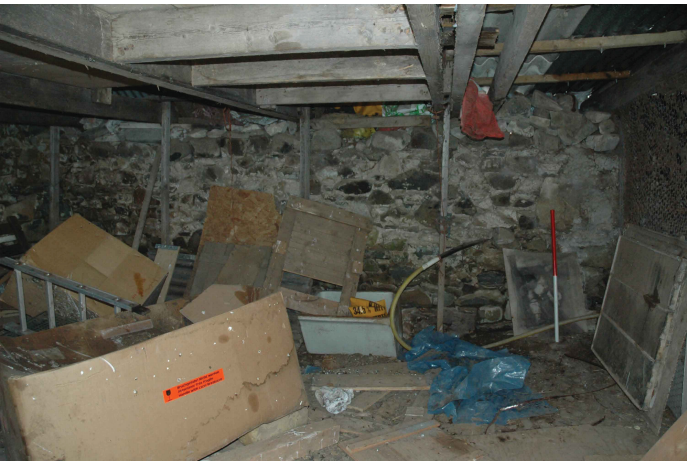
- 4.7.2 Unit 2 has plain rubble walls that stand to a height of about 2m (Plate 3). This unit has been compartmentalised with old doors and chicken-wire to create a small animal pen (Plate 4). The larger area has an original stone sett floor with a central drain. The ceiling has been created using old doors suspended on re-used timber joists. The pigeon loft has been created in the roof space.

Plate 3 - Building 2 interior shot of Unit 2, animal house

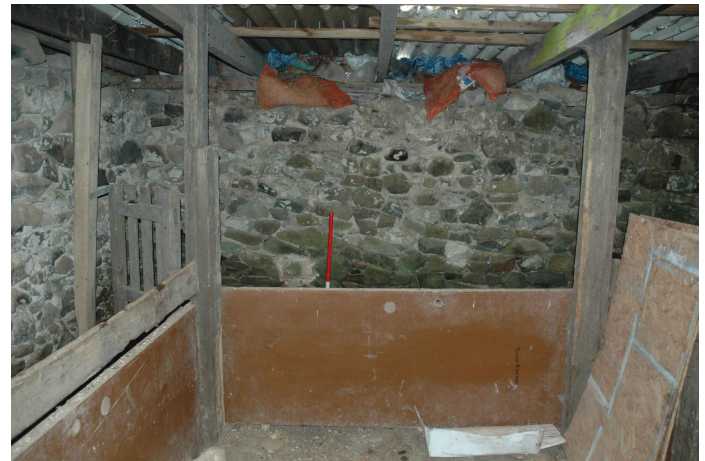
Plate 4 - Building 2 interior shot of Unit 2, animal pens

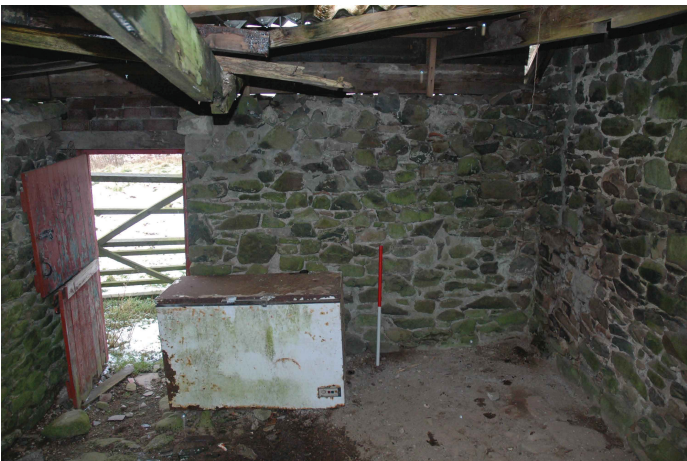
- 4.7.4 This unit measures 4m by 3.8m and has plain rubble walls (Plate 5). The floor comprises stone setts with a central drain that runs through the entrance.

Plate 5 - Building 2 interior shot of Unit 4, animal house

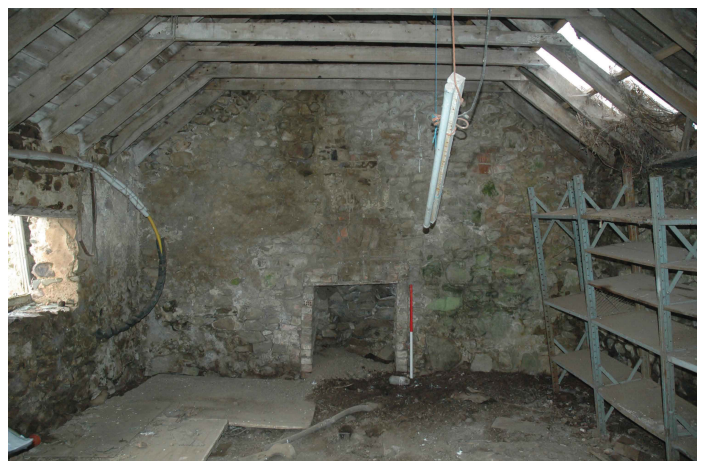
- 4.10.2 Unit 1 measures 7m by 4.7m and is lit by the window (38) on the west wall and by two plastic skylights. The roof space is open, exposing the scarf-jointed A-frame roof timbers that rest directly on top of the wall heads (Plate 6). On the west side of the building, the original sarking boards are still in situ. With the exception of the south partition wall, which carries plaster, the walls are exposed rubble. At each end of the room there is a brick-built fireplace which occupies the centre of the wall. These are later inserts; machine-pressed brick and a cast-iron strap support the mantle. The grate has not survived. Running the length of the cobble floor is a wide central drain (Plate 7). The cobbles contain kerb-stones and may represent more than one phase of floor.

Plate 6 - Building 3 interior shot of Unit 1, inserted fireplace in the gable

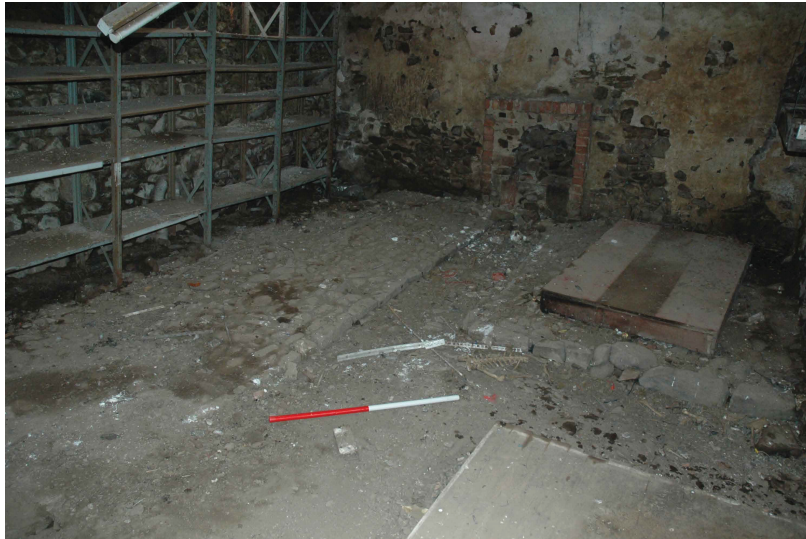
Plate 7 - Building 3 interior shot of Unit 1, central drain on the byre floor

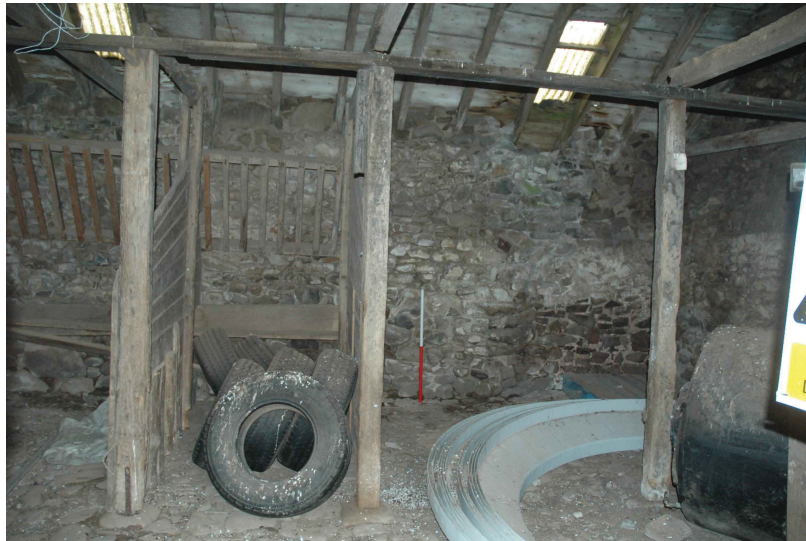
- 4.10.3 The stable measures 6.3m by 5m and is accessed by the double-leaved door on the east wall. Two plank-built trevisses forming the stalls are situated on the east wall (Plates 8-9). Hay hecks or slatted feeding troughs are present on the same wall. The stalls are 2.5m high and the largest is 2m wide with the smaller one being 1.3m wide. The stall newel posts have been inserted into socket stones and support a timber beam which runs north-south across the stable. All the walls are plain rubble with no surface coatings. The west walls have recesses built into them either side of the doorway, which contain a series of wooden posts for hanging tack. The floor is a mixture of cobbles and stone setts. Within the roof there is a galvanised vent.

Plate 8 - Building 3 interior shot of Unit 2, stable newel posts

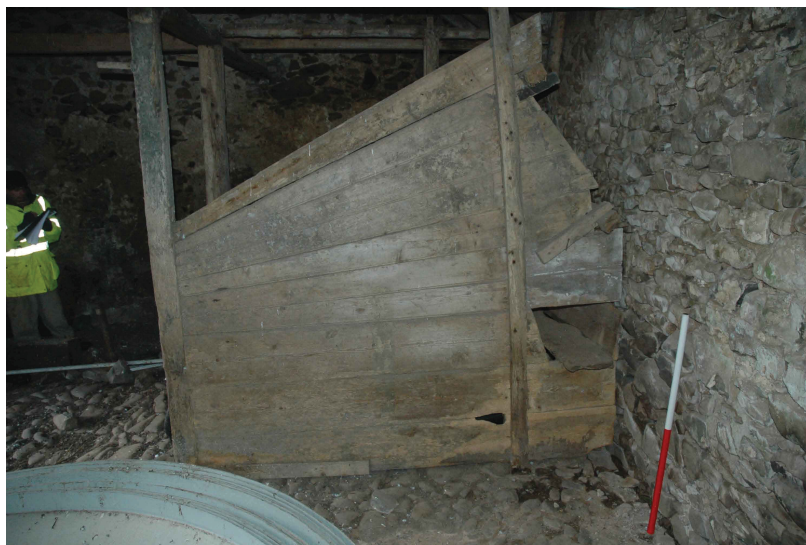
Plate 9 - Building 3 interior shot of Unit 2, plank-built stable stall
