Friardykes Steading, Crystal Rig, Scottish Borders. Archaeological Watching Brief

Data Structure Report No. 1615 v2

Author	Helena Gray MA
Illustrators	Neil Kinnaird MA & Leeanne Whitelaw BSc MA AI&S
Editor	Melanie Johnson MA PhD FSA Scot MIfA
Commissioned by	Natural Power Consultants Ltd
Date issued	April 2009
Version	2
OASIS Reference	cfaarcha1-52014
Planning Application No	08/00330/FUL
Grid Ref	NT 6618 6805

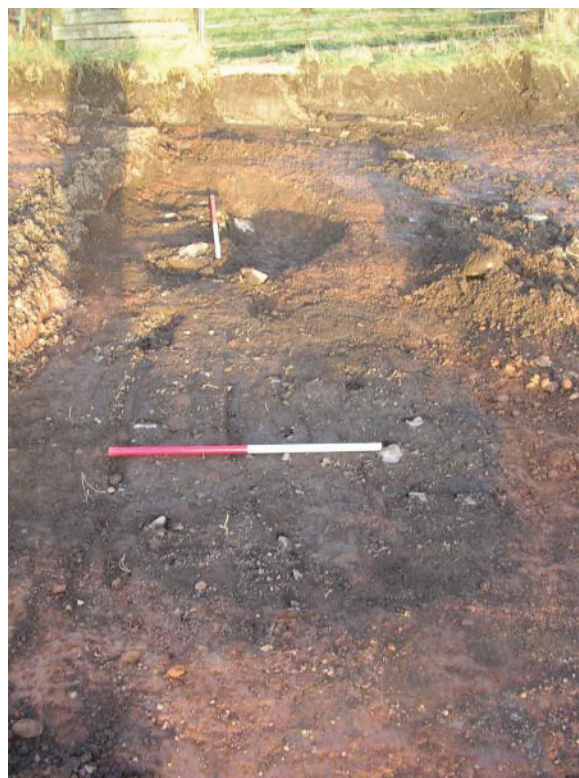
Fig. 3c General shot of pits [006] & [008] from W

- 3.2.3 Two adjacent pits (Fig. 3c) and a curvilinear feature (Fig. 3d) were identified to the south of the Friardykes buildings. The first pit consisted of a sub-circular cut (**006**) with steeply sloping sides and a flat base, measuring 1.75m by 1.6m by 0.4m deep. It was filled with (**007**), a dark grey clayey silt containing occasional sub-angular stones. The second pit (**008**) was largely disturbed and not investigated but consisted of a sub-circular cut measuring 1.7m by 1.6m, filled with (**009**), a material similar to (**007**). The curvilinear feature was located 3m to the south of (**006**) and (**008**). A single slot was excavated through the feature revealing a cut (**010**) with shallow sloping sides and a concave base measuring 8m by 4m by 0.3m deep. It was filled with a firm, dark grey-brown clayey silt (**011**) containing occasional sub-angular stone inclusions. Neither the pits nor the curvilinear feature contained any finds and the function and date of these is unclear.

- 4.4 Two pits and a curvilinear feature were excavated to the south of the buildings. No finds or other dating material were recovered from these features and their function remains unclear.

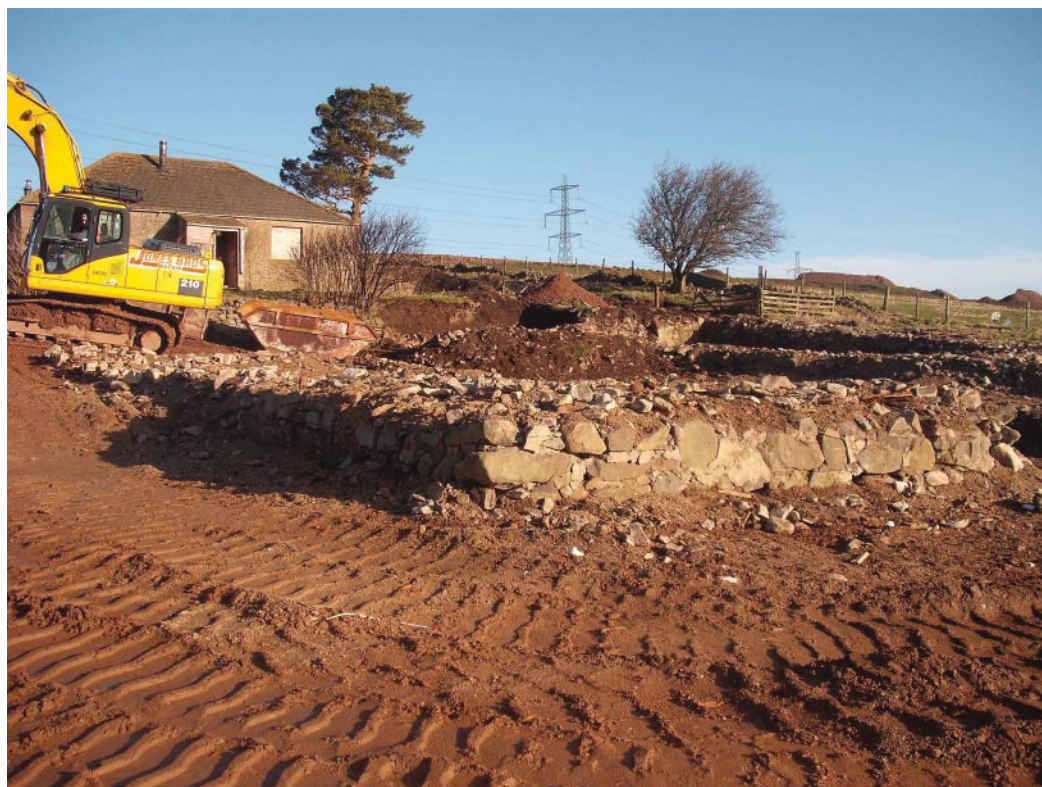
Fig. 4a General shot of Building 1 with lower courses still upstanding, from NW

- 3.3.1 The Friardykes buildings were demolished down to the lower two to three courses (Fig. 4a) prior to the second phase of the watching brief. Removal of the remaining upstanding walls under archaeological supervision revealed that all three buildings had been built directly onto natural subsoil (Fig. 4b), rather than any earlier building remains which pre-date the current 18th-19th buildings.
