**Friardykes Steading, Crystal Rig,
Scottish Borders.
Archaeological Watching Brief**

**Data Structure Report
No. 1715**

Author	Helena Gray MA
Illustrator	Leeanne Whitelaw BSc MAAIS
Editor	Melanie Johnson MA PhD FSA Scot MifA
Commissioned by	Natural Power Consultants Ltd
Date issued	November 2009
Version	0
OASIS Reference	cfaarcha1-60179
Planning Application No	-
Grid Ref	NT 6618 6805

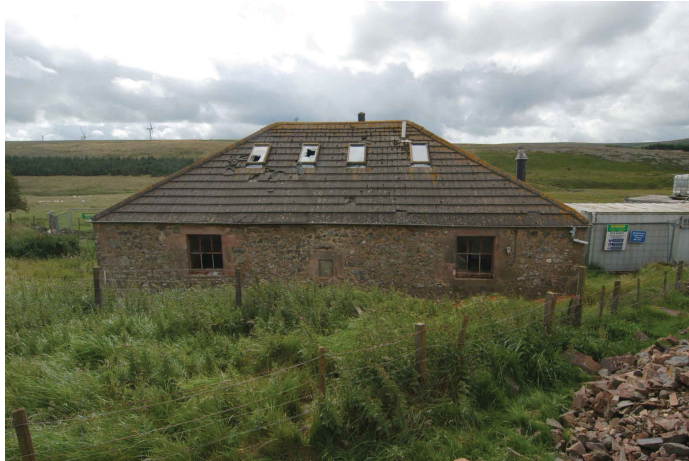
Fig. 2 General view of cottage prior to demolition, from N

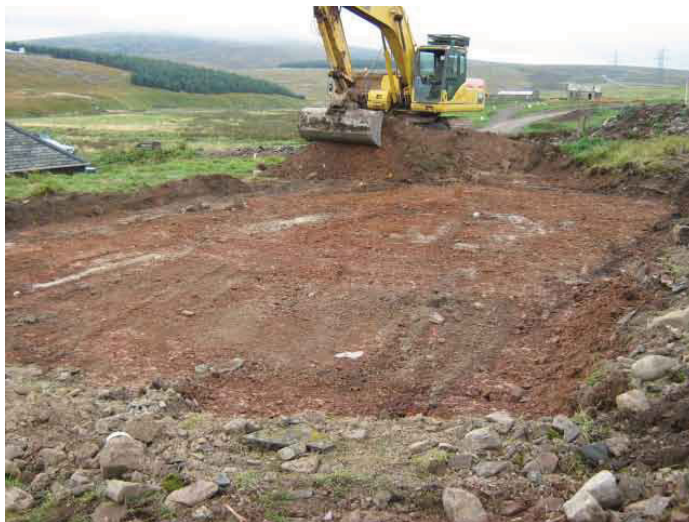
4.2 A farm cottage dating to the 18th-19th century was removed during the course of this work, but did not overlie any earlier building remains. No earlier architectural features were revealed during the soft-strip of the building interior.

Fig. 4 General shot of building footprint after foundation removal, from N
