Avon Place, Linlithgow:

Boundary Wall Survey

Report No 1635

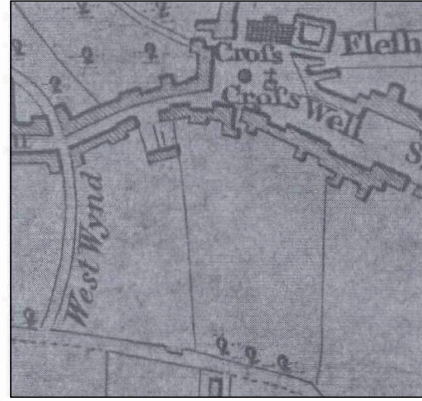
Fig. 2b - Armstrong's map 1773

3.2.2 Armstrong’s map of 1773 (Fig 2b) depicts West Wynd, which was formally created in 1692 when the council purchased a vacant plot of land. The map depicts the boundary wall with a distinct outshot break in the alignment of the wall close to the current pedestrian underpass. Whether this break marks a formal opening is not clear.

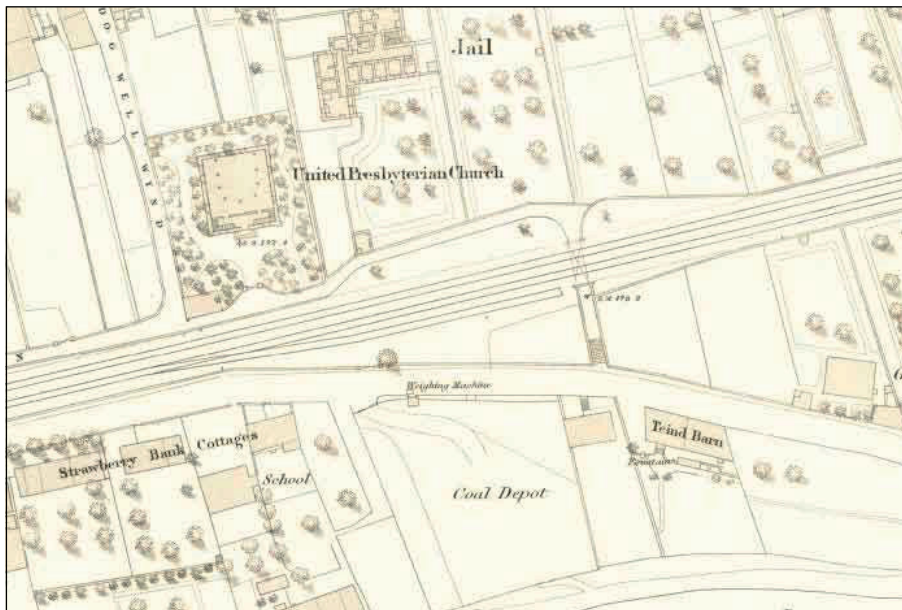
Fig. 2d - 1856 Ordnance Survey Map

3.2.4 The 1856 Ordnance Survey plan of the town (Fig 2d) shows the proposed development site was then a railway siding. The land immediately to the south was a coal yard with a weighing machine and it is assumed that the siding was associated with supplying and transferring coal by road rail and the Union Canal.

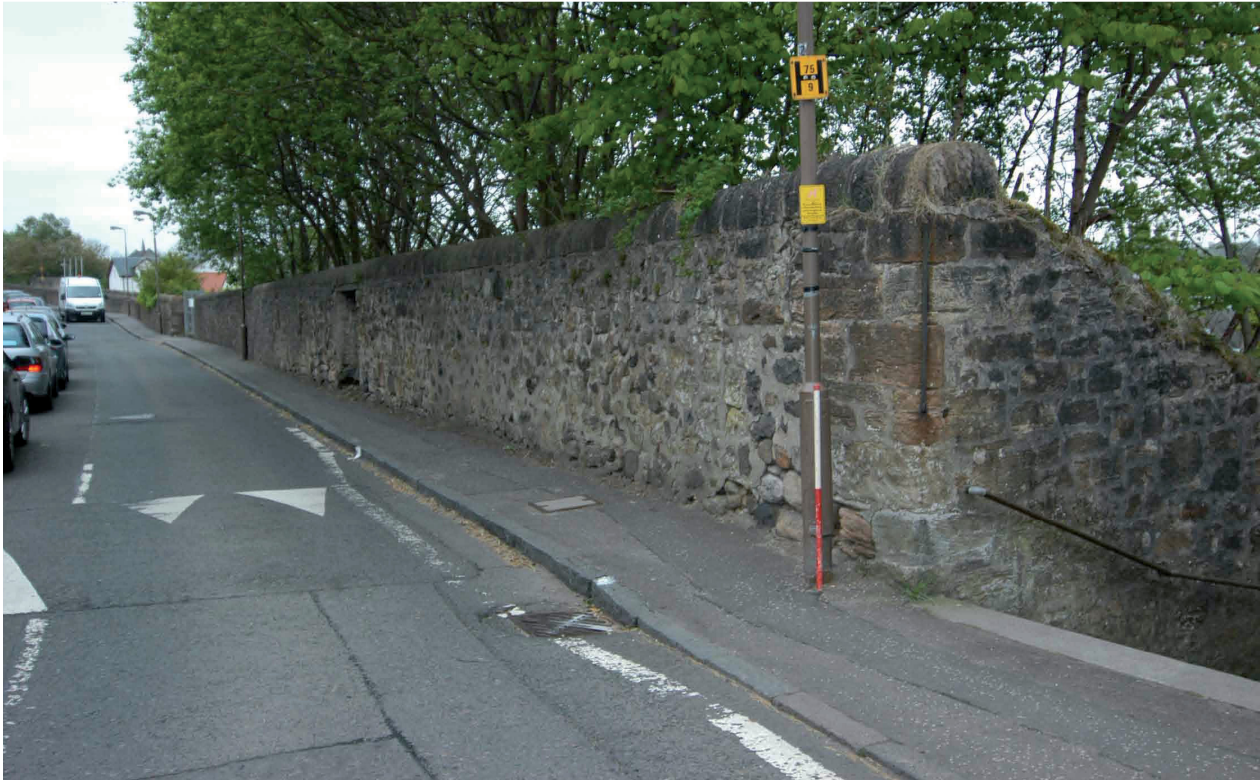
Plate 1 - General view of the south-facing elevation at Avon Place, looking east

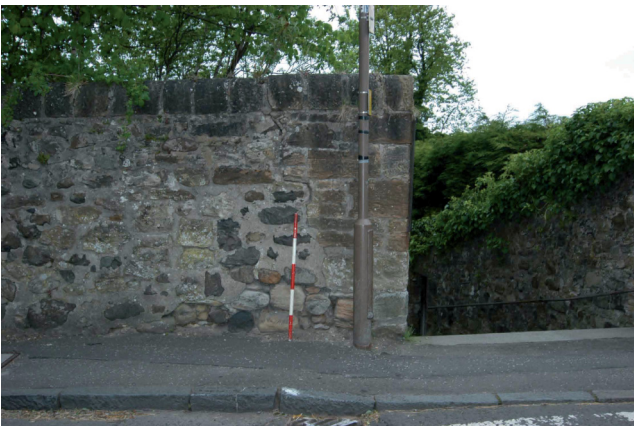
- 5.2 The break in construction at the eastern terminus of the wall where well-dressed stonework meets random rubble with great non-conformity is suggested to date from the construction of the pedestrian railway underpass, installed by 1842. The Linlithgow section of the Edinburgh to Glasgow railway was completed by this year (Butt 1995).

Plate 2 - Section of ashlar re-build associated with the railway underpass

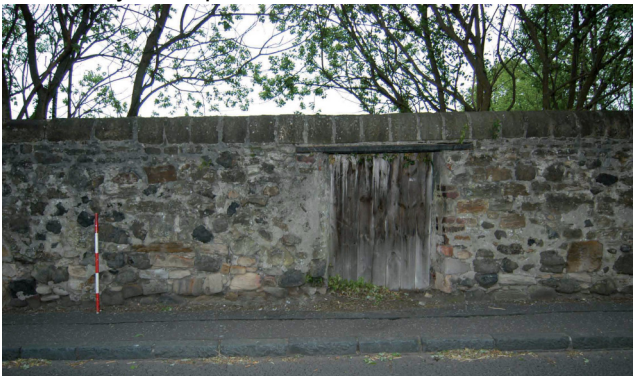
- 5.3 Door opening (3) is a secondary feature placed in the wall perhaps when the site was used as railway siding. The door surrounds incorporate brickwork which, based on their 'industrial' character, would strongly suggest a late 19th or early 20th-century date for insertion. The use of three sections of standard gauge railway line for the lintel support strongly suggests the latter.

Plate 4 - Blocked openings 3 and 4 on the south-facing elevation

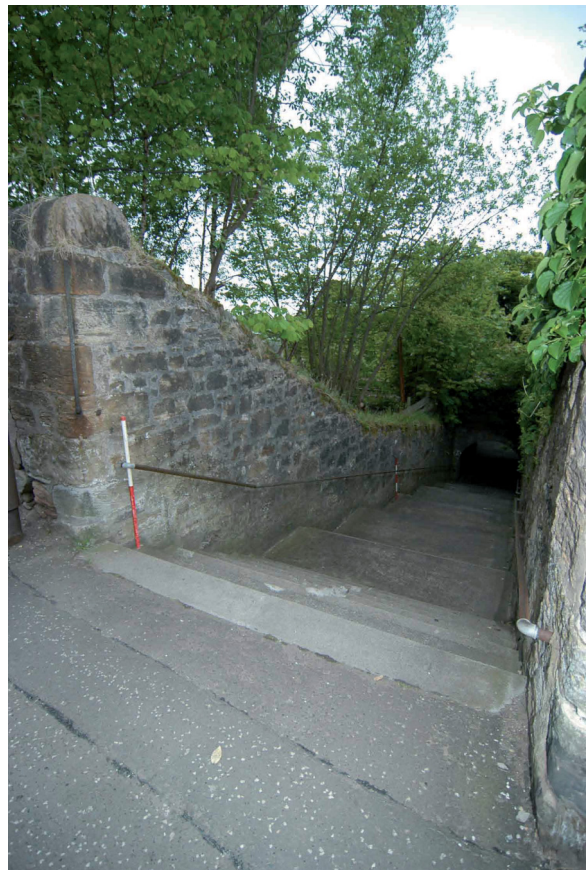
Plate 3 - West-facing site boundary wall flanking the steps to the railway underpass

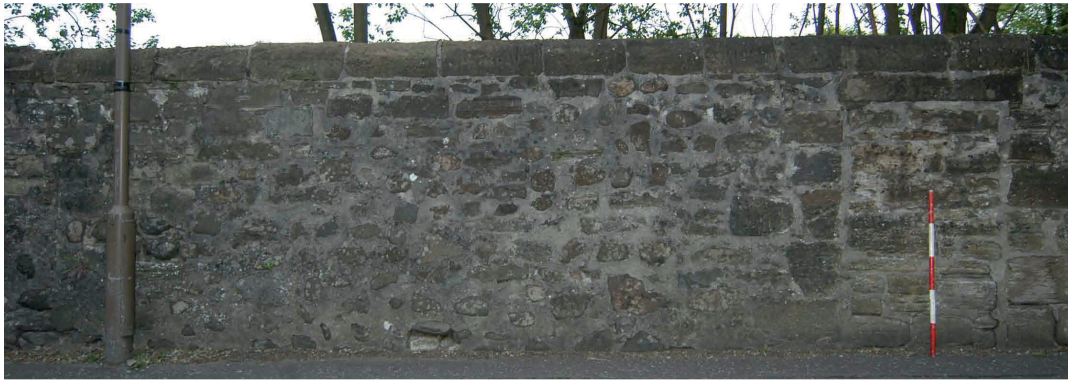
- 5.4 Assigning a chronology for the door openings (4) and (5) is more difficult but the use of chamfer moulding in the door surrounds for opening 4 points towards the 18th century or earlier. These doorways probably served as formal yardhead entries into the properties they served.

Plate 5 - Blocked openings 4 and 5 on the south-facing elevation

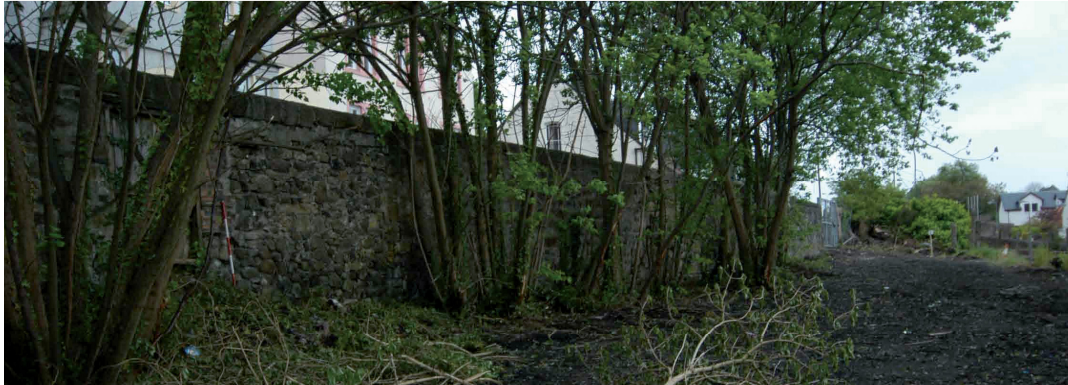
Plate 6 - North-facing elevation, general view looking east

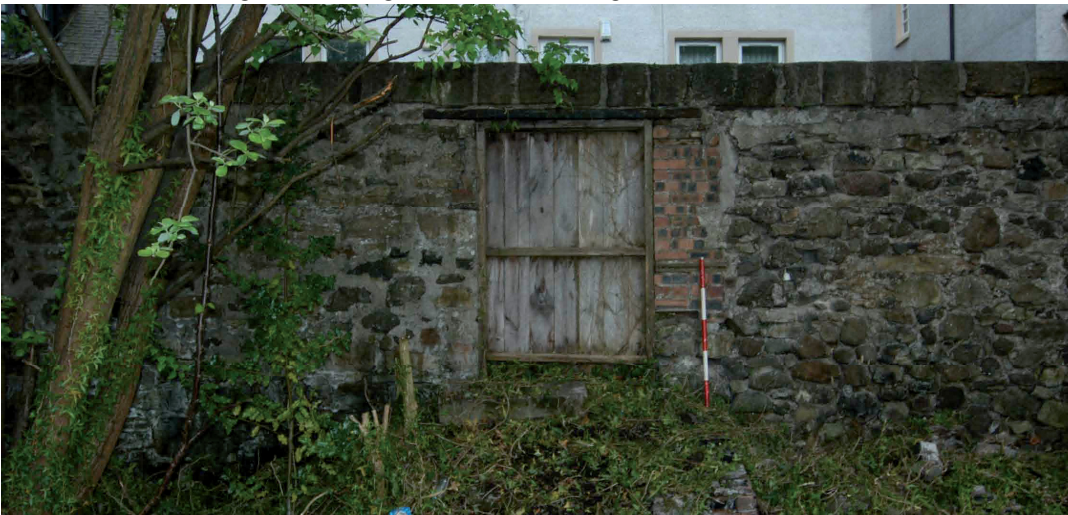
Plate 7 - North-facing elevation, blocked opening 3, general shot

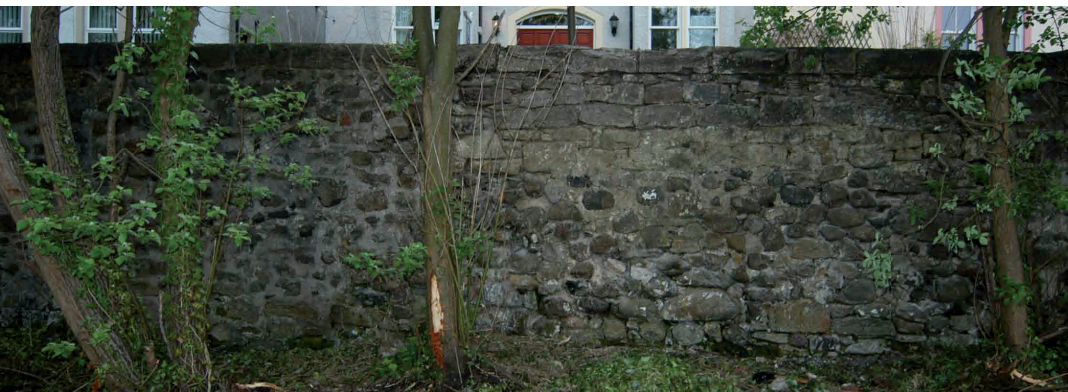
Plate 8 - North-facing elevation, section of wall that is bulging outwards
