**Broadshade Pipeline Diversion,
Westhill, Aberdeenshire**

**Archaeological Watching Brief
Data Structure Report**

No. 1658

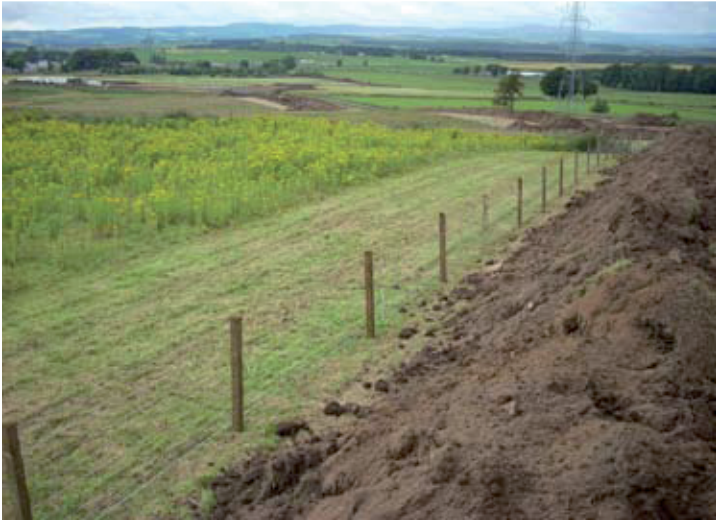
Fig. 2 - General view of the pipeline route looking south-west from near Wall 6

1.2.2 The route of the pipeline (Fig. 1) began west of the farmstead of Kilnhillock. It continued on a northerly trajectory (Fig. 2), crossing Old Skene Road before turning eastwards between the farmsteads of Hill of Keir and Broadshade. It terminated to the south-east of the farm of Berryhill (Fig. 3), between Hill of Keir and Westhill.

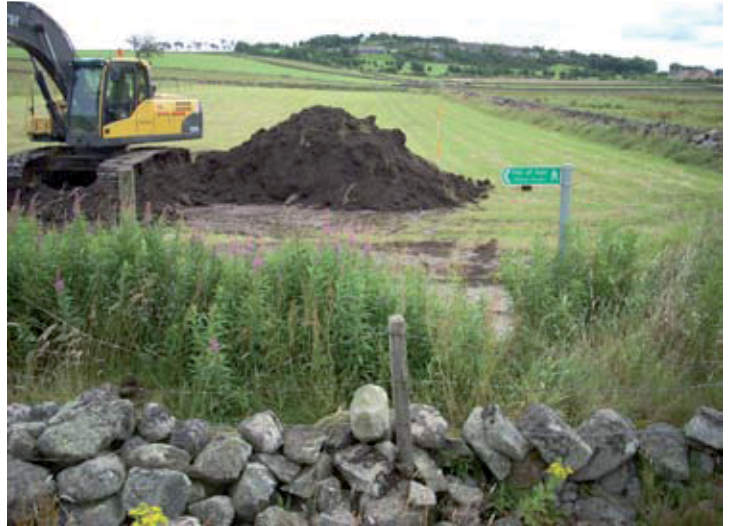
Fig. 3 - General view of the pipeline route pre-excitation looking east with the location of the northern tie-in top left and Wall 8 in the foreground

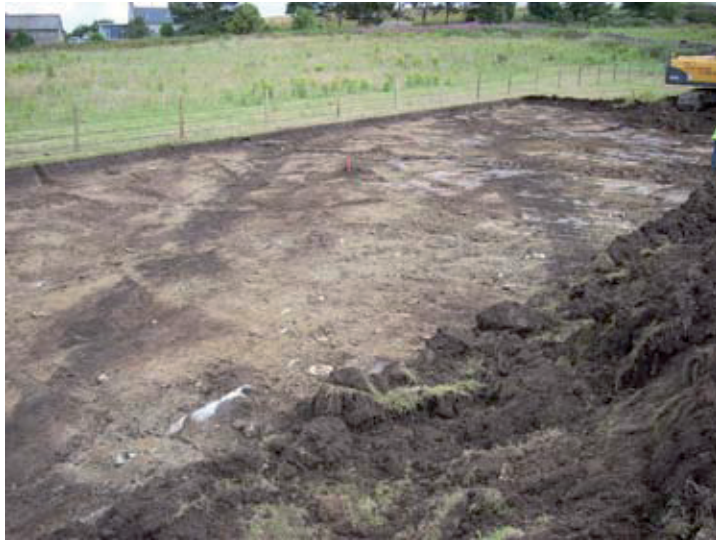
Fig. 4 - Broad rig between Walls 5 & 6

- 3.3.2 Parallel furrows representing the remains of broad-rig strip cultivation were recorded in better drained and less stony portions of the pipeline route. These included the area of the site compound and all fields to the south of Old Skene Road. Their alignment was NE-SW and they were spaced (centre to centre) at 11m-13m. Furrow widths of 1.7m and depths of 0.2m were recorded. One furrow (**003**) contained a dump of organic silt (**005**) which included sherds of post-medieval ceramic and slate. They were also recorded to the north of Old Skene Road in an area of stone-free subsoil between Walls 5 and 6 (Fig. 4), where the alignment was N-S and spacing was c.6m. Further examples lay in the area between Walls 14 and 4 (Fig. 5). In both instances, the furrows were 1.3m-1.7m wide and 0.1m-0.15m deep.

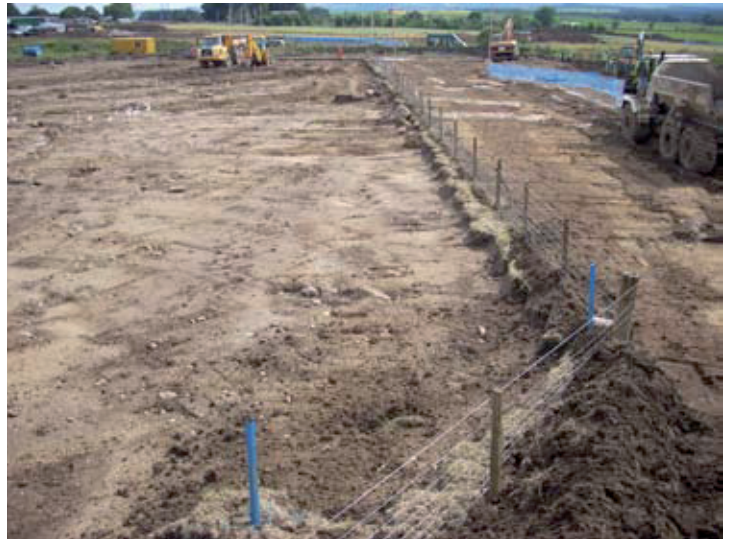
Fig. 5 - Broad rig between Walls 4 & 14 with pond excavation area on the left

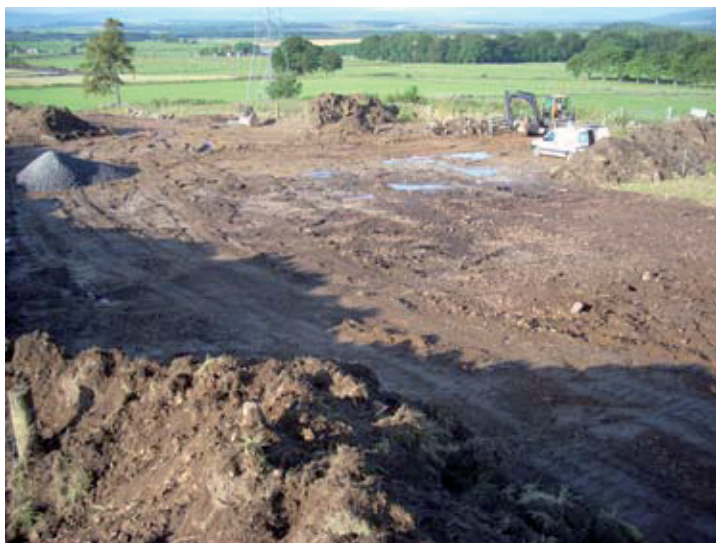
Fig. 6 - Site 2 prior to evaluation

- 3.3.4 Immediately to the north of RDX2, an extensive deposit of pinkish shattered stones in a black peaty matrix (**010**) was revealed at NJ 8109 0765 (Fig. 6). This measured 17m by 16m and was almost surrounded by a second deposit of similar shattered stones within a grey sandy matrix (**011**). Together, these deposits measured 24m north to south and exceeded the width (east to west) of the pipeline easement (23m here). These deposits were cut by numerous stone-filled field drains. The area was planned and evaluated by two machine excavated trenches (Trenches 2-3). These revealed that both deposits (**010**, **011**) overlay natural clay and stones and had formed as a result of poor drainage. No finds were recovered.

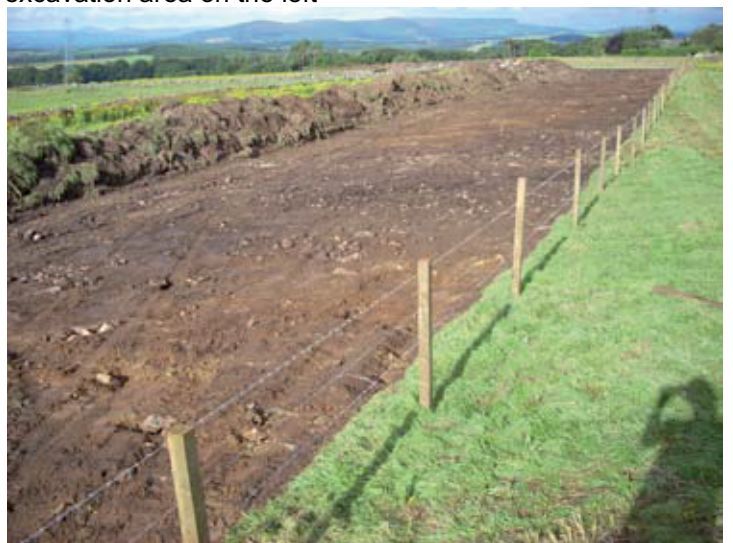
Fig. 7 - Site 3 with Wall 6 at the top right

- 3.3.5 In the field between Walls 6 and 7, in an area of exceptionally stony subsoil, a natural hollow with a width of 10m crossed the pipeline route at NJ 8130 0780 on a north-west to south-east alignment (Fig. 7). This was filled with cobbles and boulders within a loose peaty matrix (**008**). Machine excavated trenches (Trenches 4-5) found this deposit to be 0.75m deep. No finds were recovered.

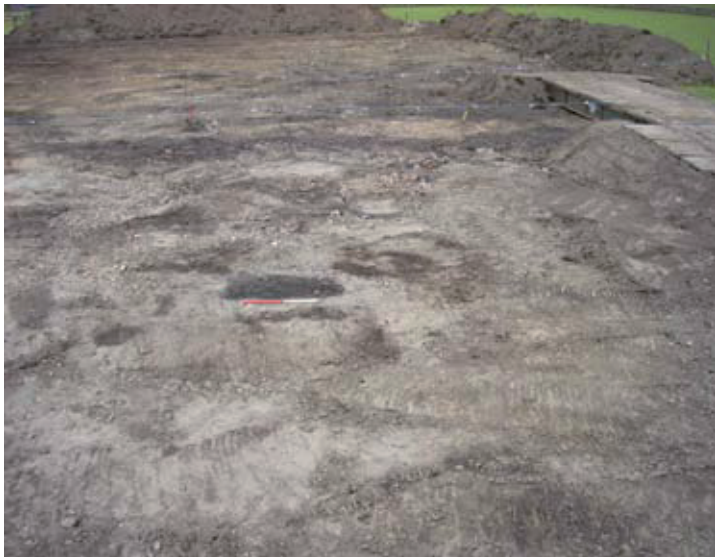
Fig. 9 - Site 5, Pit 017 pre-excitation from the SE, with stone-holes nearby

- 3.3.7 A second isolated pit (**017**, Figs 9-10) was identified in a wet area on a south-facing slope at NJ 81963 07883. Distinguished from the numerous nearby stone-holes by its black gravelly fill (Fig. 9), the feature was sub-rectangular, measuring 1.5m by 0.9m. Three fills were recorded (Fig. 10). A primary deposit of grey sand (**020**) had a depth of 0.03m and this was overlain by a lens of black silt and charcoal flecks (**019**) with a depth of 0.01m. The upper fill (**018**) consisted of 0.12m of grey and black mottled silty sand containing numerous chips and lumps of stone, much of which was degrading. No finds were recovered and all three fills were sampled.

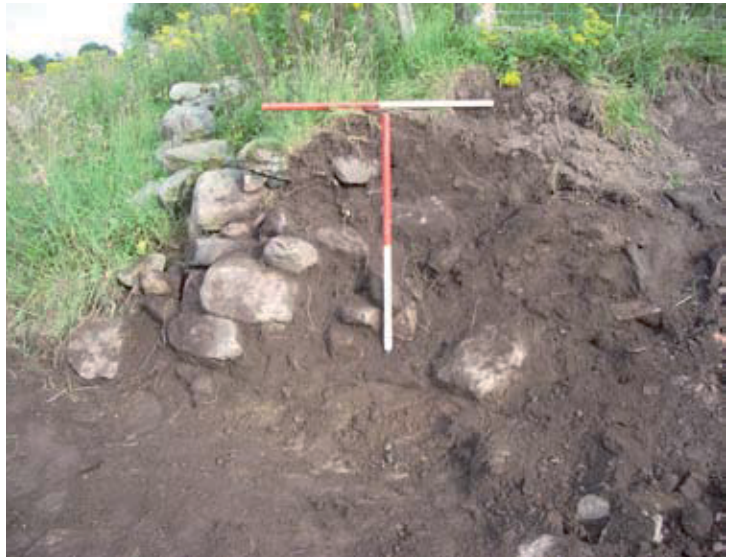
Fig. 11 - Wall 5 (Revetting), east-facing section

- 3.2.1 A programme of field boundary wall recording was undertaken in order to record their character and preservation, prior to any dismantling or removal as a consequence of the construction activity, as required in the WSI. Using standard recording methods, a written and photographic record of fourteen field boundaries (Fig. 1) was conducted, a list of which is contained in Appendix 1. These walls will be reinstated after the pipe laying process has finished.
- 3.2.2 Three types of walls were identified, and representative examples of each were recorded in section. These are revetting walls (eg Wall 5, Fig. 11), consumption dykes (eg Wall 6, Fig. 12) and field walls (eg Wall 13, Fig. 13).

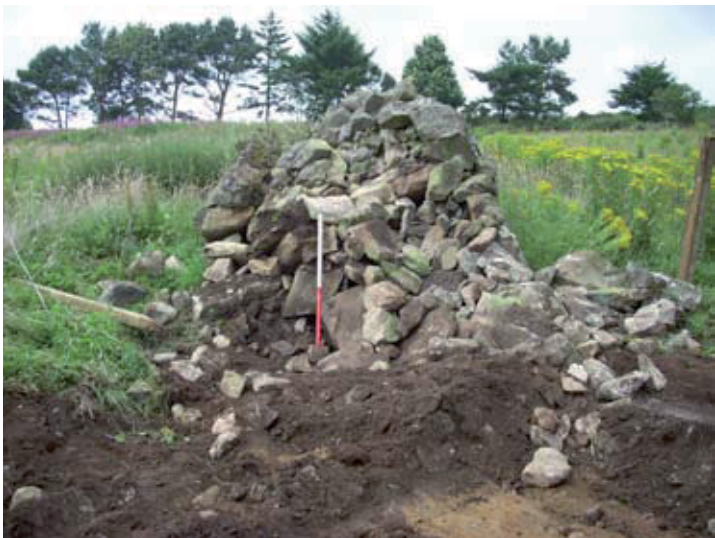
Fig. 12 - Wall 6 (Consumption), south-east-facing section

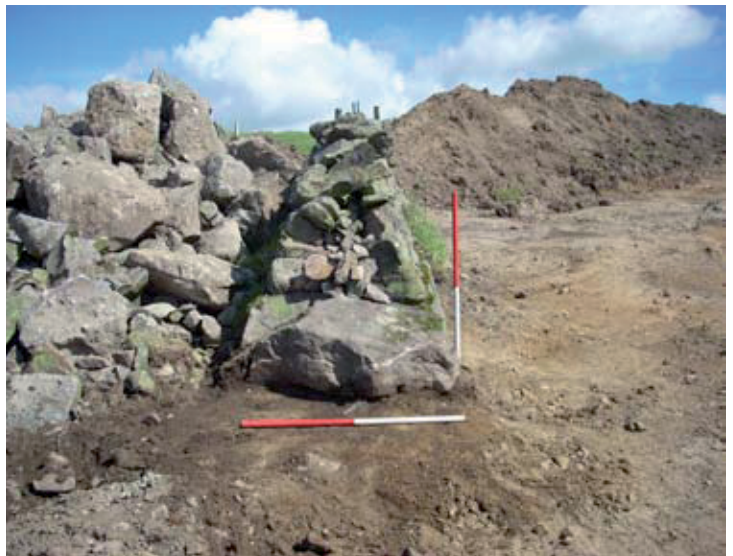
Fig. 13 - Wall 13, south-facing section

13	17	Drystone wall. Good condition. 1.1m wide at base, 1.2m high, tapering to the top. Rough coping stones. This wall is clearly of 2 phase construction, with a good quality well course primary phase overlain by a rougher build. Massive boulders in the base, 2 of which have 'plug & feather' auger/chisel holes. Poor condition fence on top. Crossed at NJ 81855 07817
14	-	Drystone wall. Good condition. 1.3m wide at base, 1.2m high, tapering to the top. No coping stones. Good condition fence on top. Crossed at NJ 81093 07350
