Braid Burn Flood Prevention Scheme (WU11) Duddingston Road West, Edinburgh

Archaeological Watching Brief

Report No. 1670

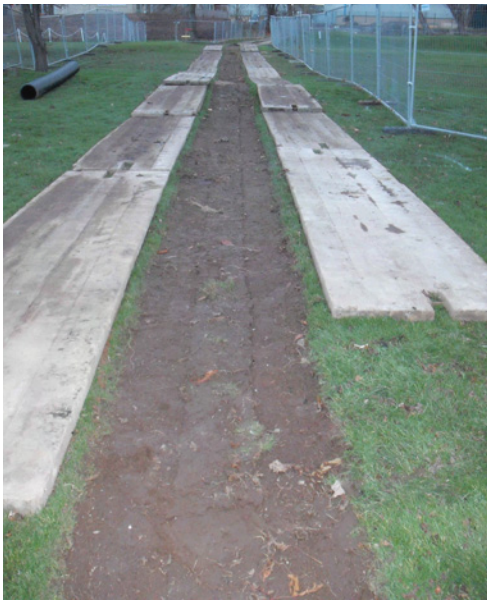
- 3.2.1 The drainage trench (Figs. 3 & 4) excavated was approximately 100m by 0.9m wide by 1.9 to 3.0m deep. A manhole excavated at the north-eastern terminus of the trench measured 2.3 by 2.5m by 1.9m deep. No features of archaeological significance were identified within Area 1

Fig. 3 - Pre-ex shot of drainage trench Area 1 from SE

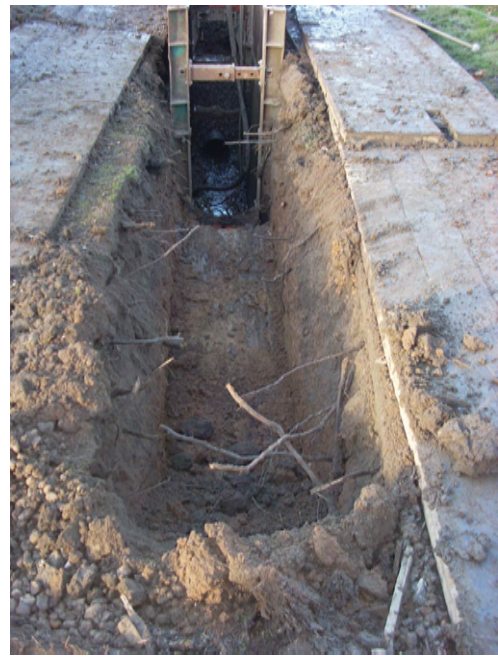
Fig. 4 - Working shot of drainage trench Area 1 from SE

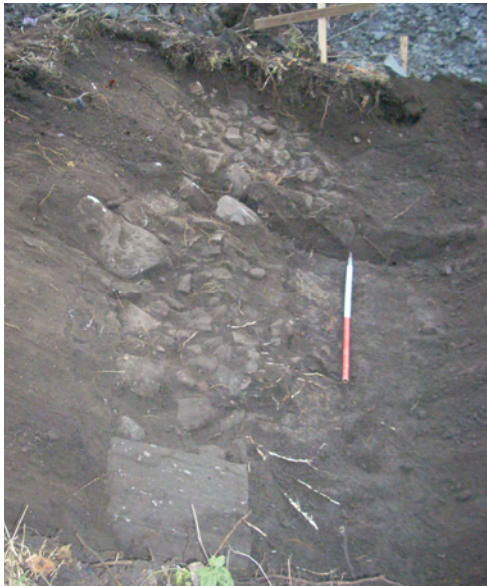
- 3.2.4 An area of 5.2 m by 3.2m by 1.0m deep was excavated prior to the construction of a head wall on the northern bank of the burn. A dump of broken mortared sandstone stones mixed with cobbles and modern debris (**019**) (Fig. 5) was identified within a soil matrix (**020**) underlying the current bank topsoil (**018**). This in turn overlay a natural river deposit (**021**) of dark

sandy clay material. Deposits (019-020) are likely to have been used to build up the Braid Burn bank in this area, possibly during construction of the golf course.

Fig. 5 - Shot of stone dump (019) from SW

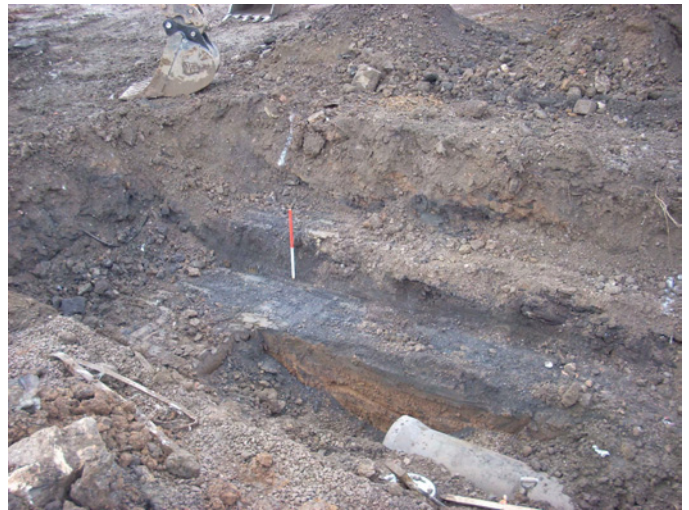
- 3.3.1 The water drain bypass trench (Figs. 2 and 6) measured 4.2m wide at ground surface level, and stepped in to 1m wide at the base, with an overall depth of 2.2m. There were no significant archaeological features found during the excavation of the trench.

- 3.3.2 Deposits in this area consisted mainly of various layers of made ground. A 1m deep deposit of mixed rubble, brick and modern debris (027) overlay three lenses, 0.1- 0.15m deep, of redeposited subsoil (028), black coal ash and dross (029), and mortar dust and mortar fragments (030). A subsoil (031) consisting of mid-red brown clay silt underlay (030) to a depth of 0.65m, under which lay undisturbed subsoil of red brown clay (032).

Fig. 6 - Working shot of bypass trench Area 2 from SE

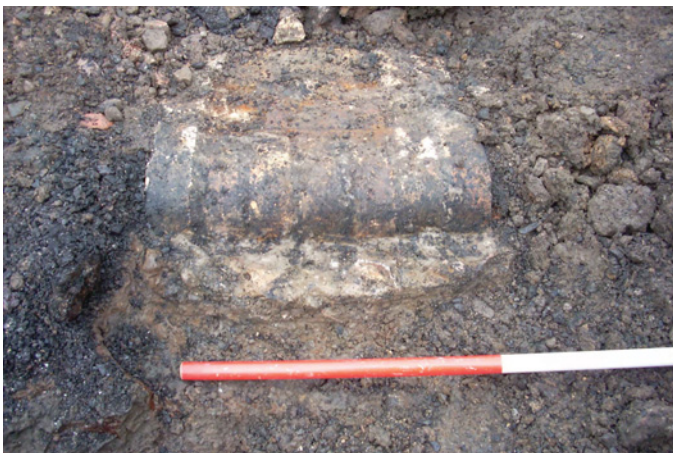
- 3.3.3 A compacted gravel and soil surface (036) was located at the southern terminal end of the trench. It lay directly over (028).
- 3.3.4 An in-situ pillar base (033) (Figs. 2 and 7) was revealed midway along the trench underlying (029) (NT 28594 72025), consisting of edge-set bricks set on a cement and rubble plinth, of dimensions 0.8m wide by 0.2m deep. A square impression probably left by a corroded iron pillar (0.36m diameter) (034), could be seen in the centre of pillar base. Bull-nose bricks were present on two edges of the pillar base.

- 4.3 Excavations in Areas 2 and 3 demonstrated that the majority of the deposits uncovered were made ground with inclusions of stone and building rubble in the upper layers (**027**) and (**023**). A brick and concrete plinth (**033**) with the impression of a square iron pillar (**034**) was found in Area 2, attesting to the presence of previous structures within this area. The pillar is probably one of the same series as those excavated by AOC in 2007 (Hunter Blair 2007).

Fig. 7 - Pillar base (033) excavated at SW side showing bullnose bricks resting on stone base from SE

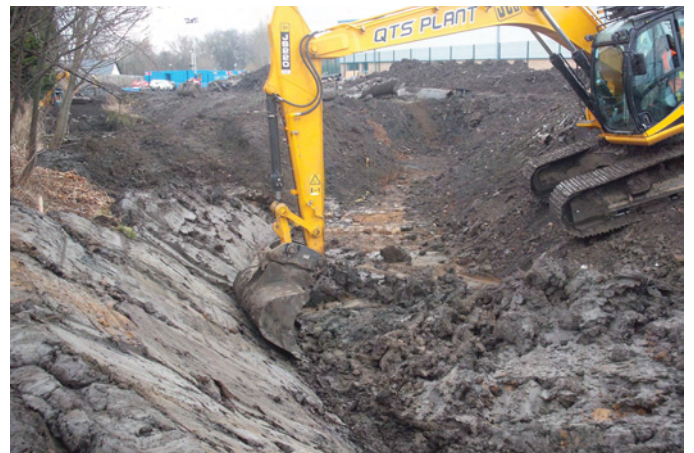
Fig. 8 - Shot of grading batter for new course of Braid Burn from NE
