**Chorach Hydro Electric Generating Station
Glen Dochart
Criarlrich
Stirlingshire**

Archaeological Works

Report No. 1689

Author	Magnus Kirby MA FSA Scot AIfA
Illustrator	Leeanne Whitelaw BSc AAIS
Editor	Melanie Johnson MA PhD FSA Scot MIfA
Commissioned by	ASH design + assessment Ltd (ASH) on behalf of Scottish and Southern Energy Ltd (SSE).
Date issued	October 2009
Version	1
OASIS Reference	cfaarcha1-65783
Planning Ref. No.	N/A
Grid Ref	NN 4621 2518

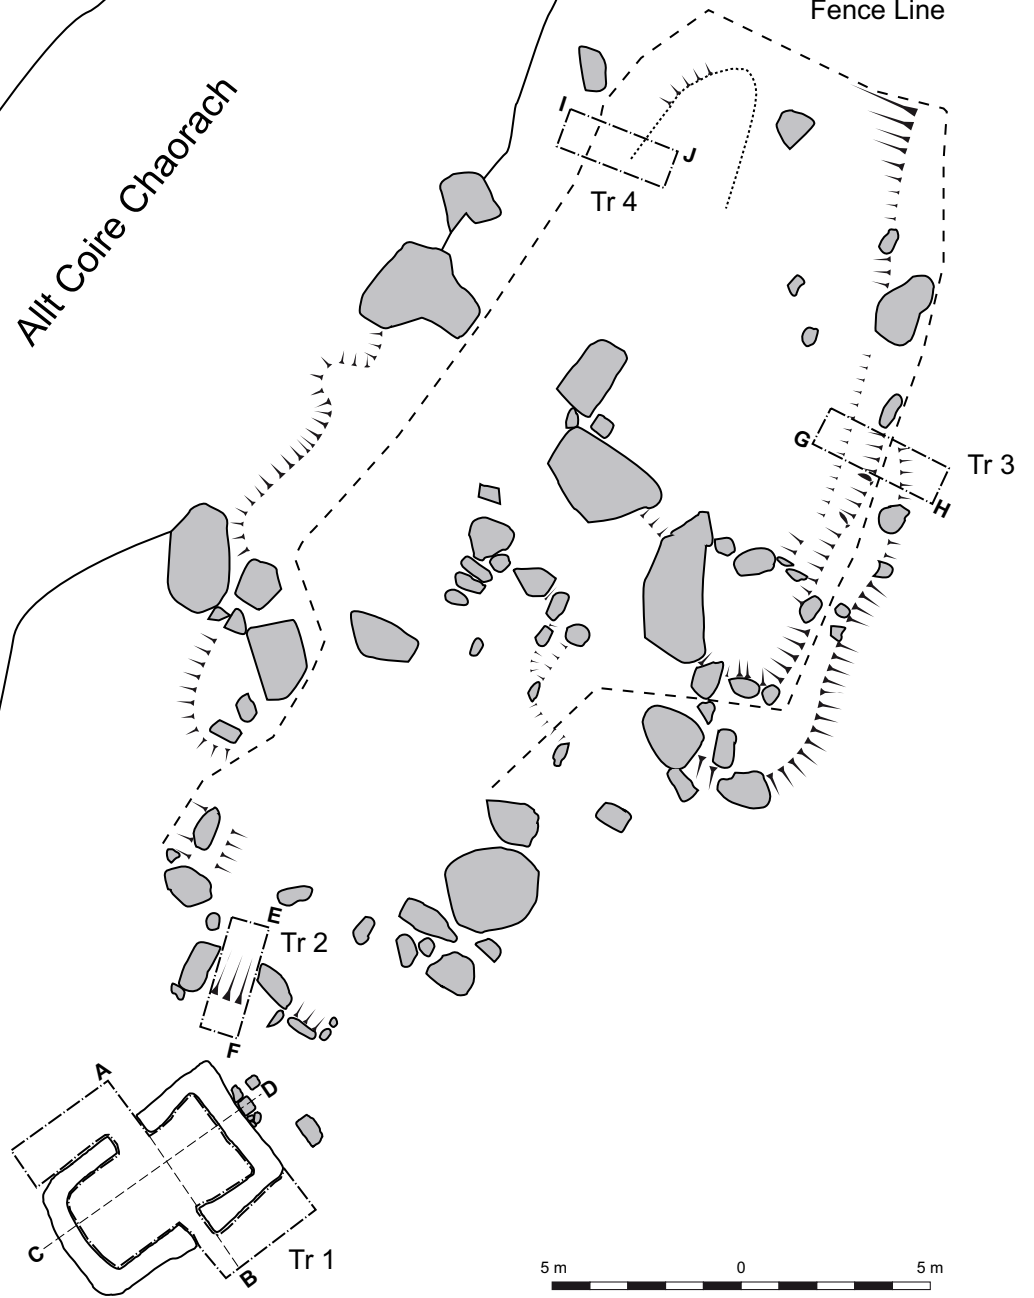
Fig. No:	2	Revision:	A	Client:	ASH
Title:	Detailed Location Plan				
Project:	Chaorach Hydro Scheme

2.2.2 A trenching plan (Fig.2) was produced by CFA and agreed in advance by the Archaeology Officer for Stirling Council. It consisted of a cross-shaped trench (Tr.1) across the interior of the shieling and three trenches (Tr. 2 – Tr. 4) across the possible enclosure bank. During the excavation, Tr. 1 was extended to incorporate the whole of the interior of the shieling.

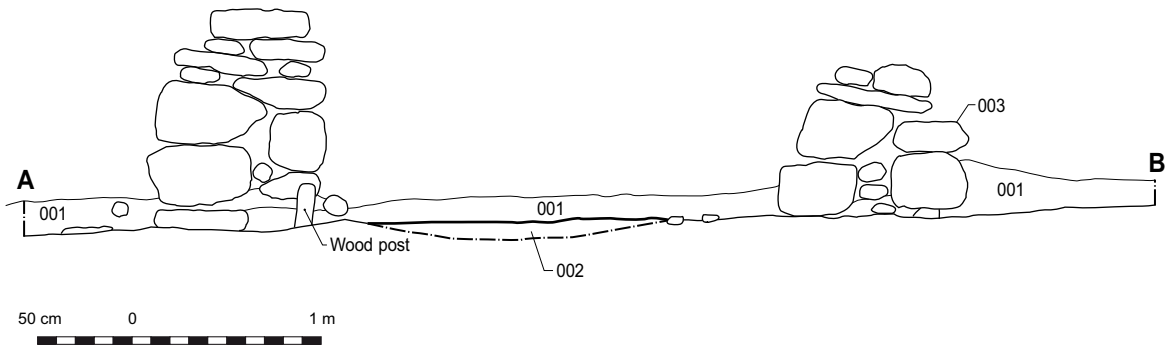
Fig. No: 3 Revision: A Client: ASH

- 3.1.2 Overall, the shieling measured 6m NE to SW by 4.2m externally and 4.2m by 2.4m internally (Fig. 3 and Fig. 4). It was of dry-stone construction, consisting of large un-dressed river-rolled boulders measuring up to c. 0.7m in length. The walls, which had been constructed directly on the subsoil, were upstanding to a height of c. 1m, and had a width of c. 0.9m – 1m at the base, tapering to c. 0.4m – 0.5m at the top. It is unclear if the walls stood to their full height, but given the nature of the usage of this type of building, this may well be the case. Two opposed entranceways were present in the north-west and south-eastern walls, measuring 0.8m and 0.6m in width respectively. Modern posts were present on either side of the entranceway where wooden gates had been erected. The corners of the shieling were slightly rounded, being more pronouncedly so at the south-western end than at the north-eastern end. There were no internal features, with the building consisting of a single compartment.

Title: SW-facing section of shieling through opposed entranceways

- 3.1.3 There was no evidence of the shieling roof, but it is likely that it consisted of peat turf or heather thatch supported on a wooden framework. No evidence of post-holes was identified, suggesting that the framework was either placed on top of the walls or sat directly on the surface of the natural subsoil.

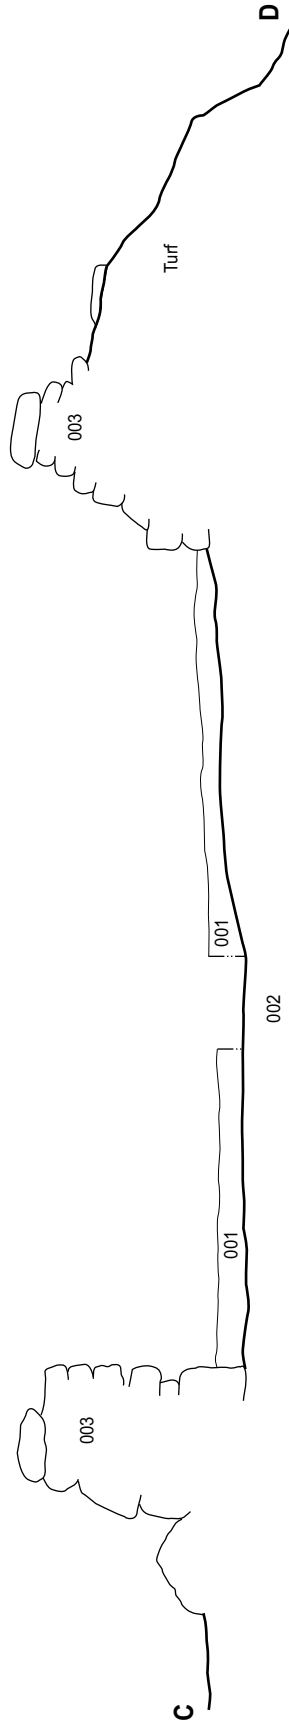
Fig. No: 4 Revision: A Client: ASH

Title: NW-facing section/profile across shieling

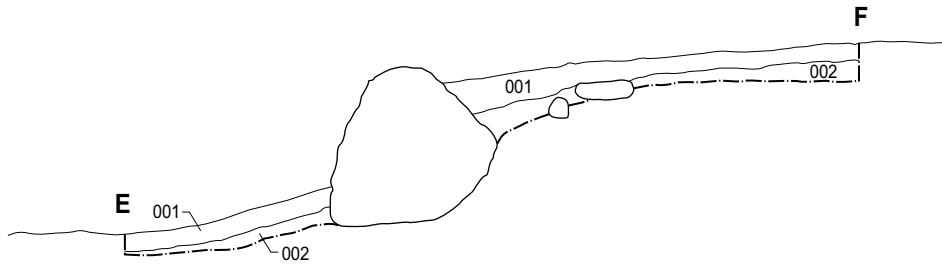
Fig. 5 - Tr 2, NW-facing section

- 3.2.3 The three trenches (Fig. 5 – Fig. 7) excavated across the possible enclosure revealed that this feature is part of a natural river bank with no evidence of any kind of anthropogenic enhancement. The deposits with these trenches consisted of c. 0.1m – 0.2m peaty topsoil overlying reddish brown sandy gravel.

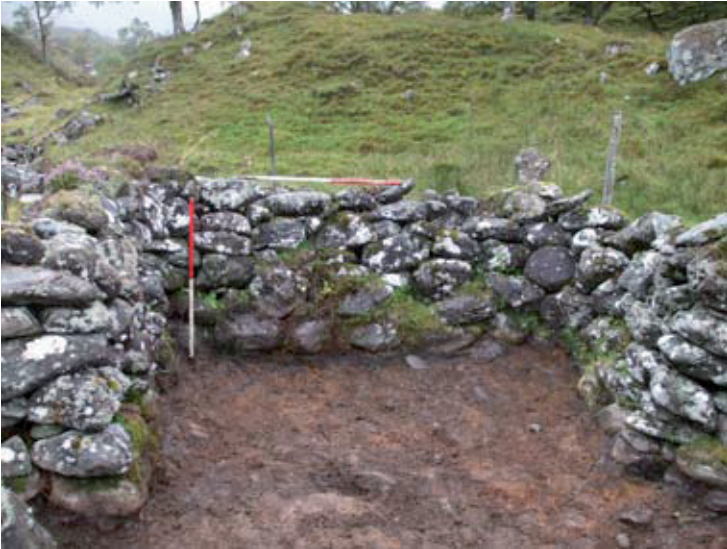
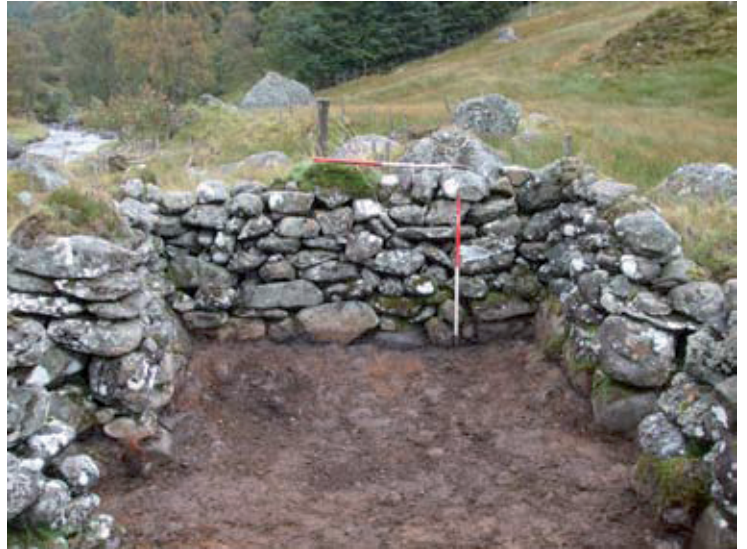
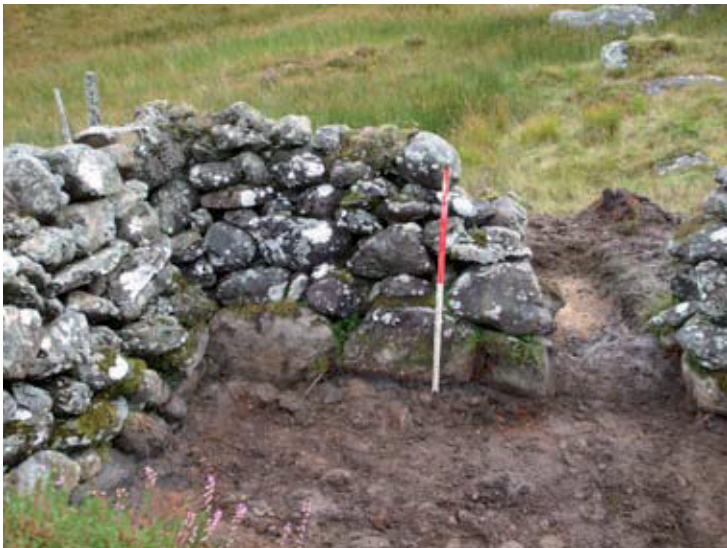
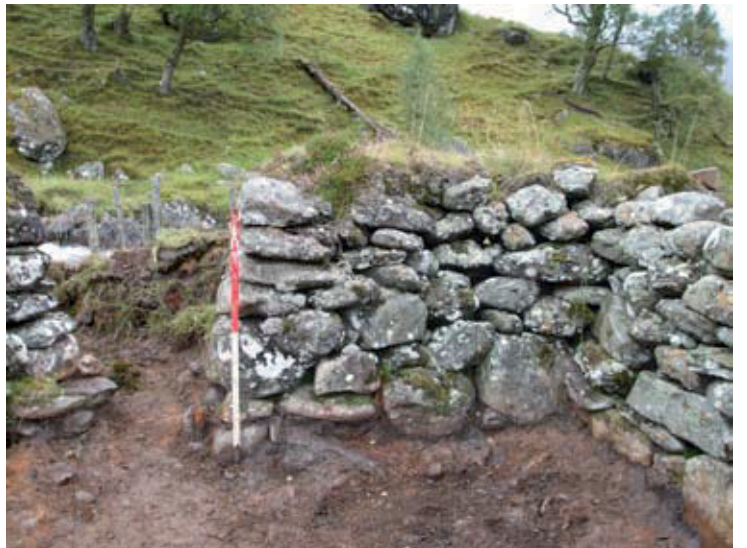
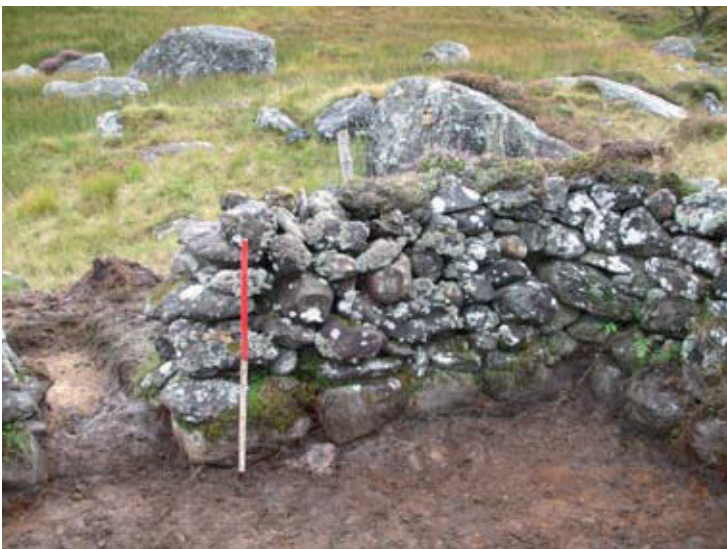
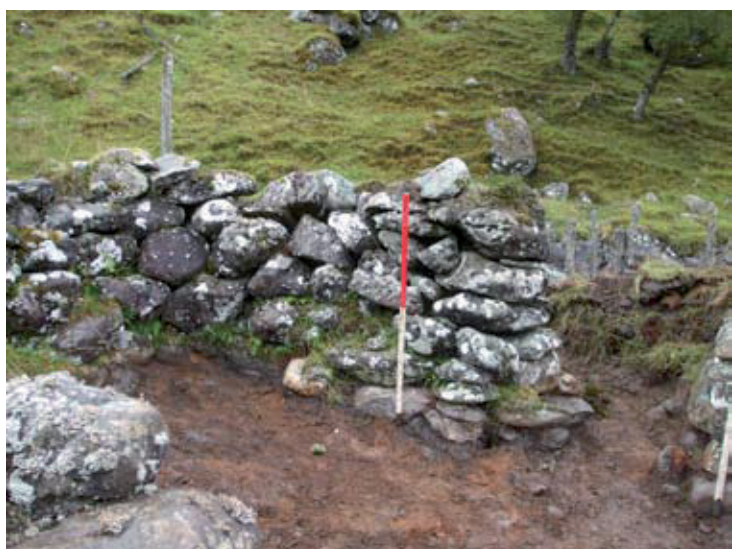
Fig. No: 9 Revision: A Client: ASH

- 3.2.1 The area evaluated consisted of the interior of the shieling together with an area immediately outwith the entranceways on either of the long sides of the building (Tr. 1). Three evaluation trenches (Tr. 2 – Tr. 4) were also excavated through the possible enclosure bank to the north-east of the shieling.
- 3.2.2 The evaluation of the shieling confirmed that it had been constructed directly on top of a free draining natural mound. The deposits within the shieling consisted of c. 0.14m of dark peaty silt overlying orange/reddish-brown gravel and sand. There were no features identified within or immediately adjacent to the shieling and no evidence of either earlier buildings or re-building. A

Title:
Internal shots of shieling

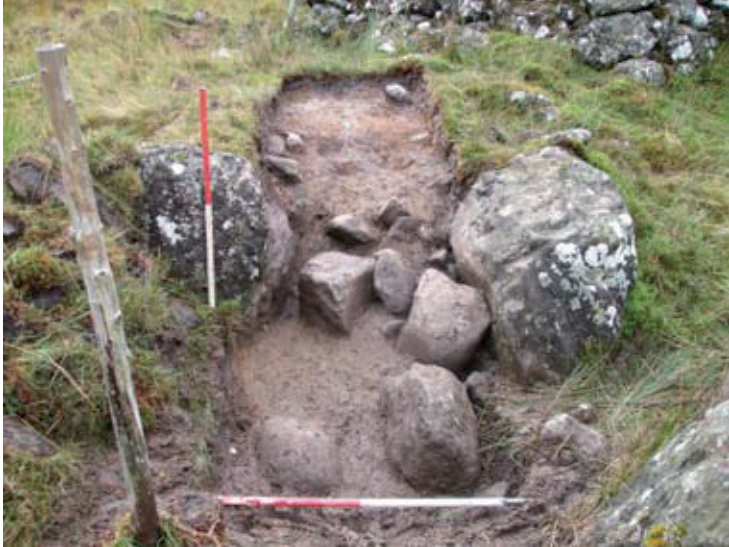
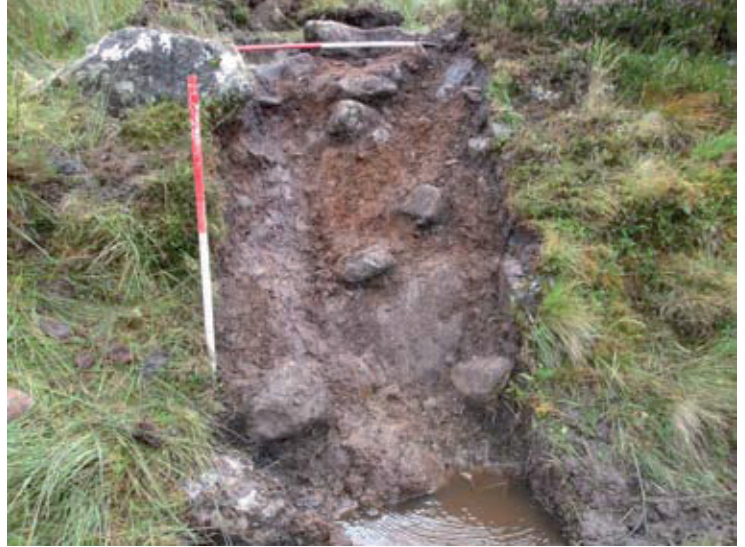
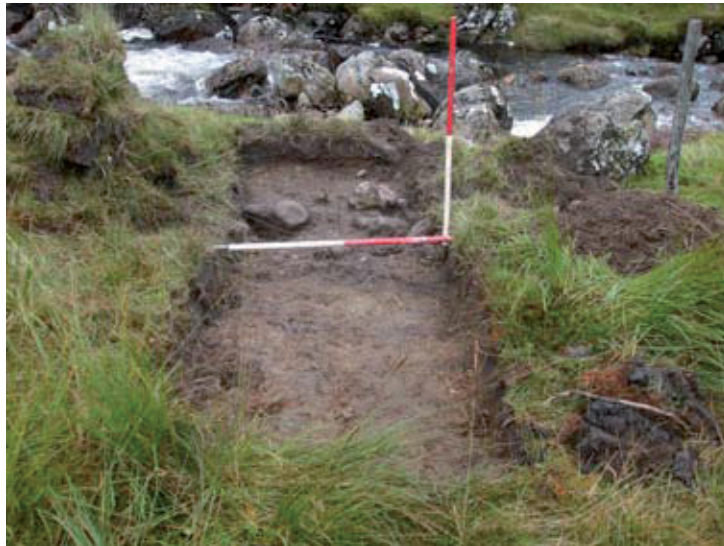
Fig. No: 10 Revision: A Client: ASH

Title:
Trenches across possible bank
