Prestongrange Community Archaeology Project, East Lothian

Archaeological Field Survey

Report No. 1593

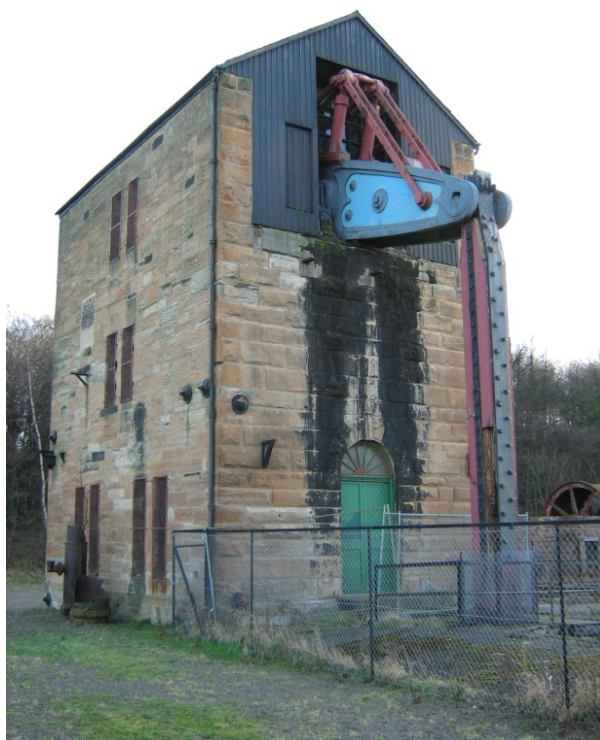
Plate 4 - Cornish beam engine

Other features recorded by the NMRS include elements of the Industrial Museum, such as the Hoffman Kiln (12), the Scheduled Cornish Beam Engine (3), the power station (10) and a pump house (9). Features which are no longer visible as upstanding remains include sites 6 and 11.

- The surviving pit bath cubicles (7) are being damaged by an unstable and leaking roof.
- The reservoirs (23) are at risk from the extensive and ever increasing vegetation.
- The Hoffmann Kiln (12) is at risk from general disrepair.
- The Cornish Beam Engine House (3) is at risk from general disrepair.

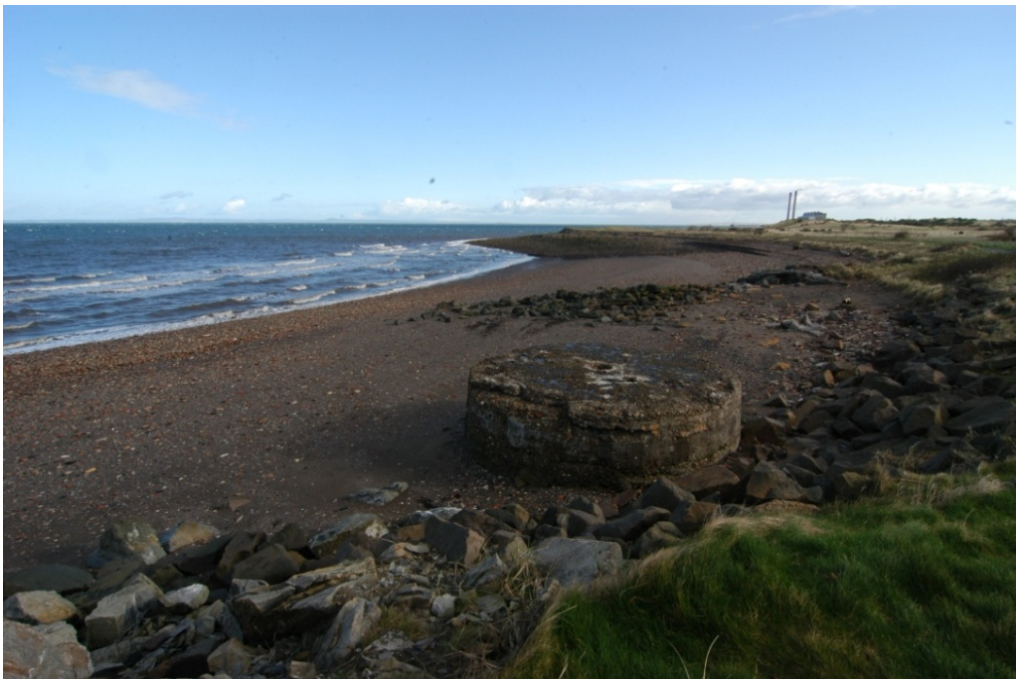
Plate 5 - The surviving remains of the pier and beacon stance

Morrison's Haven (5), a village and harbour, dates to the 16th century and at one point was referred to as the safest harbour within the Firth of Forth (Graham 1962). The Harbour fell into disuse after World War One and was infilled in the 1960s. No upstanding remains of the buildings survive today, with the area now reclaimed land. Elements of the harbour, however, still survive: the main quay is still discernible, although part of it now lies within the tidal zone. Also surviving are the remains of two flanking walls (discernible by horizontal stone slabs), upright wooden posts (possible buffers for boats docked at the quay) and rubble infill (between the outside flanking walls). Graham theorises that what survives today is probably part of the modifications documented in the late 18th century (Graham 1962). Photographs taken as part of this study compared with photographs taken by Graham in the 1960s highlight how much of the quay has now been lost. Today, most of the wooden infrastructure had gone although some upright posts survive, albeit in a degraded state. The NE beacon stance, discernible in 1960, is almost unrecognisable today, with only a few courses of brick surviving. The SW beacon stance, recorded within the NMRS as a WW2 defensive structure, still survives, although it is now isolated from any other harbour features. A notch is discernible on top of the feature, although no fixtures survive associated with the structure.

- The surviving pier associated with the harbour (6) is being gradually eroded away by intertidal action.

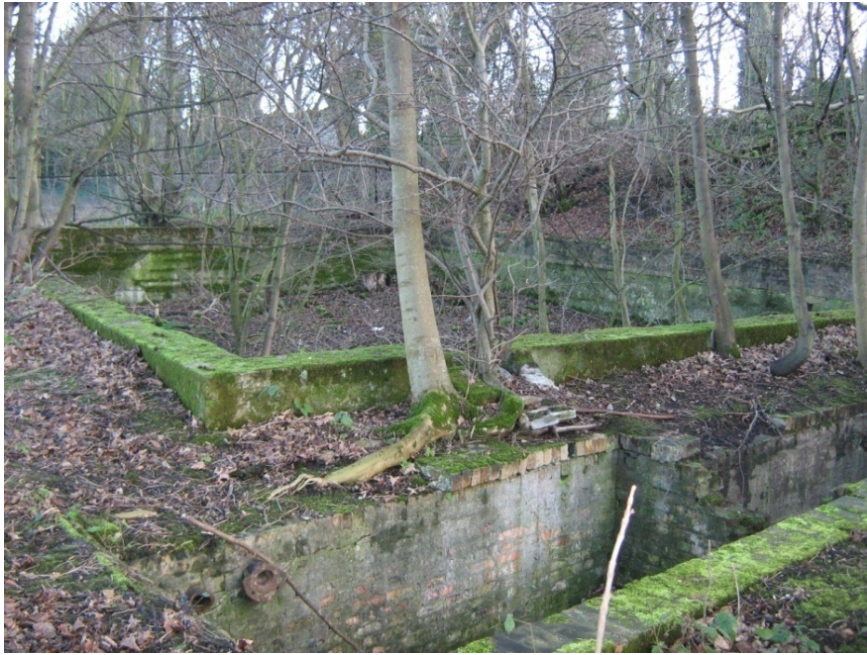
Plate 6 - Reservoir 23a, highlighting the extensive tree growth in the area

Two large reservoirs (23) lie to the south of the colliery, as well as small buildings (37) and a larger enclosure (41). There are no upstanding remains of the enclosure (41), the location of which was (at the time of field survey) wooded and overgrown. The reservoirs (23) still survive but are now covered in established trees. A second enclosure (42) is depicted north of the colliery. The enclosure no longer survives, mostly probably destroyed by a route change of the coast road in the later part of the 20th century.

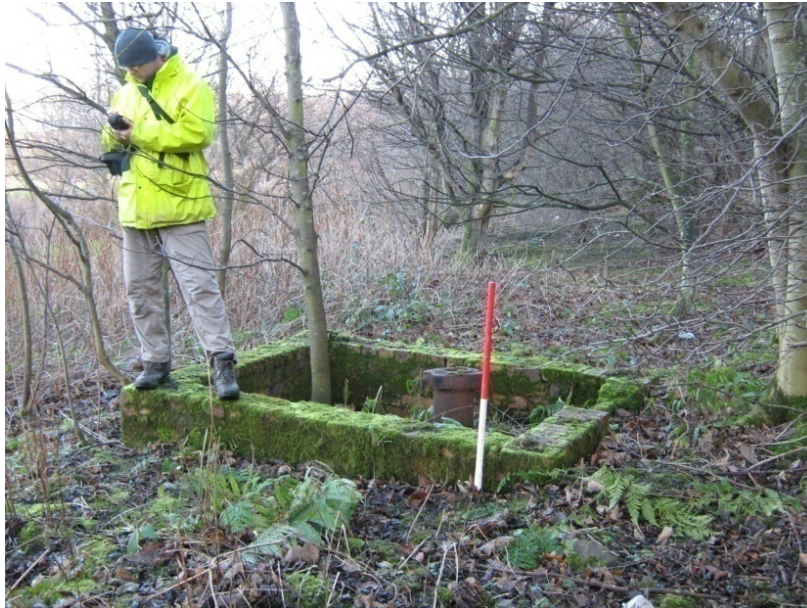
Plate 7 - Remains of the detonator store (37)

Three further buildings (22) are depicted east of the reservoirs (23) and annotated as a magazine and detonator store. A concrete path (21) was recorded by field survey running past the buildings. An additional magazine (38) is depicted beside an earlier enclosure (41) shown on the Ordnance Survey 1854 map.

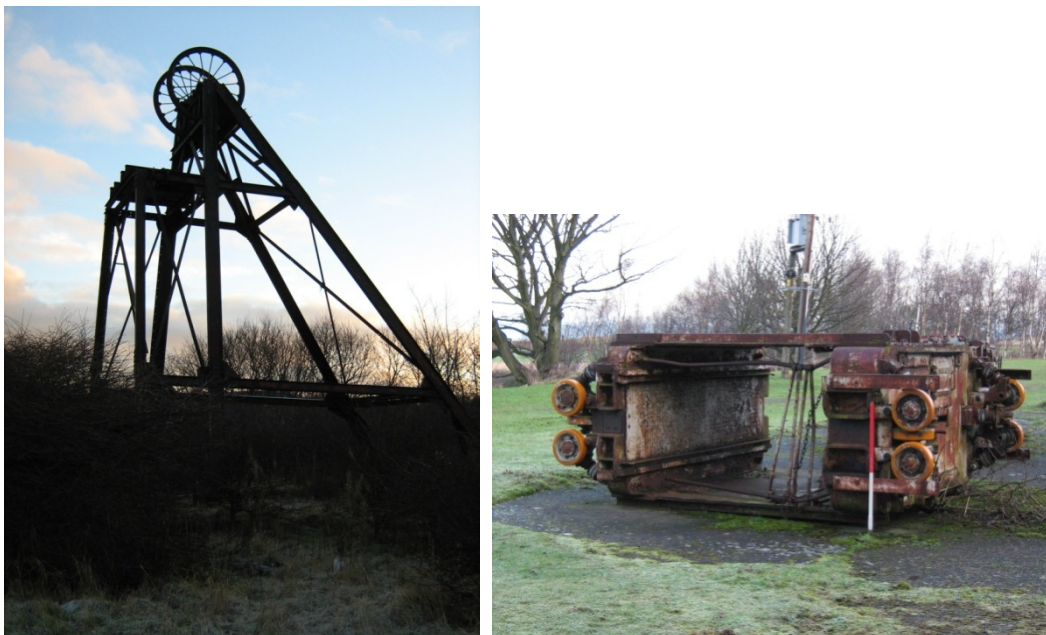
Plate 8 – Examples of features re-located from their original positions

complex, although features such as the Hoffman Kiln (12) are now fenced off and are falling into disrepair. Additional fixtures and fittings have been re-located around the site, such as the A-frame pit winding gear (48), the railway bridge remains (46), wagons and a pit cage (39), all outdoor museum exhibits.

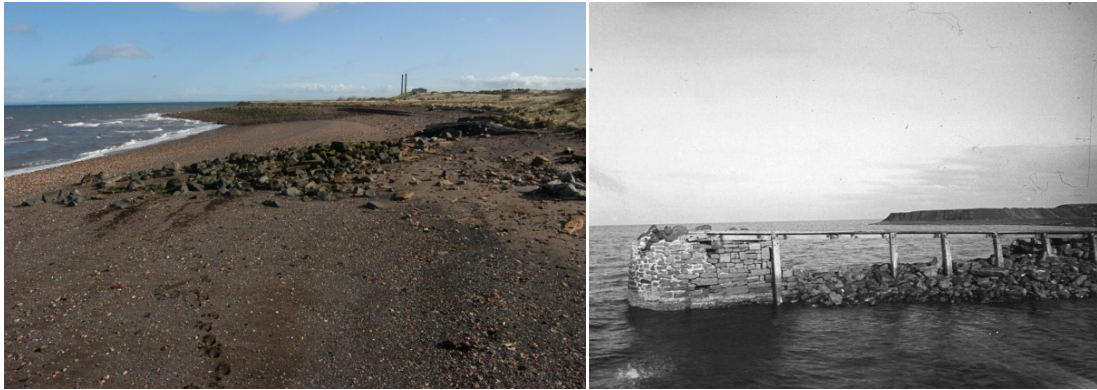
Plate 9 - The pier of Morrison's Haven in 2009 and in the 1960s

As stated in Richardson et al 2009, the study area has been much altered through the long history of industrial land use and subsequent landscaping. Many of the early features identified through the desk-based assessment and the historical research are now lost or, at best, severely truncated. Some of the identified sites have been preserved as part of the museum, but the field survey recorded that some of these features are decaying and show signs of little upkeep. For example, photographs taken of the harbour 50 years ago compared with photographs taken today clearly highlight the change in the baseline condition of the pier.

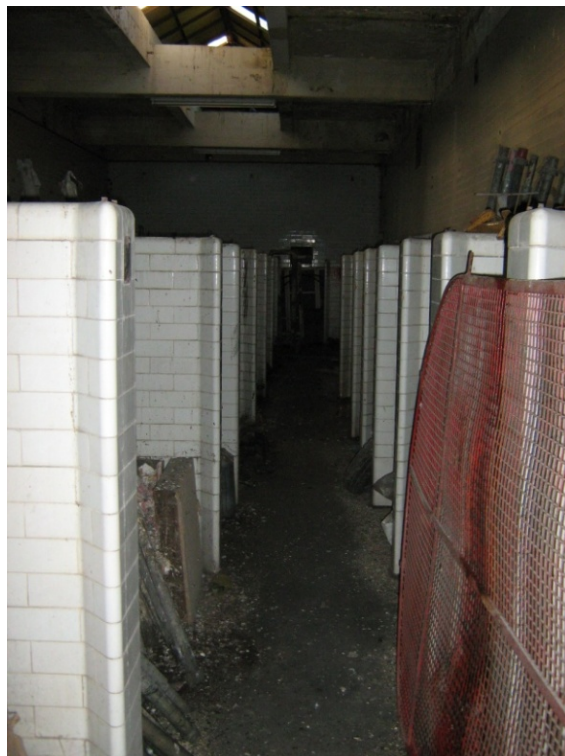
Plate 10 - The surviving pit baths

While it is recognised that there are limited resources to spend on the museum site, features such as the pit baths are possibly a unique survival of a site type which was once abundant, but is now becoming increasingly scarce.

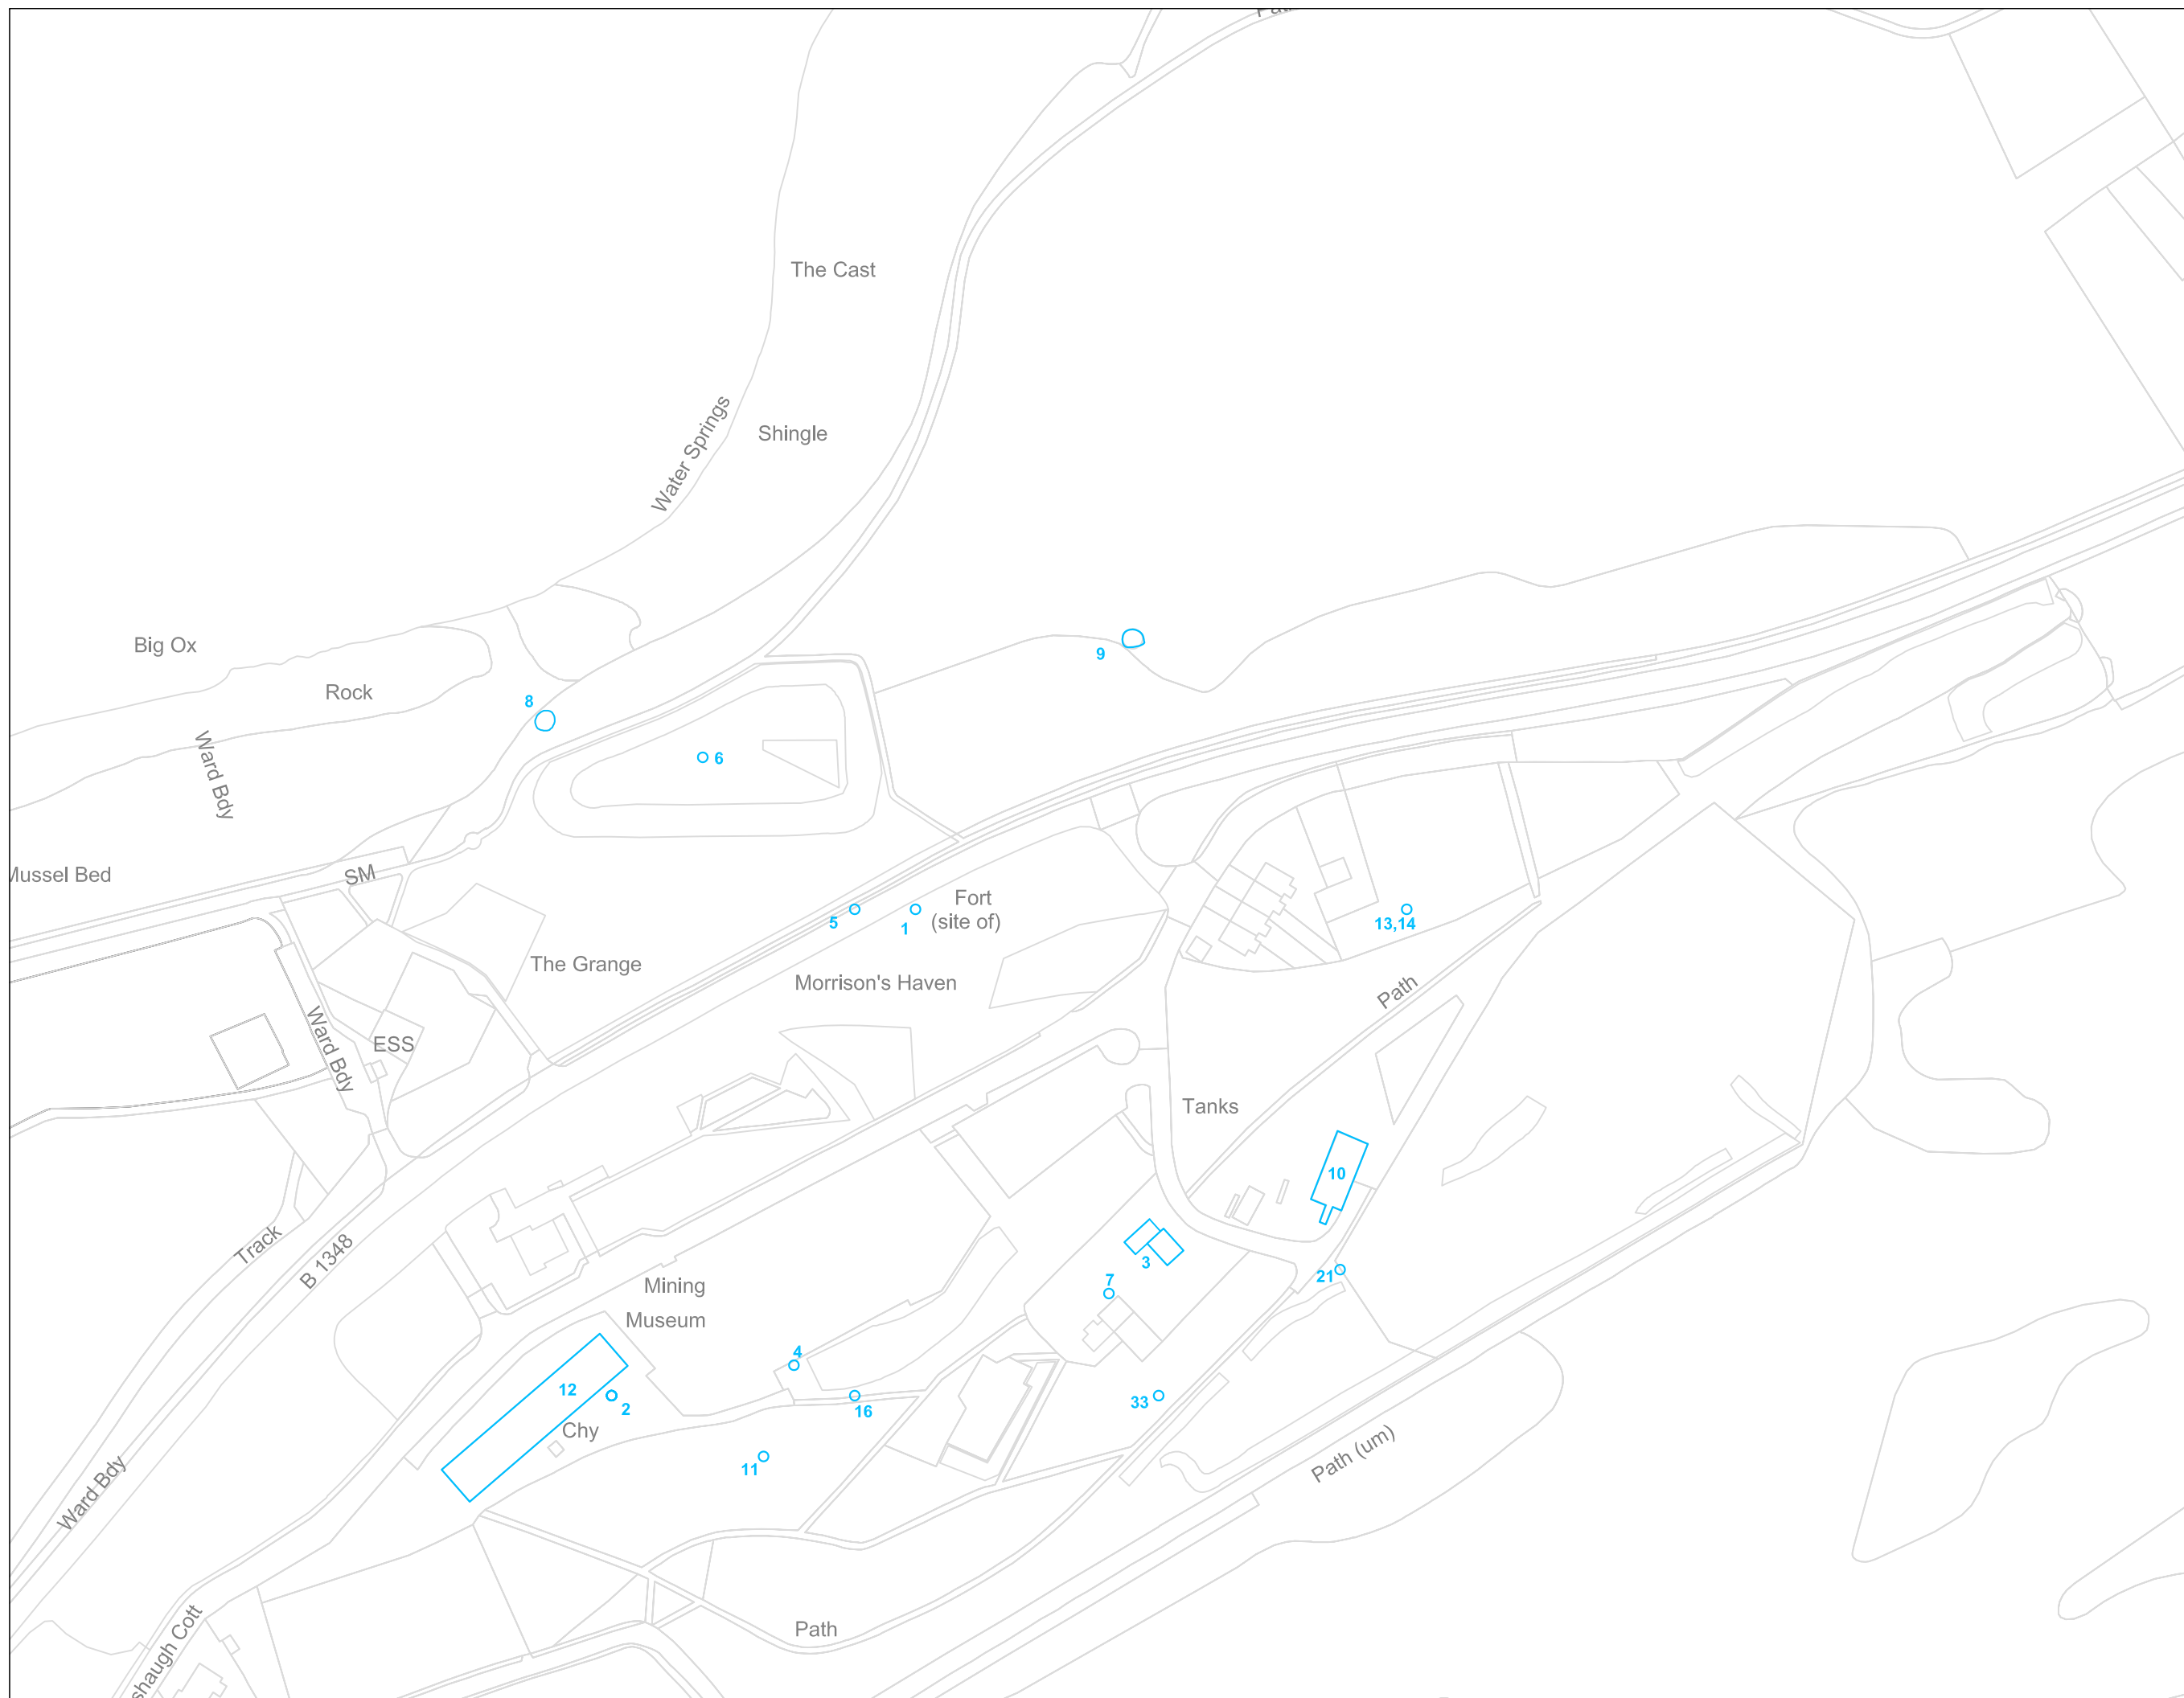
Fig. No: **2** Revision: **A**

The NMRS and SMR record fifteen sites within the study area, which include PCAP field seasons (13, 14). A cist (2) was recorded in the 19th century, reputed to contain human remains, although there appears to be confusion as to the exact location. The description in the Name Book states that the cist was identified within the harbour mouth although the grid reference cited is further inland. No upstanding remains of the cist were identified at the cited grid reference location or within the harbour area, suggesting that the remains have been removed or destroyed.

A 16th century Cromwellian Fort (1) is recorded by the NMRS and depicted on early cartographic sources. There is now no upstanding trace of the fort, the location of which now stands within reclaimed land.

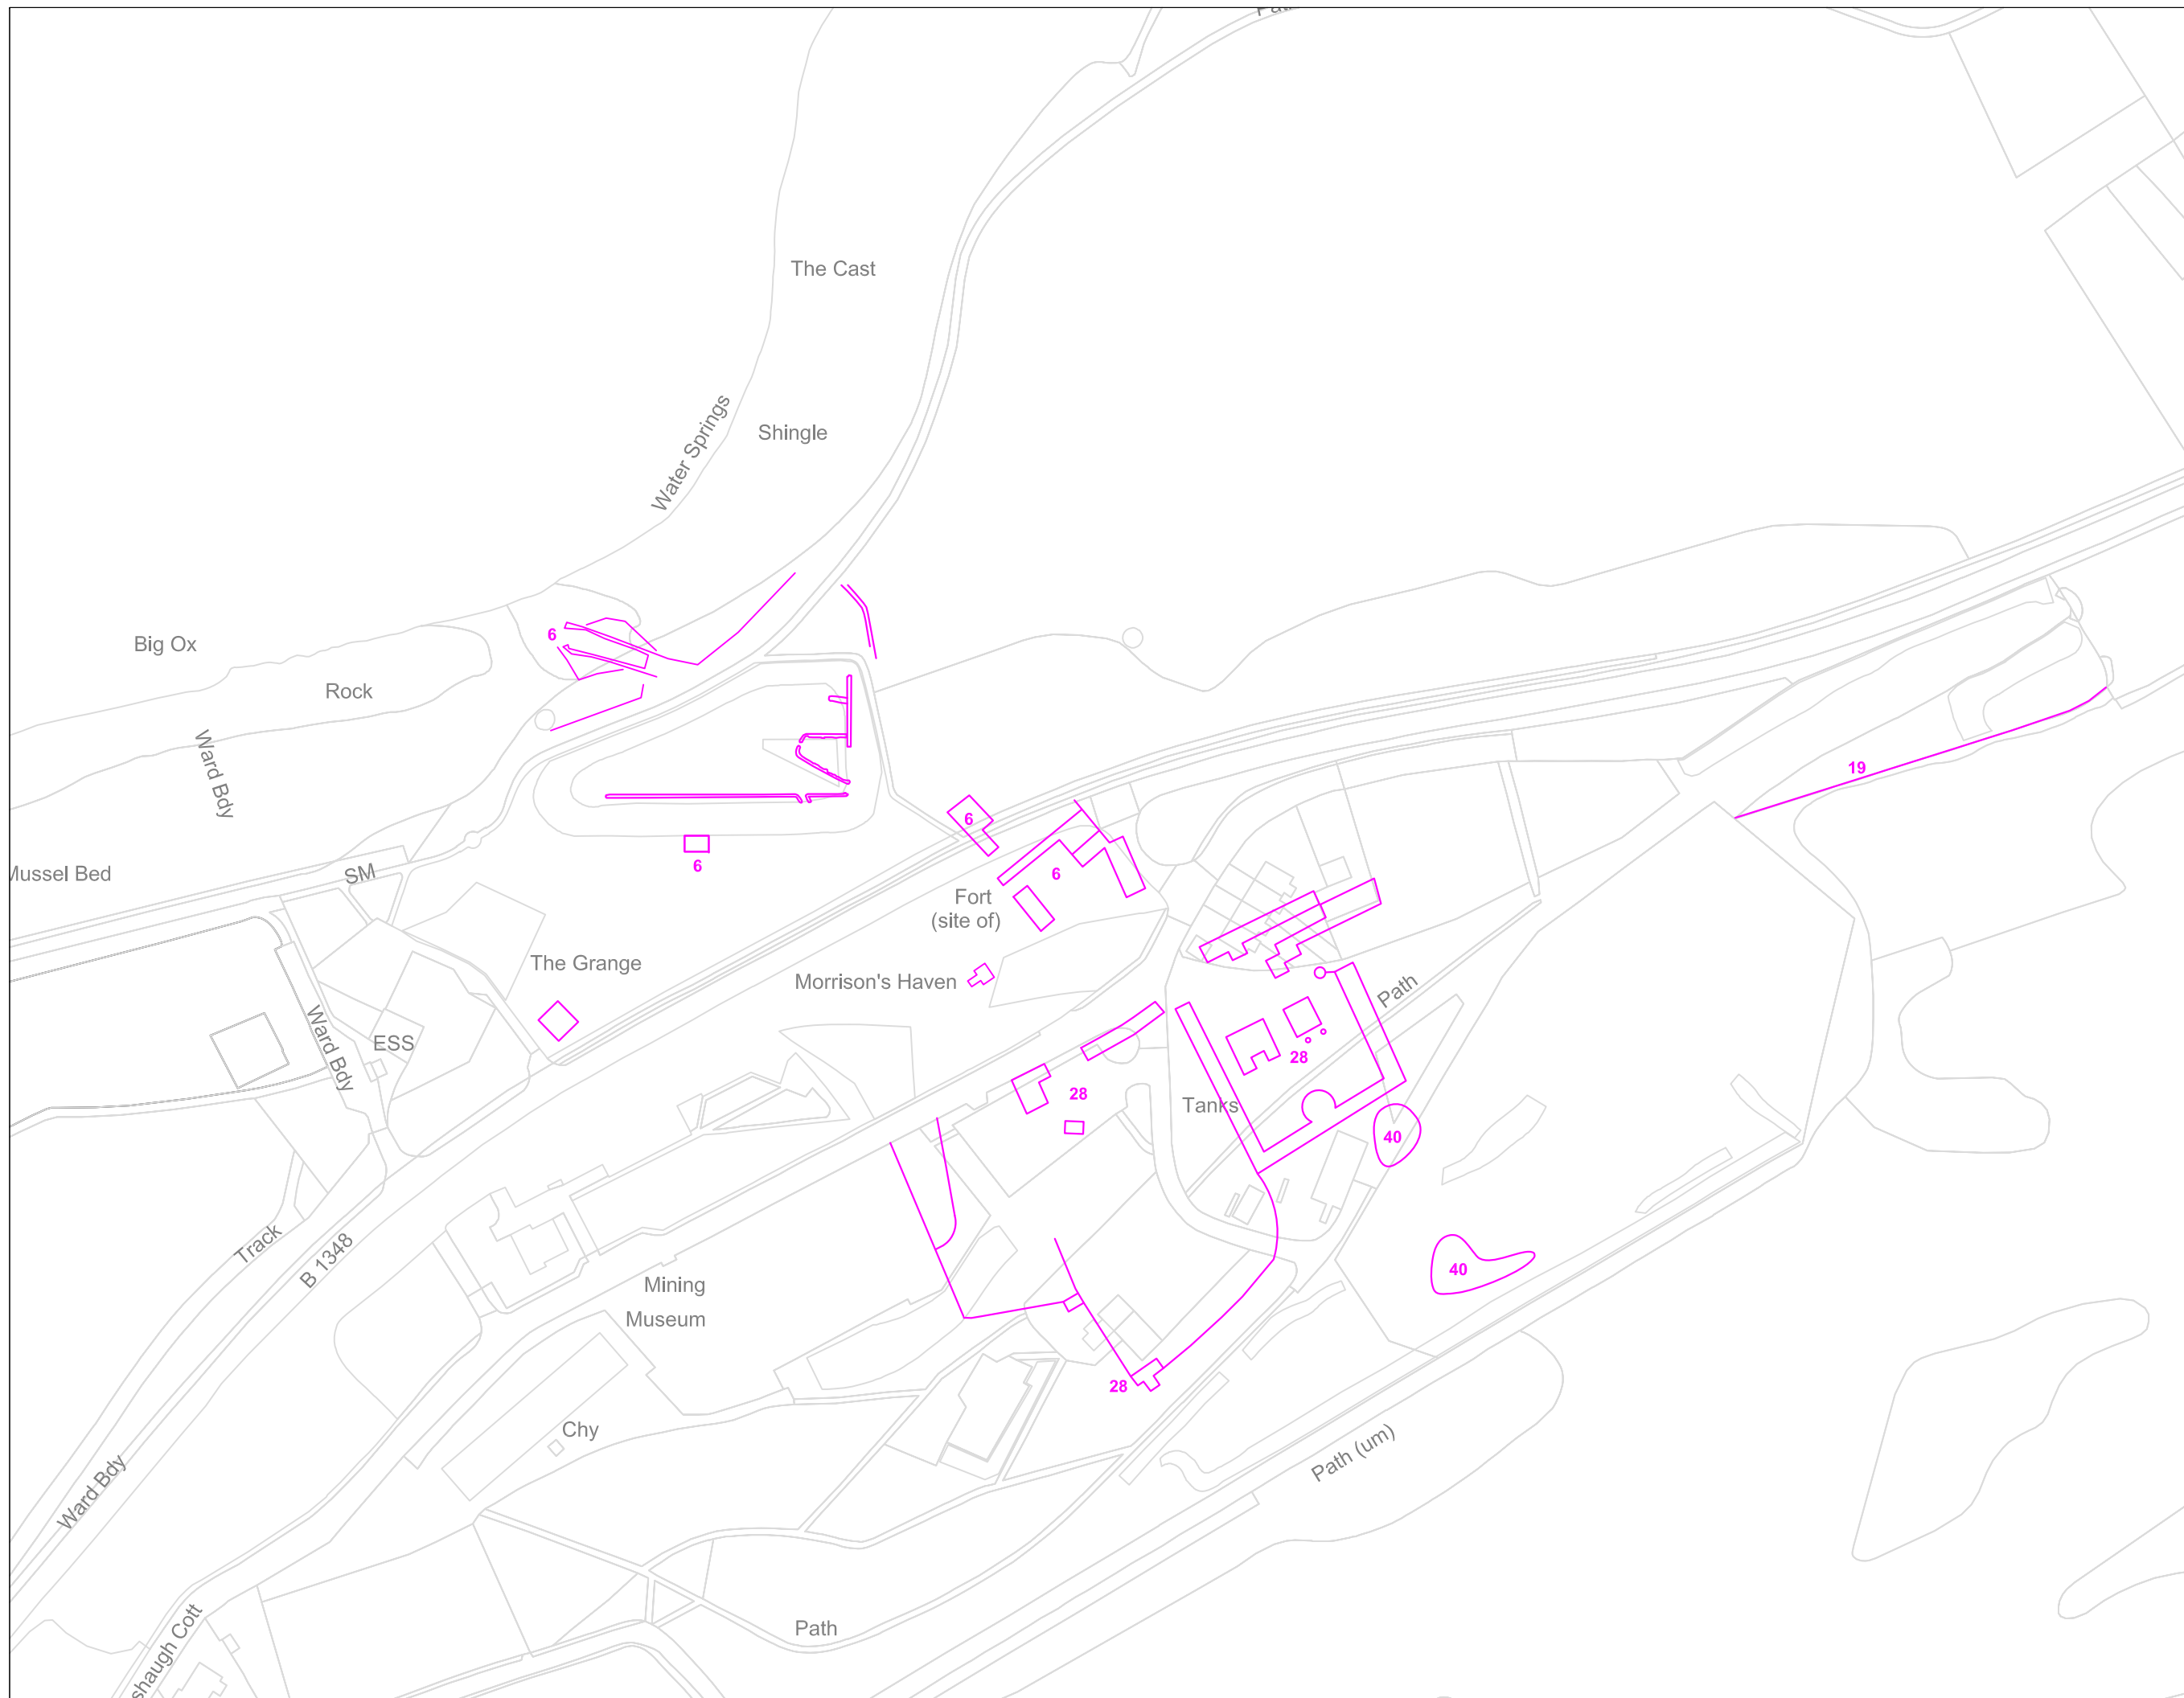
Fig. No: **3** Revision: **A**

A Brick and Tile Works (28) and associated clay pits and enclosures are depicted on the Ordnance Survey 1854 First Edition map. A shaft is also depicted and annotated, suggesting that mining was taking place. There is also a rectangular structure depicted on the north-facing hill in the area later utilised by the reservoirs (23).

A small enclosure or reservoir is depicted south of the brick and tile works, within the woods, as are several features annotated as clay pits (40). No surface traces were visible of the small enclosure or clay pits; the enclosure was probably destroyed by the early 20th century reservoirs (23) and the location of the clay pits (40) has been heavily landscaped during the late 20th century.

Morrison's Haven harbour (6) is also depicted on the Ordnance Survey 1854 Edition map, together with a saw mill and four other associated buildings. All are shown depicted as roofed. No upstanding remains survive of the buildings or saw mill, the area of which was used as a spoil heap during the 20th century.

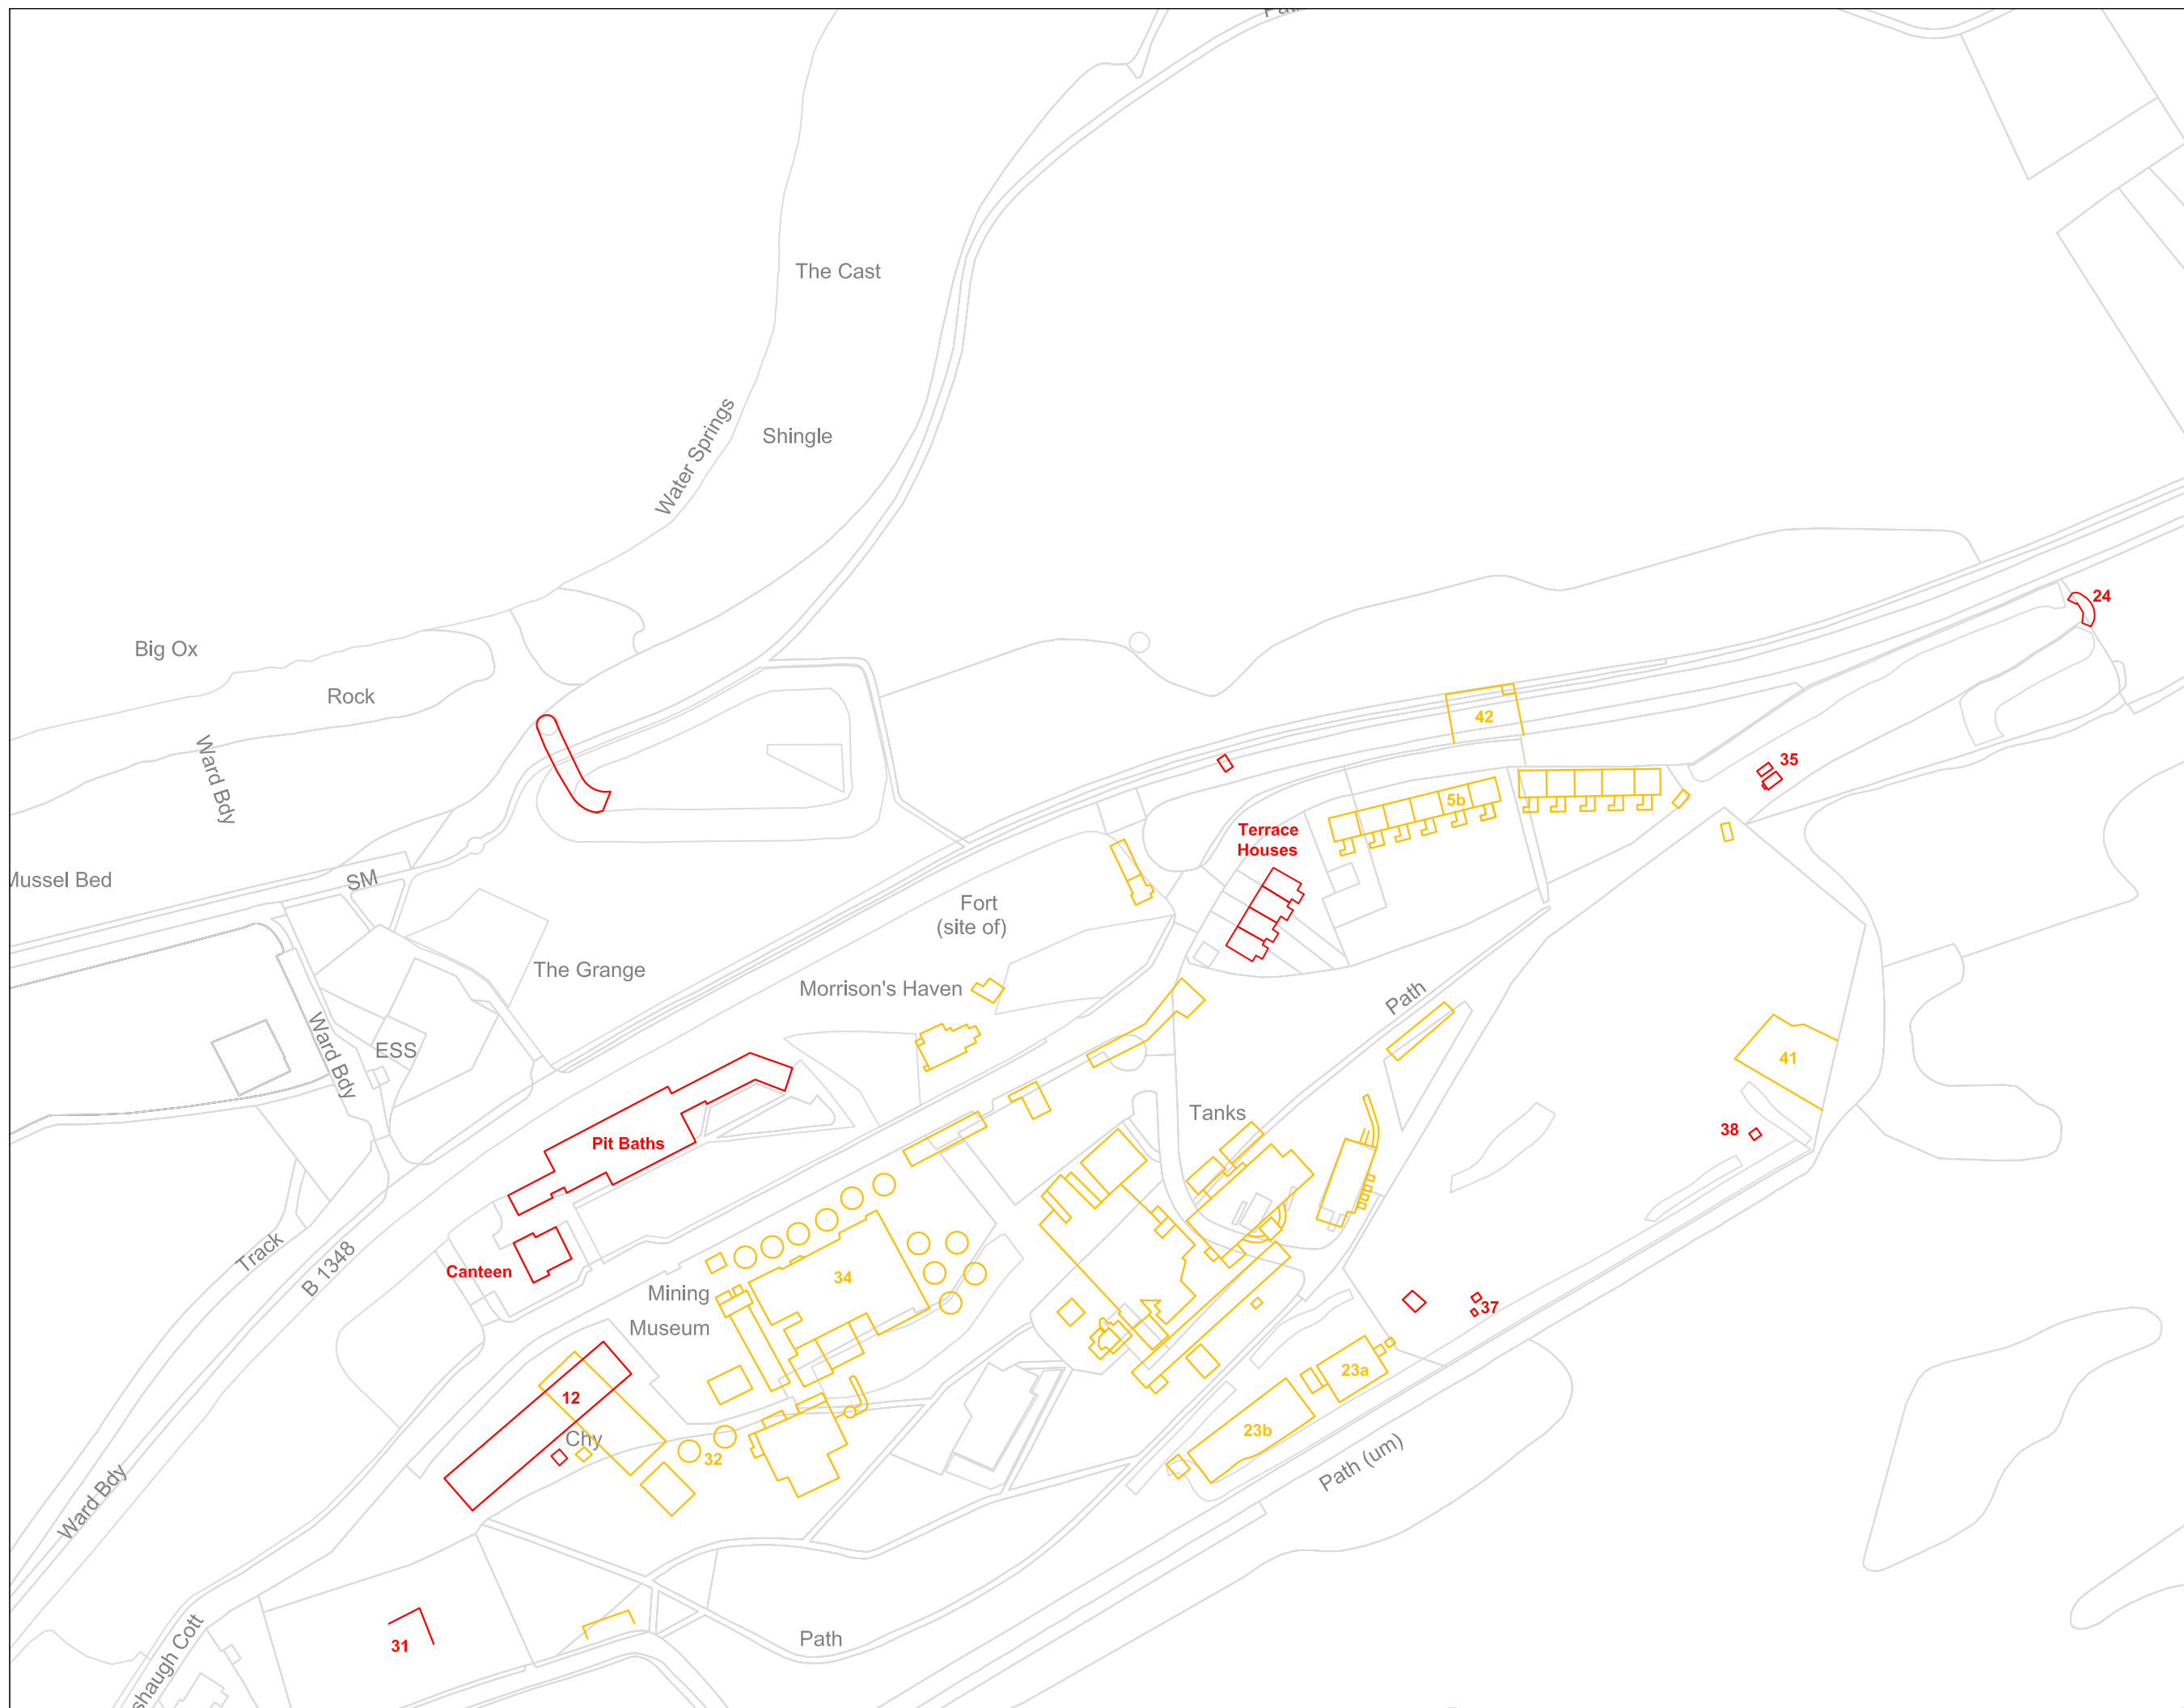
The 1956 Coal Board site plan depicts the main area of the colliery (4), showing how densely packed the area was with buildings and associated features, such as railway lines. The 1956 plan also annotates the buildings, providing us with the functions of various structures, such as the weight station (34), the lamp room, machine house, workshops, canteen, and the pithead baths. The site of old kilns (32) are depicted and annotated near a machine house, suggesting that older remnants of the industrial past were visible amongst the modern features of the colliery. The Hoffman Kiln (12) was built in 1937, and is now designated a Category A Listed building, which survives today as part of the Prestongrange Museum.

Two pumps (9) are depicted on the 1956 map, one of which still survives, the other has been destroyed by the modern coast road.

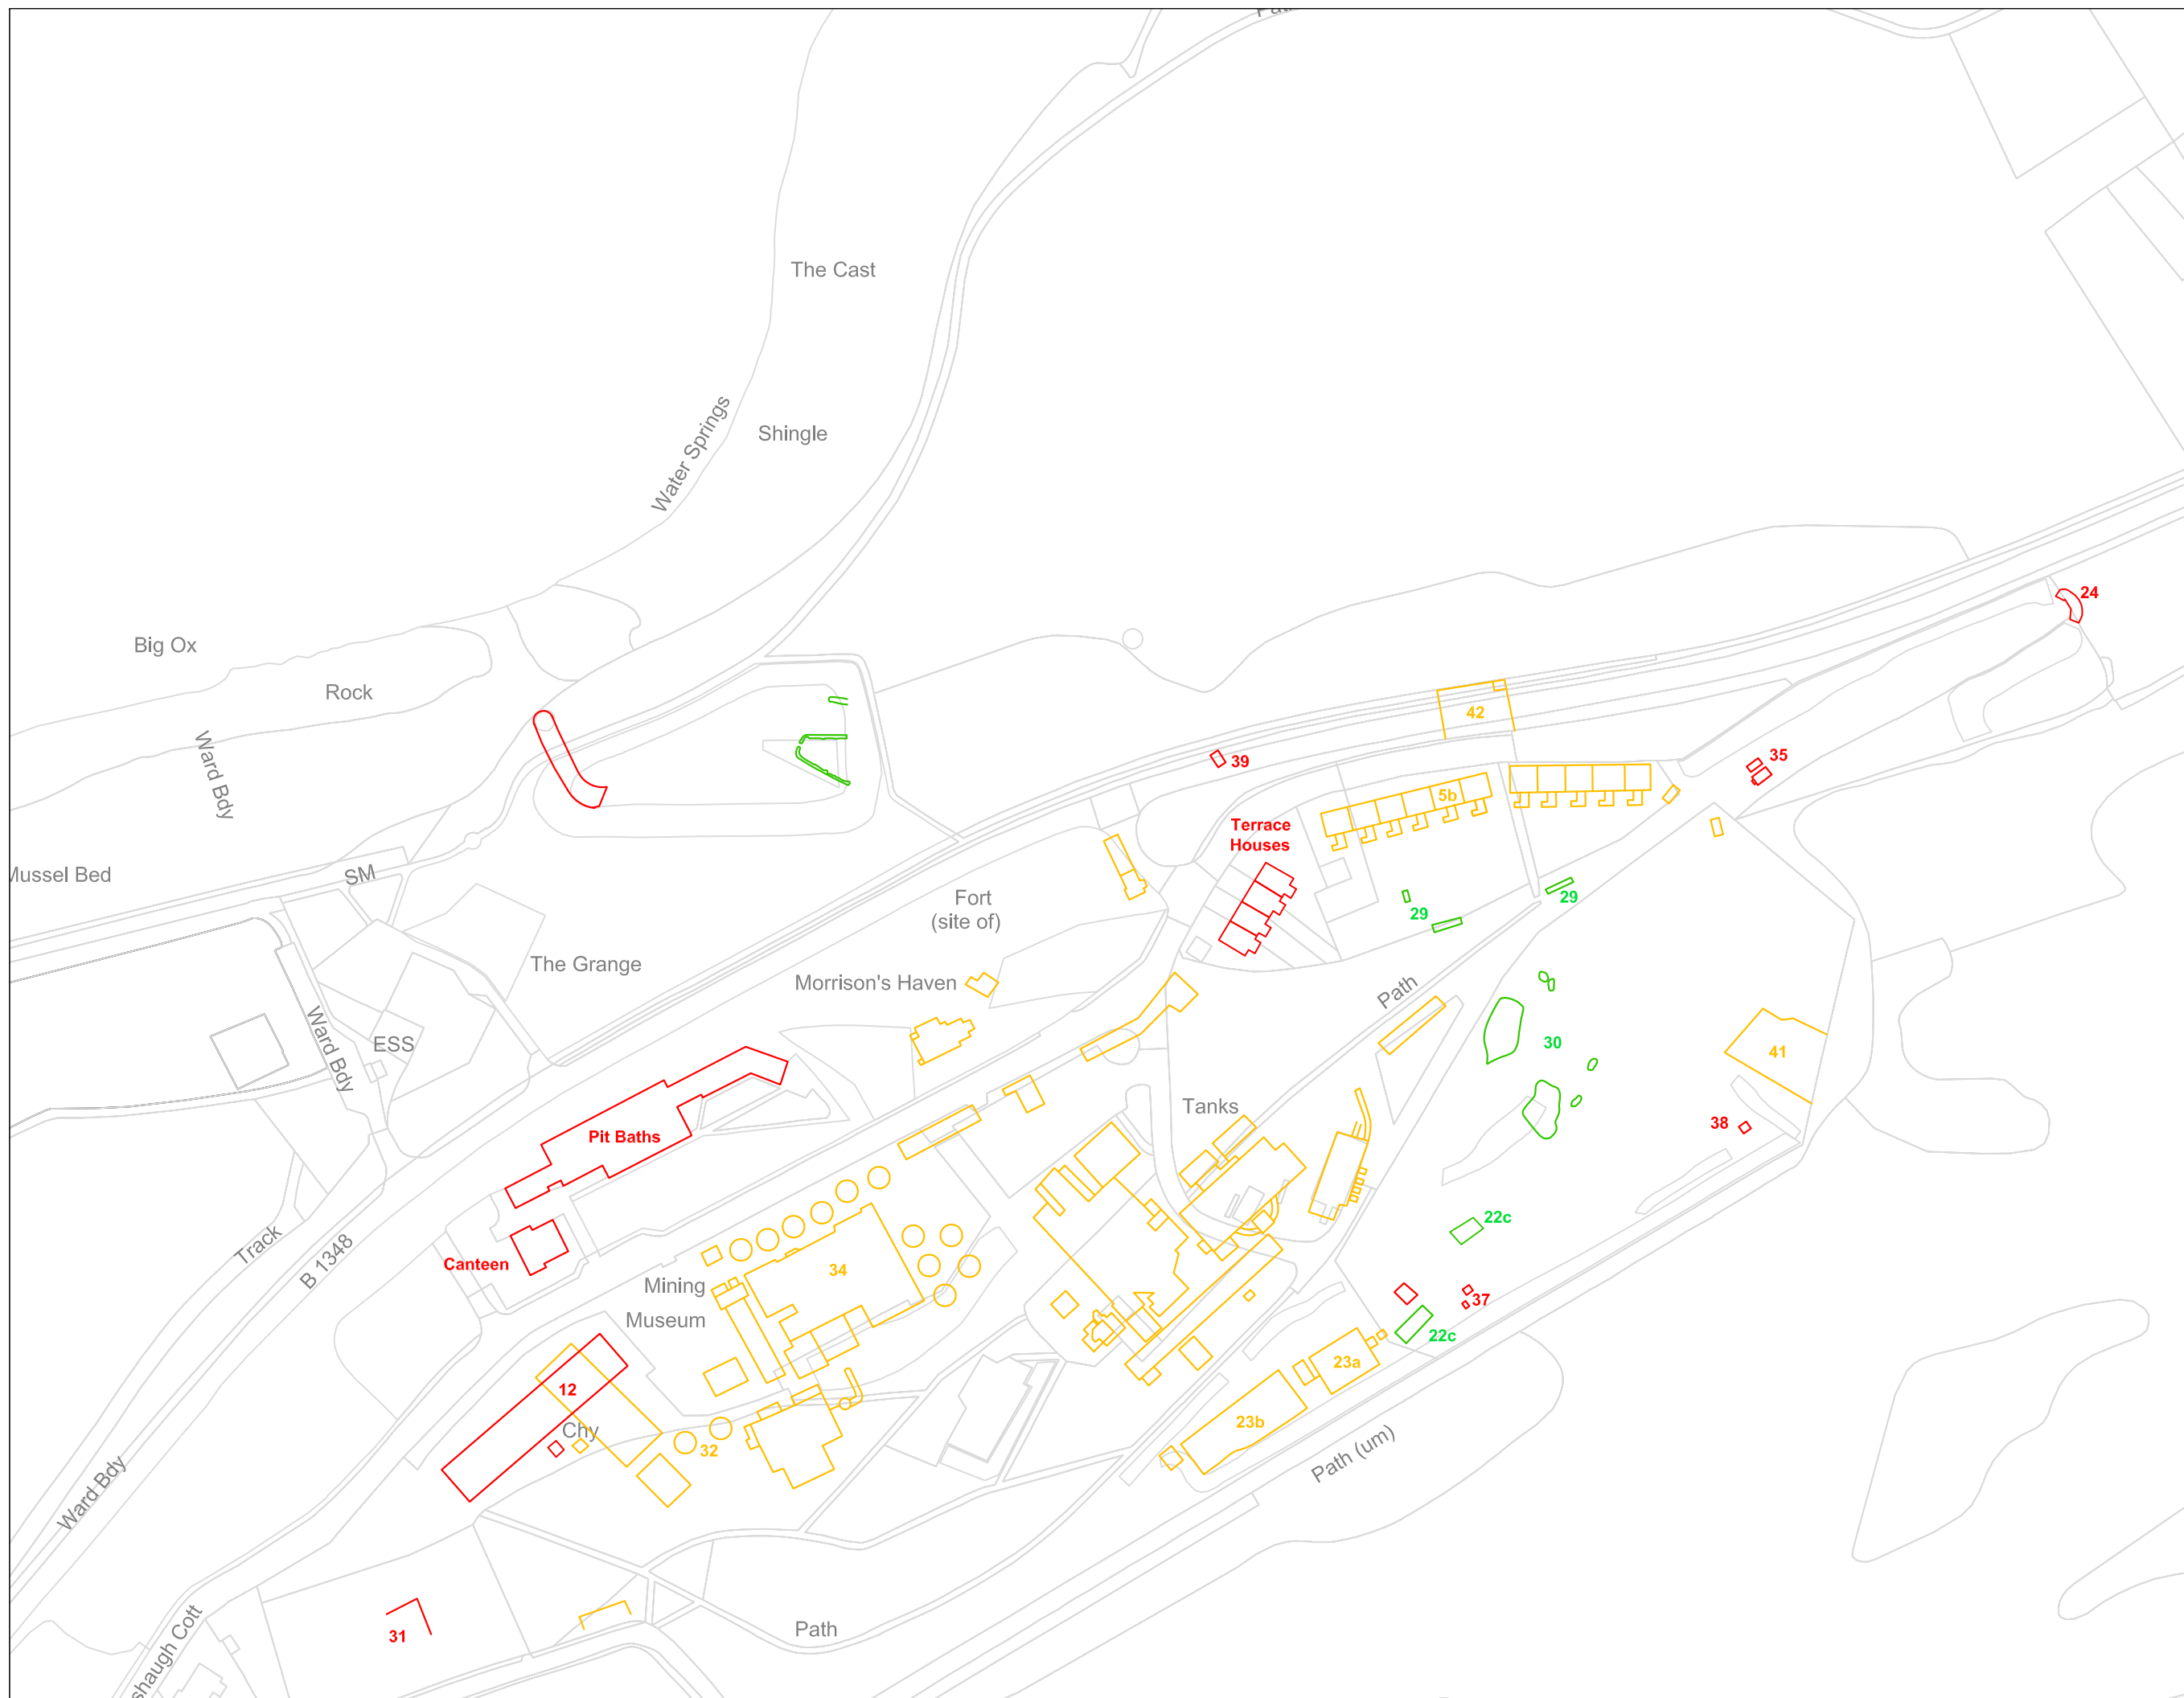
Fig. No: **6** Revision: **A**

Fig. 6 depicts additional features visible on the 1972 plan, produced by East Lothian Council. The site is now 'abandoned' (date of the colliery closing) but the 1972 plan provides useful annotations of the features. For example, site **23b**, a reservoir, is annotated as 'empty but overgrown' suggesting it went out of use before **23a**.

A group of 'rubbish mounds' (**30**) is depicted and it was hoped that these would prove to be waste mounds associated with the 18th and 19th century pottery. Field survey recorded several overgrown mounds, but these appeared to contain 20th century waste material associated with the colliery. Three features, annotated as air raid shelters (**29**), are also depicted associated with the terraced houses (**5b**). Two of these no longer survive as upstanding features, but one (which utilised the 18th century glass flue) is still present. A section of wall (**17**) is depicted on the 1972 site plan and was recorded by field survey; it may relate to the terraced housing (**5b**).
