Prestongrange Community Archaeology Project, East Lothian

Archaeological Field Survey

Report No. 1593

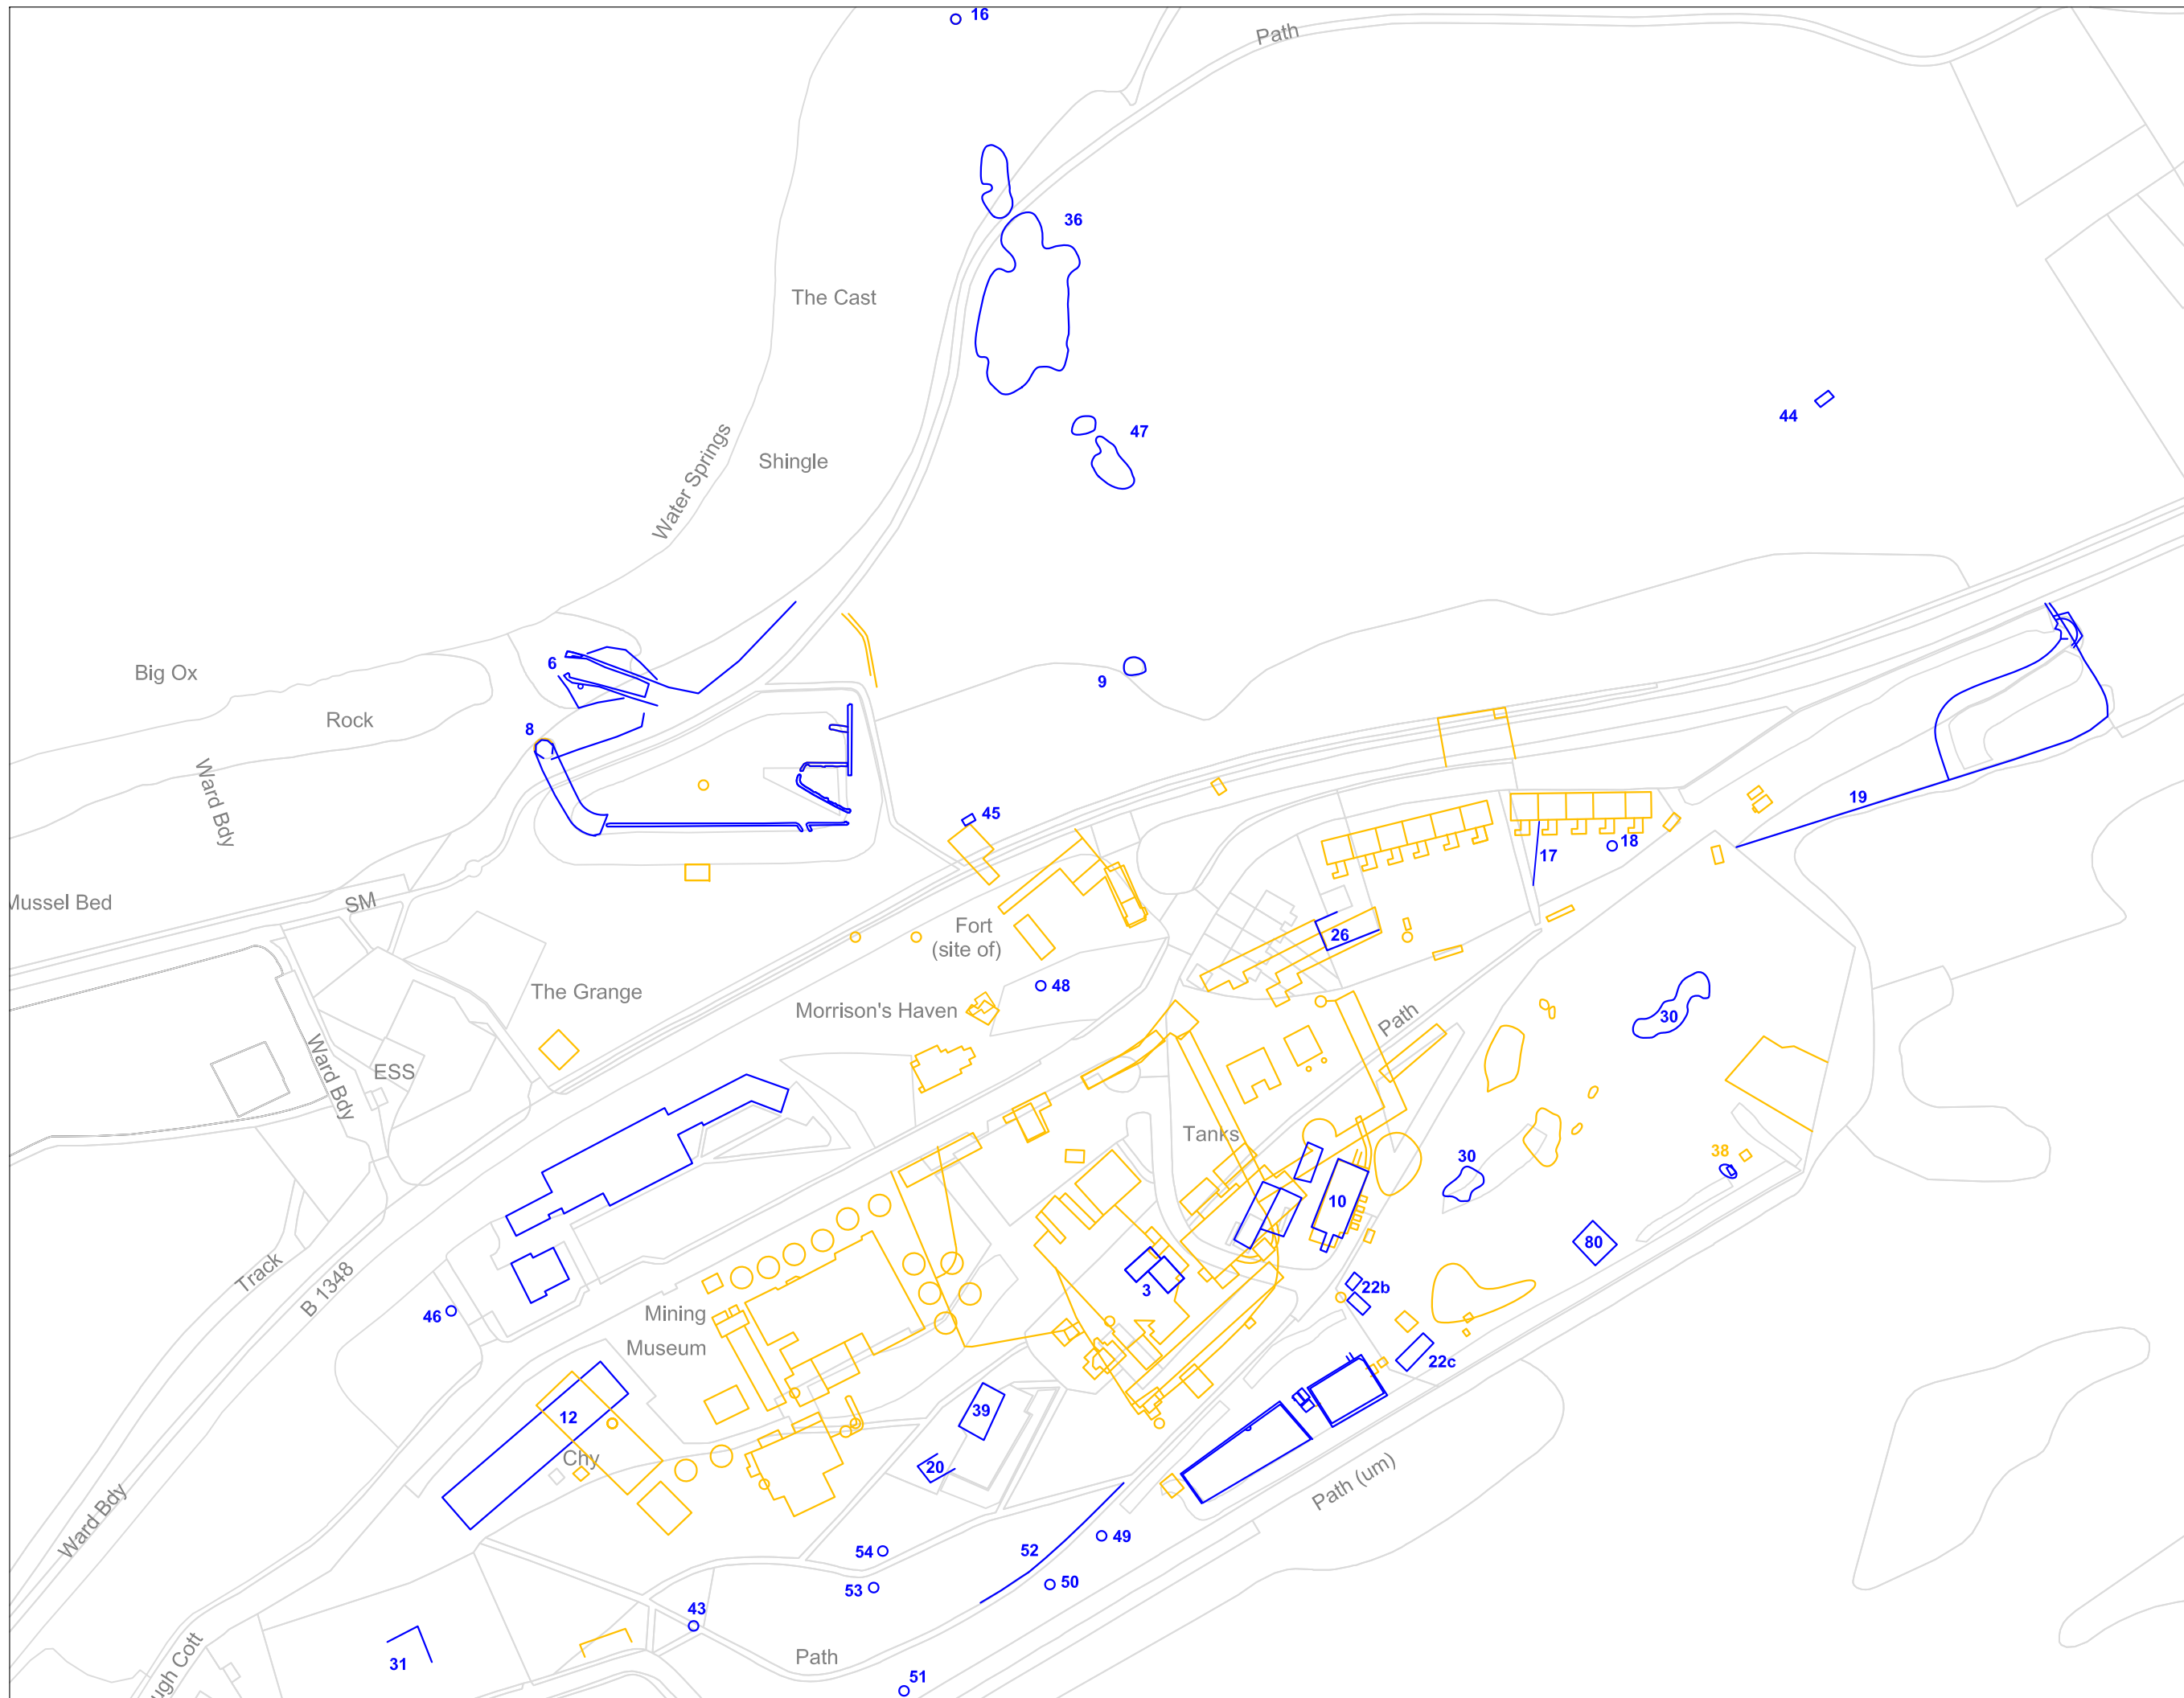
Fig. No: **7** Revision: **A**

Fig. 7 depicts features which were identified as upstanding features at the time of field survey. Despite the extensive landscaping that has taken place within the study area, features (such as the reservoirs) still survive within the woodland and other overgrown areas. Elements of the colliery were preserved as part of the museum

A possible quarry (25) is situated on the eastern edge of the study area. Today it appears as a substantial feature although this is because of the railway track running to the north. The tree survey confirmed that trees within the majority of the feature are at least 150 years old suggesting that the quarry was perhaps associated with the excavation of material for the pier.

Within the coal tip area (to the north of the Colliery), field survey identified concrete slabs (44 and 45), possibly covering old shaft entrances. A large area of concrete rubble was also identified by field survey and this may relate to the 'concrete works' (lying outwith the study area) annotated on the 1956 Coal Board plan. Within the same area, field survey also recorded two stone rubble mounds (47), possibly relating to now destroyed buildings. Other features, such as 49-51, most probably relate to 20th century industrial activities.
