**Outhouse at Kirkbride House,
Traquair,
Scottish Borders.**

**Archaeological Watching Brief
Report No. 1706**

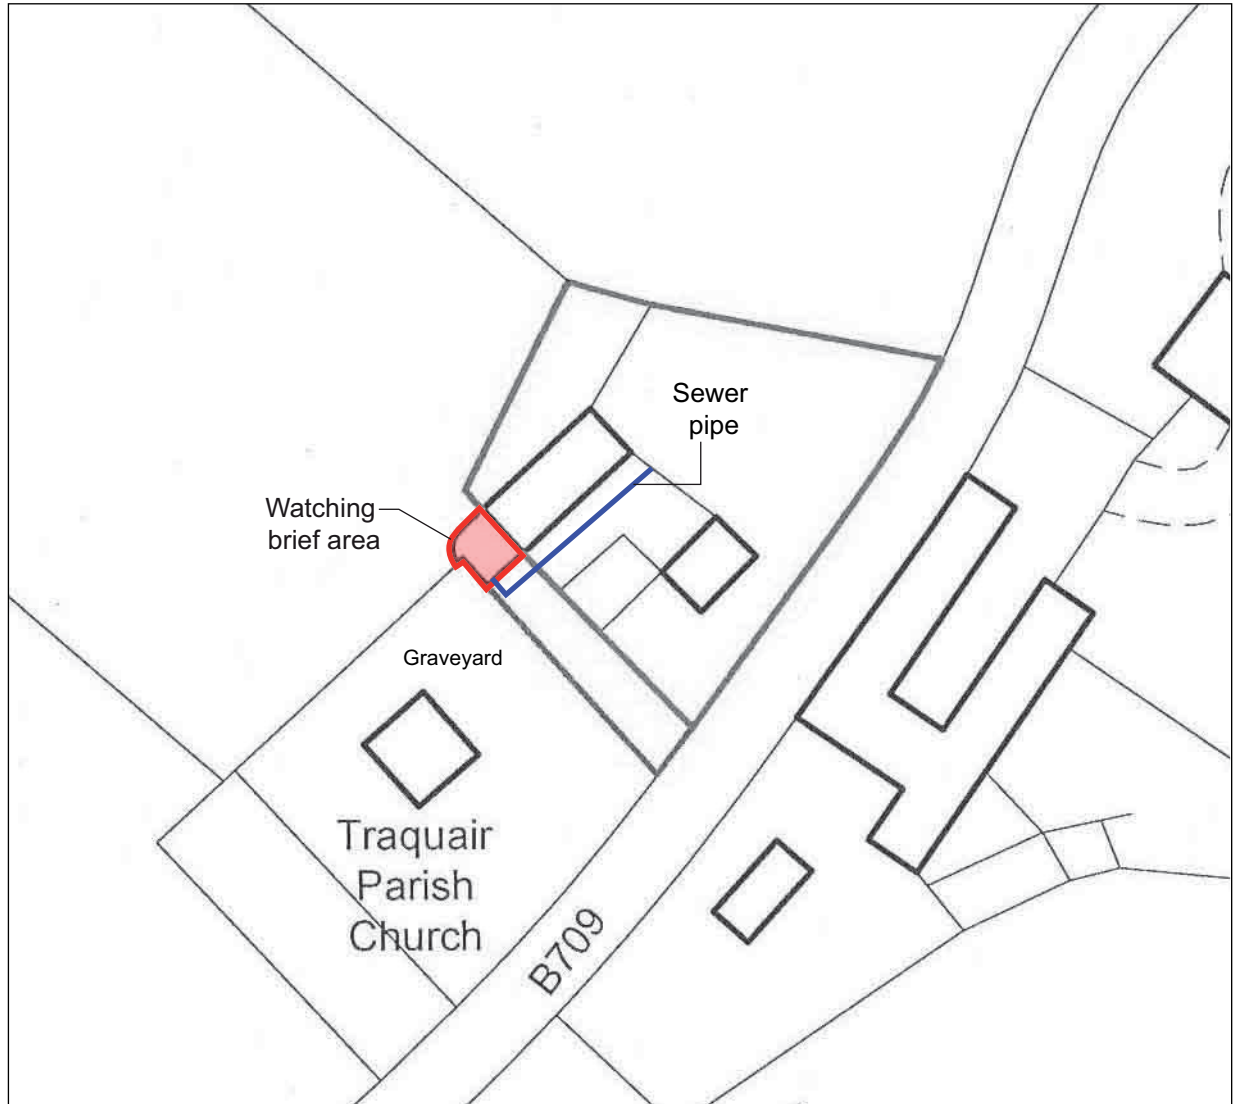
Fig. No: 2 Revision: A Client: Fi Martynoga

Title: The location of the watching brief between the graveyard wall and the building centre left

- 1.2.1 The site lies adjacent to the northern corner of the graveyard wall surrounding Traquair Parish Church (Fig. 2). An information board in the churchyard states that there has been a church on or near this location from as early as 1116 at which time it belonged to the diocese of St Kentigern of Glasgow. The existing church dates to 1778, with notable additions being made in 1914. The church manse, within whose grounds the watching brief took place, dates to 1790.
- 1.2.2 The extension to the existing outhouse was situated in a narrow gap between it and the high graveyard wall to the south (Fig. 2). The ground level within the graveyard is much elevated over that on the site of the outhouse extension. Three elements of the development were recorded.

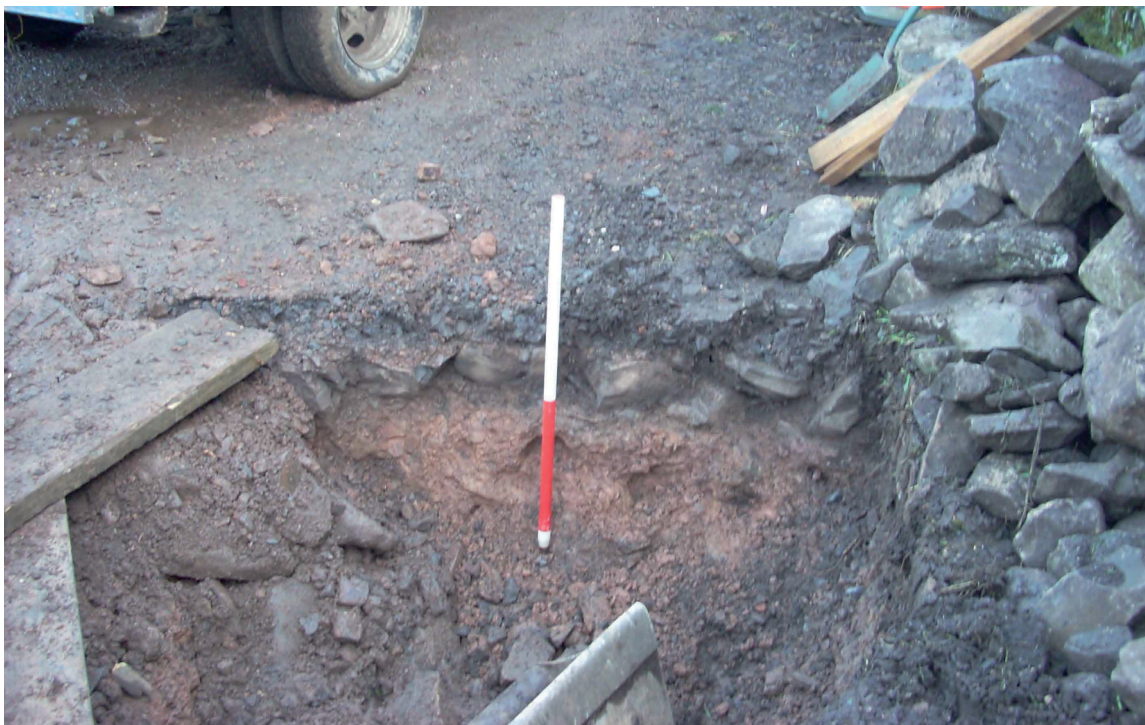
Fig. 4 Section showing the large cobbles of the former yard surface under gravel and over natural subsoil

- 3.1 Numbers in bold and parentheses below refer to contexts, a list of which is contained in Appendix 1.
- 3.2 Within the footprint of the outhouse, under surface gravel and soil (**001**) was a layer of substantial cobbles (**002**) with a depth of up to 0.2m (Fig. 3). These appeared to be the remains of a cobbled yard which overlay natural subsoil (**003**). This consisted of a compact and stony pinkish sandy silt.
