Author	Magnus Kirby MA FSA Scot AIfA
Illustrator	Leeanne Whitelaw BSc AAI&S
Editor	Melanie Johnson MA PhD FSA Scot MIfA
Commissioned by	Capita Symonds for Cumbria County Council
Date issued	March 2009
Version	0
OASIS Reference	
Planning Application No	SMC reference number HSD 9/2/8989 CLASS 7
Grid Ref	NY 3401 5570

**A7 Scotland Road / Church Terrace,
Carlisle, Cumbria:
Archaeological Watching Brief
Data Structure Report No. 1606**

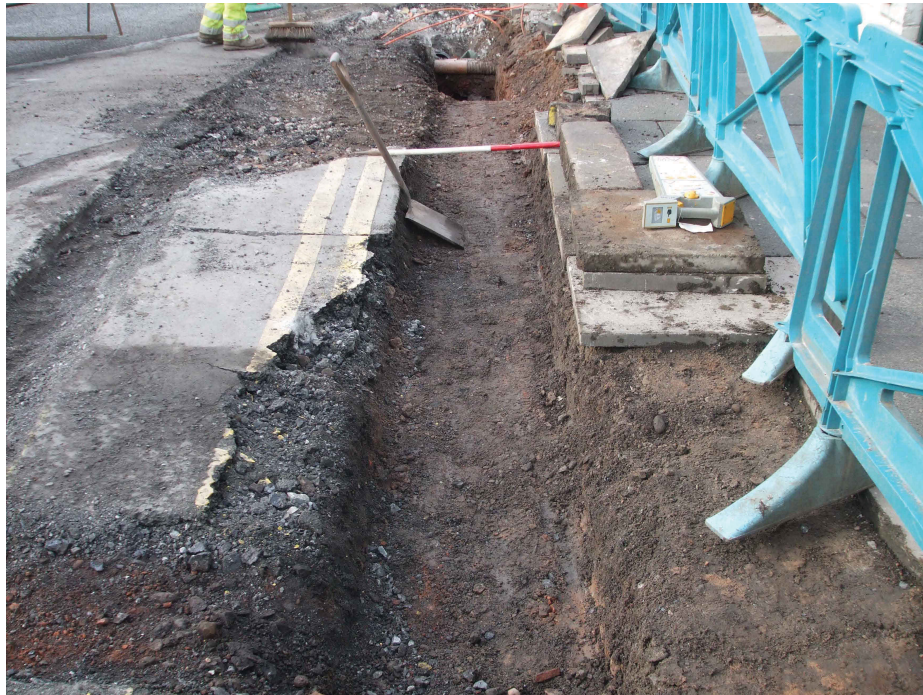
- 3.2 The installation of the side entry gully required the excavation of a pit (Fig. 4) measuring 0.9m long by 0.6m wide, which was cut into the subsoil (**1004**) to a depth of 0.5m, and the installation of the connecting pipe required the excavation of a trench (Fig. 3) with a width of 0.6m, which was cut into the subsoil to a depth of c. 0.1m. This work was carried out within the area previously disturbed by the kerb (**1013**). Hadrian's Wall was not exposed or disturbed during this programme of works and there were no other archaeological features, deposits or artefacts identified.

Fig 3 - Trench for connecting pipe taken from Southeast

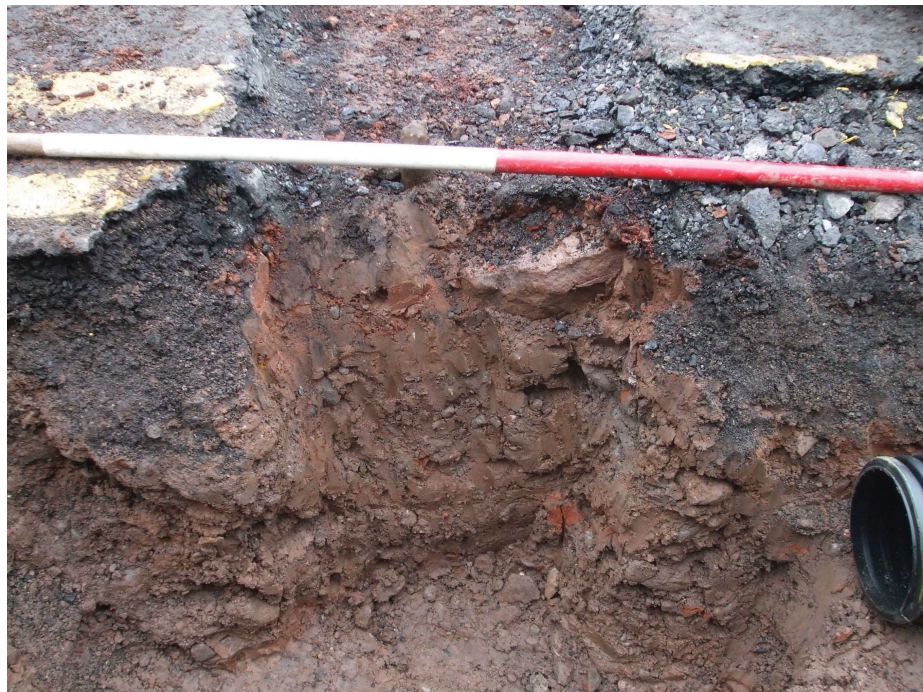
Fig 4 - Pit for side entry gully, Northeast-facing
