**Castle View  
Holy Island  
Berwick-upon-Tweed  
Northumberland**

**Archaeological Works**

**Report No. 1713**

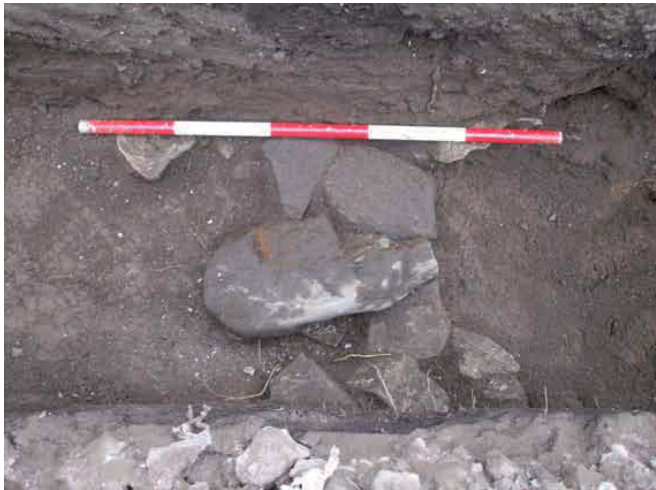
Figure 8 - Wall 007 from West

3.2.3 Wall **007** (Fig. 4 - Fig. 6 and Fig. 8 – Fig. 12) was situated 0.9m below the current ground surface. It measured c. 0.7m in width and was of dry-stone construction. It consisted of a single course of un-dressed stones measuring up to 0.5m in length and showed no clear evidence of any kind of facing. The wall sat c. 0.08m above the level of the subsoil on a shallow deposit of orange-brown sandy silt (**009**), which was of a similar colour and consistency to deposit **003**. Deposit **003**, which had built up against the wall and partially overlay it, was in turn partially overlain by a shell rich midden deposit (**008**).

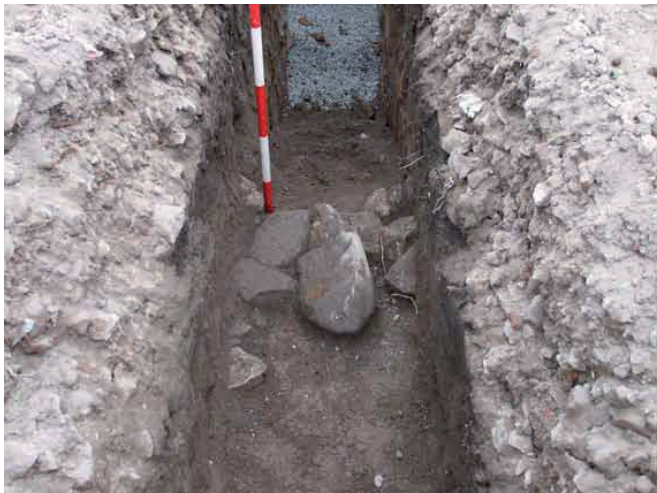
Figure 9 - Wall 007 from North

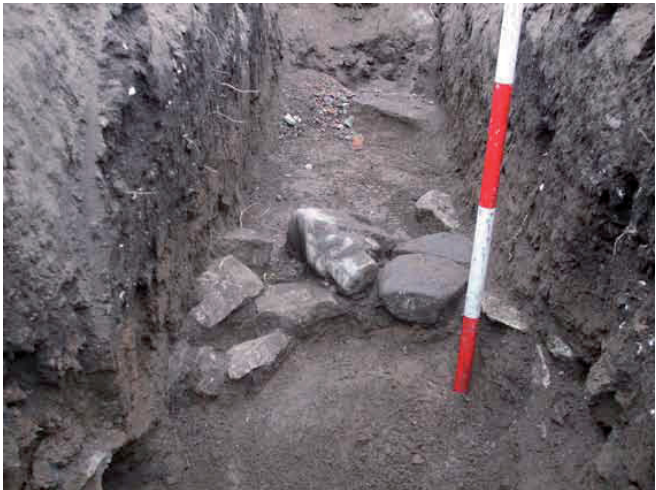
Figure 10 - Wall 007 from South

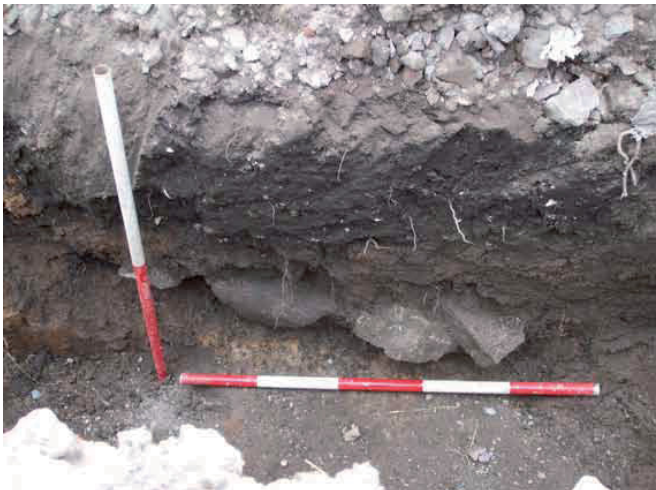
Figure 11 - Wall 007 East-facing section

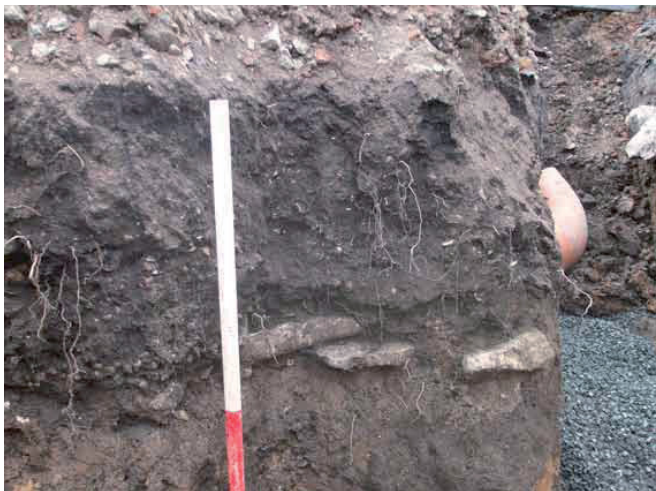
Figure 12 - Wall 007 North-facing section

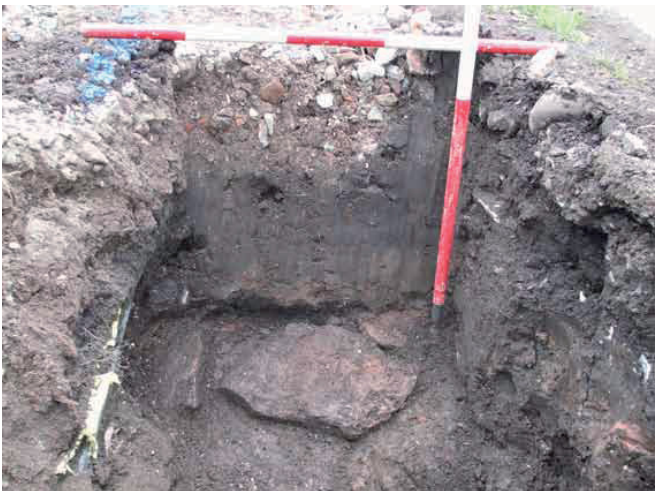
Figure 13 - Paving 010 from East

- 3.2.5 One flat stone was uncovered and a further two flat stones were partially uncovered during the excavation of a trench for the purpose of identifying existing services (Fig. 7 and Fig. 13). The stones (**010**) were situated at a depth of c.0.6m below the current ground surface and sat directly on top of deposit **003**. The stone that was fully uncovered measured c. 0.5m by 0.25m. These stones might represent an area of paving, but the small area uncovered make it impossible to be able to state this with any great degree of certainty.
