| Commissioned by | Commissioned by Copeland Borough Council |
| Date issued | January 2010 |

**Albion Square, Whitehaven, Cumbria**  
**Desk-based Assessment**  
**& Level 1 Building Survey**  
**Report No. 1741**

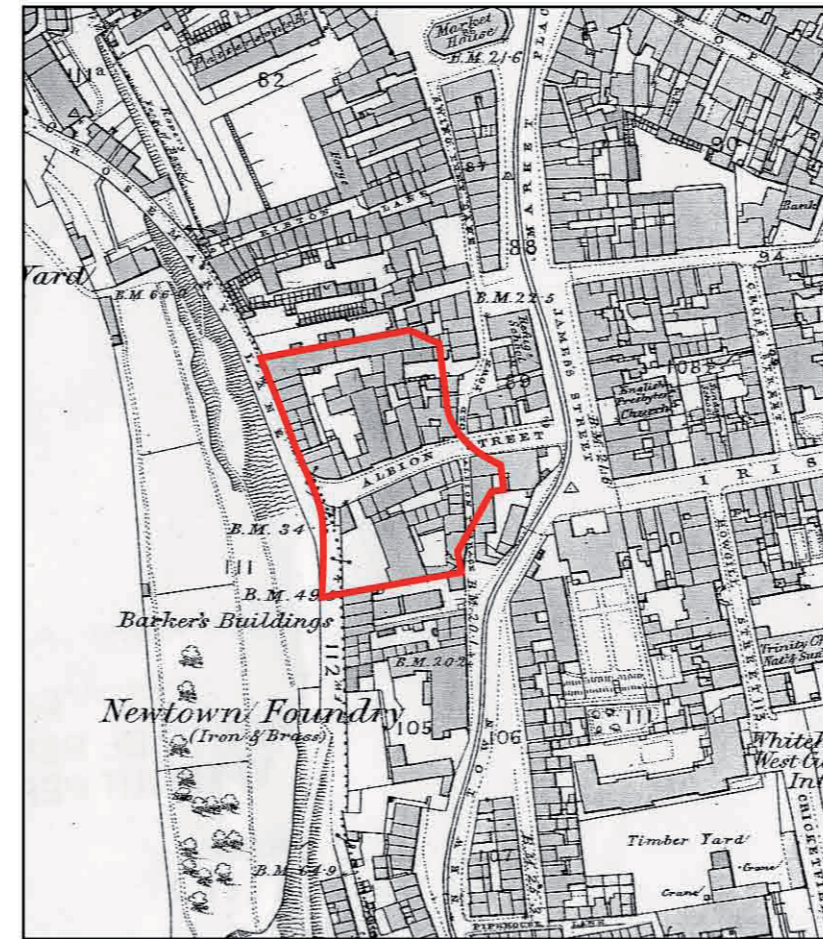
Fig. 2c - Ordnance Survey 1st Edition, 1865 map

| Figure No | Year | Author | Descriptive summary |
|---|---|---|--|
| 2c | 1865 | First Edition O.S. 6" map | The properties fronting Rosemary Lane have increased in number and are more standardised in terms of layout. The north side of Albion Street is completely developed with three public houses present in the area named as Old Town. The Dusty Millar Inn is named for the first time along with the Fish Inn and Queens Head Inn, the latter is on the north side of Barker Court. At least six properties are situated on the north side of Albion Street. On the south side, seven unnamed properties are shown. At their rear, four properties are named as Dobson's Buildings. These buildings adjoin a series of properties fronting Albion Terrace which is named for the first time. The slaughter house is present but the buildings adjoining its west end are named Barker's Buildings and consist of four regular properties trending east-west. A large rectangular building (engineering shop see below) occupies the centre of the site and is aligned more or less |

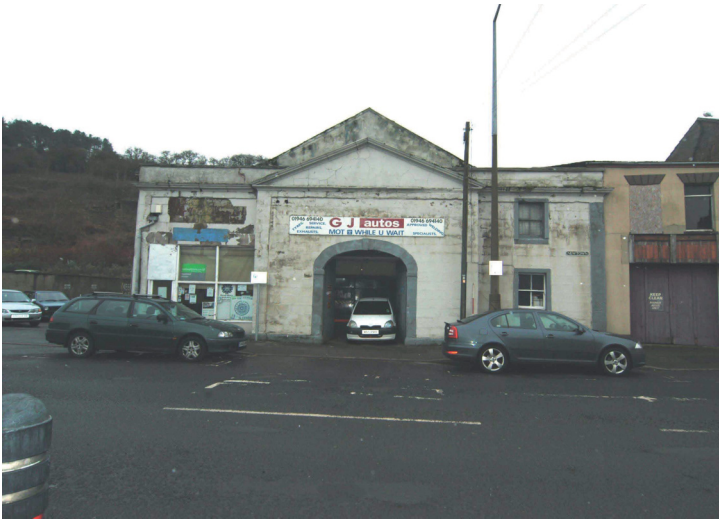
Plate 1 - The east-facing elevation of J & G Autos Garage (Unit 1) fronting Newtown Road

- 4.2.1 The garage measures 13.4m long and is 25.5m wide and has a steel-framed roof-trusses with timber purlins covered with sheet metal and Perspex roof lights. The west gable is constructed of coursed rubble and is noticeably thicker at the base. The north wall is constructed on breeze blocks. The garage is accessed by a large sliding door on the south elevation which is constructed of randomly coursed sandstone and is 0.60m thick. The east elevation fronting Newtown Road has a central arched opening surmounted by a pedimented pitched gable with pilasters and raised quoins in a pseudo neo-classical style. The floor of the garage is concrete but an area of original cobble flooring exists just within the main arched doorway on the east elevation.

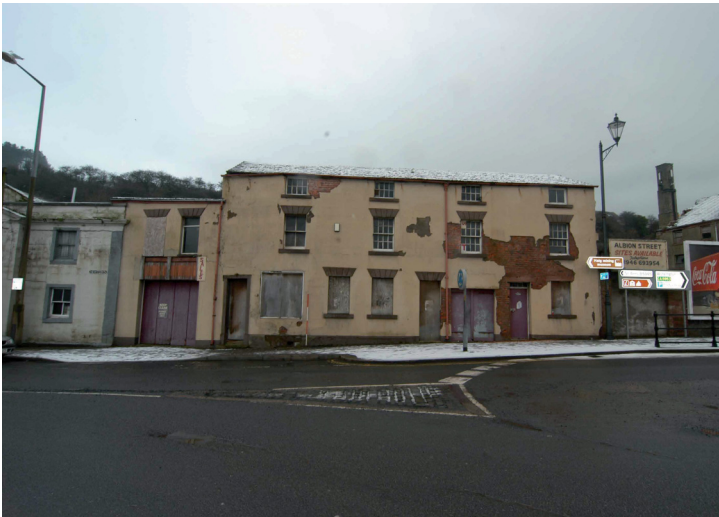
Plate 3 - The east-facing elevations of the 1-3 Newtown Cottages (Unit 6) fronting Newtown Road

- 4.2.6 Units 6a-d represents a series of cottages which have been lately used as part of a metal-working shop. Four individual ground-floor rooms (Units 6a-d) are present on the ground floor. The first floor and attic floor was not accessed as the floors are unsafe. The individual units are now described.

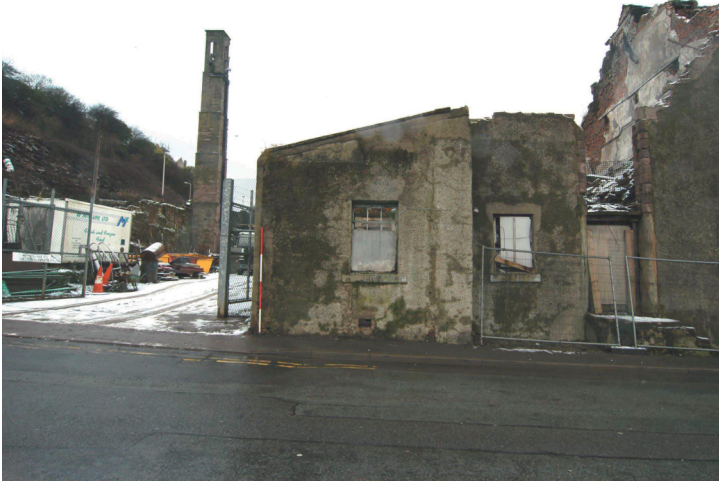
Plate 7 - South-facing elevation of a former warehouse (Unit 15) and No/13 Albion Street

- 5.1.3 The existing buildings fronting the north side of Albion Road are mainly domestic with the exception of a warehouse (Unit 15, plate 7) which has almost been demolished to the ground floor. Plate 15 shows that the main entrance to the foundry was situated on the west side of the warehouse, now roughly were the scrap yard entrance is today. Plate 15 shows a set of ranges surrounding a courtyard. Both the west range and north range survive in part and are represented by Units 18, 20 and 21. Interestingly, the west range of the foundry had a pitched gable roof which envelops the chimney. The roofline of the depicted west range is not broken by chimneys near the chimney stack which strongly suggest that the blocked-up fenestration identified as Unit 21, were probably associated with foundry's pattern workshops or offices.

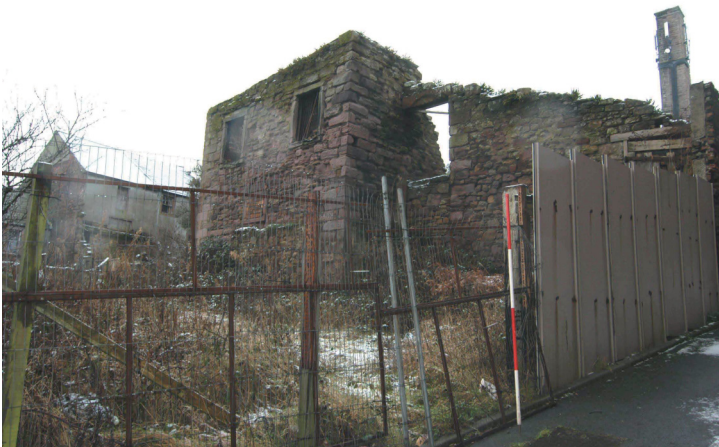
Plate 11 - East facing gable of the former Phoenix Foundry (Unit 18)

- 4.2.23 Unit 18 comprises the upstanding east end of the north range of the former Phoenix Foundry. The east gable wall is built of coursed sandstone with ashlar quoins and survives to above its second floor window openings which have sandstone sills and lintels. The north-east corner of the building survives for a length of about 4m which has another cross-wall with a square opening present at its wall head. The southern wall is substantial and in is estimated to be over 10m long. The interior of the building is very overgrown and could not be accessed but is estimated to be in the region of 7m wide.

- 8.1 It is recommended that further programme of standing building recording be carried out to an appropriate level on the upstanding remains of the former Phoenix Foundry (Unit 18), on the grounds that these remains are important to the industrial history of the town of Whitehaven

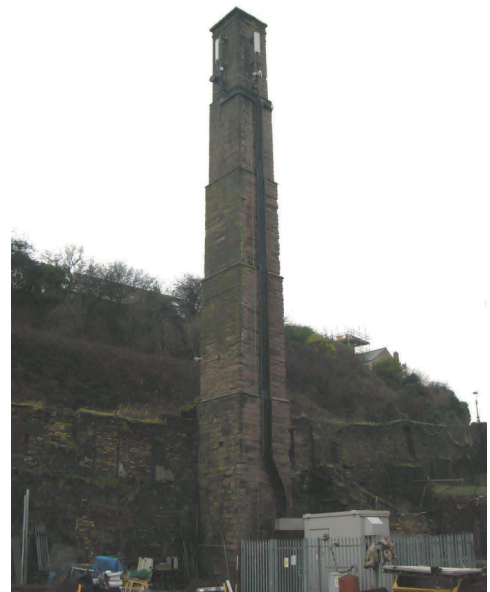
Plate 12 - South-east corner of the Phoenix Foundry chimney (Unit 20)

- 4.2.25 Standing against the western boundary wall of the proposed re-development area is a free-standing chimney built of coursed sandstone. The chimney is stepped in five individual lifts, each reducing in size from bottom to the top. There is a moulded cornice on the top of the chimney. The chimney was re-pointed recently as part of restoration and telecommunication cable works (P Hanratty pers comm.). On the south side of the chimney there a roof-raggle corresponding with the pitch of a roof associated with the west range of the foundry which incorporated domestic dwellings and workshops.

its north range which bounded the northern edge of the proposed redevelopment site. The foundry chimney (Unit 20, Plate 12) has had a series of floor-joist sockets cut into its lower section. A roof raggie (incised groove for holding lead flashing) of a pitched roof is visible on its south side. This evidence shows that it was structurally integral to the west-range of the foundry.

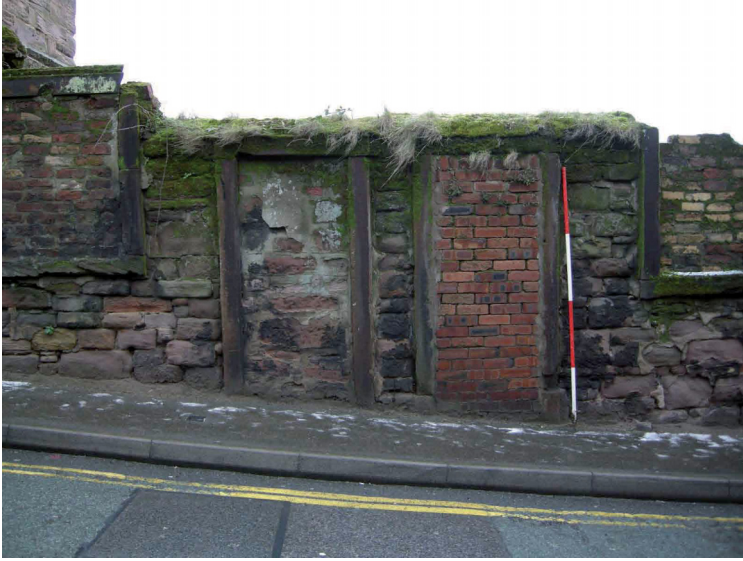
Plate 13 - West-facing building remains (Unit 21) fronting Rosemary Lane

- 4.2.26 Unit 21 is a collection of eight blocked openings associated with a series of demolished dwellings that fronted Rosemary Lane. The main wall is rubble built and the doors and windows have sandstone margins that are raised. The windows and doors are blocked with red bricks and in some cases white brick. The wall is staggered, reducing in height as one goes down the hill. The building remains show that they were situated above a lower basement floor of the west range of the former Phoenix Foundry.

- 8.4 The blocked fenestration (Unit 21) fronting Rosemary Lane should also be recorded to an appropriate level as these represent the remains of the first floor of the west range of the Phoenix Foundry.

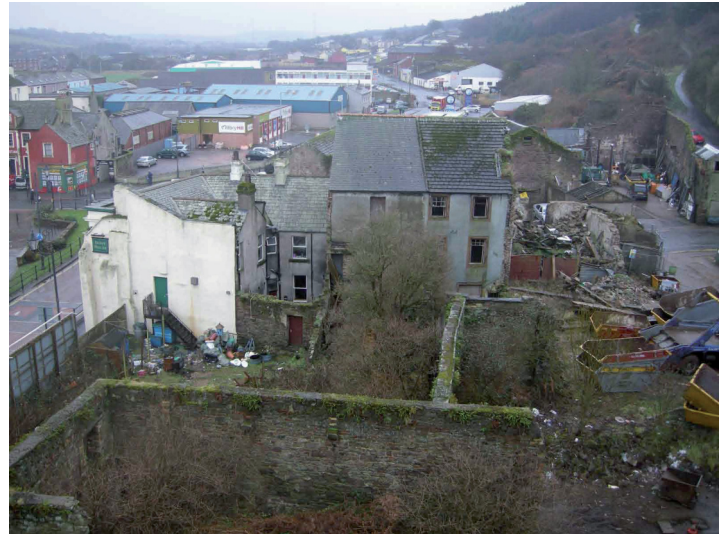
Plate 14 - Aerial view looking southwards with the upstanding foundry walls (unit 18) in the foreground

5.1.2 The most substantial remains within the proposed development area are the surviving walls of the Phoenix Foundry (Units 18 and 19, see also Plate 14) which are upstanding to a height of about 4.5m. The building remains represent the remains of
