**76 Ravensdowne Road  
Berwick-upon-Tweed  
Northumberland**

**Archaeological Test-Pit Evaluation  
Report No. 1749**

**Archaeological Test-Pit Evaluation**

**Report No. 1749**

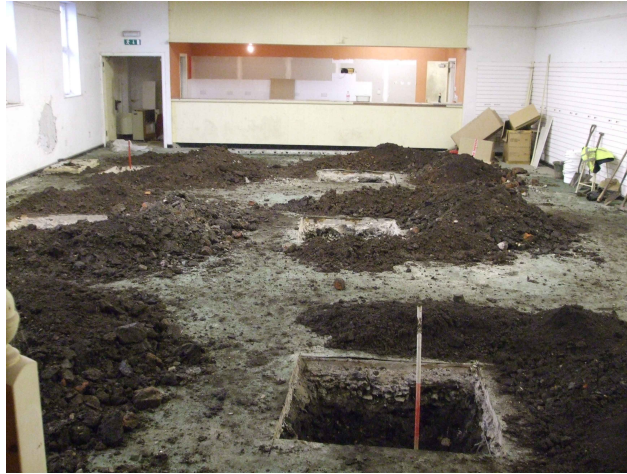
Fig. 7 General shot of Test Pits 1-6. Ranging rods are 2m in height

3.1.1 **TP1 – TP6** (Fig. 2 and Fig. 7) were excavated to the maximum safe depth of c.1.5m. The same deposits extended across these six test pits. Following excavation these test pits flooded indicating that the water table was present at a depth of c. 1.4m below the ground surface. Coring with a hand auger indicated that there were potential archaeological deposits going down to at least a depth of 4.2m below the current floor surface. Natural subsoil was identified within **TP8** and **TP9** at depths of 0.6m and 0.8m below the current ground level respectively. Sherds of pottery were recovered from **TP1 – TP6** and **TP8 - TP9**. Details of the individual test-pits are contained in Section 3.2 and details of the finds are contained in Section 3.3.
