**Kirkpark Access Road, Inveresk,
East Lothian**

Archaeological Evaluation

Report No. 1758

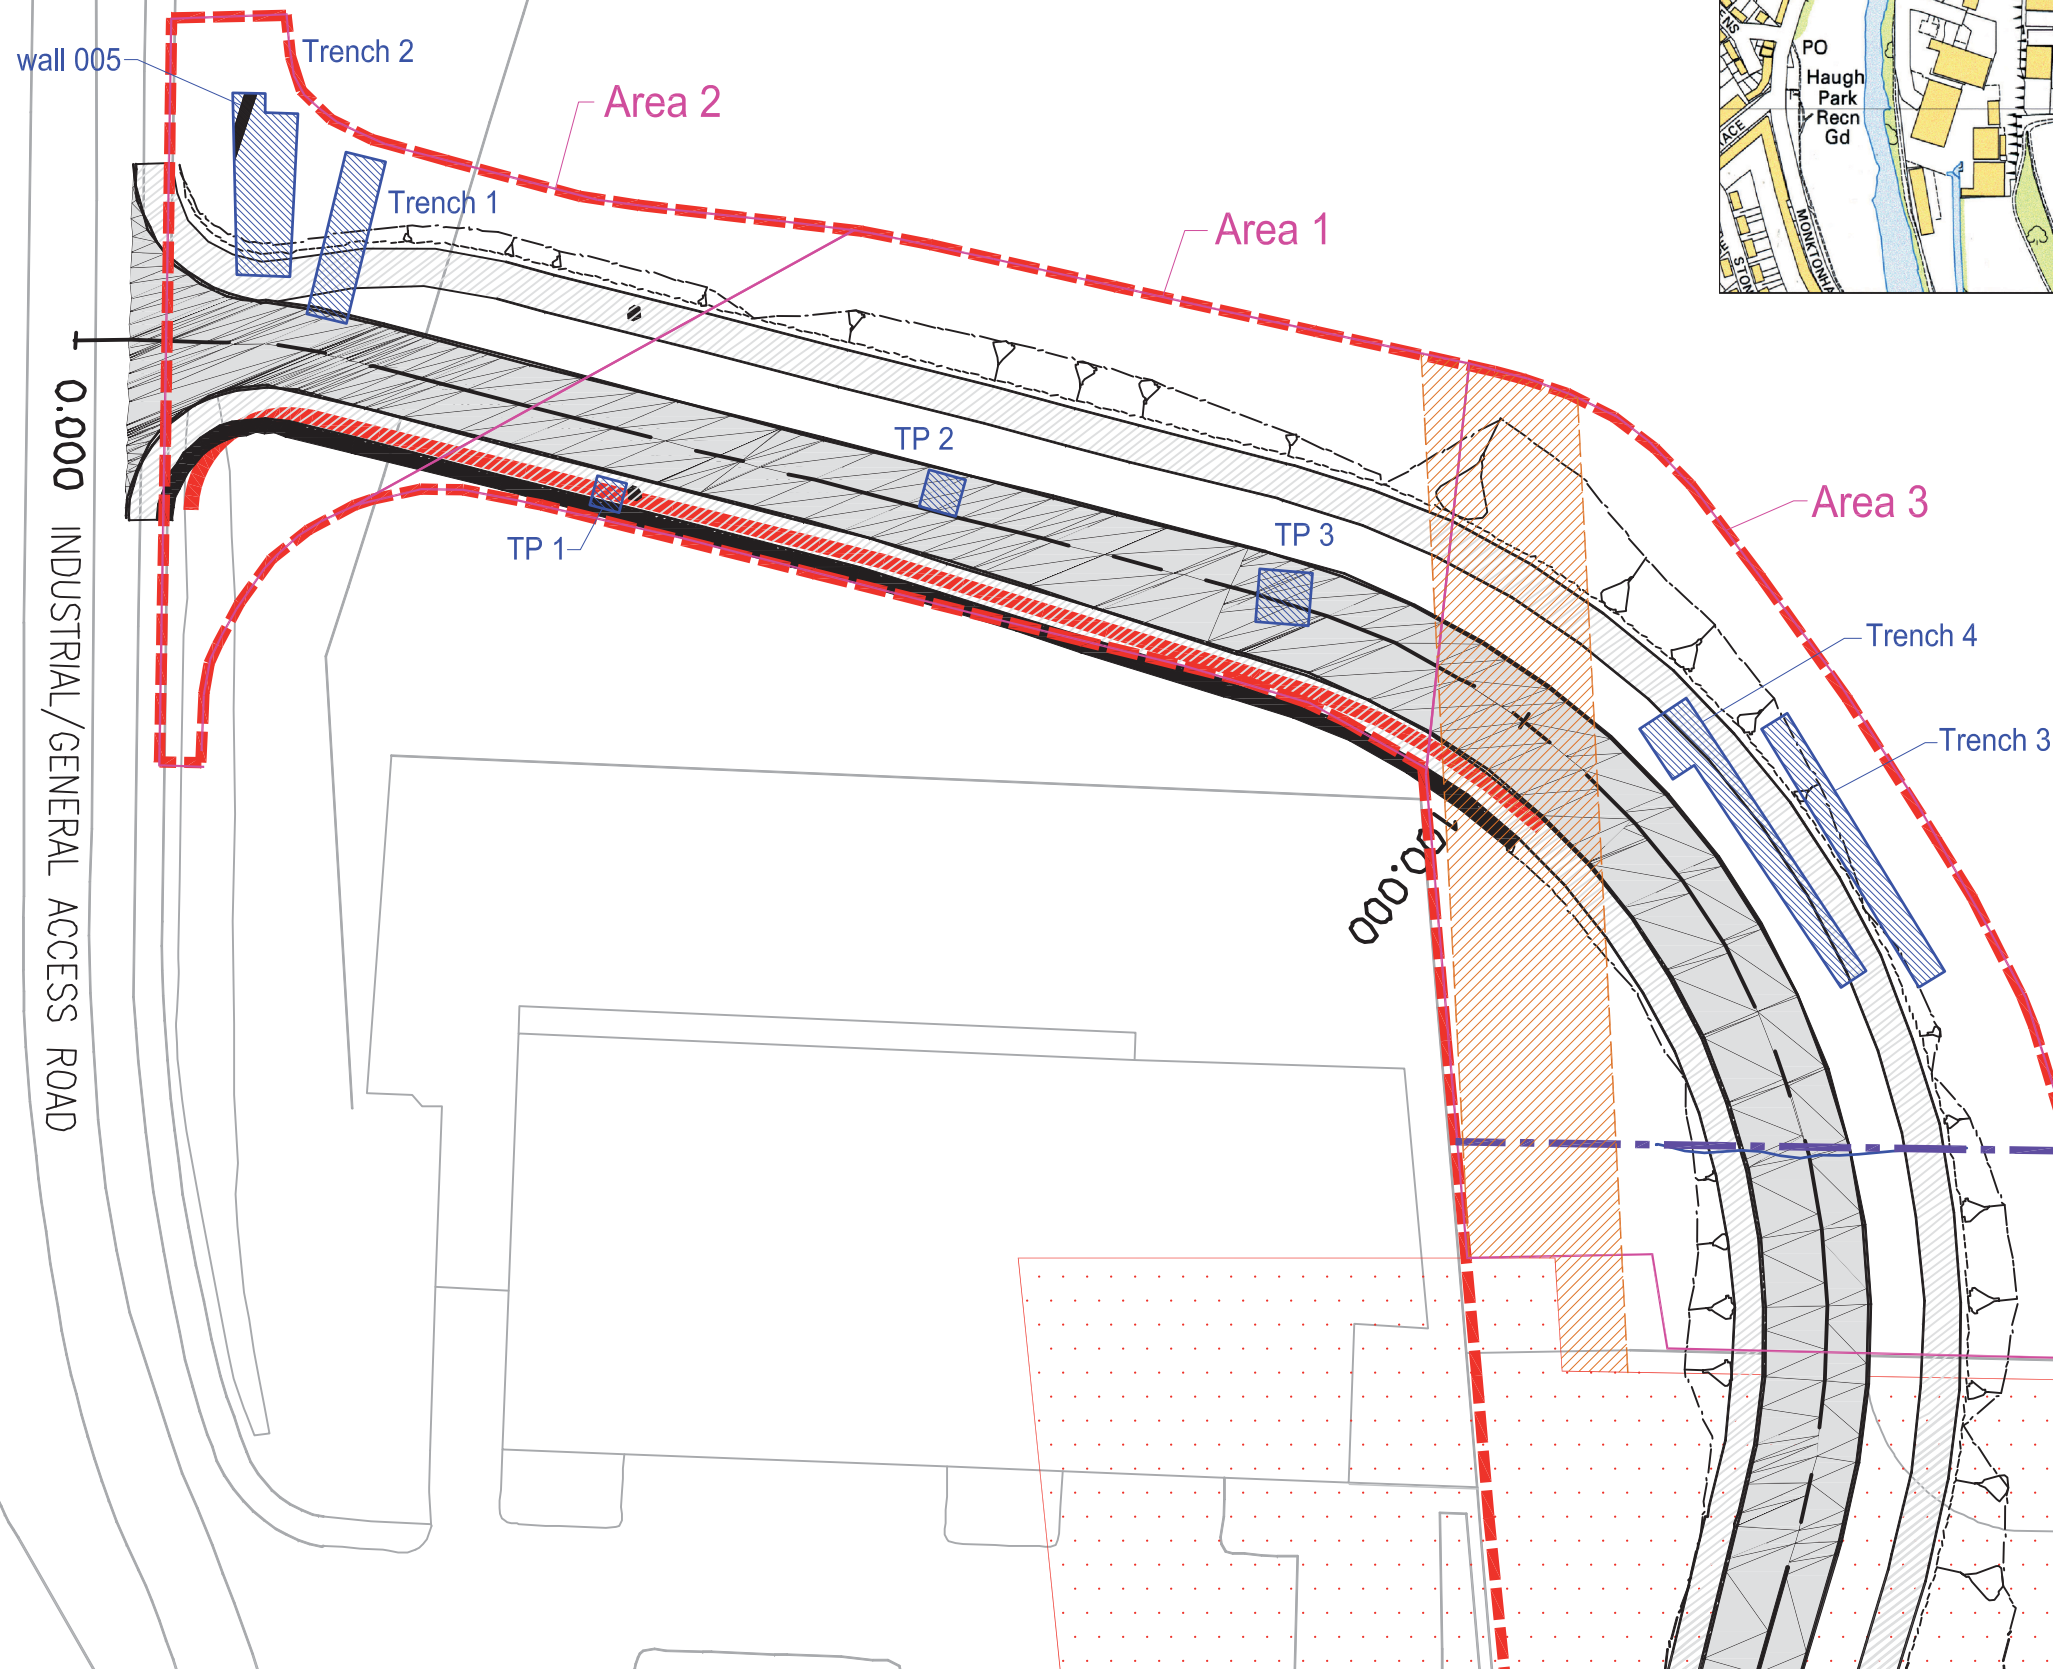
Fig. No: 1 Revision: C

- 3.4.1 The positioning of trenches in this area was constrained by the presence of a gas pipe and underground electricity cable, as well as concrete base of a demolished building (Fig.1)

Title:
Location of trenches and test pits

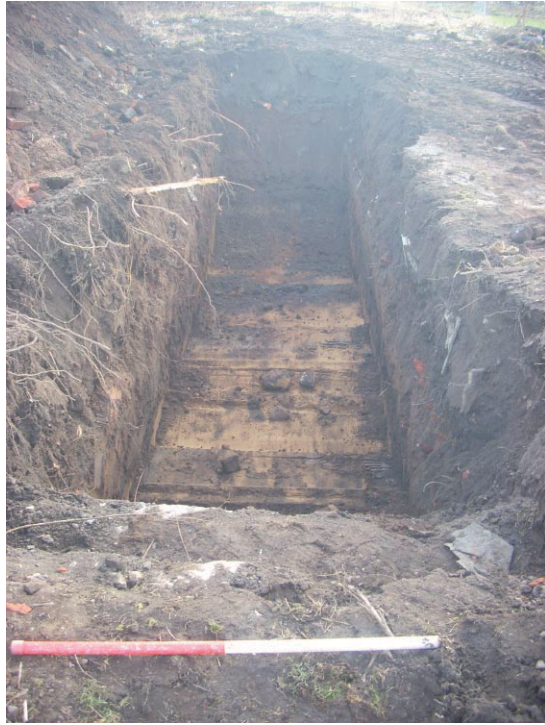
- 3.3.1 Topsoil (001) was 0.6m deep and overlay over a deposit of red-brick rubble (002) and mixed yellow and brown sand (003) that was 0.35m deep (Fig. 3). This overlay a mid-brown homogeneous sandy silt 0.55m deep (010). Two red clay pipe field drains were dug through this deposit. This in turn overlay (011), a dark brown-grey sandy silt 0.3m deep which overlay natural yellow sand with some iron panning visible (012).

Fig. 2 - Post-ex photograph of Trench 1 from NNE

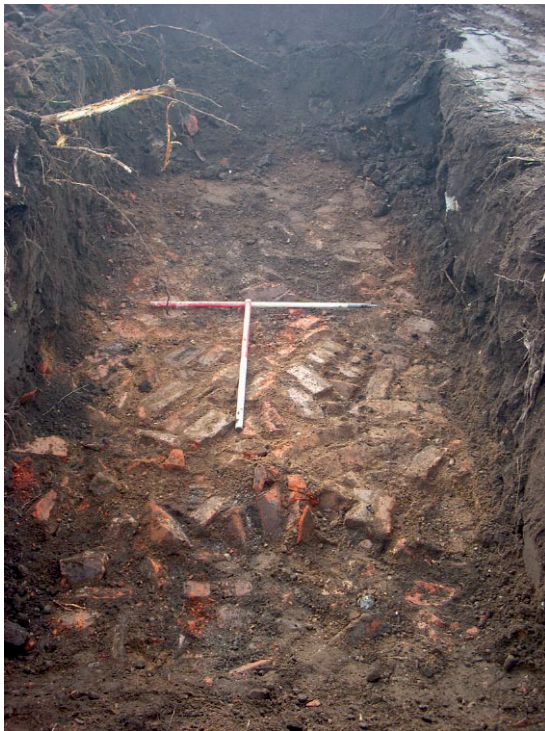
Fig. 3 - Photograph of rubble deposit (003) in Trench 1 from the NNE

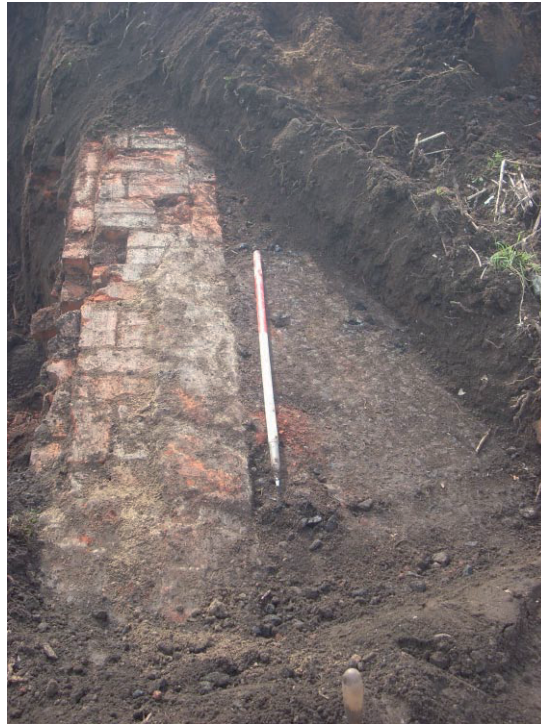
- 3.3.2 Topsoil (001) was 0.3m deep and overlay a modern red-brick mortared wall (005) located in the north end of the trench (Fig. 4). The wall was aligned NNE-SSW and was exposed to a length of 3m by 0.7m wide and 0.65m deep. The western side of the wall was abutted by a hardcore surface.
- 3.3.3 Abutting the wall (005) on its eastern side was a deposit of made-ground of mid brownish grey silt with brick rubble inclusions (006). This was 0.4m deep and overlay (007), a red-brick rubble with yellow sand, ash and mortar, similar to (003) and (002) in Trench 1. This deposit was 0.3m deep and overlay (008), a mid brown silty sand that was 0.4m deep. Underlying this was (009), a dark grey gravelly silt similar to (011). This was 0.3m deep and overlay natural yellow sand (004).

Fig. 4 - Photograph of wall 005 in Trench 2 from NNE

- 4.4 Trial trenching in Area 2 revealed the remains of a brick wall (005) close to the surface and demolition layers c. 0.6m below the current site surface. Natural was c 1.8m below the current site surface. The walls and demolition deposits probably relate to the remains of the Eskmills Net Works that occupied this area. Trial trenching in Area 3 revealed only natural deposits.

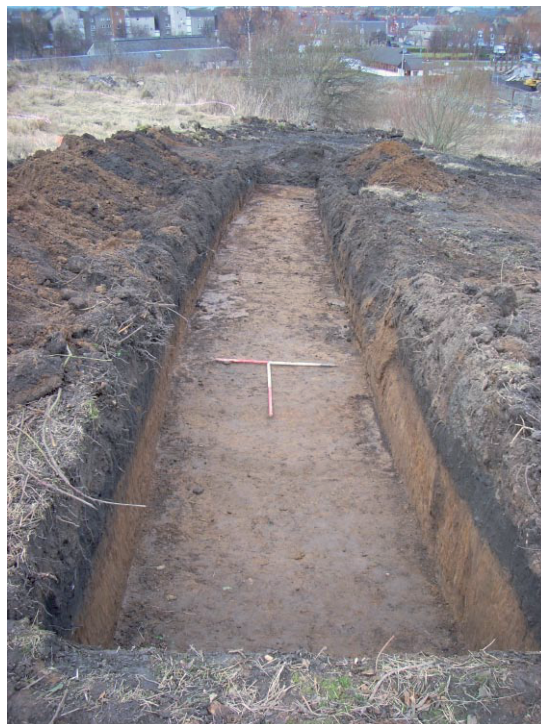
- 3.4.2 A recent dump of mixed redeposited natural and topsoil (022) overlay the topsoil at the south-eastern end of the trench to a depth of 0.3m. Topsoil (001) was 0.25m deep at the south-eastern end of the trench and 0.45m deep at the north-west end of the trench. This overlay a mid brownish grey clay sand (023) which was 0.15m deep at the south-eastern

end of the trench and 0.05m deep at the north-west end of the trench. This overlay a mid pinkish orange and orange grey clay sand (024). This was 0.45m deep at the south-eastern end of the trench and 0.2m deep at the north-western end and overlay natural (027).

Fig. 5 - Post-ex photograph of Trench 4 from SE

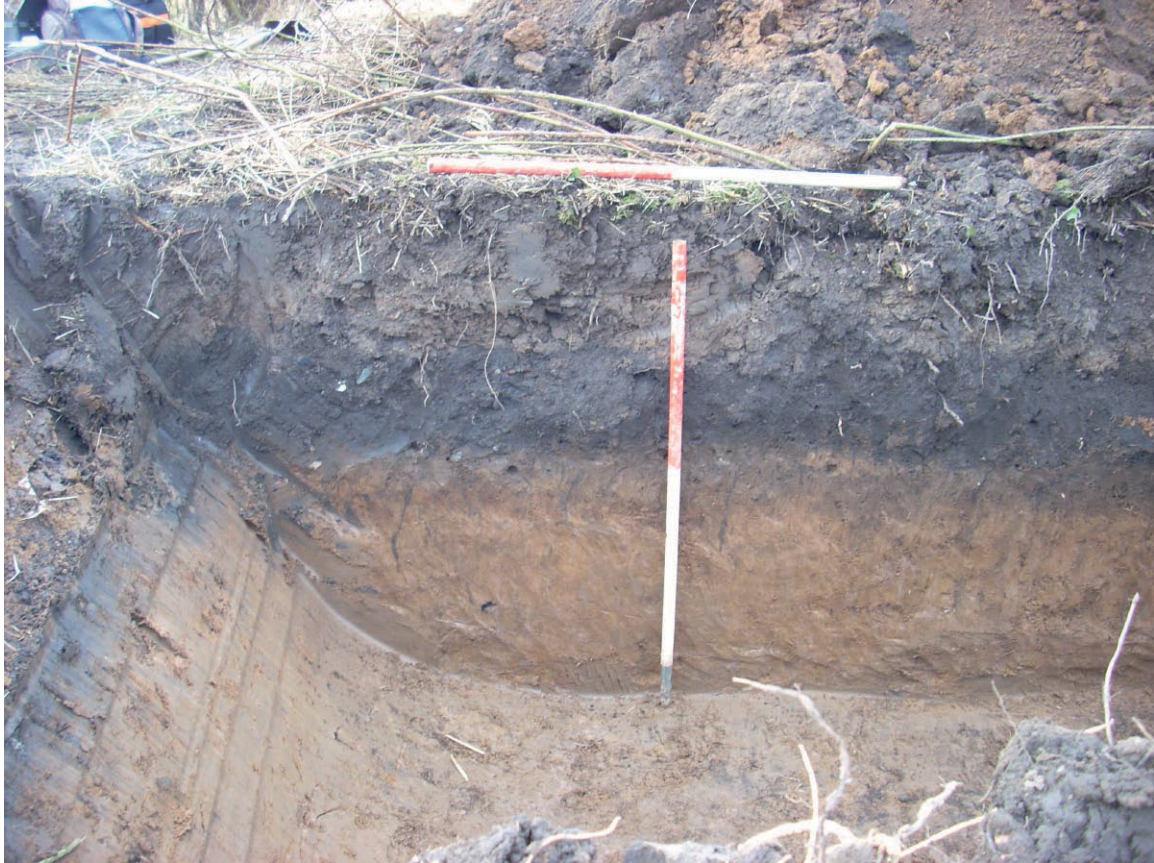
Fig. 6 - NE facing section of Trench 4
