**Canongate Car Park,
Jedburgh,
Scottish Borders**

Archaeological Watching Brief

Report No. 1762

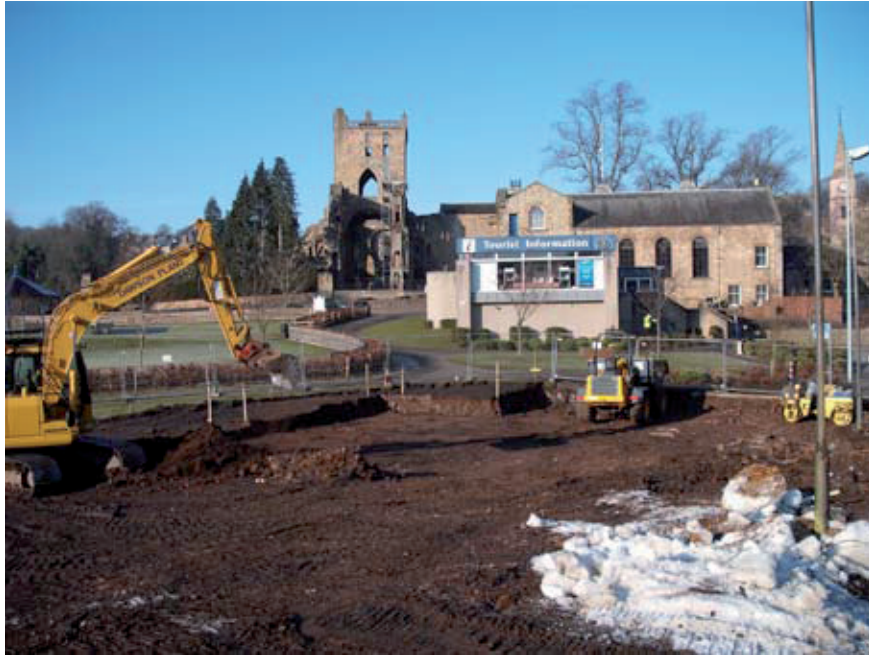
- 3.1.1 The removal of topsoil and the modern bund revealed made ground with frequent inclusions of demolition debris from Wilson's Mill (Fig. 2 & 6). This deposit was intermingled with modern detritus such as plastic and has been interpreted as a post-demolition accumulation of material prior to the area's use as a car park. This deposit spread across the entirety of the site and measured up to 0.8m in thickness. The majority of the excavation was conducted to a depth of 1m or less resulting in this being the only exposed deposit across the majority of the site.

- 3.1.2 Excavations for the drainage ditch and associated features reached a depth of up to 2m, revealing in situ concrete foundations and brickwork of Wilson's Mill (Fig. 2). The concrete foundations were located at a depth of 1.5m below ground level, were 0.2m in thickness, and extended from the south of the soakaway for 31m. The foundations were largely intact apart from in the south-facing section of the soak away where some in situ brickwork was found truncating the concrete foundations (Fig. 4). Overlying the foundations was a layer of demolition material between 0.15m and 0.3m thick which lacked any soil content and did not contain modern detritus as seen in the post-demolition accumulation deposit (Fig. 3). Further to the north, a patch of in situ brickwork was located overlying the concrete foundations which may relate to a circular chimney or machine base, given the curving nature of the brickwork (Fig. 5). The remains of a tarmac road were noted in the drainage ditch 34m from the south of the soakaway.

Fig. 2 General shot of site under excavation

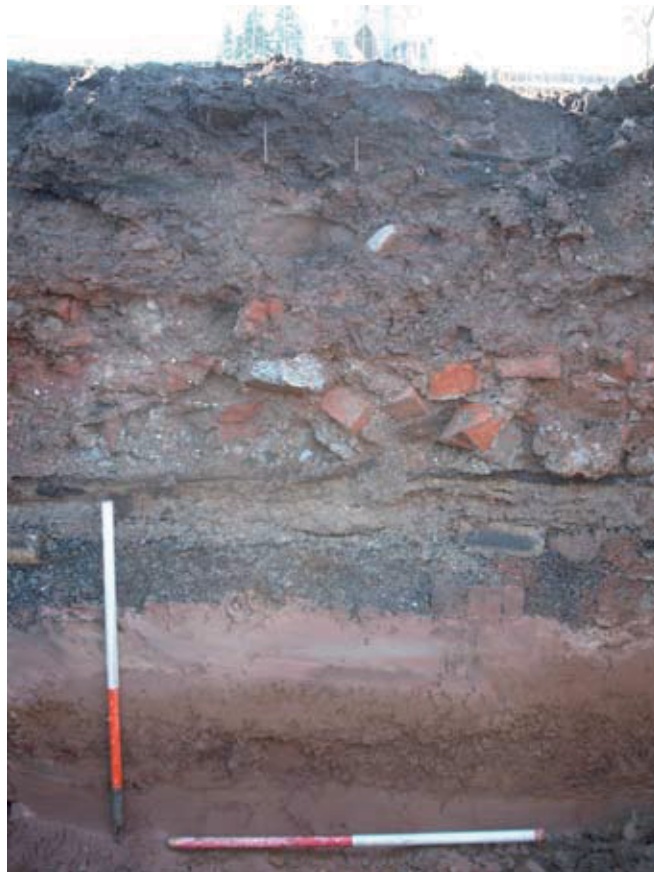
- 3.1.3 The drainage works required sections of the foundations and in situ brickwork of Wilson's Mill to be removed using a narrow bucket and pecker. Recording in the form of section and plan drawings and photographs took place prior to the removal of in situ remains. Natural subsoil was found directly underlying all of the concrete foundations so it appears that the latest phases of Wilson's Mill have truncated any potential earlier archaeological features or deposits. Natural subsoil was not encountered towards the north of the trench outwith the extent of the concrete foundations and the potential for archaeological features or deposits exists in these areas.

Fig. 3 East-facing section of soakaway showing foundations and demolition layer of mill

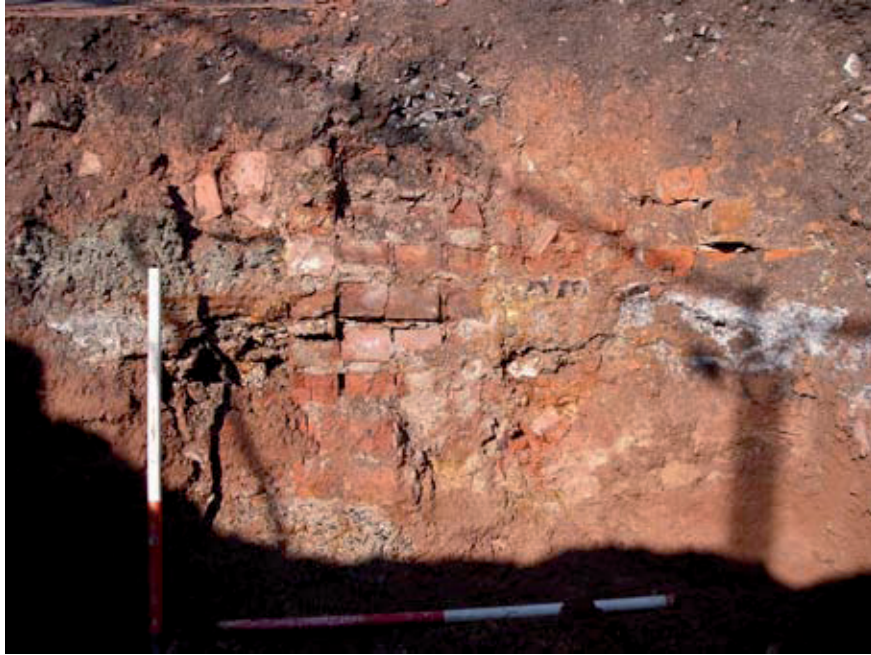
Fig. 4 South-facing section of soakaway showing in situ brickwork

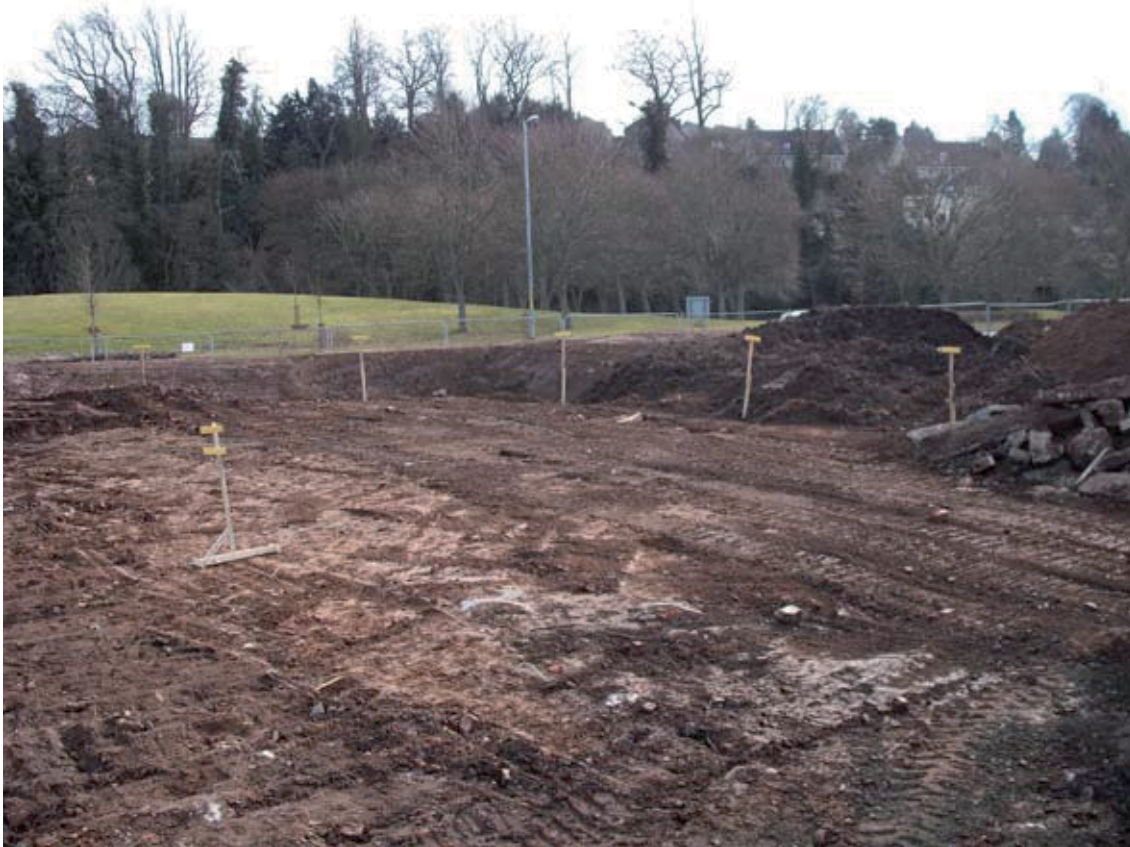
Fig. 6 Eastern half of site following excavation
