**House Development, Dean Path,
Edinburgh.
Archaeological Evaluation and Watching
Brief**

**Data Structure Report
No. 1619**

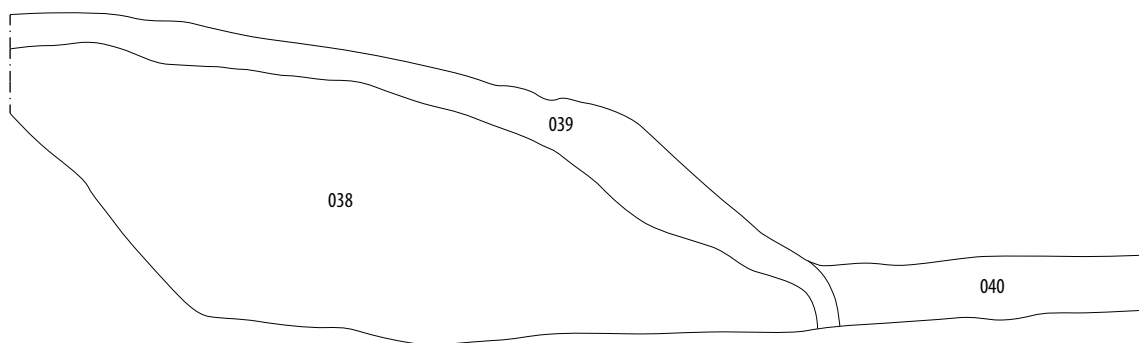
Fig. 3a - East-facing section of Trench 2

- 3.3.2 Trench 2 was orientated north-west to south-east and measured 1m by 6m. Deposits **033** and **038** were interpreted as natural due to their homogenous composition and lack of finds. Deposit **033** was overlain by a mid-brown sandy topsoil **032/036**. Deposit **038** was overlain by modern overburden, accumulated as part of the housing development. The west-facing section had been disturbed by a cut (**037**) and subsequent insertion of a concrete block (**035**). There were no archaeological features in Trench 2 (Fig. 3a-b).

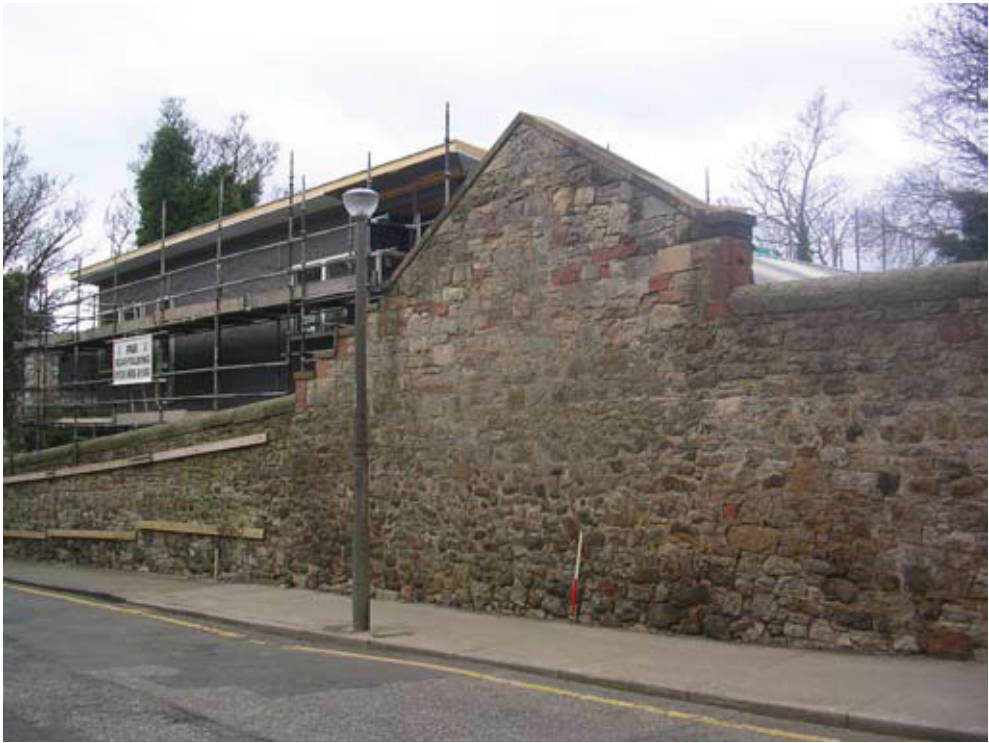
- 3.4.1 The possible Victorian potting shed was demolished prior to CFA attending site, and a modern garage now stands in its place. The east gable, however, survives due its incorporation into the boundary wall running along the east edge of the development (Fig. 5)
- 3.4.2 The remains of the Victorian shed appeared to have two phases of construction. The lower part of the gable is constructed from rounded stone boulders which were mortar bonded and which possibly form part of the original boundary wall associated with the earlier phase of the Dean Cemetery circa its construction in 1845. The upper level of the gable is constructed from bonded square-cut stone, edged with ashlar blocks. The remains of the roof were capped with skeins and were crow stepped on the south side. This second phase of building is the same construction as the Dean Cemetery Lodge indicating contemporaneity.

- 4.2 The remains of the potting shed could be seen in the surviving north-eastern elevation which fronted onto Dean Path. It is suggested by the surviving remains that the lower course of the shed comprised the boundary wall of the cemetery, with the gable end built onto this wall.

Fig. 5 -Oblique shot of NE-facing elevation of former potting shed

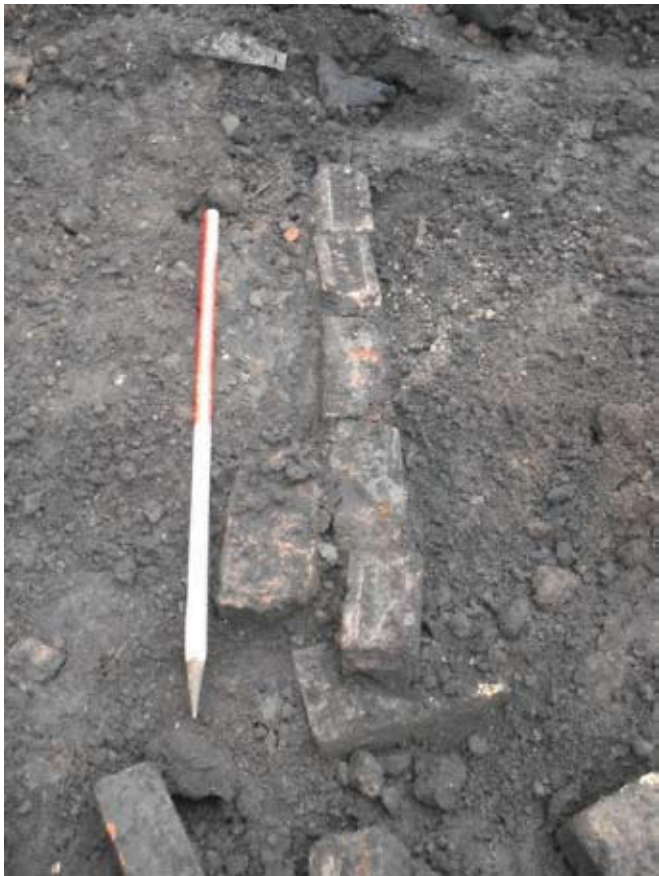
- 3.5.1 A watching brief was conducted on all additional groundbreaking work (Fig 1). The monitoring uncovered two courses of brick work (**041**) to the west of the new building, at 1m below the modern surface (Fig. 1 & 6). The surrounding ground was interpreted as made ground comprising tipped deposits with modern finds. The frogged brick was stamped 'Dougal Winchburgh' and the wall was approximately 2m in length. The precise purpose of these remains is unknown, although Dougal's Brickworks operated between 1873 and 1970. As such, the deposit is interpreted as a relatively modern, possible external retaining wall. Its single brick thickness suggests the remains were unlikely to belong to any substantial structure.

- 4.3 Two courses of truncated brick wall were recorded. These remains were interpreted as being relatively modern in origin, probably 20th century. The superficial wall possibly functioned as an external retaining wall, built during landscaping at this time.

Fig. 6 -Shot of brickwork 041

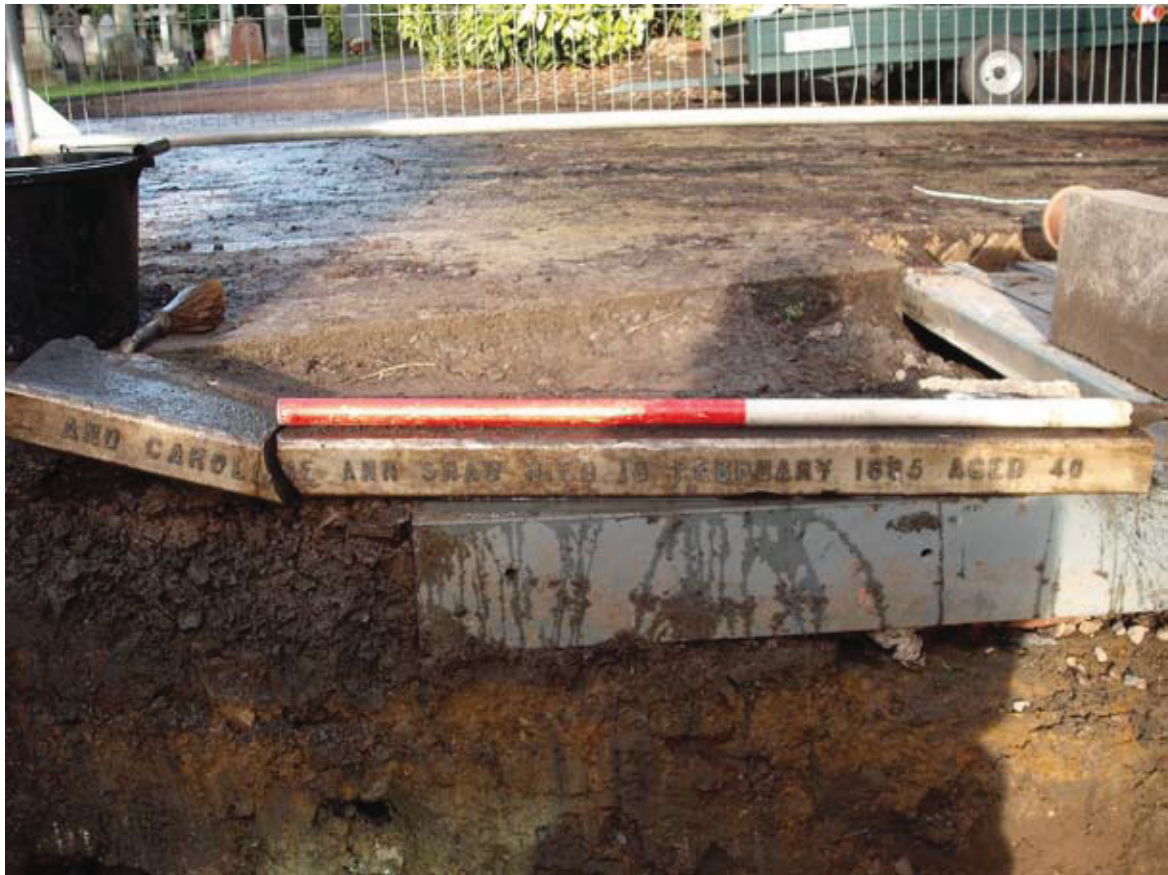
- 3.5.2 Overburden removal in the western corner of the site (Fig. 1) uncovered several fragments of concrete and marble grave furniture. The fragments include two pieces of marble annotated "AND CAROLINE ANN SHAW DIED 18 FEBRUARY 1885 AGED 40" (Fig. 7). The provenance of these pieces is unknown, although their incorporation on site is presumably the result of dumping from the cemetery itself.

- 4.4 An annotated marble memorial slab and several other pieces of memorial masonry were recovered and retained for further analysis.
- 4.5 No features of archaeological significance were recorded during the evaluation or watching brief.

Fig. 7 -Shot of memorial masonry 043 recovered during watching brief
