**St Abbs Marine Station
St Abbs
Scottish Borders**

Archaeological Watching Brief

Report No. 1766

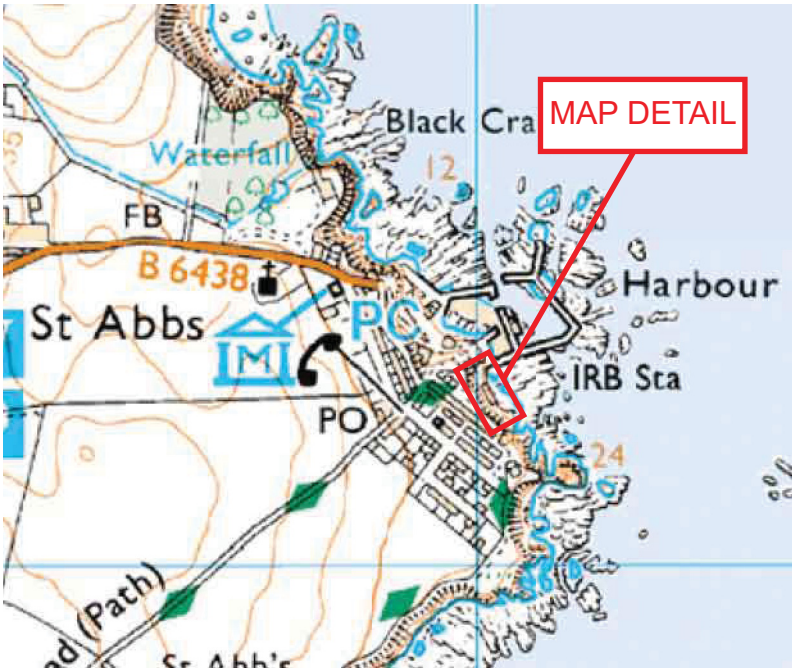
Fig.1 General site plan showing location of test and inspection pits

- 1.3.1 The objectives of the watching brief were to monitor the excavation of machine dug Test Pits and hand dug Inspection Pits (Fig. 1) and record any archaeological remains that were present.

- Inspection pit
- Test pit
- Cobbled surface revealed

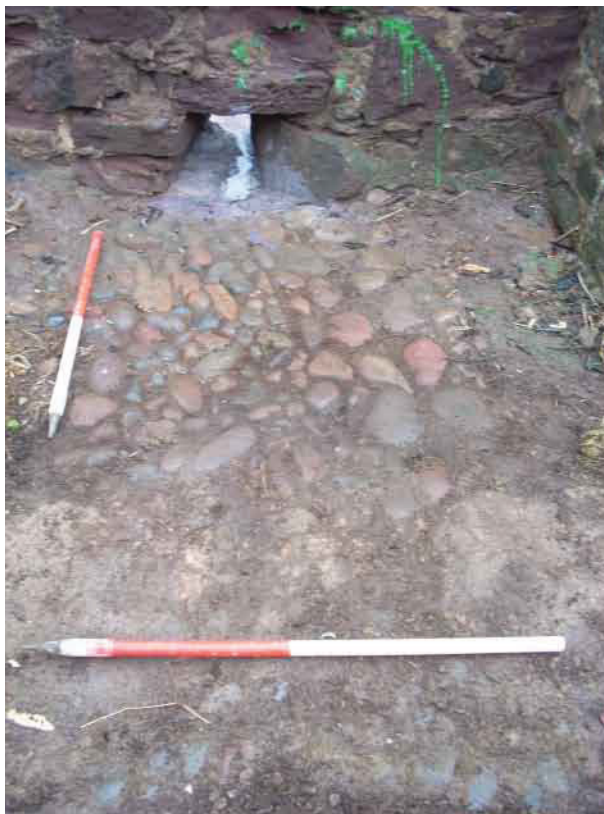
Fig. 2 Cobbled surface in area of TP 1

- 3.1.1 Test Pit 1 (TP 1) was opened at the west-facing side of the north-south running revetting sea wall (Fig. 1). It measured 3m by 1.3m and reached a depth of 2.1m before bedrock was struck. A cobbled surface at the surface consisted of rounded stones between 0.1m and 0.15m in size (Fig. 2). The west face of the revetting wall was revealed at a depth of 2.1m below ground level. The north and south-facing sections revealed a construction cut for the wall which truncated the natural subsoil. The cut was filled with loose unworked stone (Fig. 3). In the south-facing section of TP 1, a patch of made ground overlying the natural subsoil was present. It seems likely that this provided a bedding layer for the north-south orientated rough track (Fig. 1).

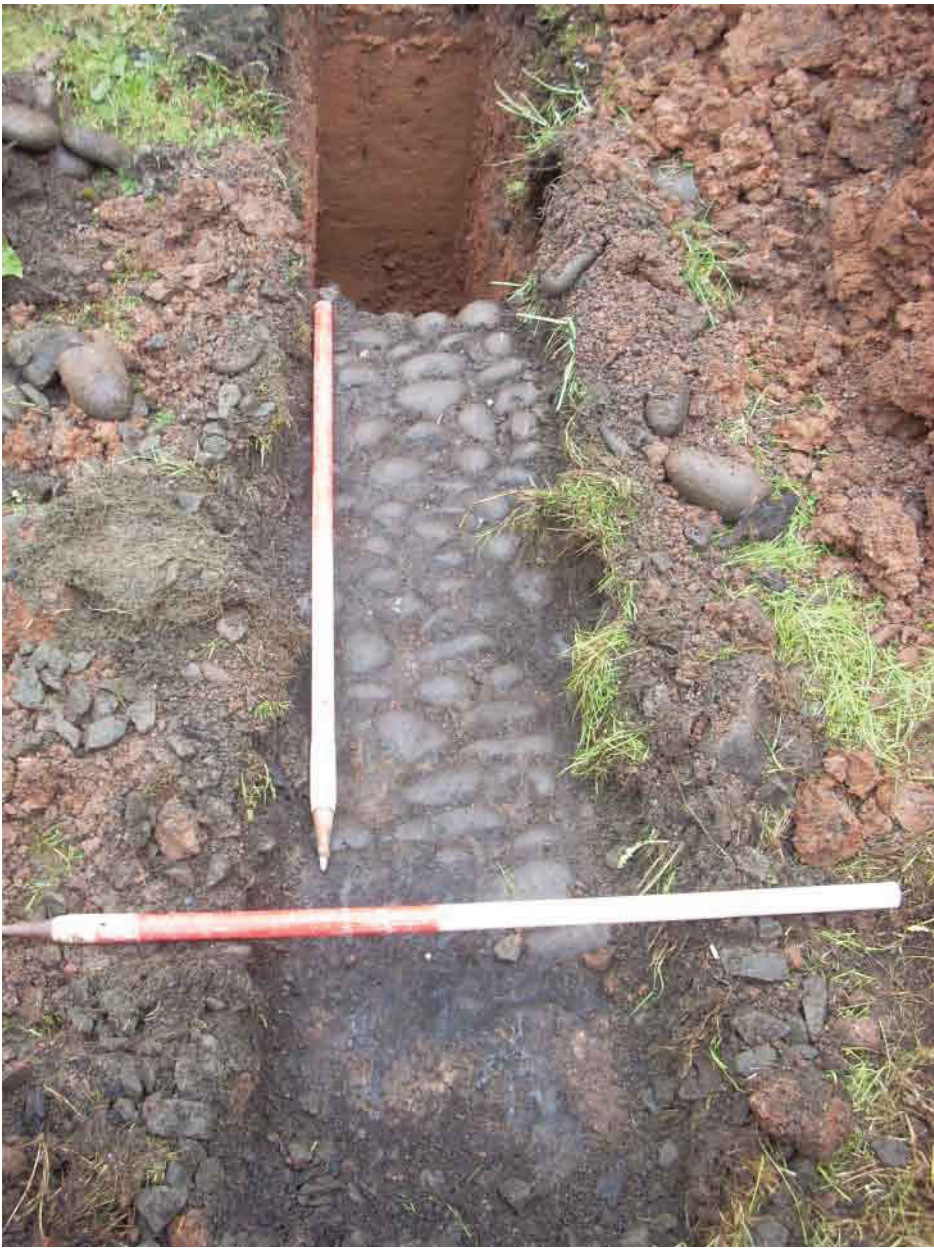
Fig. 4 Cobbled surface in area of TP 3

- 3.1.3 Test Pit 3 (TP 3) was situated to the west of the brick built garages (Fig. 1) and measured 1.5m by 0.5m and reached a depth of 1.7m before bedrock was encountered. Grass and topsoil overlay a thin layer of tarmac which overlay a cobbled surface very similar in form to that seen in TP 1 (Fig. 4). The cobbles directly overlay the natural subsoil or bedrock.
