**Orocco Pier Hotel  
17 High Street  
South Queensferry**

**Archaeological Watching Brief**

**Report No. 1764**

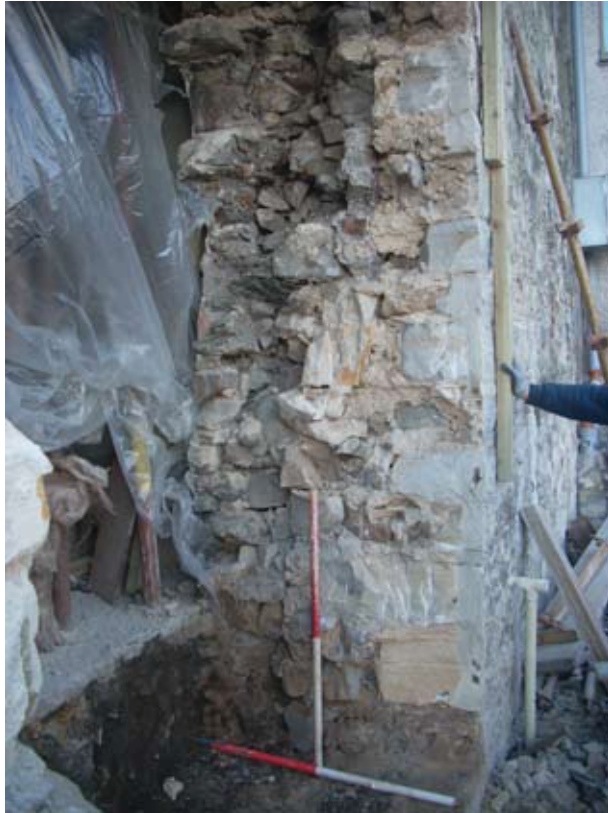
Fig. 2a Shot of north-facing section through wall

- 2.2.5 Masonry deposits (3), (4) and (7) are distinct from Phase 1 deposits (3) and (6). This is evidenced by the abutment of Phase 2 deposits to the Phase 1 wall fabric, and the overlying physical relationship of deposits (7) and (5) (Fig. 2a, 2b & 3).
