**Westport Dental Practice
261 High Street
Linlithgow, West Lothian**
Archaeological Watching Brief
Report No. 1785

Archaeological Watching Brief

Report No. 1785

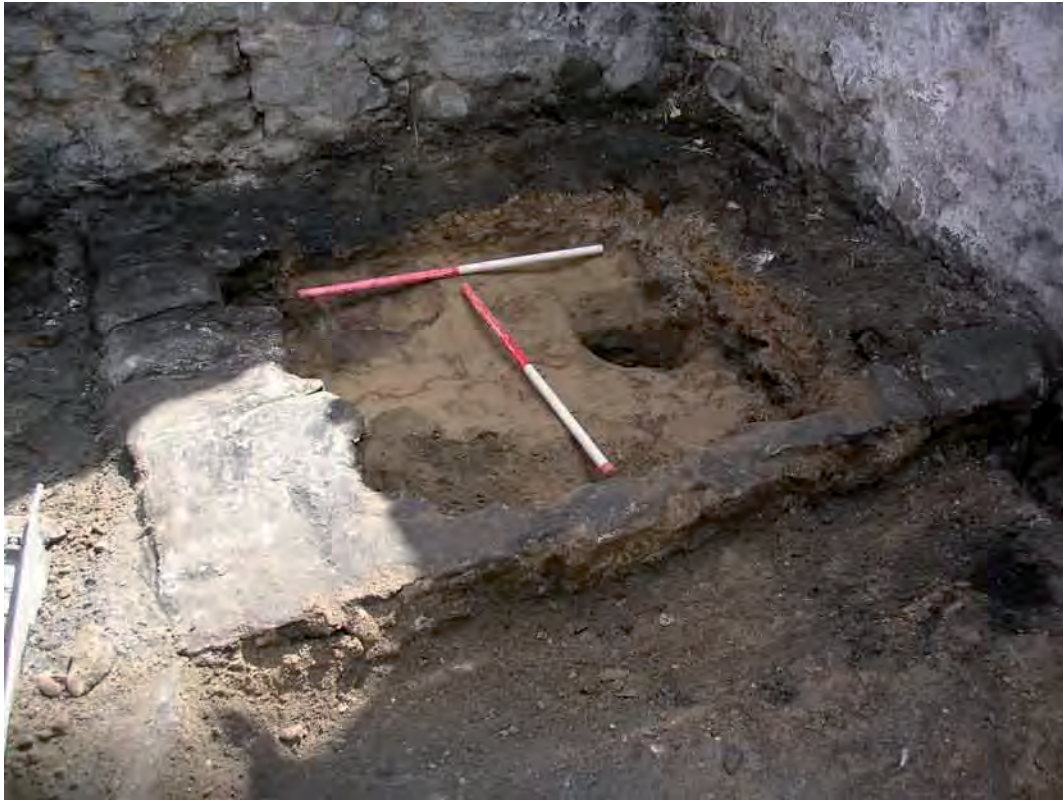
Fig 3. General view of masonry 009 and cut features 003, 005 and 007

- 3.5.5 Given the nature of the respective fills of pits [003], [005] and [007] they appear to be relatively modern in origin and it is doubtful if they predate the outbuilding by any great length of time.

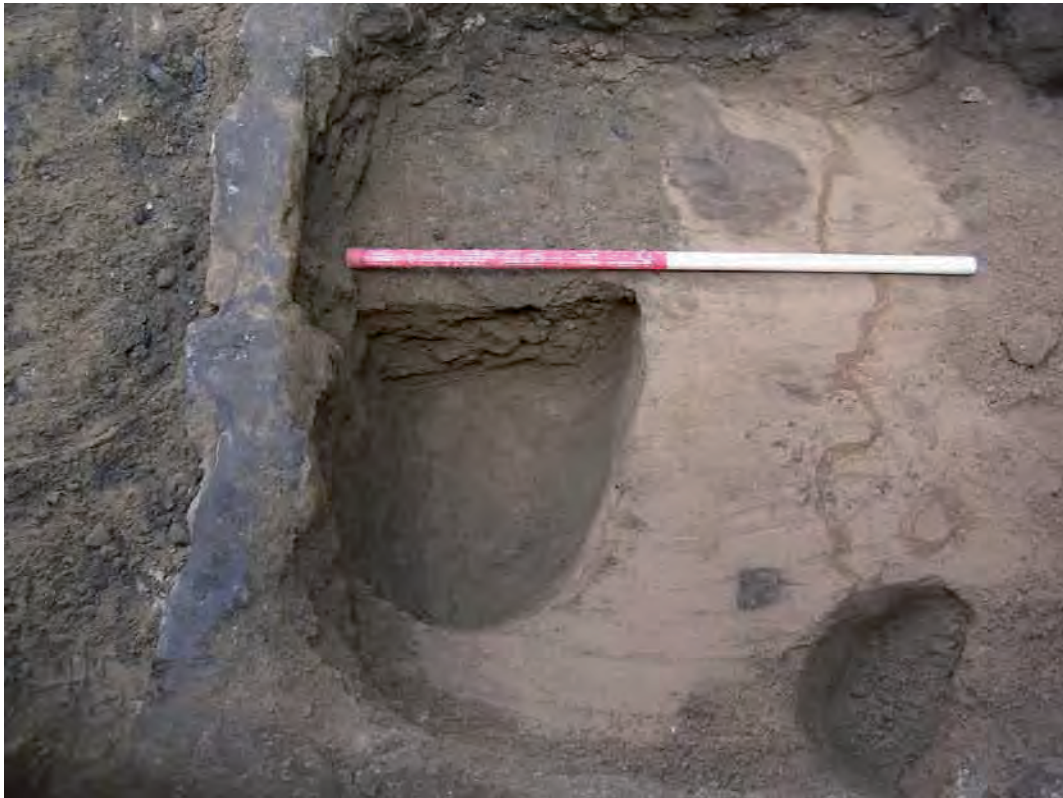
- 3.5.4 Pit [007] formed a large cut, only exposed in part, measuring 1m by 0.45m with a depth of 0.4m and a flat base with sharply sloping sides (Fig. 4). The fill (008) was of the same composition as (004).

Fig 4. South facing section of feature 007

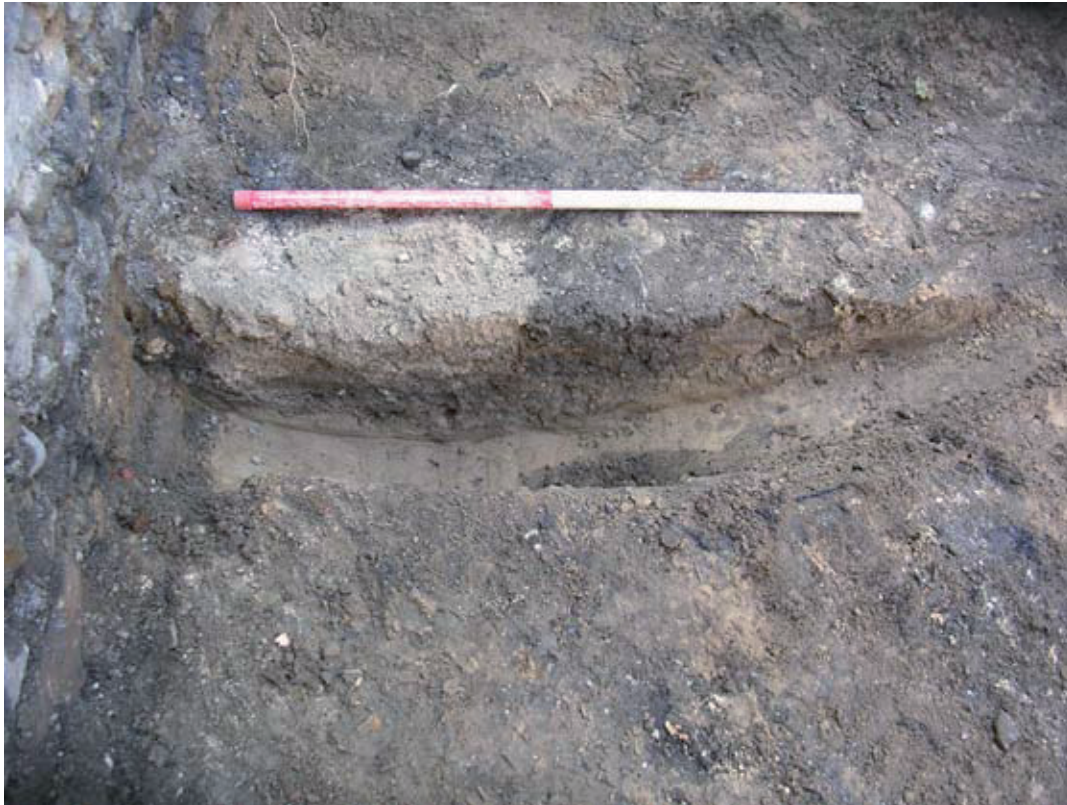
- 3.4.1 An ash and charcoal dump was uncovered and comprised of an initial cut [012] filled by two ash deposits, (016) and (017), and a re-cut [015] into which had been placed a wooden container (014) which was in turn filled with another ash deposit (011) (Fig. 5).

- 3.4.2 The earlier cut was a smooth sided sub-rectangular pit measuring 0.9m by 0.75m with a depth of 0.3m [012]. This pit cut through the cobbled surface bedding layer (013), and was either respected by or truncated the cobbled surface (010) and was defined to the north, east and south by the walls of the outbuilding, indicating that its use was contemporaneous with that of the outbuilding (Fig. 5).

- 3.4.4 The fills of [012] had been truncated by a small circular cut [015], measuring 0.5m in diameter and with a depth of 0.2m. Into this cut had been placed a circular wooden container (014) which was filled with a yellow-white sand-ash with frequent mortar inclusions (011) (Fig. 5).

Fig 5. North-facing section through ash dump (012)

- 3.4.3 Pit [012] was filled by a lower deposit (017) of yellow-grey sand with frequent coal, ash and mortar inclusions and an upper fill, (016), a similar deposit with a higher grit composition.

- 3.4.5 The wooden container (014) had a diameter of 0.5m and a thickness of 0.02m. It was constructed from thin staves and appeared to be made from some sort of wood composite such as plywood or chipboard. It had no evidence of a bottom and seems likely that it was inserted into the cut [015] for use as an ash refuse container.
