CFA ARCHAEOLOGY LTD

**Queenstonbank Farm, Nr Dirleton
East Lothian
Historic Building Appraisal Report**

Report No. 1610

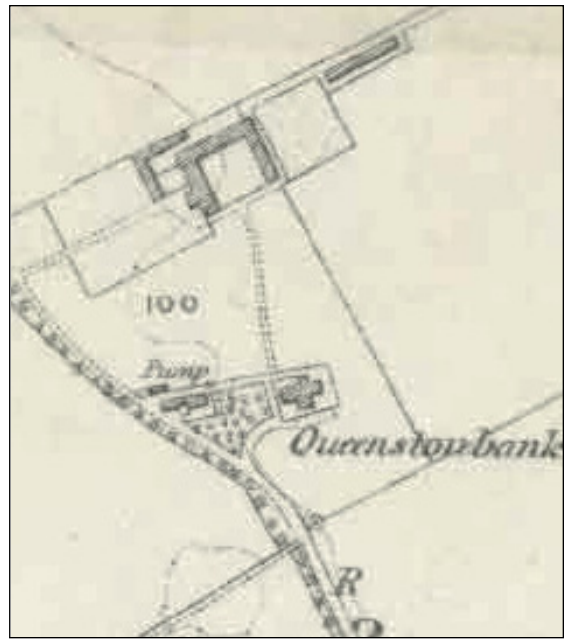
Fig. 2d - Ordnance Survey 1st Edition, 1856

- 3.2.3 The 1856 First Edition Ordnance Survey map (Fig 2d) shows Queenstonbank Farm to comprise a farmhouse occupying a cruciform plan with a walled garden on its west side. A linear building is depicted on the west side of the garden. A smaller detached building is shown immediately to the north-west. The 1894 Second Edition map (Fig 2e) shows the same layout as the first edition map. The 1907 Third Edition map (Fig 2f) shows that the yard area has been made into two units. The 1938 map (Fig 2g) appears strongly to suggest

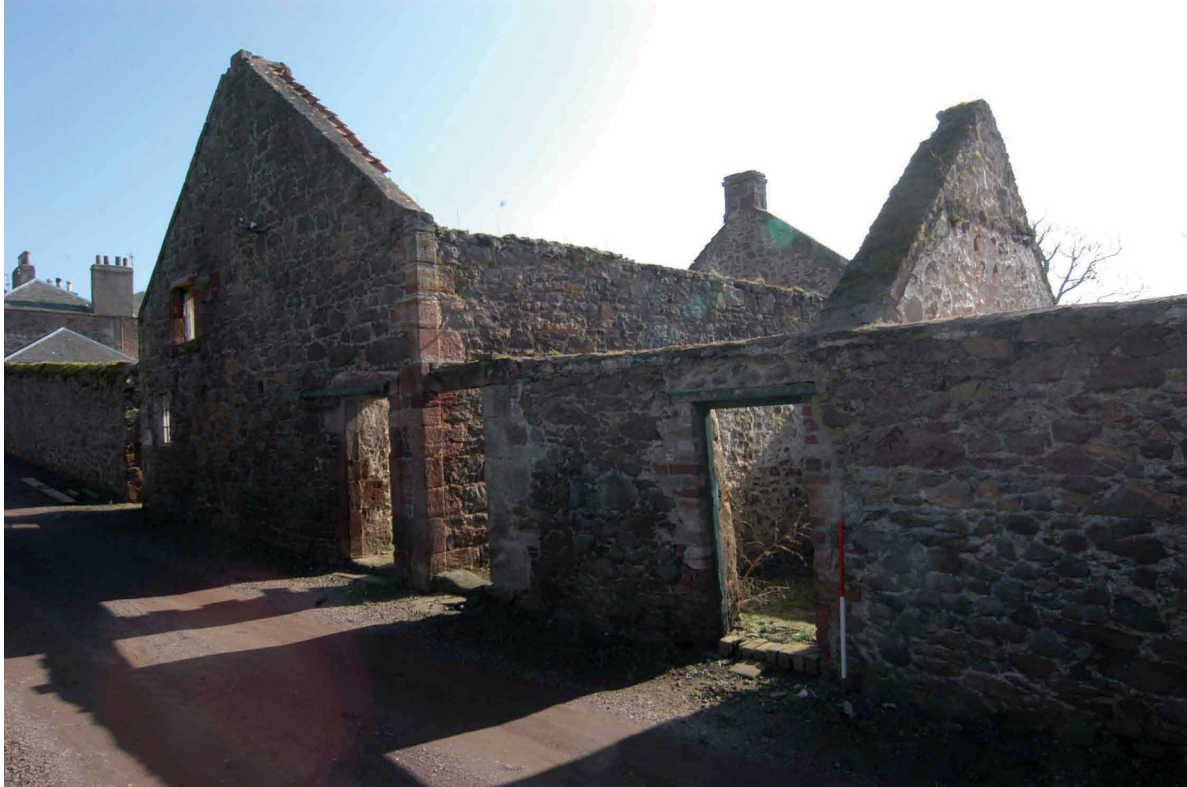
Plate 1 - Building 1 & 2 north-facing elevation

- 4.3.1 The north elevation (Plate 1) forms part of the northern boundary of the complex, and comprises a gable end with a pitched roof. It has an open doorway (7) (0.9m x 1.85m) giving access to B1, U2, and has a metal rail (21) for a sliding door fixed to the wall above the door. The upper storey has an original window (8) with a square timber frame. A later window (9) (0.5m x 0.9m) has been fitted in the lower storey has a brick surround and a thin timber frame. The lower storey has three small square vents (10) (c. 0.25m x 0.25m).

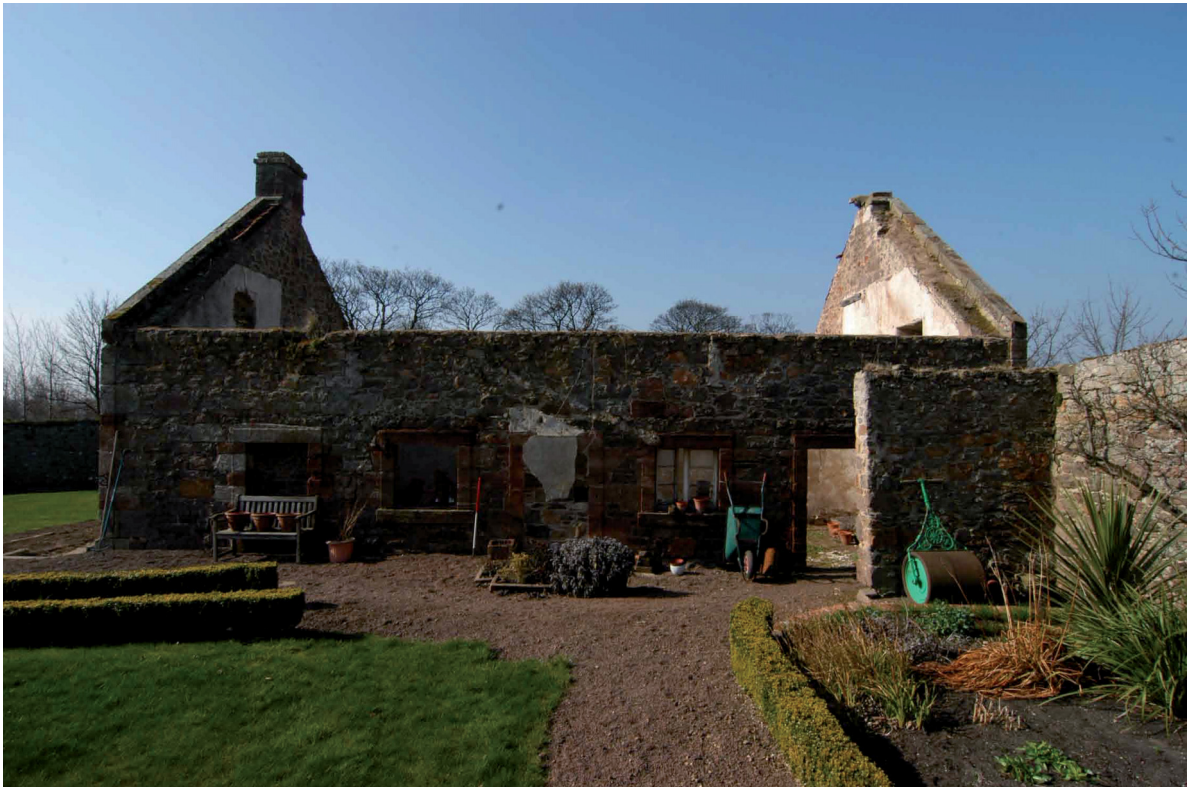
Plate 2 - Building 1 east-facing elevation

- 4.3.2 The east elevation (Plate 2) faces the garden and features three doors (**1**, **2** & **5**) (0.9m x 1.6m), two windows (**3** & **4**) (0.9m x 0.9m), and the remains of a roof raggie (**6**) for a lean-to porch. Two of the doors (**1** & **5**) have been blocked off. A third door (**2**) is open and situated at the north end of the elevation, giving access to B1, U1. A roof raggie (**6**) comprising mortar and fragments of red pantiles is situated above the door **1**, indicating the former presence of a substantial lean-to porch. The windows have splayed sides and timber frames.

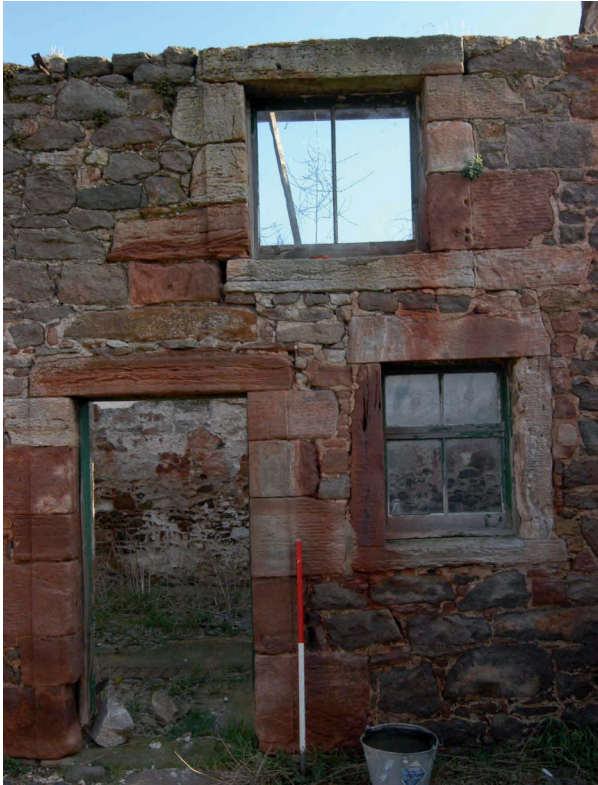
Plate 3 - Building 1, west-facing elevation

- 4.3.4 The west elevation (Plate 3) faces the yard and features two doors (**11** & **12**) (0.9m x 1.85m) and a window (**13**) (0.7m x 0.9) at ground floor level, and a single window (**14**) (0.9m x 0.9m) on the upper storey. Both windows have timber frames and are glazed. Door **11** has been bricked up to a height of 0.95m and a timber-framed window installed in the upper half. Door **12** is open and gives access to B1, Unit 3.

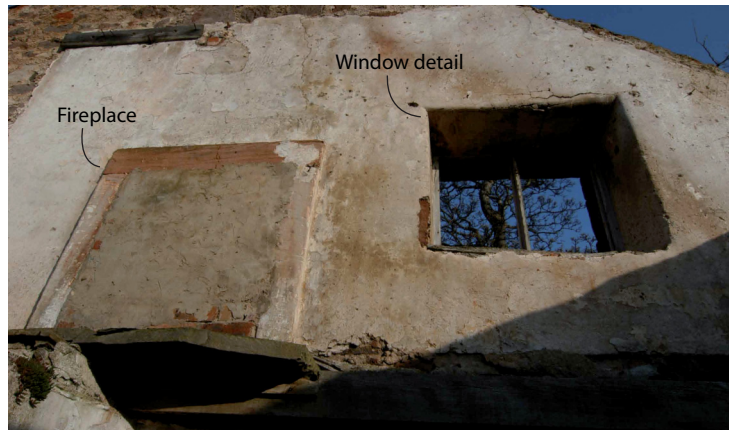
Plate 5 - Building 1, attic interior south-facing elevation

- 4.4.4 No remains of the floor or any dividing walls survive, however features on the gable end walls are still visible. A blocked off fireplace (19) is located centrally on the south elevation of the gable, built from red sandstone (Plate 5). The walls on both north and south elevations are rendered to approximately halfway up the gable roof space, indicating the presence of a loft. The render on the south elevation covered only the area above B1, Unit 1, and extended only c.1m over Unit 2. Beyond this, the wall is unrendered bare stone, suggesting that much of the area over Unit 2 was not living space but instead was used as a loft.

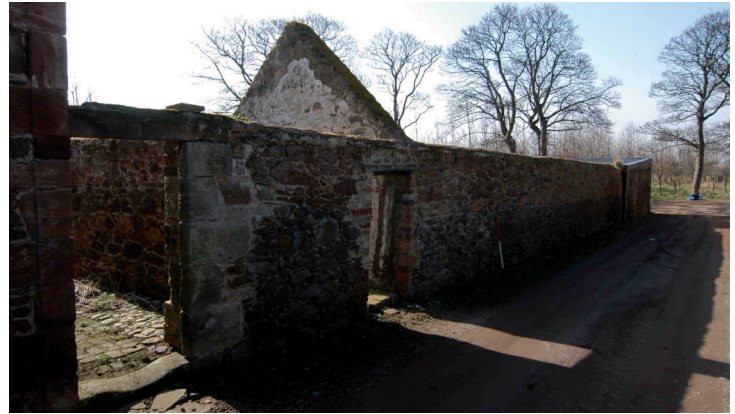
Plate 6 - Building 2, north-facing elevation, Oblique view

- 4.6.1 The north elevation (Plate 6) comprises part of the garden boundary wall. It forms a continuous wall from the NE corner of B2 and abuts the garage to the west. It has been built in two distinct phases. The initial build is of dark volcanic rubble to a height of 1.2m. It has been later heightened to c. 2.4m using mainly pale orange volcanic stone. A door giving entry to B2, U2 is situated at the east end of the building. The door has been cut into the wall and has a rough brick and cement surround and a timber lintel.

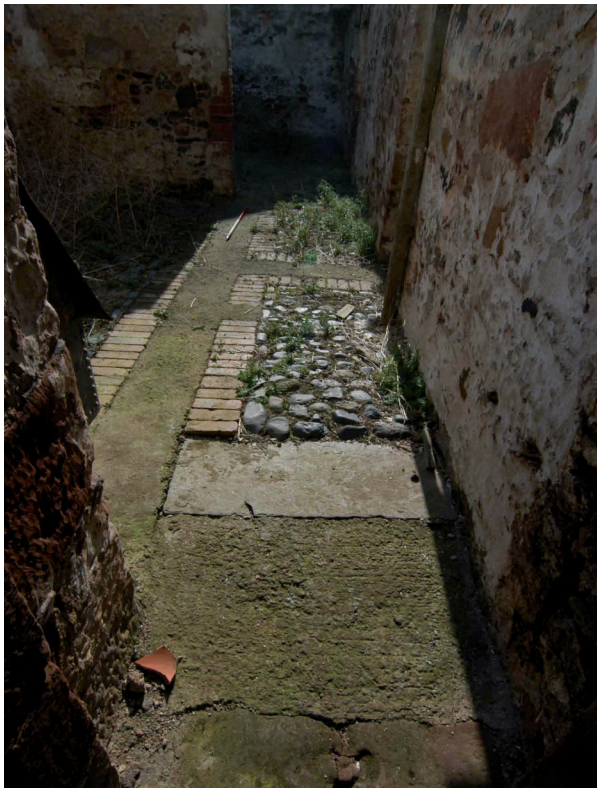
Plate 4 - Building 1, Unit 2, Floor detail

- 4.4.2 Unit 2 occupies the NW of B1 and is accessed through door 7 and from Unit 2. The walls have been lime rendered and whitewashed. A metal cistern (26) is fitted to the south elevation by door 7. The north elevation comprises a wall dividing Unit 2 from Unit 3, which has been partially knocked through and finished with brick to link the two units. The sawn-off stubs of timber ceiling/floor rafters protrude from the east elevation. The floor comprises a concrete, brick and cobbled surface (Plate 4) which forms a specific route through the unit and continues to Unit 3. Its course through to Unit 3 respects the butted end of the dividing wall so it is likely to post-date the knocking through of the wall.

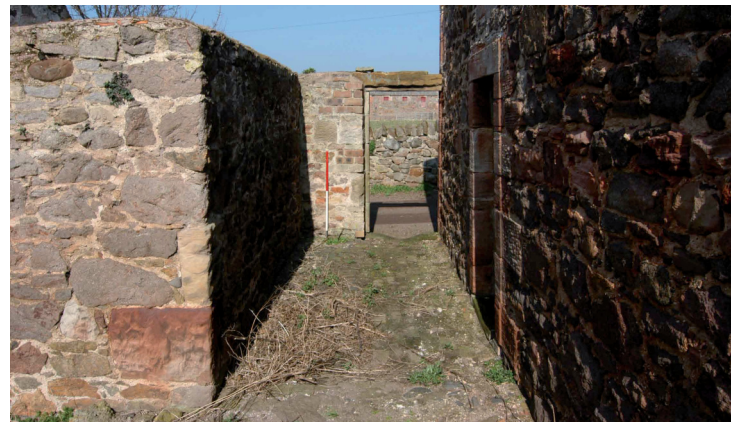
Plate 7 - Passage between buildings 1 & 2

- 4.6.2 The east elevation forms the west side of the passage between B1 and B2, and is featureless (Plate 7).

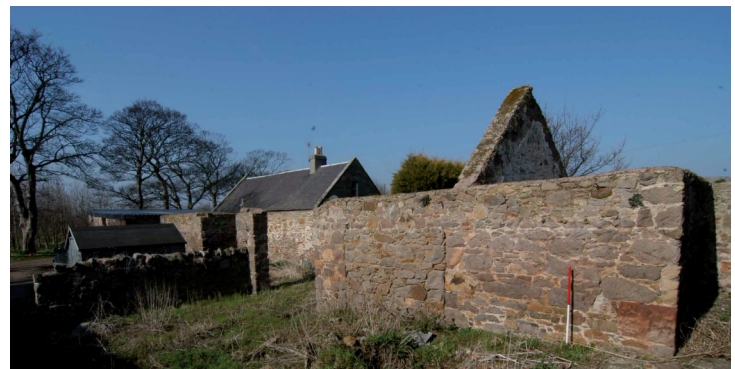
Plate 8 - Building 2, south-facing elevation

- 4.6.3 The south elevation (Plate 8) faces the yard and appears to have been built in two phases, the initial phase (1.4m high) being built of large volcanic stones with a later heightening (0.6m high) being of smaller, flatter volcanic stones. A thick course of mortar runs between the two phases. The south elevation has two open entrances (**28 & 30**), separated by a 1.2m long section of wall. There are two blocked off entrances (**27 & 31**) which suggest that the building has been modified on several occasions for different uses.
