**Royal Edinburgh Military Tattoo Grandstand
Works,
Edinburgh Castle Esplanade.
SMC B: Scottish Horse & North Esplanade
Wall
Photographic Survey & Watching Brief
Report No. 1780**

**Royal Edinburgh Military Tattoo Grandstand Works,
Edinburgh Castle Esplanade.
SMC B: Scottish Horse & North Esplanade Wall**

**Photographic Survey & Watching Brief
Report No. 1780**

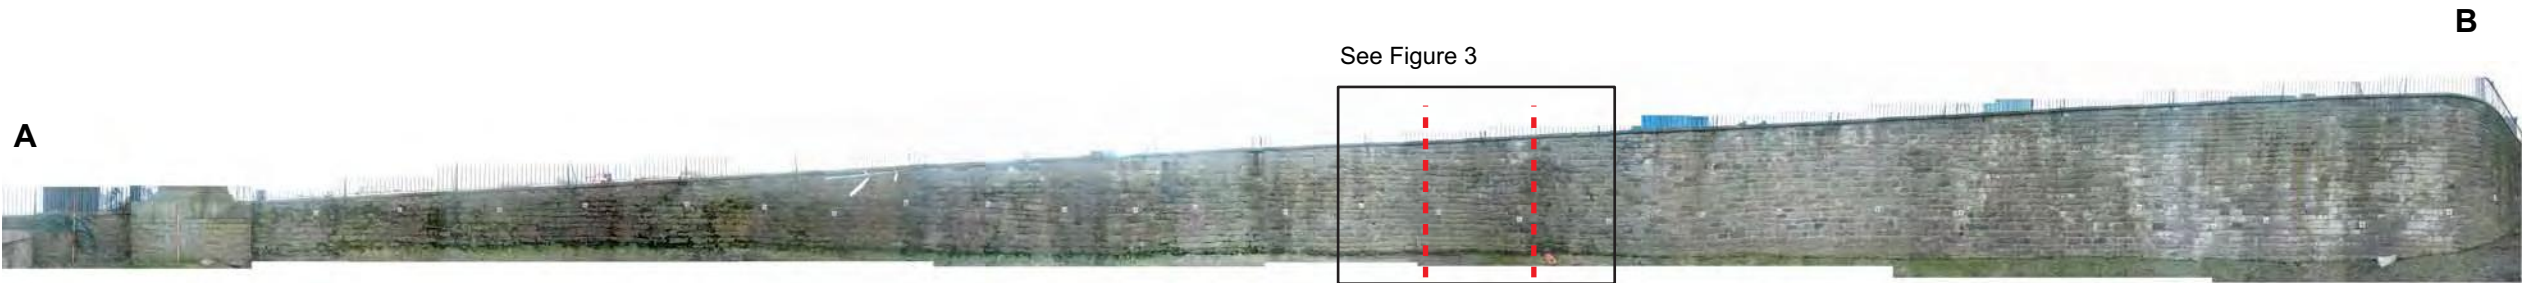
Figures 2 and 4 present photographic montages of the North Esplanade Wall together with a map showing the locations of the parts of the wall that were recorded. Fig. 3 shows in detail the part of the Wall which will be affected by dountaking.

The Wall is 90m long and increases from 1.8m high at the east end to 5.4m high at the west end. The elevation includes the existing bastion for the India Cross. At the western end of the Wall, below to the Afghan Needle, there were a number of cables fixed to and passing through the wall along with ducting and a junction box (Fig. 4).

The Wall is constructed of rock-faced sandstone blocks bonded with grey lime mortar. In parts the blocks are stained with iron-salts as a result of differential weathering. Some blocks have been stugged (a form of rough dressing with a masons chisel). The masonry has been laid in regular courses and includes blocks ranging in size from c.0.30m by 0.10m to c.0.50m by 0.15m. Near the terminus of the Wall, on the upper section, smaller blocks have been used in its construction. The bonding joints are generally uniform.

The Wall is topped with flat coping stones with spear-headed cast-iron railings on top.

Fig. No:	2	Revision:	A
Title: North-facing elevation of North Esplanade Wall			
Project: Edinburgh Castle Esplanade			
Scale: Plan 1:800 @ A3 Elevation 1:250 @ A3			
Client: Sir Robert McAlpine on behalf of Royal Edinburgh Military Tattoo Ltd			
Drawn by:	GC	Report No:	1780

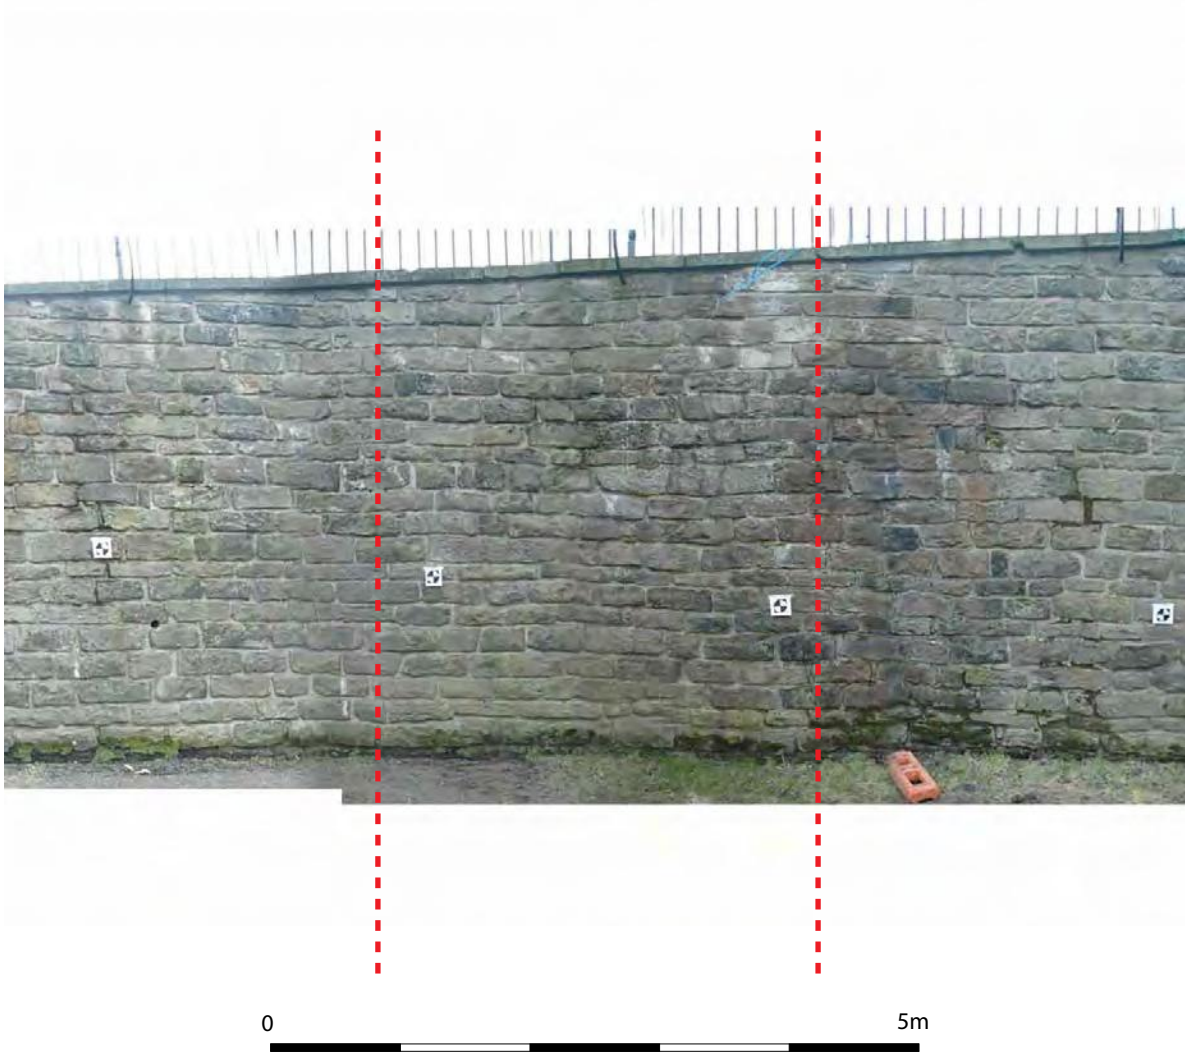
The removal of the railings and the dountaking of a portion of the North Esplanade Wall (Fig. 3) revealed that the stonework formed the cladding for a concrete wall (Figs. 7-8) which retained the made ground forming the Esplanade. None of the made ground deposits were exposed. The concrete Raker foundations for this retaining wall were revealed (Fig. 7 below the yellow gas main).

Fig. No: 3 Revision: A Client: Sir Robert McAlpine on behalf of Royal Edinburgh Military Tattoo Ltd

Title: Portion of North Esplanade Wall to be affected by proposed works

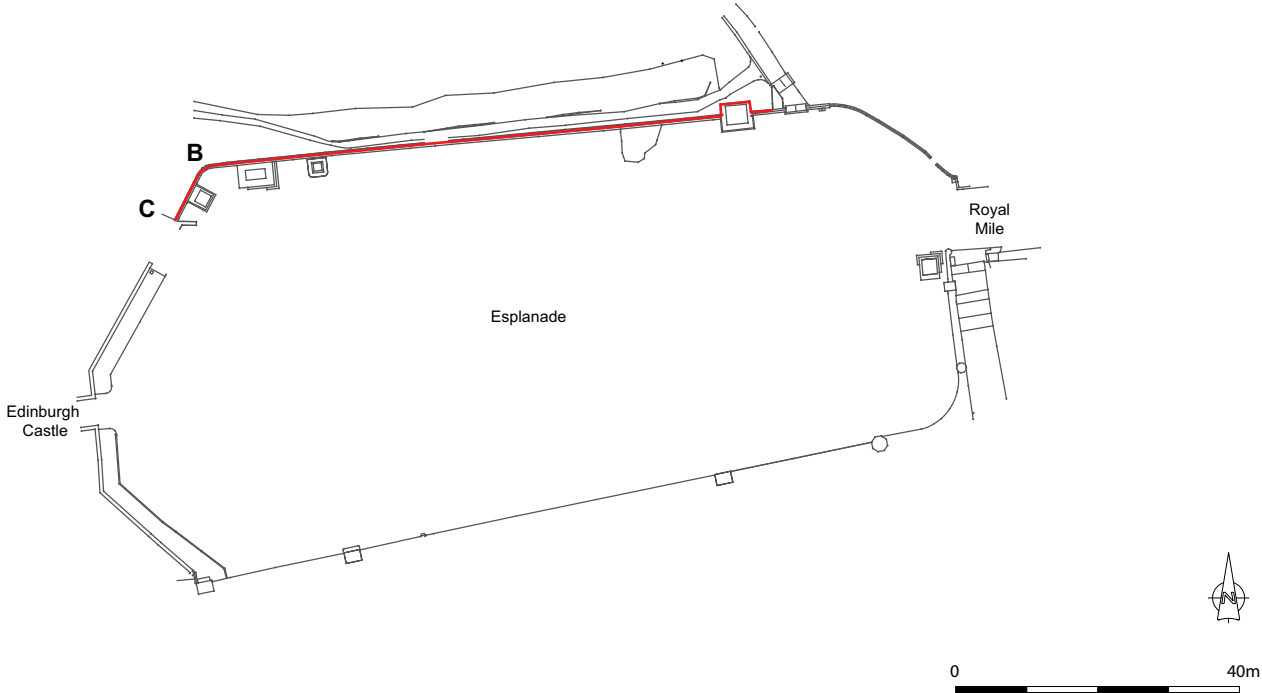
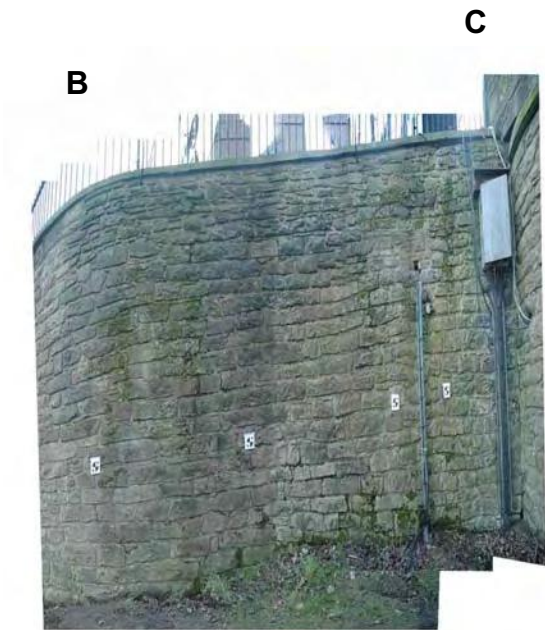
Key:	Fig. No: 4	Revision: A	Client: Sir Robert McAlpine on behalf of Royal Edinburgh Military Tattoo Ltd

The west-facing part of the North Esplanade Wall, below the Afghan Needle, appears not have been dismantled in the 1960s. The joint between the earlier Wall, which presumably dates from the 1750s, and the rebuilt Wall is visible at the corner between the Afghan Needle and the Remains of Ensign Ewart (Fig. 5); the earlier Wall is of slightly different construction: the blocks of sandstone are slightly less regular and less well coursed and the blocks are not as stained by mortar dissolution.

<div>CFA ARCHAEOLOGY LTD The Old Engine House Eskmills Park Musselburgh East Lothian, EH21 7PQ t: 0131 273 4380 f: 0131 273 4381 e: info@cfa-archaeology.co.uk w: www.cfa-archaeology.co.uk</div>
	Title: West-facing elevation of North Esplanade Wall			
Scale:	Project: Edinburgh Castle Esplanade			Drawn by: GC
				Page No: Report No: 1780

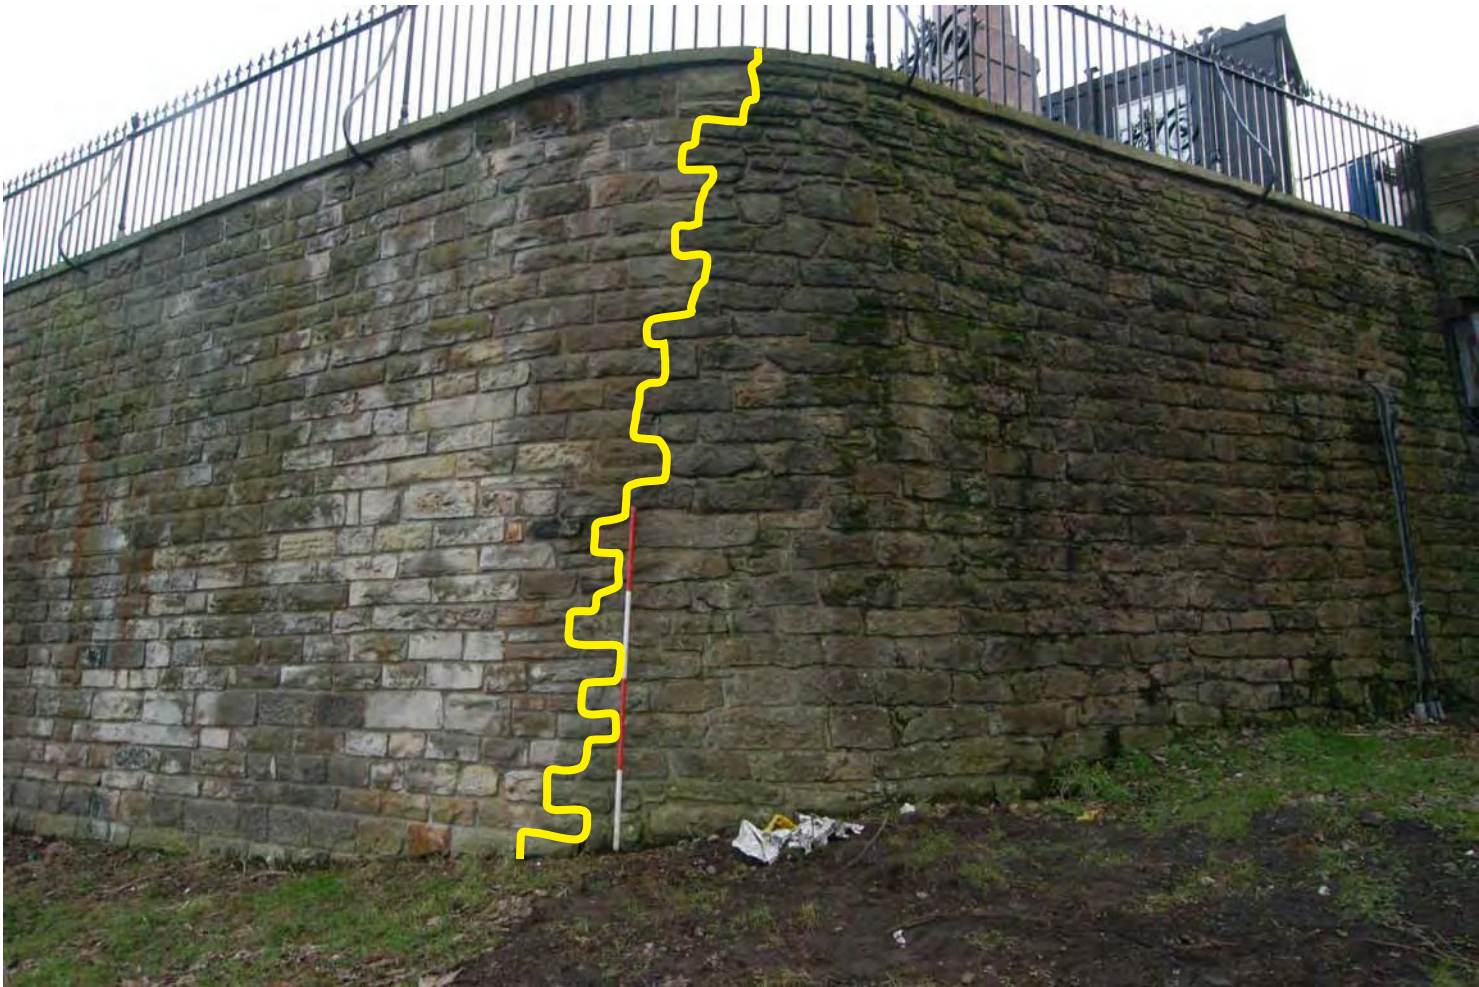
The west-facing portion of the North Esplanade Wall abuts, and post-dates, the external wall of the Moat Vault (Suddaby & Johnson 2010b).

Fig. No: 5 Revision: A Client: Sir Robert McAlpine on behalf of Royal Edinburgh Military Tattoo Ltd
Title: The joint between the original North Esplanade Wall (on the right hand side of the picture) and the portion of the Wall that was rebuilt in the 1960s. The ranging rod is at the location labeled 'B' on Figs 2 and 4

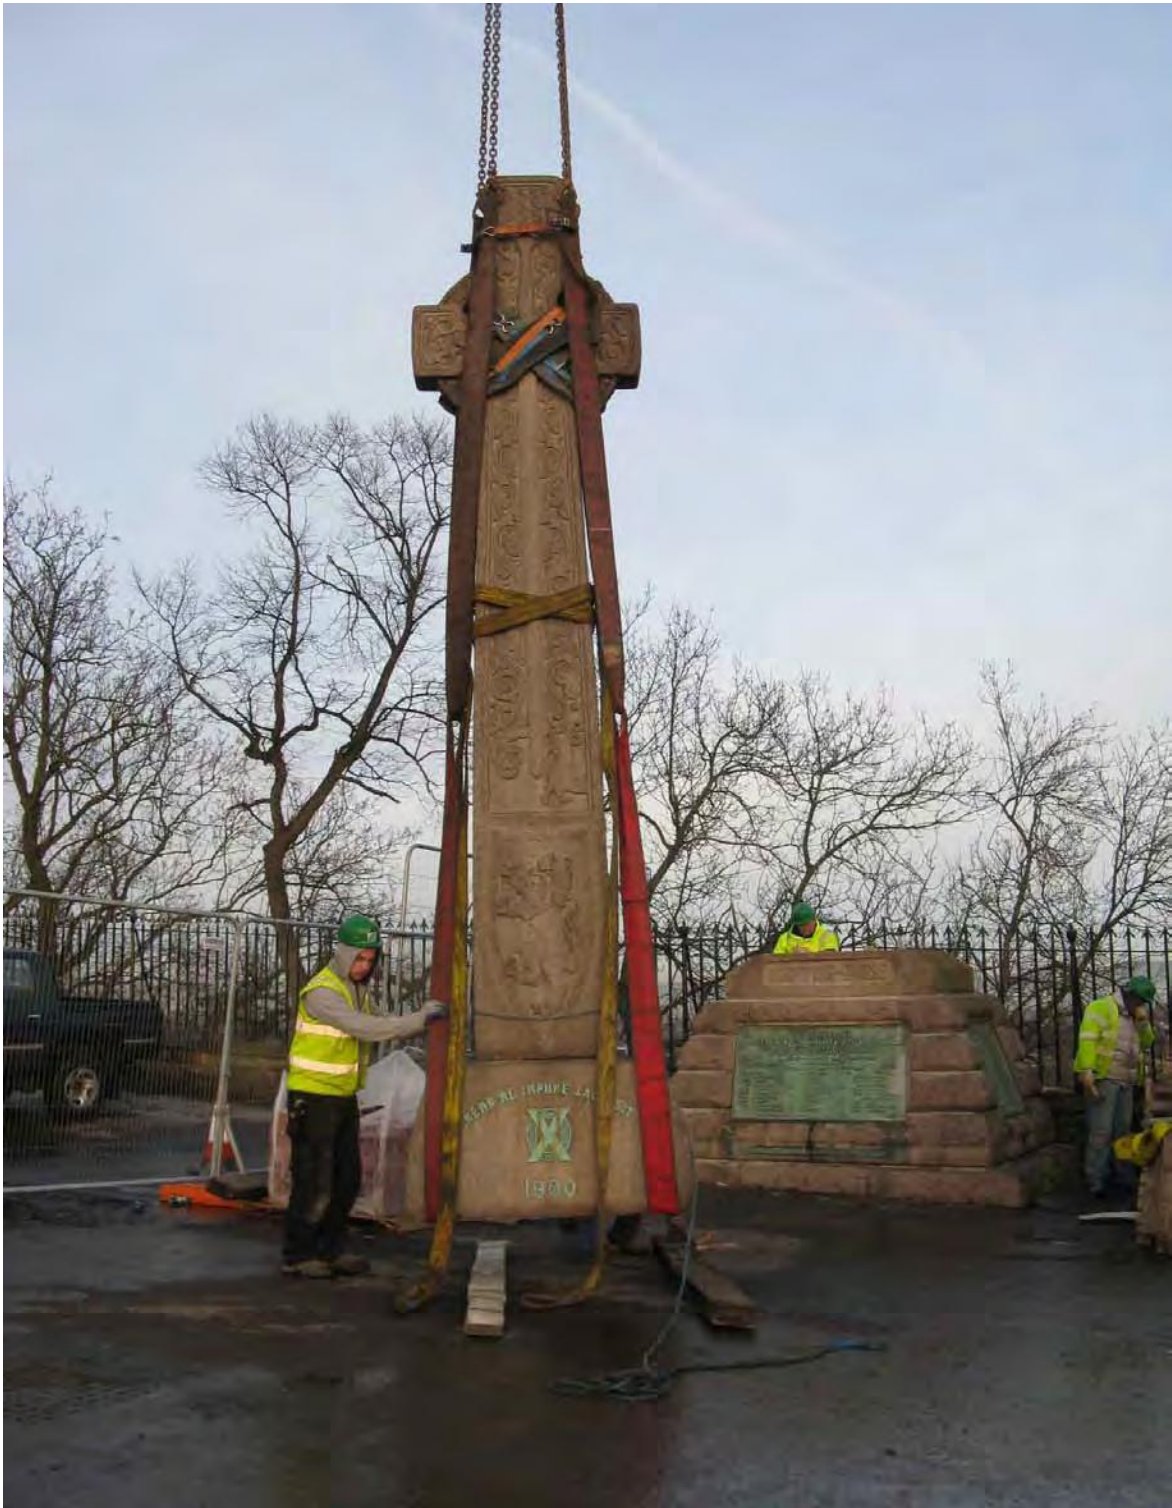
The cross and shaft were first removed by crane (Fig. 6). The external granite cladding at the base was then removed by a combination of hand and electrically powered tools, with the stones being numbered to allow accurate reassembly. The core of the monument's base was dismantled using electrical and hydraulic machinery.

Upright iron pins held the uppermost stone of the base (inscribed with the words 'Scottish Horse') in place. These rods were cemented into the upper part of the base.

The core of the base was a rectangular block made from modern frogged bricks cemented together. The cladding had been fitted to the exterior of this core.

Title: The cross shaft being removed

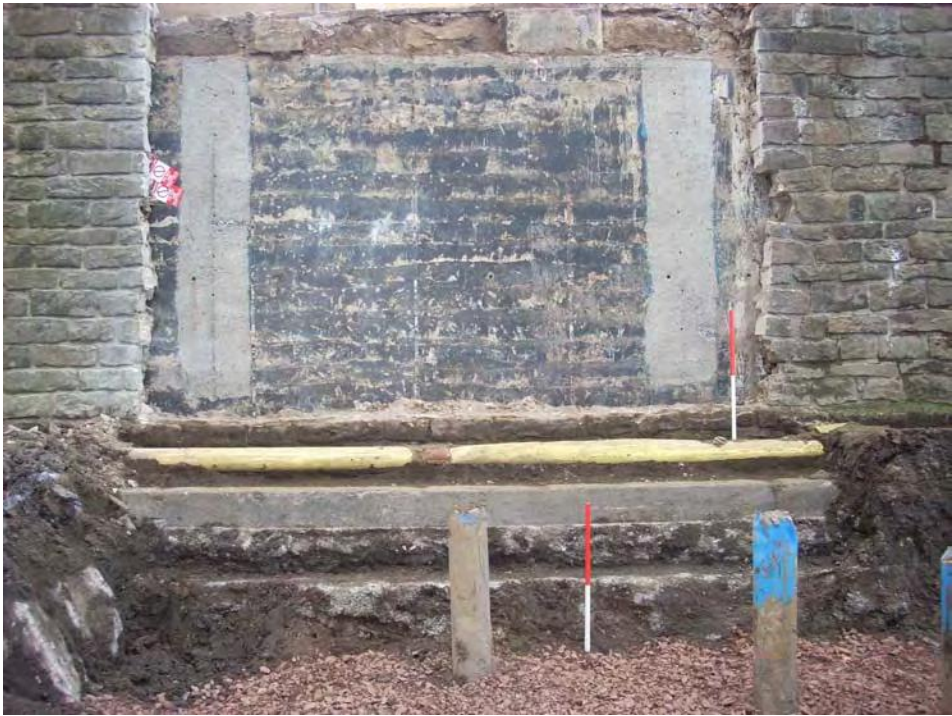
Where down-taking work affected the North Esplanade Wall in season 2010-2011, the exposed section of the wall was recorded. The visible stonework was revealed to be a thin veneer concealing a concrete retaining wall.

Fig. 7 - View from the north of the concrete wall exposed following the removal of the stone cladding. The concrete foundations are below

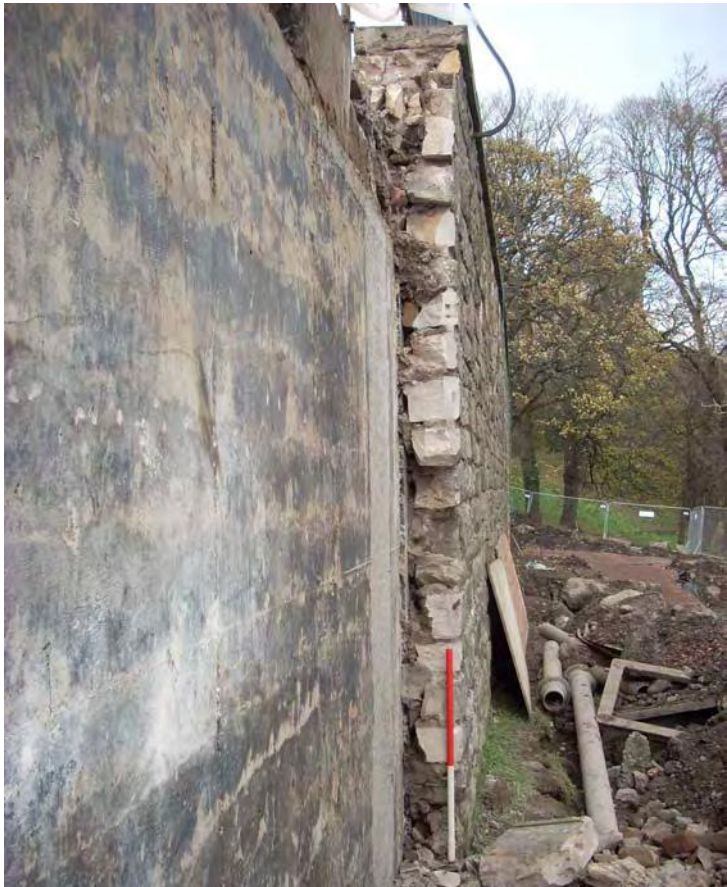
Fig. 8 - View from the east showing the stone cladding of the concrete wall

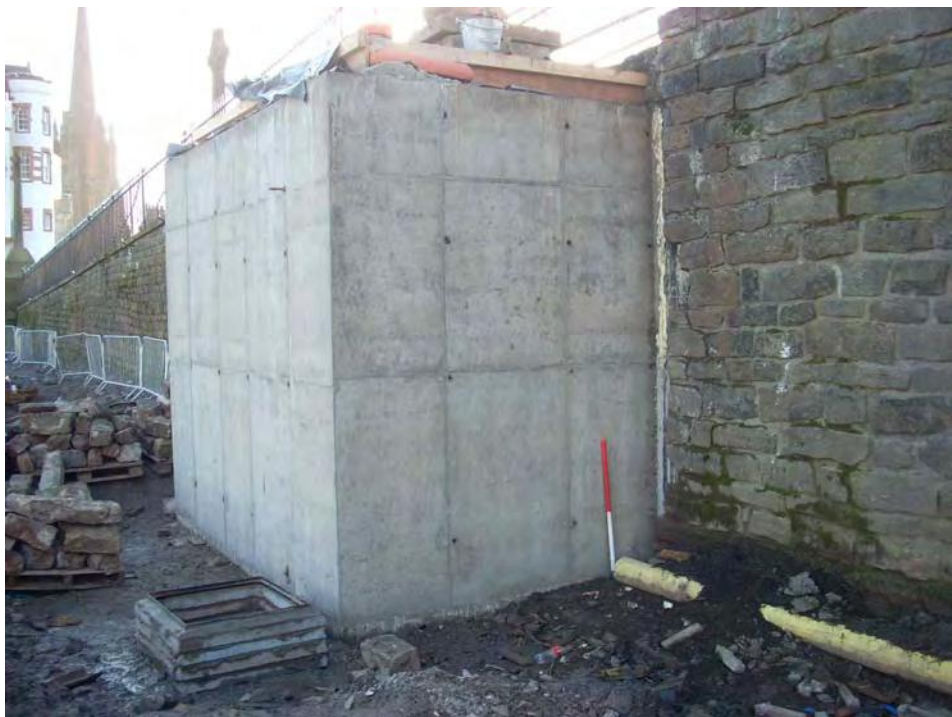
Work on the new abutment required the excavation of new foundation trenches, which lay entirely within ground disturbed during the construction of the North Esplanade Wall in the 1960s.

The new abutment foundations lay within ground previously disturbed during the construction of the Raker foundations for the North Esplanade Wall in the 1960s. No features or deposits of archaeological interest were exposed.

Fig. 9 - General view from the west of the concrete structure of the new abutment

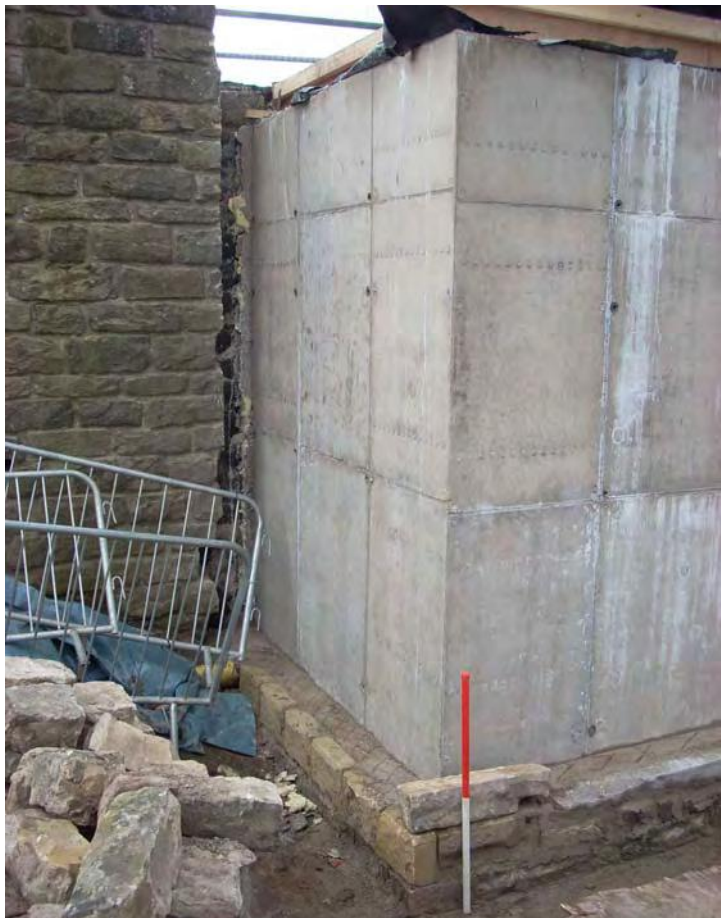
Fig. 10 - The stone cladding being replaced on the new abutment
