**Edinburgh Military Tattoo Grandstand
Works,
Edinburgh Castle: Hospital Square.
SMC D: Earl Haig Statue Relocation**

**Watching Brief & Excavation
Data Structure Report No. 1873**

Author	Ian Suddaby MA FSA Scot MifA
Illustrator	Leeanne Whitelaw BSc MAAIS
Editor	Tim Neighbour BSc FSA Scot MifA
Commissioned by	Edinburgh Military Tattoo Ltd
Date issued	18 May 2011
Version	1
OASIS Reference No.	cfaarcha1-78685
SMC Reference No.	AMH/90130/1/3
Grid Ref	NT 2506 7353 (centre)

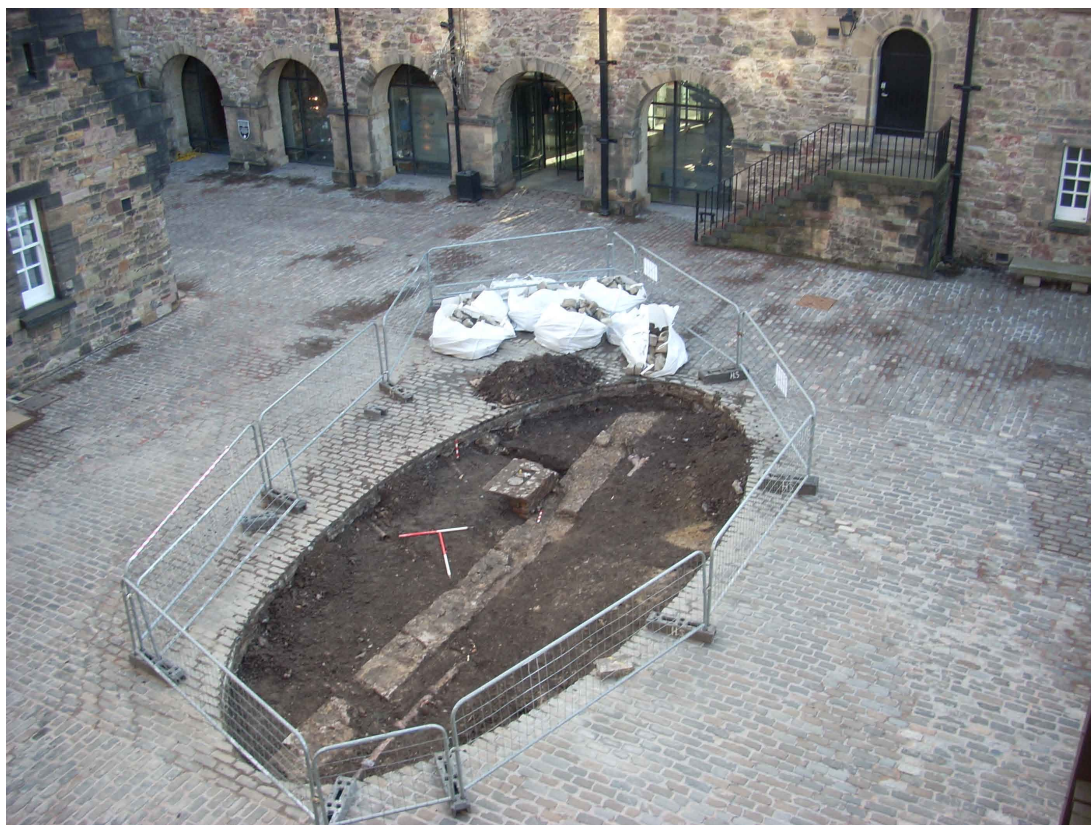
Fig. 2 - View of the 'flower bed' from the north-west once the setts and underlying grout were removed. Most of the overlying drains have also been removed

A watching brief was carried out during the removal by machine of a raised area of setts in the centre of Hospital Square (Figs 1 and 2) known as the 'Flower Bed' and the underlying deposits recorded. The stone setts were dislodged using a machine-mounted hydraulic hammer and removed by machine.

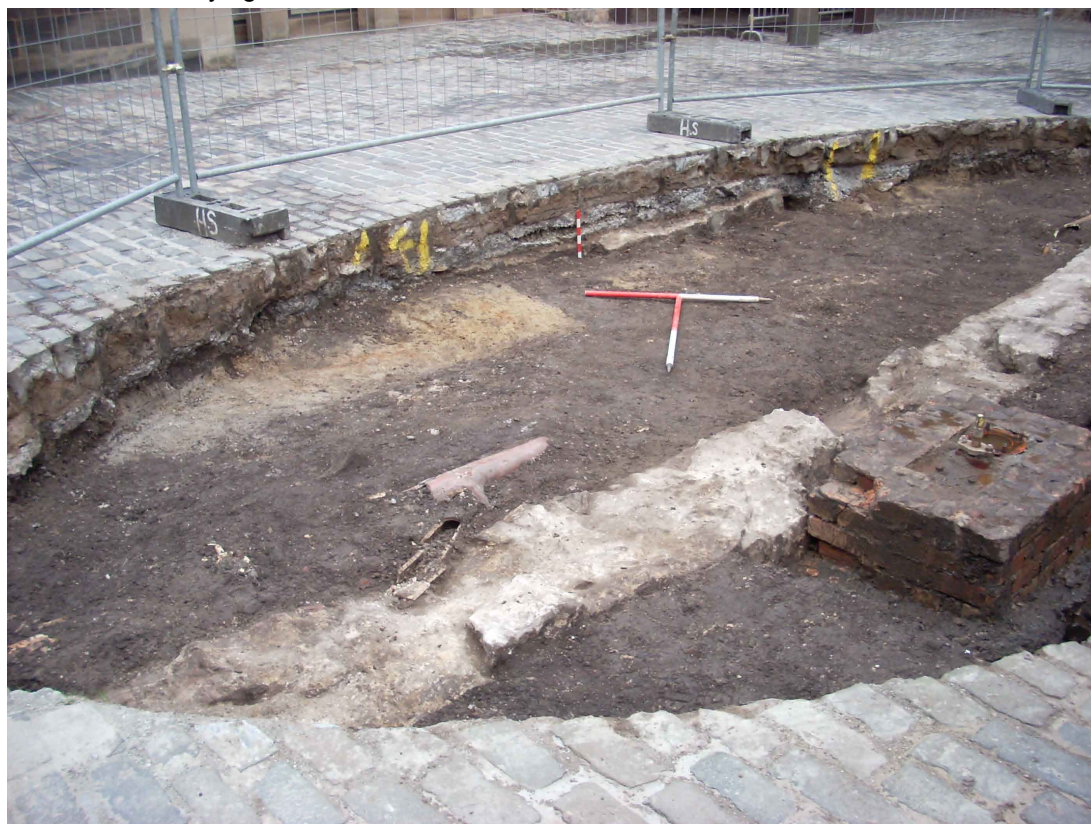
Fig. 3 - The Magazine Wall 666 from the south-east

The earliest deposit revealed was a dark brown silty sand soil with frequent stones, mortar chunks and bones (**660**). Above this, thin deposits of clean, iron-mottled yellow sand (**668**, **669** and **691**) were revealed. These deposits were cut (**692**) by the foundation trench for the eastern wall (**666**) of the 1748 powder magazine. The wall was exposed to a length of 3.75m and a depth of 0.1m (Figs. 3 and 4), but its full width was not exposed. The facing stones were creamy-green sandstone ashlar blocks of a type not recorded elsewhere during the Esplanade Project.

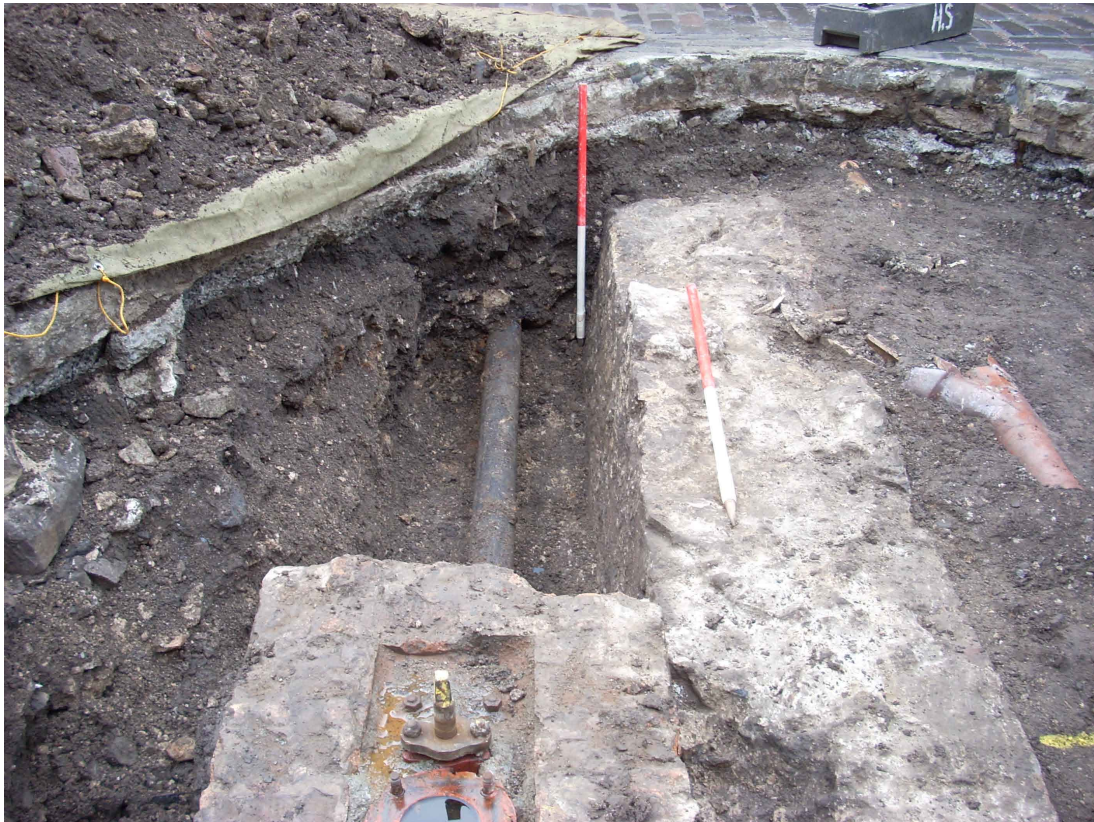
Wall **665** (Figs. 4 and 5) is the 'enclosure' or 'blast' wall to the east of the magazine. It was 9.6m long and 0.6m wide at the surface, although during work to replace the fire hydrant alongside the wall in the south of the trench, a notable batter (Fig. 5) was observed; this was less apparent in the sections recorded during the reduction in levels to the north. The wall was constructed of red and creamy-red sandstone rubble and much of the external faces were covered with a lime mortar.

Fig. 5 - The location of the fire hydrant (662) adjacent to the Blast Wall 665. The vertical ranging rod shows the batter of the wall

A disused and covered over brick fire hydrant within the trench was removed and replaced with a new steel hydrant which can be accessed when required. An amendment to the SMC was agreed with Historic Scotland.

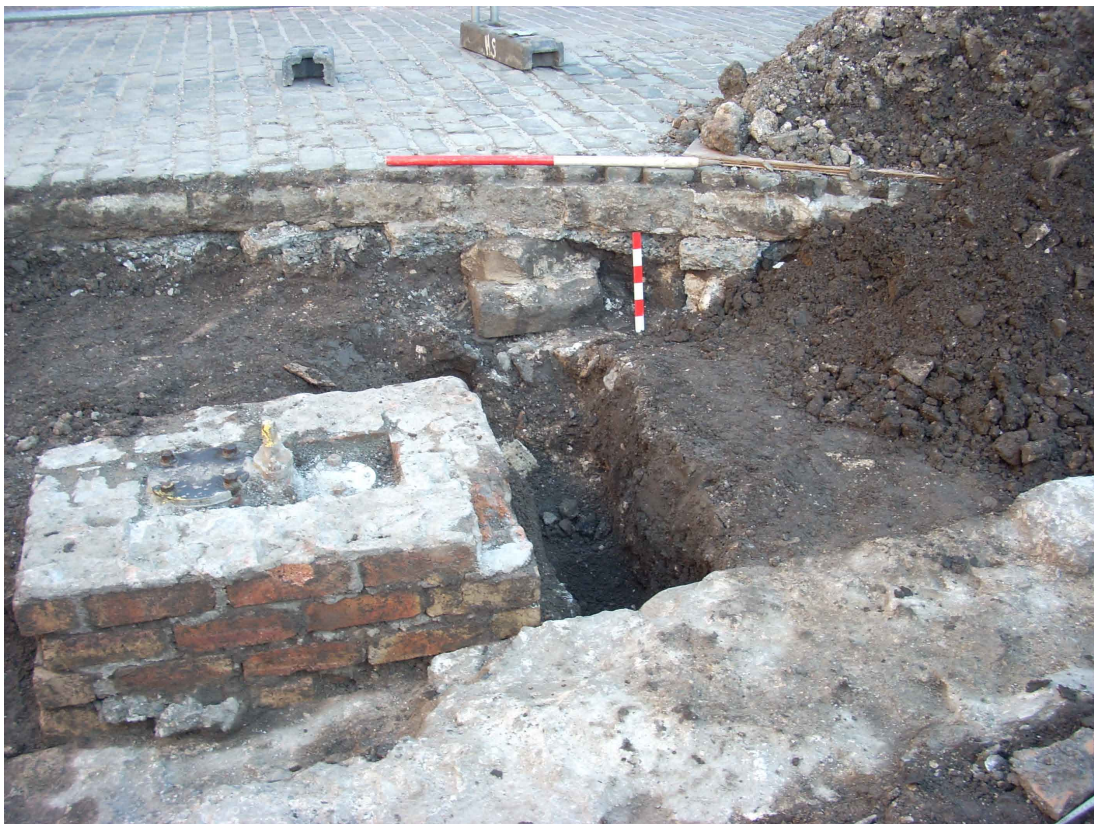
Wall **667** (Figs. 4 and 6) may be part of a square feature shown on the 1854 Ordnance Survey Town Plan and was exposed in the south-east edge of the trench. It was 0.4m wide and 0.2m deep. Formed from yellowish sandstone rubble, it was founded on a loose rubble base (**672**).

Fig. 6 - Wall 667 from the west
