## **Edinburgh Military Tattoo Grandstand Works, Fencing to North of Esplanade: Archaeological Watching Brief**

**Report No. 1968**

Author	Gary Savory MA and Hana Kdolska
Illustrator	
Editor	Tim Neighbour BSc FSA Scot MifA
Commissioned by	Edinburgh Military Tattoo Ltd
Date issued	21 October 2011
Version	1
OASIS Reference No.	cfaarcha1-78685
SMC Reference No.	AMH/90130/1/3
Grid Ref	NT 25315 73530 (centre)

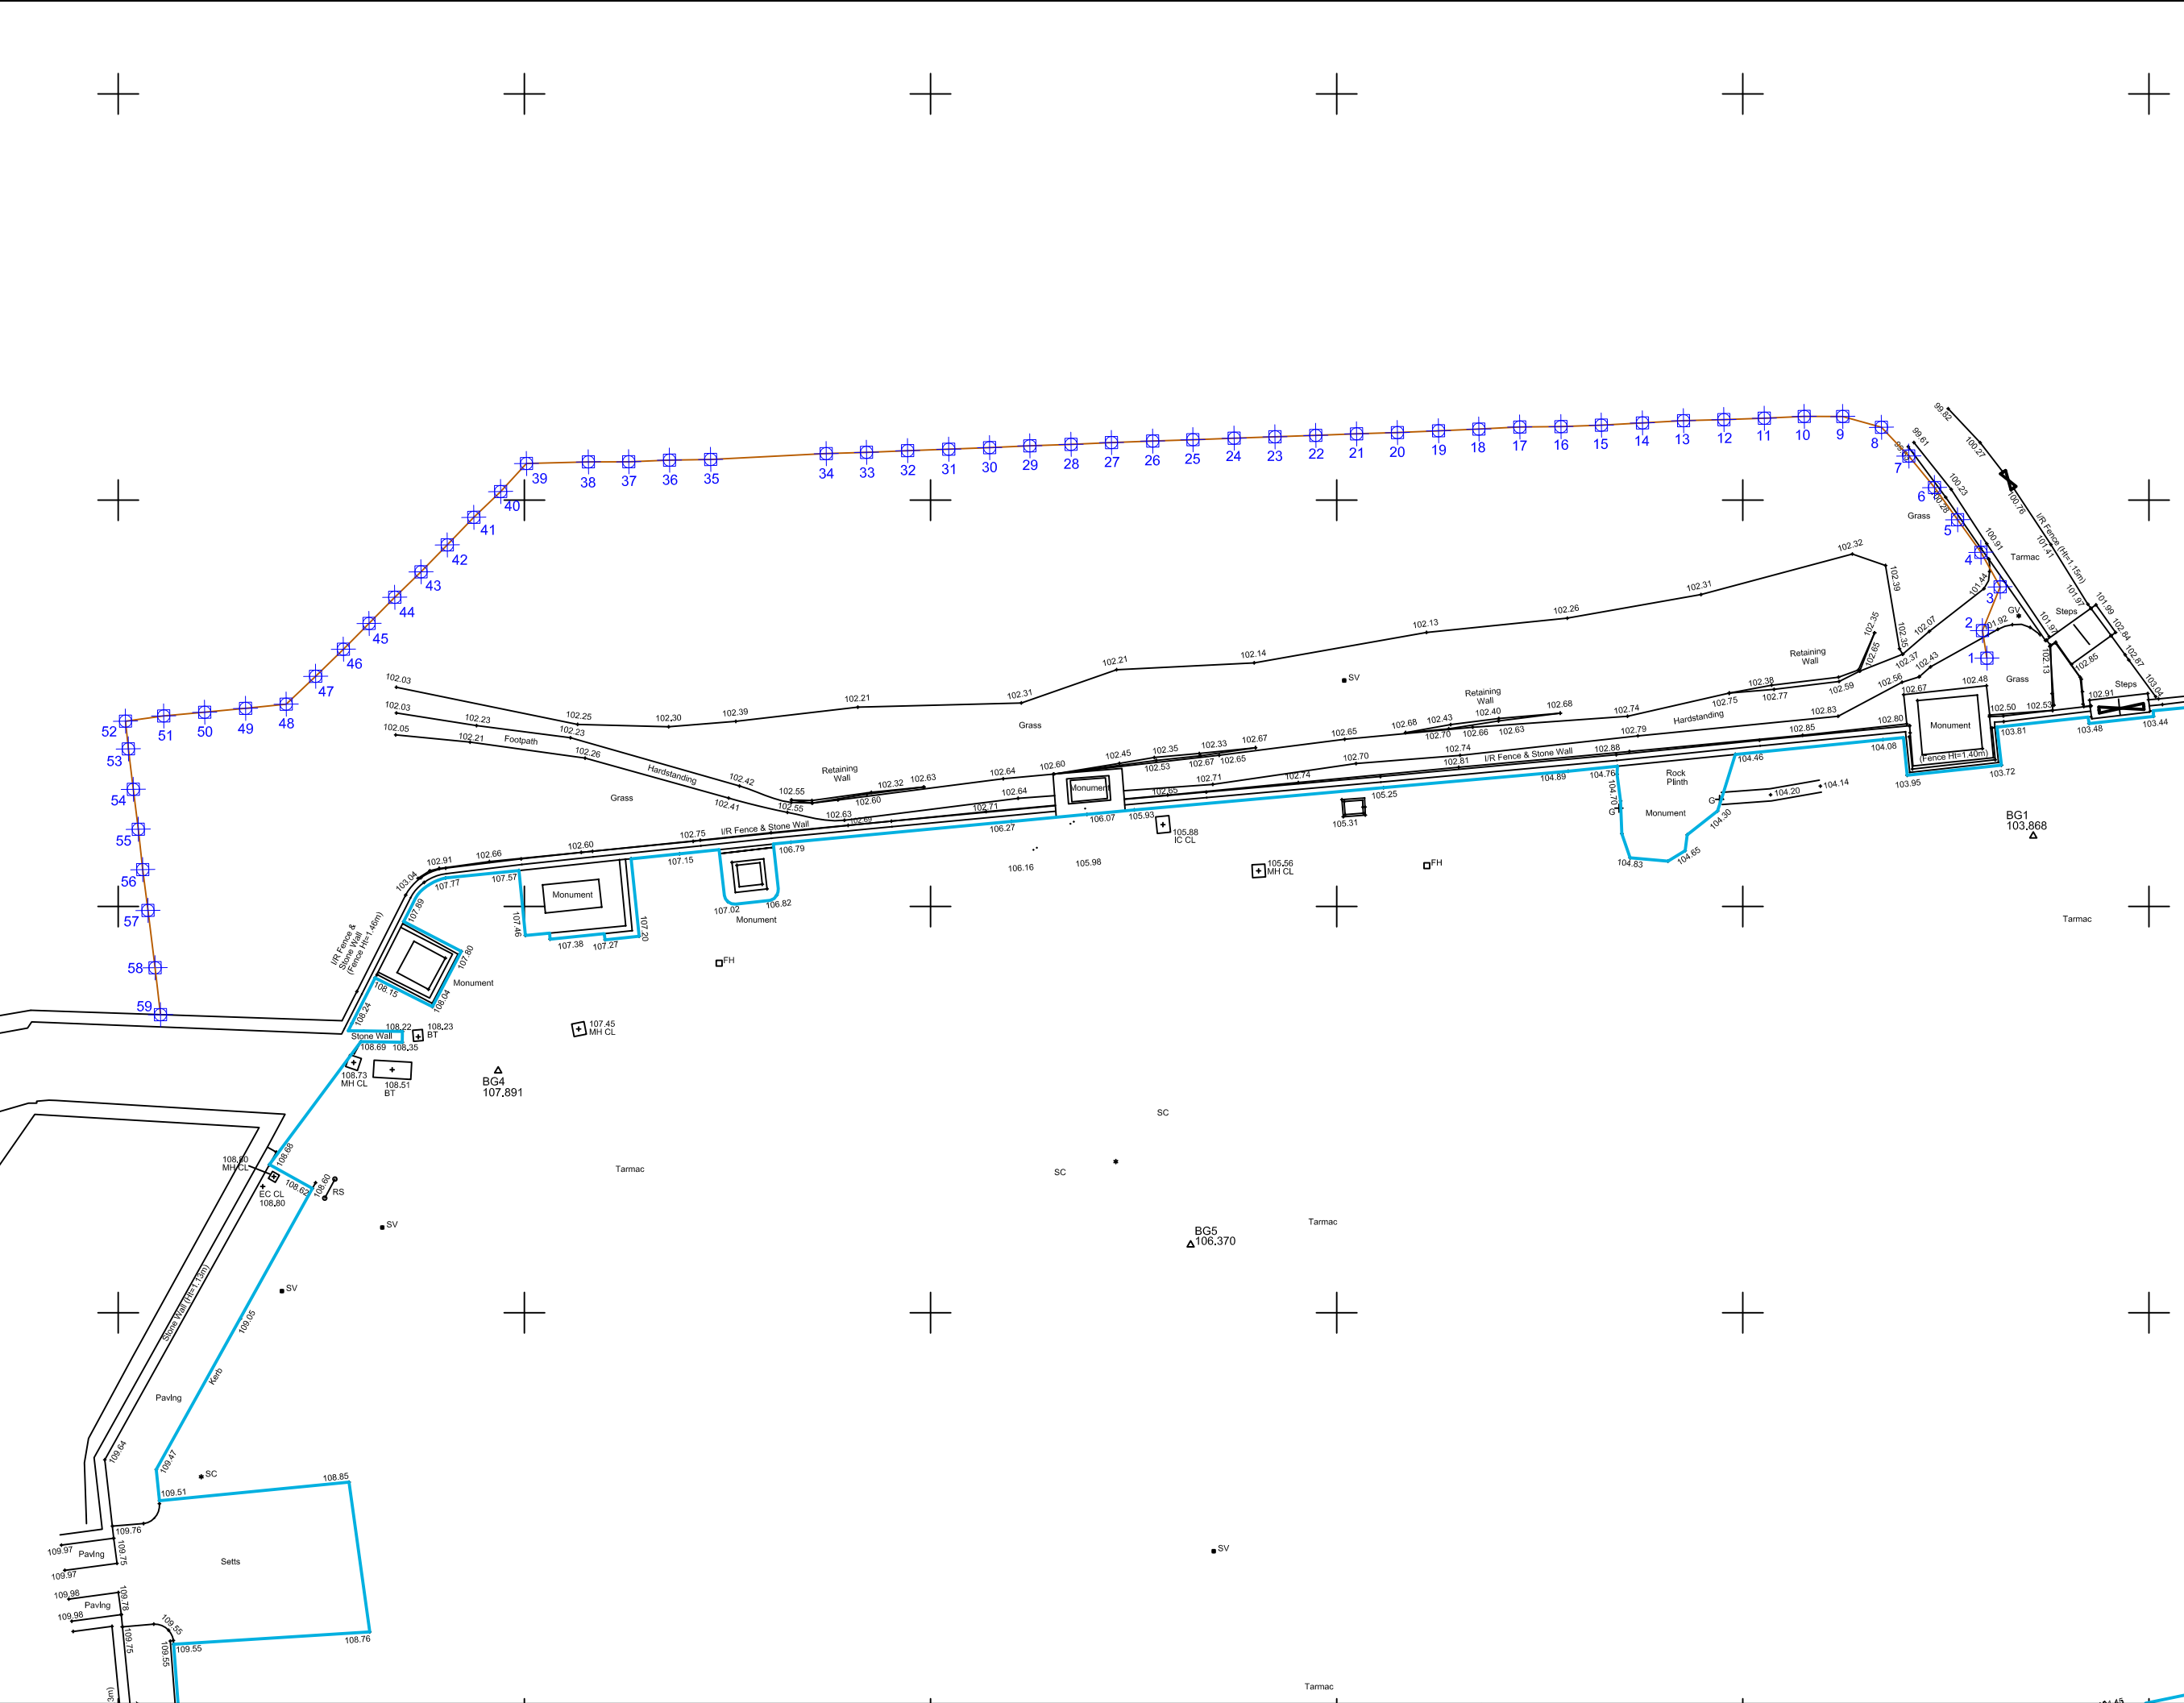
Fig. No:	2	Revision:	A
----------	---	-----------	---

A summary of the excavation results of the postholes, with the prefix H, is contained in Appendix 3 and their locations shown on Fig. 2.

Title:  
**Plan of new fence enclosing  
stand bases within Princes  
Street Gardens**

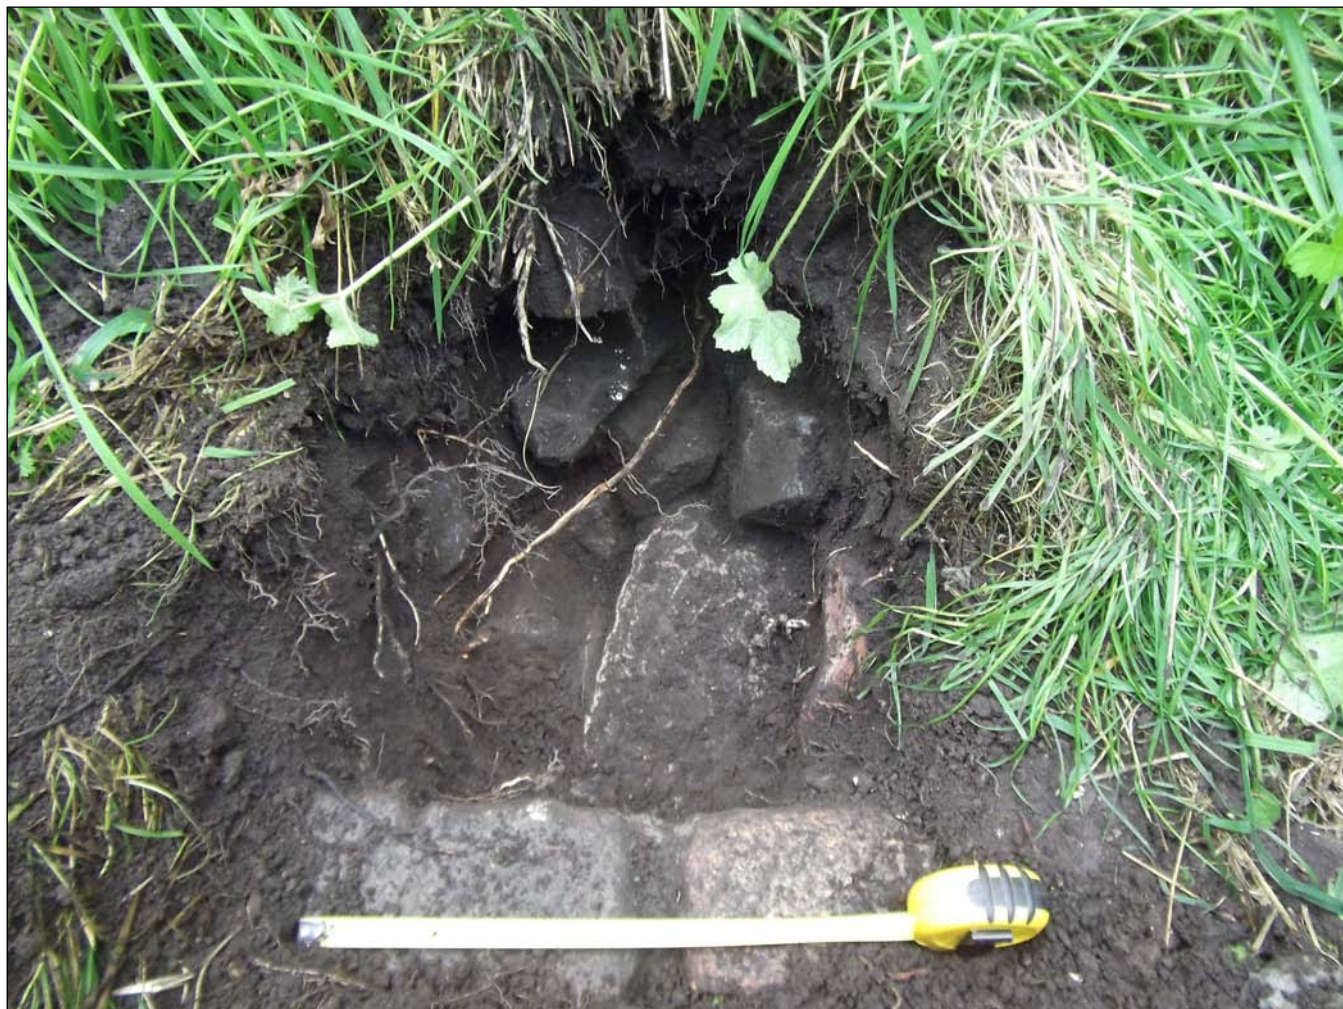
3

Posthole H12 contained a stone feature (**1201**) located under the topsoil (**001**) at a depth of 0.26m (Fig. 3). The three courses of flat, angular/sub-angular masonry blocks, measuring 0.30m in height, possibly formed part of a revetment wall at the bottom of the slope. Assuming that the feature was on an east-west alignment, continuations of the wall would have been expected in H11 and H13. However, due to the keyhole nature of the excavations the absence of associated remains in H11 and H13 does not mean that the feature in H12 was not part of longer masonry feature; slight deviations to its route and/or differential survival could account for its absence from H11 and H13. The feature did not underlie the western extent of modern kerbstones, which were also exposed during excavation, and respected the north-south alignment of the modern kerb.

Plan view of posthole H12

A watching brief was carried out during the excavation of postholes prior to the erection of a temporary, re-usable fence. One possible archaeological feature, consisting of three courses of masonry blocks, was uncovered. It is considered possible that this feature formed part of a revetment wall at the bottom of the slope, similar to that found on the south side of the Esplanade (Suddaby 2011, 12-13 and Figs. 30, 32, 34).
