Proposed Vehicle Storage Building, Swinton, Scottish Borders

Archaeological Evaluation

Report No. 1793

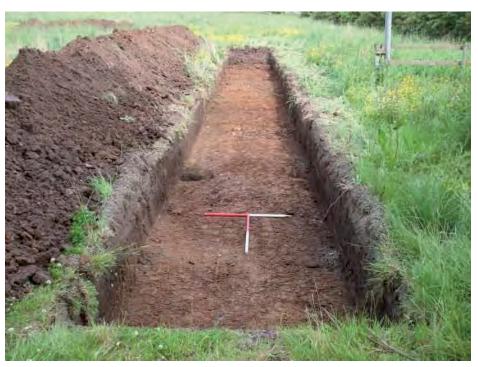
Fig. 3 General shot of Trench 1 from SSE

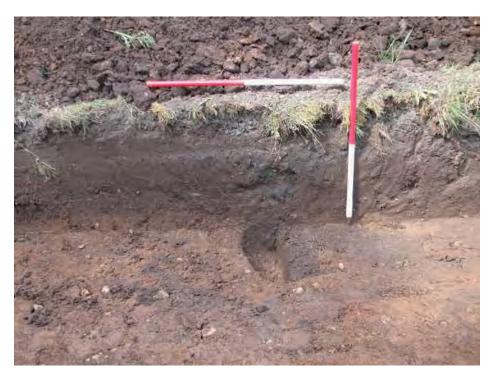
- 3.2.2 The terminal end of a modern linear feature (**004**) (Figs. 3-4) was also located within Trench 1 at 4.75m from the southern end of the trench. The feature cut the topsoil (**001**) and was overlain by (**010**), which also partially infilled it. The exposed cut was 0.5m long by 0.35m wide by 0.3m deep with steep sloping sides and a flat base. It was filled with (**005**), a mixed purplish grey brown clay silt and continued into the western side of the trench. It may be for drainage.

Fig. 3 ENE facing section of Trench 1 showing 005 and deposits 003,010 $\,$

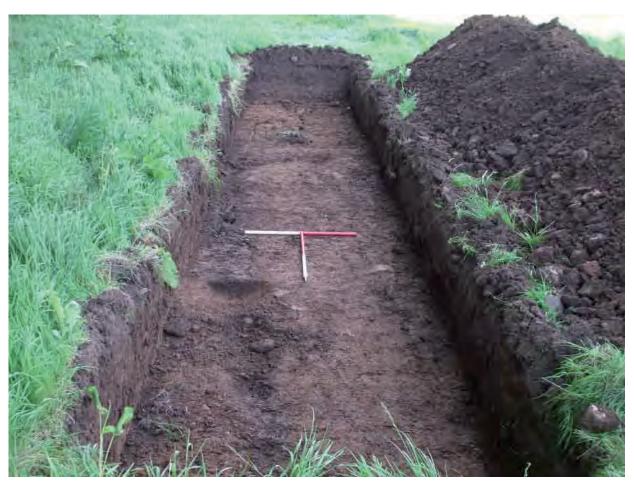
3.2.3 Trench 5 contained two linear features (006) and (008) (Fig. 5), both of which were filled with a mid grey-brown clay silt (007, 009), very similar to the topsoil (001). Linear feature 006 was aligned NE-SW of dimensions 0.4m wide by 0.1m deep with sloping sides and a concave base. Linear feature 008 was aligned NW-SE of dimensions 0.27m deep by 0.05m wide with a concave base. There was no stratigraphic relationship between the two features and they may be the remains of field drains.

Fig. 5 General shot of Trench 5 showing 006 and 008 from ENE
