Burnfoot Hill Windfarm, Clackmannanshire: Grid Connection Route Archaeological Mitigation Works

Report No. 1786

Author	Helena Gray MA (Hons)
Illustrator	Graeme Carruthers MA (Hons) MAAIS
Editor	Melanie Johnson MA PhD FSA Scot MifA
Commissioned by	Wind Prospect Ltd
Date issued	July 2010
Version	0
OASIS Reference	cfaarcha1 - 79188
Planning Application No	-
Grid Ref	NS 88784 97519

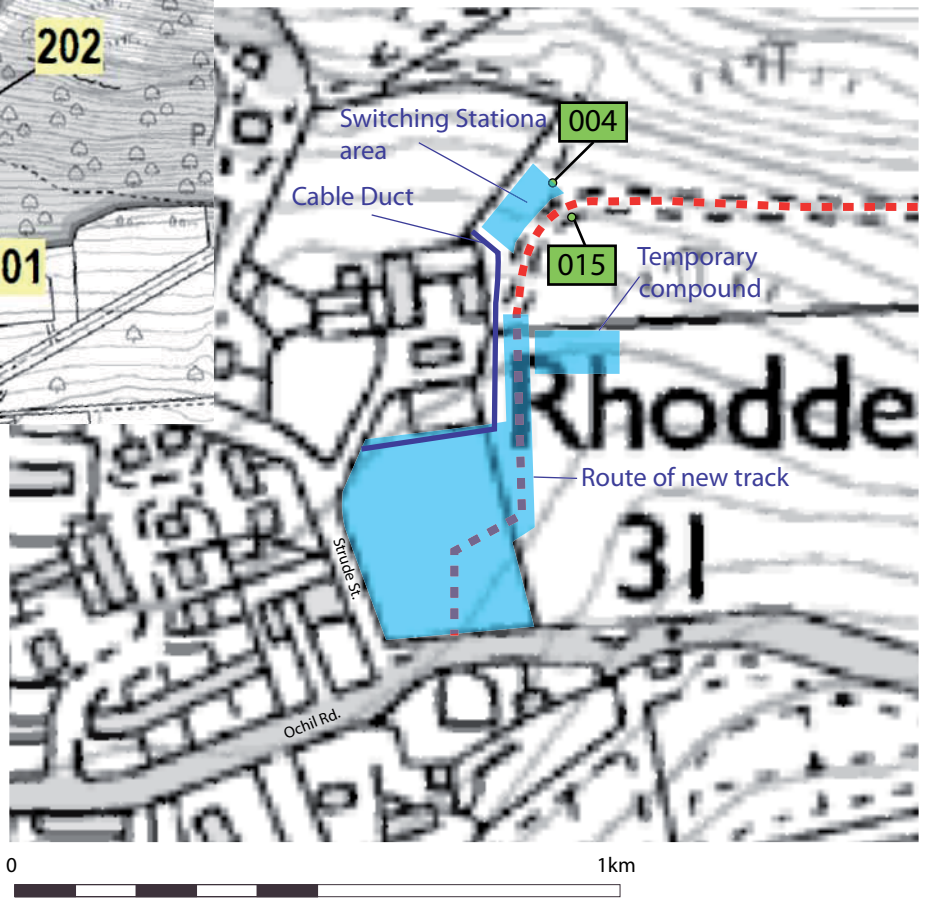
Fig. No:	2	Revision:		Client:	Wind Prospect Ltd
Title:	Detail of southern part of map showing areas monitored during watching brief				
Project:	Burnfoot Windfarm, Clackmannanshire: Grid connection route

- 3.2.1 Numbers in bold refer to contexts, a full list of which is contained in Appendix 2.
- 3.2.2 Only limited monitoring along the grid connector route was felt to be necessary as much of the farm track that the route followed had been terraced into the natural bedrock of the hillside (Fig. 2). Monitoring was targeted at areas where upstanding archaeological features were present near or adjacent to the trackway. Other monitored ground-breaking works included the topsoil stripping for a temporary compound and access road; excavation of foundations for a switching station; a small electricity cable trench; and anchor base pits for protective catch wires running along the outer edge of the farm track (Fig. 2).

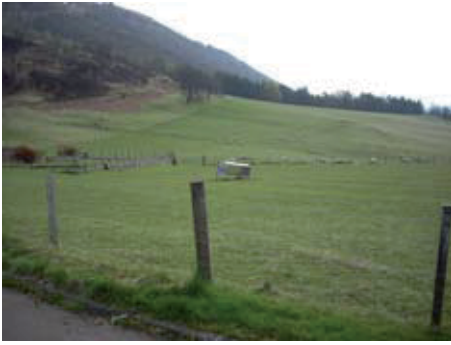
- 3.1.7 Site 210 is an area of rig-and-furrow. It was not practical to fence off this area, but a watching brief was conducted on all ground-breaking work in this area.

- 3.2.9 The temporary compound, access track and small electricity cable trench were located within fields containing rig-and-furrow (Site 210). No sub-surface remains of the furrows were identified and most topsoil stripping occurred at an oblique angle to the rigs which were only upstanding in these areas to a height of 0.1-0.15m and were not visible in section.

Site 210 from SW

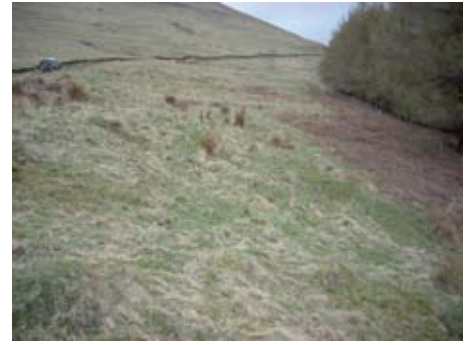
- 3.1.2 All sites were fenced off appropriately using orange netlon fencing.
- 3.1.3 Site 205 covered a length of approximately 250m and was 20-30m away from the track. Blue-rope bunting was used for this site and the fencing was moved along the length of the trackway so that it always lay adjacent to the working area.

Site 205 from S

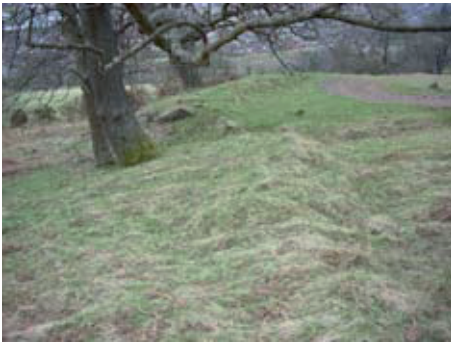
Site 201 from NE

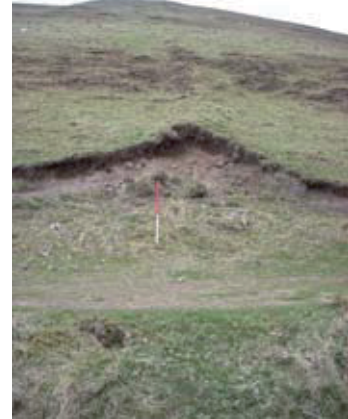
206		Boundary bank	NS 8909 9823	NS89NE 53 / 1115	NMRS; SMR; Field survey	Local	<p>Field survey identified a boundary bank up to 2m wide and 0.5m high running up slope to the W from the W side of the present track. The bank does not continue on the E side of the track where the ground drops steeply away down to the Silver Burn.</p>
207		Enclosure	NS 8910 9875		Field survey	Local	<p>Field survey identified the truncated remains of a two-compartment enclosure measuring c.65m N-S by 20m on the NE slopes of The Nebit, on the W side of the present track. The larger compartment measures c.38m N-S and the smaller southern compartment is c.15m N-S. The enclosure is truncated along its whole E side by the track.</p>
208		Enclosure bank	NS 8910 9890		Field survey	Local	<p>Field survey identified the remains of a boundary bank spread to 2m wide and 0.4m high curving around the contours on the NE slopes of The Nebit on the E side of the present track. The bank can be traced from NS 8910 9890 almost to the enclosure (207) at NN 8910 9875.</p>

Site 206 from NW

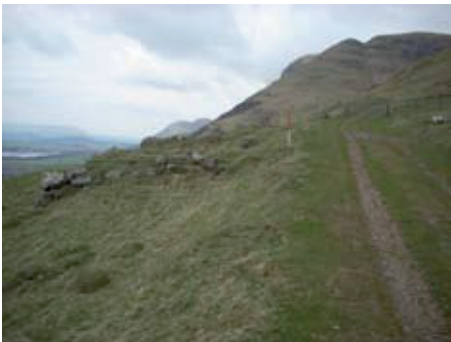
203		Buildings	NS 8900 9771		Field survey	Local	Field survey identified the remains of a terrace of four buildings lying on the S side of and parallel to the present track. The buildings are all 4m wide across turf covered stone walls c.1m wide and 0.5m high. The buildings measure 8m long, 10m long, 6m long and 8m long respectively from E to W. There are detectable entrances to the easternmost three buildings from a broad terrace to the S in the centre of their lengths. The westernmost building has a possible entrance in the SE corner of the S wall.

Site 203 from W

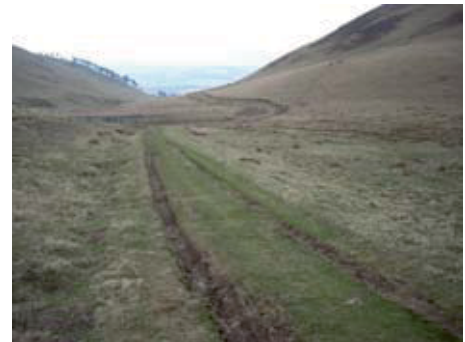
- 3.1.4 Site 207 was found to extend to both sides of the farm track and was fenced accordingly.
- 3.3.5 Site 204 was found to have a different grid reference to that stated in the ES chapter, the actual location being c.25m away from the farm track. New coordinates were taken and the site gazetteer (Appendix 1) amended.

Site 207-8 from N

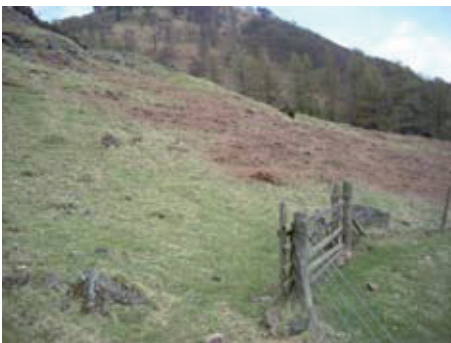
Site 204 from W

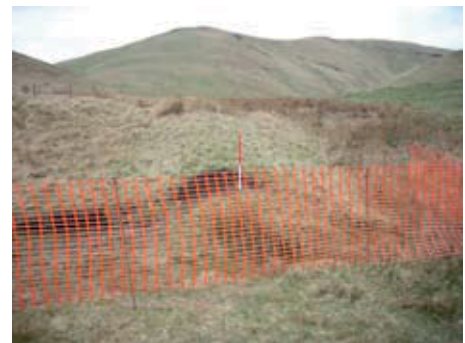
- 3.1.8 A new site, site 211, was located just to the north of site 208. This consisted of a turf bank measuring 3.5m wide by 0.4m high, and was cut by the trackway. This site was also fenced off.

Site 211 from SSE

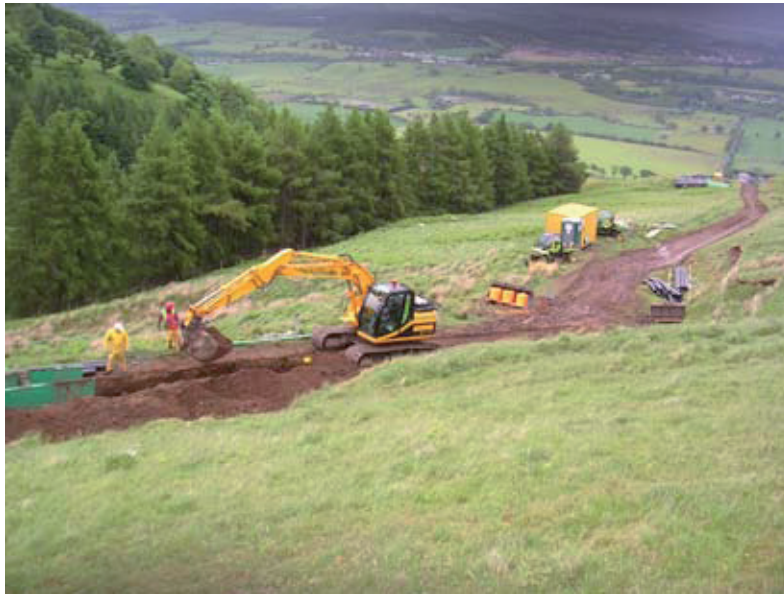
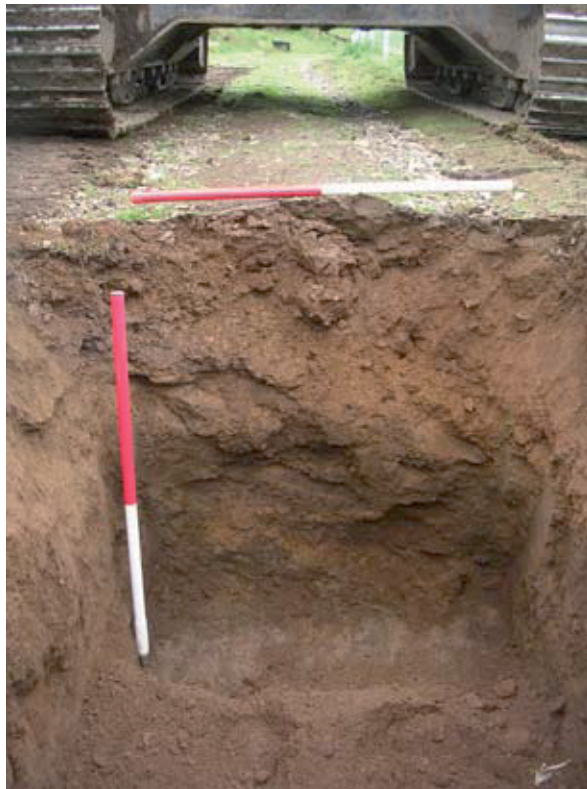
Key:	Fig. No: 4	Revision:	Client: Wind Prospect Ltd

- 3.2.4 The trench excavated for the grid connector cable was c.1m wide by 1.2m deep (Fig. 4). In the areas monitored, deposits generally consisted of 0.15m of mid brown-grey sandy silt metallised trackway surface (**020**), overlying 0.3-0.5m of reddish-brown and grey-brown sandy silt made-ground/trackway make-up (**021**). In places this overlay natural subsoil (**002**), or bedrock (**024**) directly, but some parts of the trench also contained 0.1-0.15m of old ground surface/turf line (**022**), a grey-black silt which either overlay natural or 0.3-0.5m of hillwash (**023**).
- 3.2.5 The deposits encountered suggest that the trackway was constructed by cutting quite deeply into the hillside and which was then infilled with material and levelled. The trackway has thus probably truncated any previous remains along the grid connector route.

General shot of excavation of grid connection cable from NW

W facing section of cable trench through existing farm track

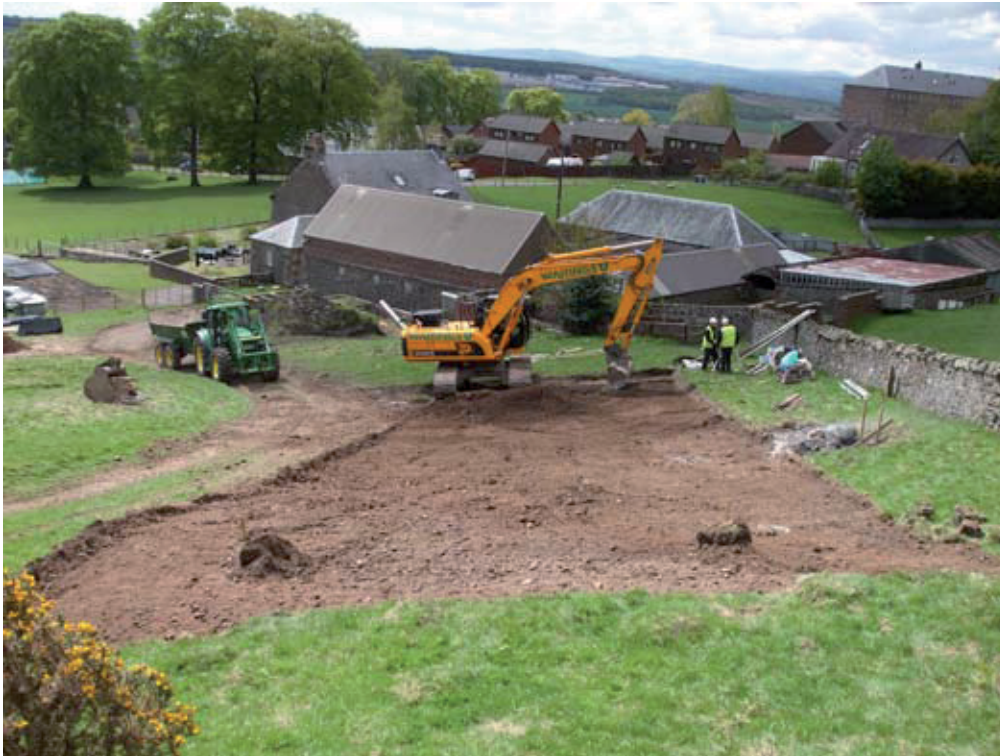
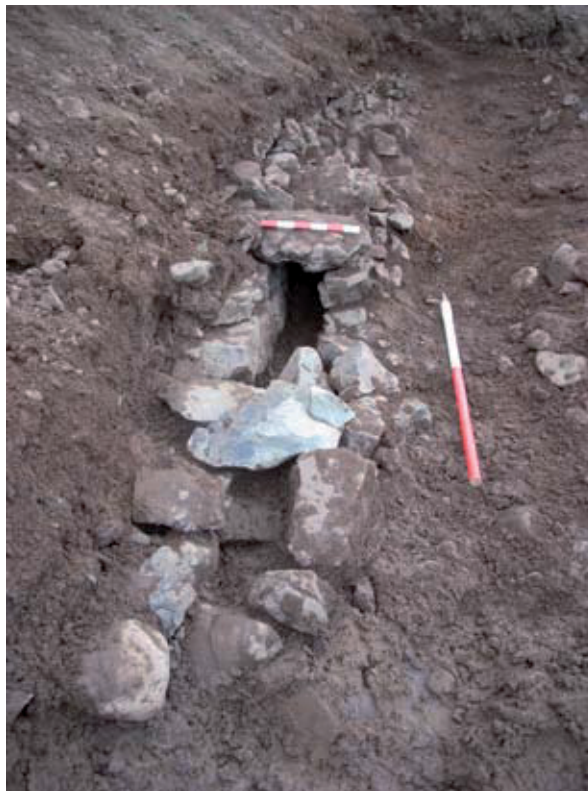
Key:	Fig. No: 5	Revision:	Client: Wind Prospect Ltd

- 3.2.6 An area c. 35m by 20m was opened up and excavated into the side of a steep hillside slope beside Rhodders Farm (Fig. 5). Deposits consisted of 0.3m of topsoil (**001**) of mid grey-brown sandy silt with frequent medium sized angular stone inclusions. This overlay a hillwash/subsoil deposit (**003**) of mid orange-brown silty sand of depth 0.3m, under which a stone-lined rubble field drain was found in the northern part of the area (Figs. 2 & 5). It was aligned NW-SE and comprised a linear cut (**004**) measuring at least 3.6m in length by 0.5m in width by 0.35m deep, with vertical sides and a flat base. It was partially lined with 2-3 courses of roughly rectangular stones (**005**) of average dimensions 0.2m by 0.1m. Four capping stones (**006**) were still present, generally 0.4m across by 0.1m thick, but otherwise the drain was infilled with small to medium sized angular to sub-angular rubble (**007**). The drain was still working and was re-used by the contractors on site. It was cut into a 0.3m deep hillwash/subsoil deposit (**008**) of mid brownish-orange compact silty gravel, which overlay a natural subsoil of mid pinkish-grey gravelly clays (**002**).

General shot of area being stripped for switching station from N

Shot of stone lined culvert (004) from NW

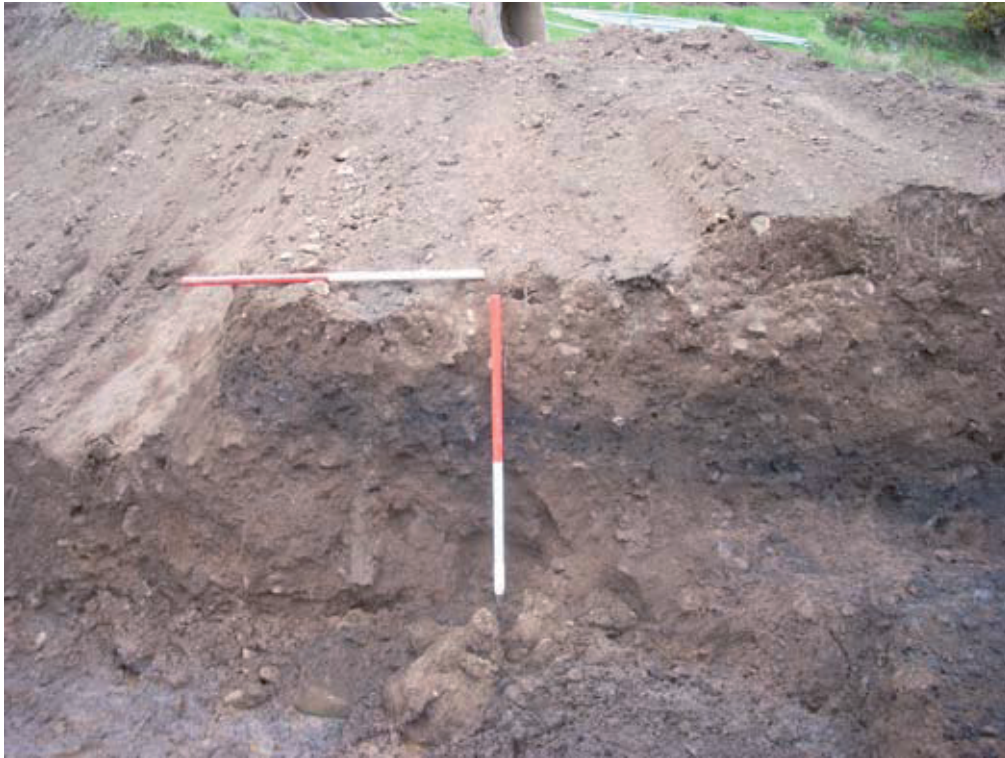
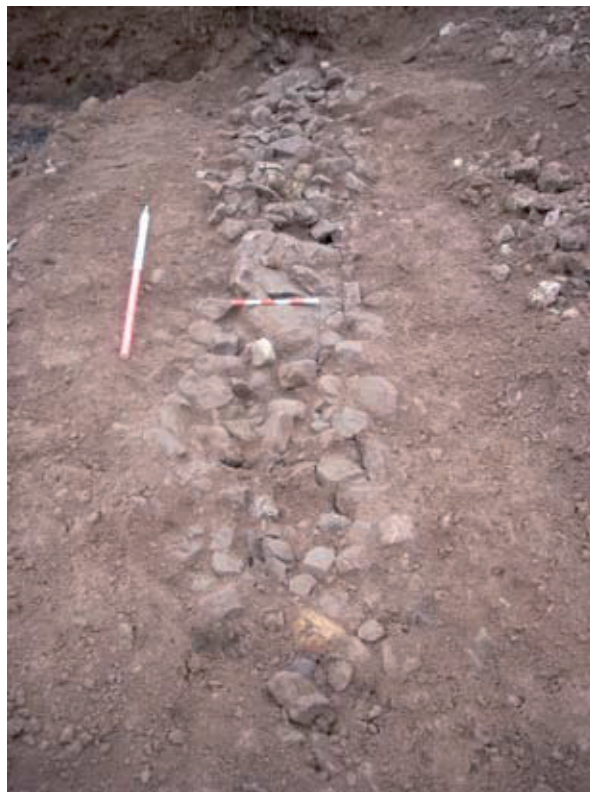
Key:	Fig. No: 6	Revision:	Client: Wind Prospect Ltd

- 3.2.7 Further downslope and to the east, a probable continuation of the stone-lined drain **004** was revealed underlying subsoil deposit **003**. The drain (Fig. 6) was aligned NNE-SSW and consisted of a linear cut (**015**), measuring at least 4.6m in length by 0.5m wide by 0.6m deep of similar shape and form to **004**. It was of similar construction comprising a stone lining (**016**), capping (**017**) and rubble infill (**018**). The drain was cut into a deposit (**019**), similar to subsoil deposit **008**, of depth 0.5m. This overlay an old ground surface or turf layer (**014**) (Fig. 6), of mid-dark brown-grey silt of depth 0.2m. This layer overlay natural subsoil (**002**) of mid-orange gravelly silt. The drain **015** had been constructed over **014**, but not cut into it.

Shot of SSW facing section of part of switching station excavation showing layer (014)

Shot of stone lined culvert (015) from S

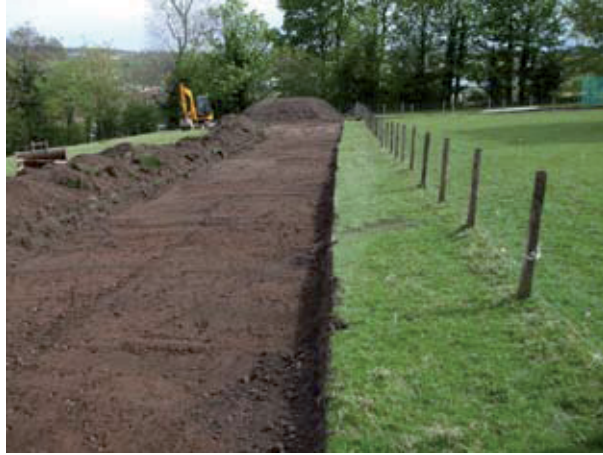
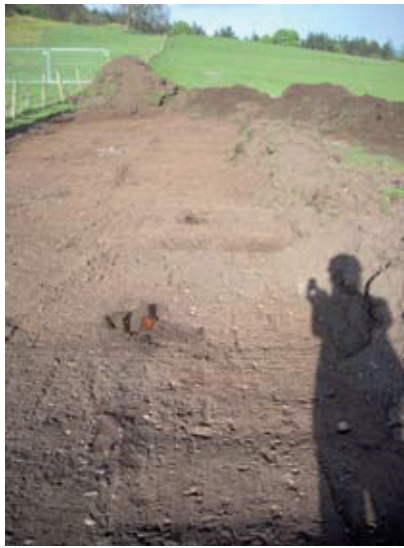
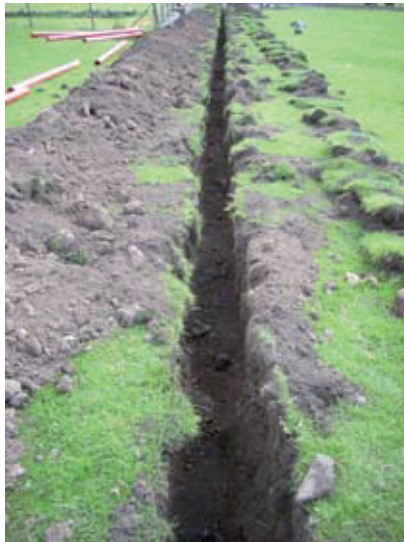
Key:	Fig. No: 7	Revision:	Client: Wind Prospect Ltd

- 3.2.8 An area c. 20m by 30m was stripped for the temporary compound, and a 4m wide strip was excavated for the access track. The electricity cable trench was c. 0.3m wide by 0.7-0.8m deep and extended along the south and eastern sides of Rhodders Farm (Fig. 7).

- 3.2.10 Deposits in this area consisted of 0.2-0.25m of topsoil (**001**) of mid grey-brown sandy silt. This overlay a hillwash/subsoil deposit (**010**) of mid orange-brown gravelly silt sand of depth 0.3-0.7m. Natural subsoil (**002**), where reached, was a compact mid-orange gravel. A ceramic drain was found in the western end of the cable trench (**013**).

General shot of excavation of access track from NW

General shot of topsoil stripping for temporary compound showing bases of modern fence posts

General shot of small electricity cable duct from W
