**St Leonards Primary School,  
St Andrews, Fife**

**Archaeological Investigation**

**Report No. 1805**

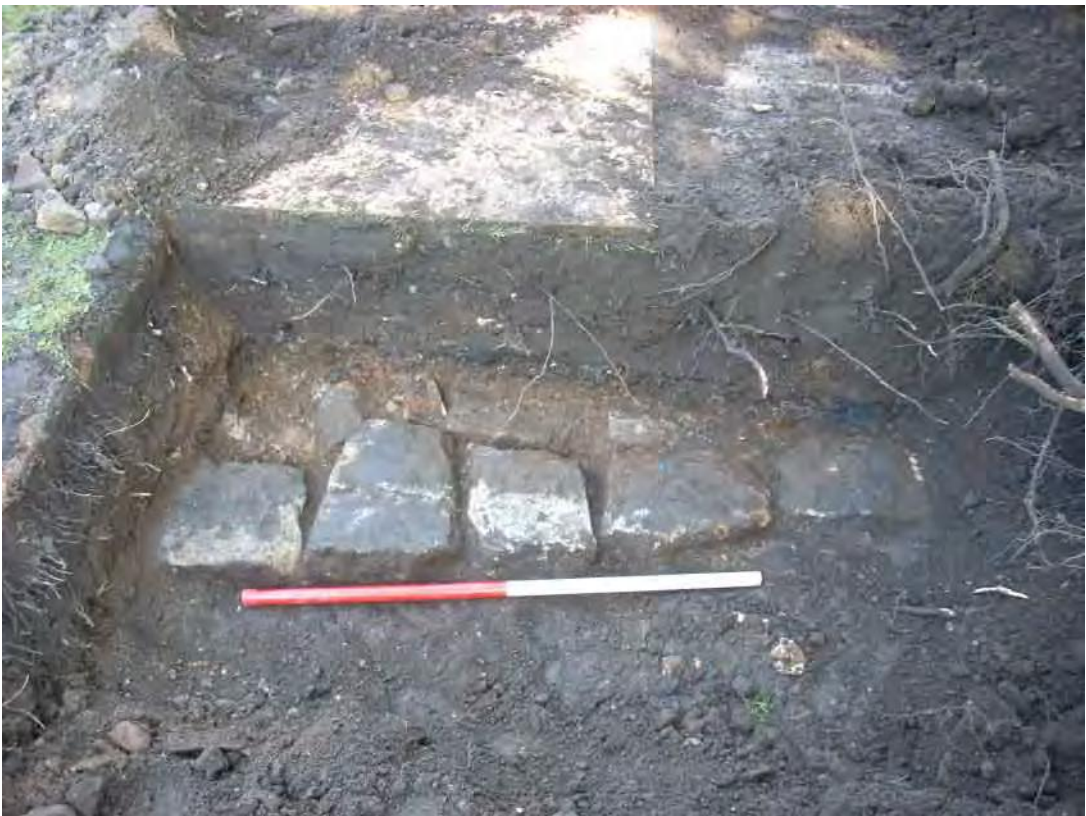
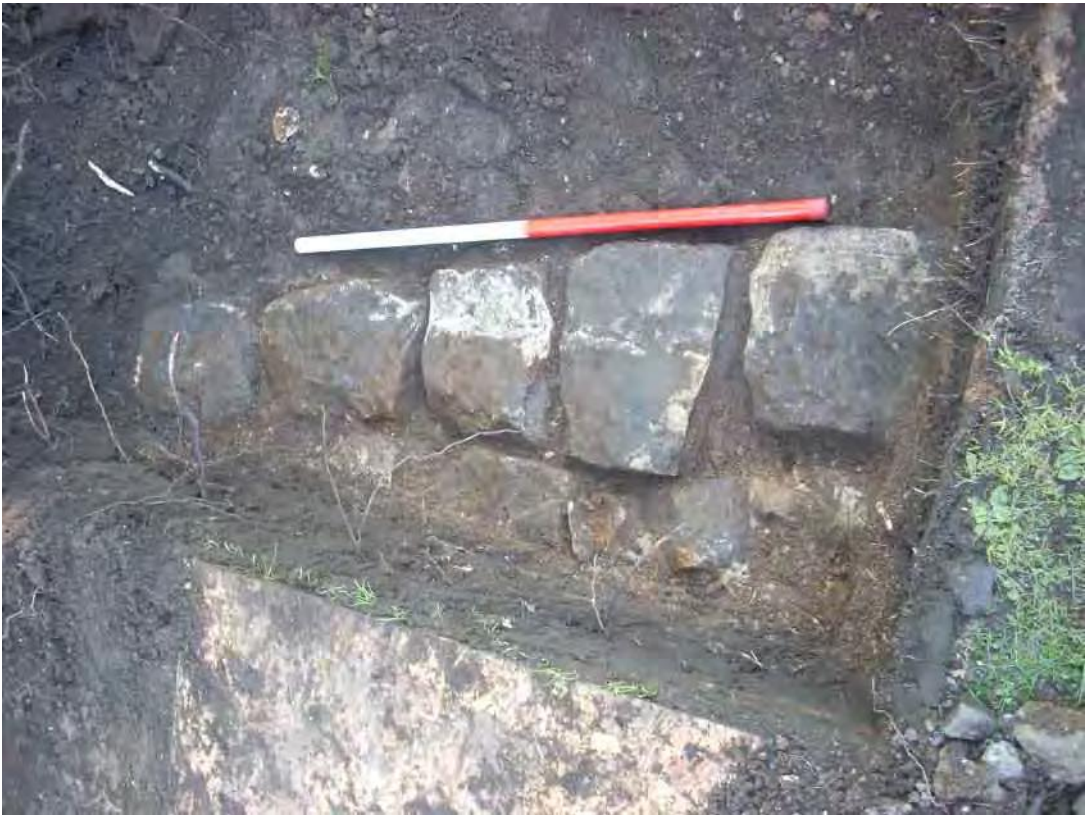
Fig. 4 Sandstone surface in Trial Pit 2

3.3.2 Trial Pit 2 (TP02; Figs. 2-5) was located to the south of the prefabricated building, c.4m from Hand Pit 4, and was surfaced with grass. Due to the discovery of an earlier surface this test-pit was hand dug to a depth of 1.2m, from where it was machine dug without affecting the archaeological remains. Following on site discussions with Oliver Lewis of Historic Scotland, the pit was extended by 0.5m to further expose the earlier surface. Topsoil (TP02/01) was 0.28m thick and overlay a 0.05m thick layer of gravel and ash (TP02/02). Below this the edge of a surface of sandstone cobbles (TP02/03) aligned roughly north to south was revealed. The cobbles were rough hewn and rectangular in shape, and poorly founded on stony made ground (TP02/04). The stratigraphic position of the sandstone surface suggests that it is of no great antiquity and is most likely the remains of a path surface leading from the main entrance drive towards St Catherine's House. Similar cobbles are visible on the surface of the nearby main driveway. The made ground (TP02/04) was 0.25m thick and overlay a further 0.75m deep deposit of made ground (TP02/05) comprising soil, clay and frequent large stones. This deposit had been mixed by root action from a nearby tree. Natural subsoil (000) was coarse sand and was reached at 1.35m.

Fig. 5 Sandstone surface in Trial Pit 2

- 4.2 The only feature identified was the remains of a sandstone cobbled surface in TP02. It was set onto a deep made ground deposit and is thus unlikely to be of significant antiquity. It was poorly founded and is likely to be the remains of a former path or track leading to the front of St Catherine's House. It is likely that more of the surface remains outwith the trench; however, it is unlikely to have survived entirely intact due to more recent building and services.

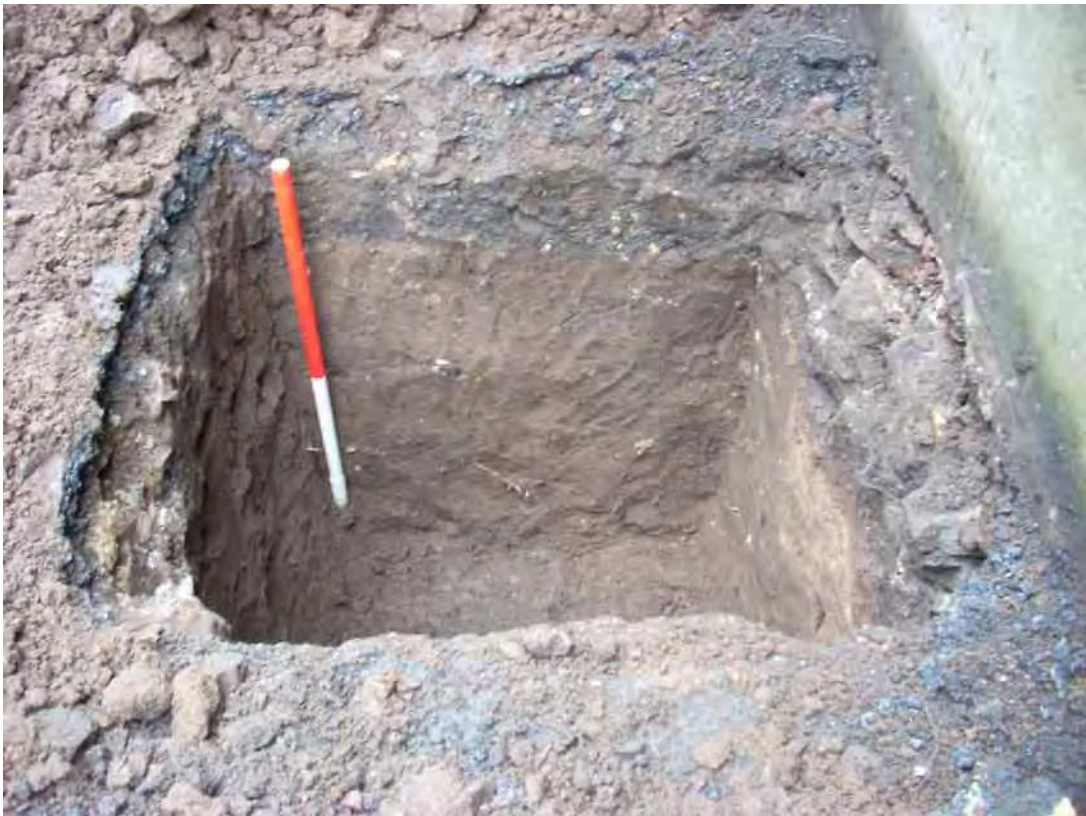
Fig. 6 Section of HP01

- 3.2.1 Hand Pit 1 (HP01; Fig. 6) was located on the west side of St Catherine's House, abutting the edge of a set of steps. It was excavated to 1.2m deep. The surface comprised a 0.03m layer of tarmac (**HP01/01**) overlying made ground deposits to a depth of 0.38m. The uppermost deposit was a spread of rubble (**HP01/02**) underlying the steps. In the north facing section this overlay a lens of crushed sandstone and rubble (**HP01/06**) which was not present elsewhere in the test-pit. Below this was a layer of dark soil (**HP01/03**) which in turn overlay a dark garden soil deposit (**HP01/05**) this extended beyond the base of the test-pit. In the west facing section an irregular cut (**HP01/07**) was visible this cut in to the garden soil (**HP01/05**) and was sealed by (**HP01/03**). This cut was directly beneath the step, it was 0.38m deep and was back filled with sand (**HP01/04**). It is likely that this cut was associated with the building of St Catherine's House or the steps. Natural subsoil was not reached and no finds were recovered.

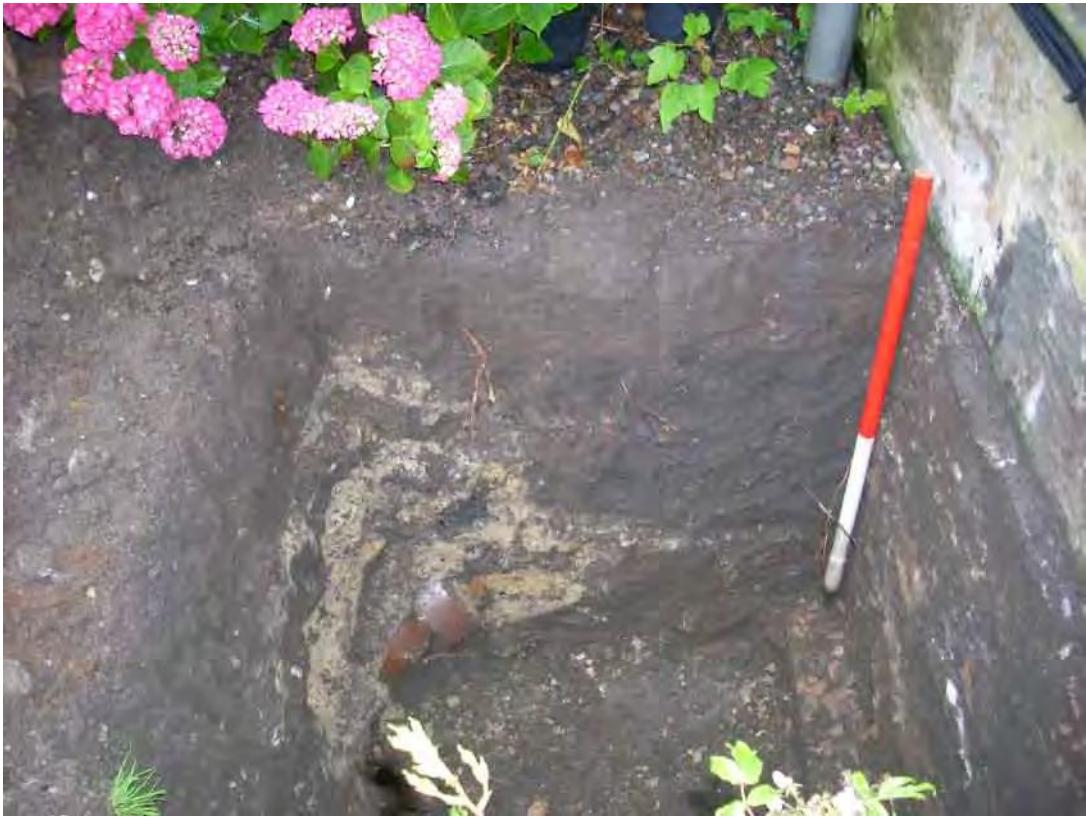
Fig. 7 Section of HP02

- 3.2.2 Hand Pit 2 (HP02; Fig. 7) was located in a flower bed abutting the south side of St Catherine's House. It was excavated to a depth of 1.2m. The top 0.3m comprised topsoil (**HP02/01**), which overlay a deposit of silty garden soil (**HP02/02**) which had a maximum depth of 0.7m. This overlay a discontinuous 0.1m thick red sand lens (**HP02/03**). These two deposits (**HP02/02 & HP02/03**) appeared to be contained within a cut (**HP02 07**) which given its location was presumably excavated for repairs to the wall (such as damp proofing) of the current building, or to create the flower bed. This cut the sandy rubble fill (**HP02/04**) of a large sewer pipe (**HP02/06**). Below the sewer pipe was deposit of sandy silt (**HP02/05**) which extended below the depth of the test pit. The foundation of the current building did not cut through this deposit suggesting it was deposited after construction and fills whatever foundation trenches were excavated for this building. Natural subsoil was not reached and no archaeological deposits or features or finds were identified. The base of the foundation of St Catherine's House was not reached although

a wider sandstone foundation course was exposed in the base of the pit suggesting that this was the basal course of the foundations.

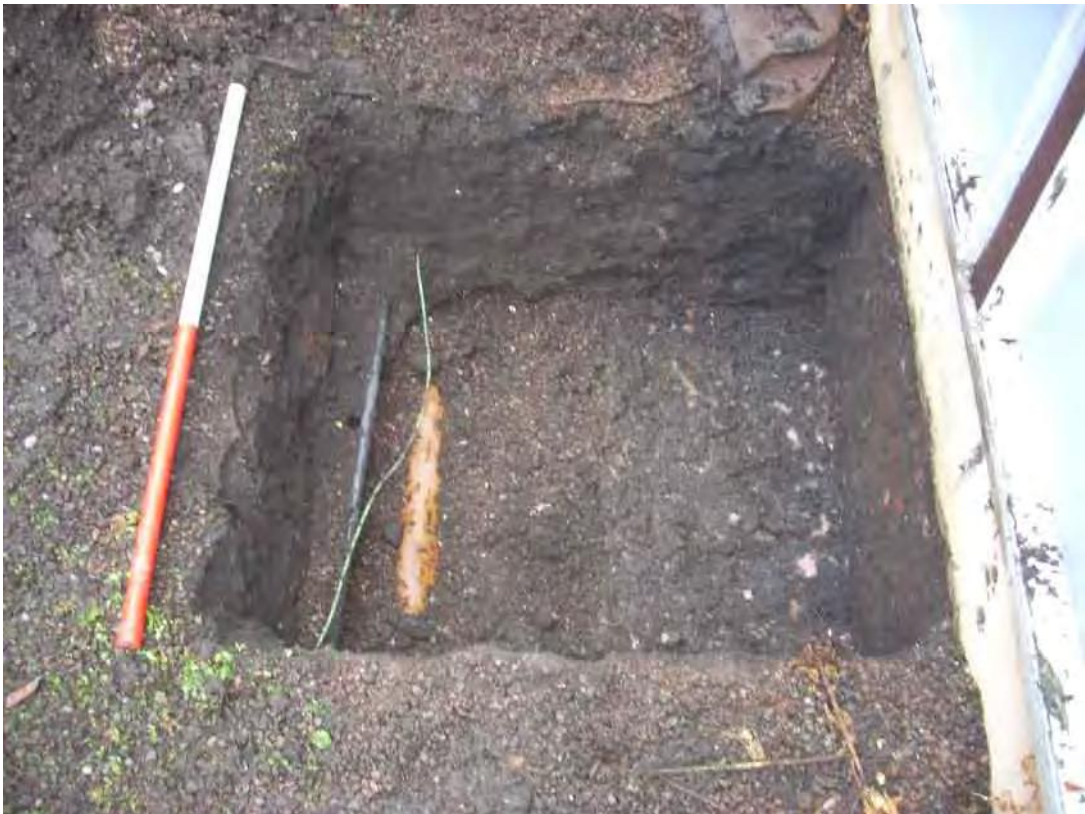
Fig. 8 Section of HP03

- 3.2.3 Hand Pit 3 (HP03; Fig. 8) was located in a flower bed on the north edge of a brick and pre-fabricated panel building to the south of St Catherine's House. It was excavated to a depth of 0.6m as the SI contractor did not need to excavate below this level. Topsoil (HP03/01) at c.0.4m thick overlay 0.2m of deposits of made ground (HP03/02, HP03/04) including the infill of live electricity (HP03/06) and water services (HP03/05). The concrete raft foundation (HP03/03) for the pre-fabricated building was exposed at a depth of 0.6m. Natural subsoil was not reached and no archaeological deposits or features were identified

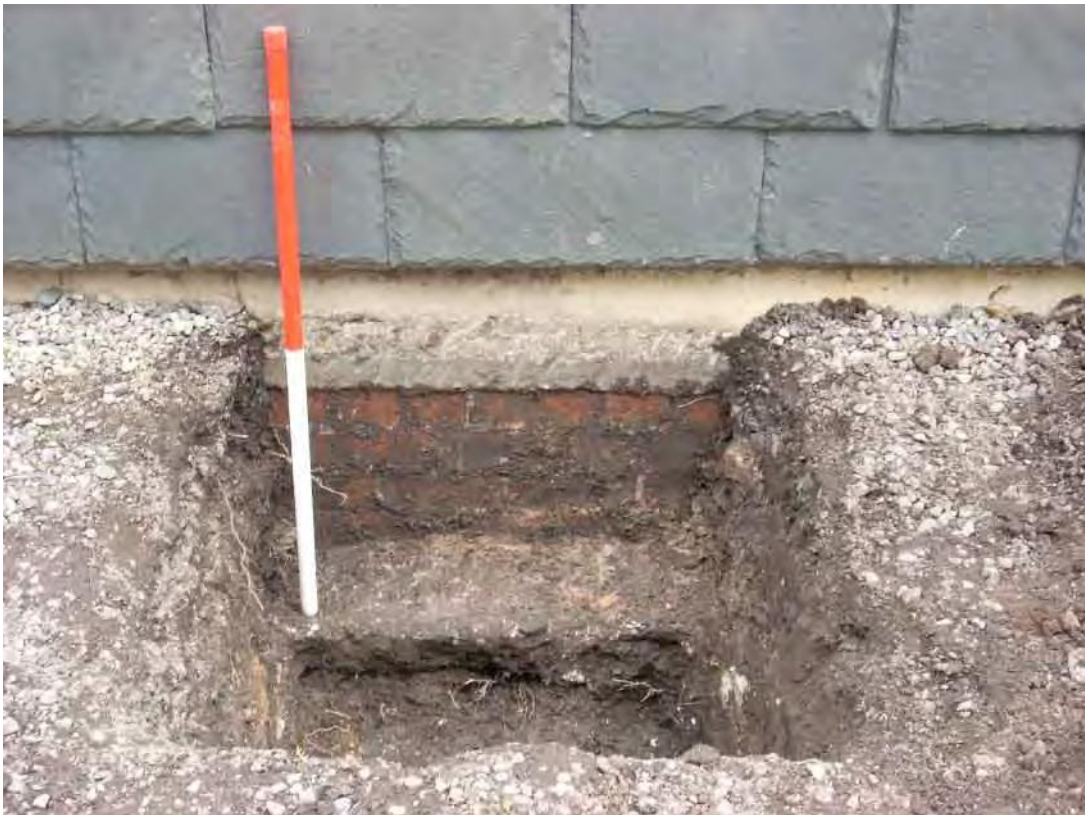
Fig. 9 Section of HP04

- 3.2.4 Hand Pit 4 (HP04; Fig. 9) was located on the south side of the prefabricated building and was dug to a depth of 0.70m as the SI contractor did not need to excavate below this level. The surface deposits were tarmac (HP04/01) and with a hardcore bottoming (HP04/02) these were 0.1m deep in total. Below the current surface were made ground layers comprising 0.35m of rubble and soil (HP04/05), 0.1m of reddish clay and sandstone (HP04/06), and 0.25m of sand and rubble (HP04/08). The made ground (HP04/05, 06, 08) was cut by a foundation trench (HP04/04) for the concrete raft foundation of the prefabricated building (HP04/07). Natural subsoil was not reached and no archaeological deposits or features were identified.

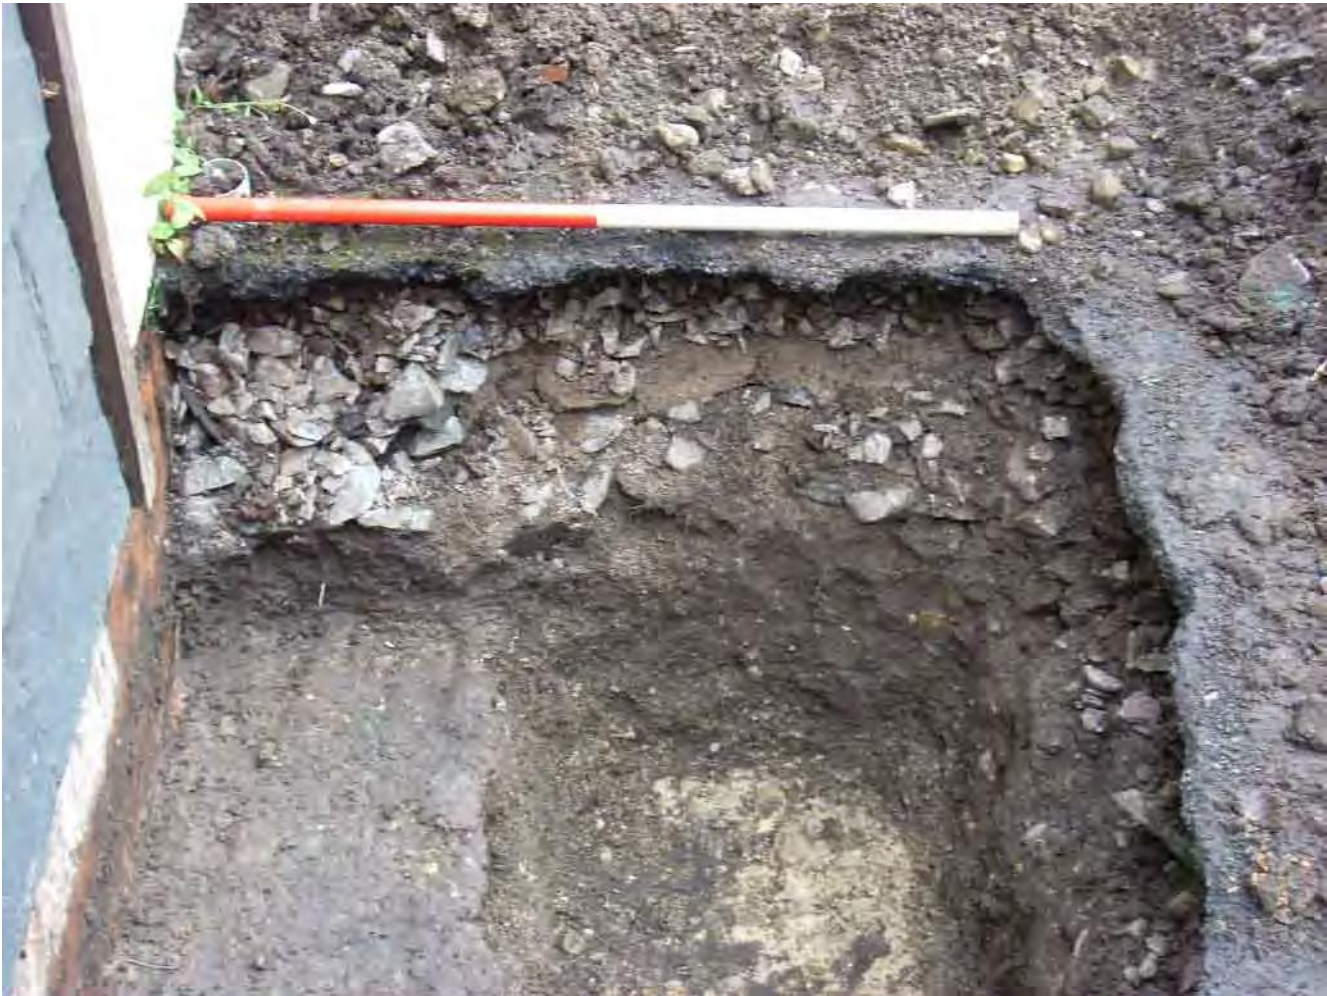
Fig. 10 Section of HP05

- 3.2.5 Hand Pit 5 (HP05; Fig. 10) was located on the east side of the prefabricated building and was dug to a depth of 0.70m as the SI contractor did not need to excavate below this level. It was surfaced with tarmac (HP05/01) and hardcore (HP05/02) to a depth of 0.2m. These overlay made ground deposits comprising 0.25m of grey clay rubble (HP05/03), 0.15m of reddish clay and sandstone (HP05/05), 0.1m of grey clay and sandstone rubble (HP05/06), and 0.1m of crushed sandstone (HP05/07). The concrete foundation (HP05/04) of the prefabricated building was exposed in the trench and was at a depth of 0.45m, it was sealed below (HP05/02 & HP05/03), but no foundation cut was visible in HP05/05, HP05/06 or HP05/07 suggesting that these were deposited after the construction of the building and fill the foundation trench for this building. The Natural subsoil was not reached and no archaeological deposits or features were identified.

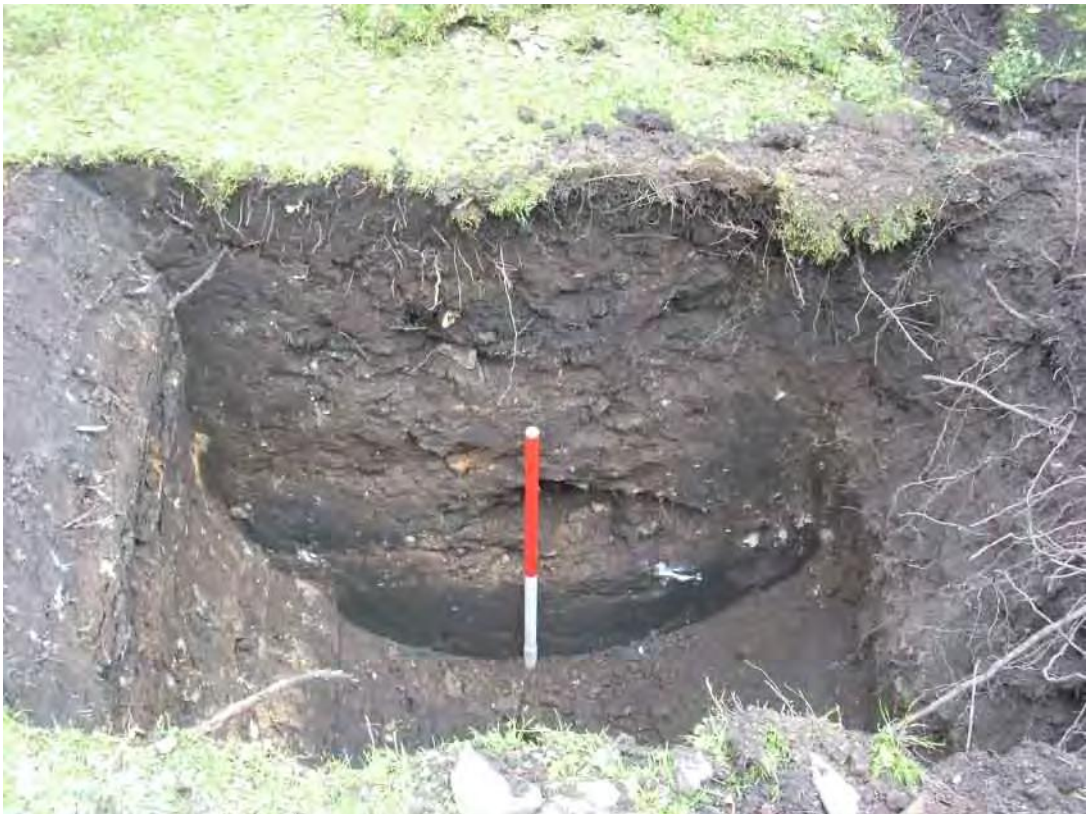
Fig. 11 Section of TP02

- 3.3.1 Trial Pit 1 (TP01; Fig. 11) was located to the south of the prefabricated building on a landscaped area surfaced with grass and was dug under archaeological supervision to natural undisturbed subsoil (1.6m). Topsoil (TP01/01) 0.6m thick overlay a discontinuous 0.1m thick layer of pale crushed sandstone (TP01/02). This in turn overlay a 0.5m thick layer of made ground (TP01/03) comprising soil and rubble underlay. A 0.6m thick layer of darker soil (TP01/04) underlay this and overlay natural subsoil (000) which was coarse sandy gravel with occasional larger stones. The dark soil (TP01/04) may be topsoil indicating an earlier surface of the site buried

underneath more recent landscaping. No archaeological deposits or features were identified.

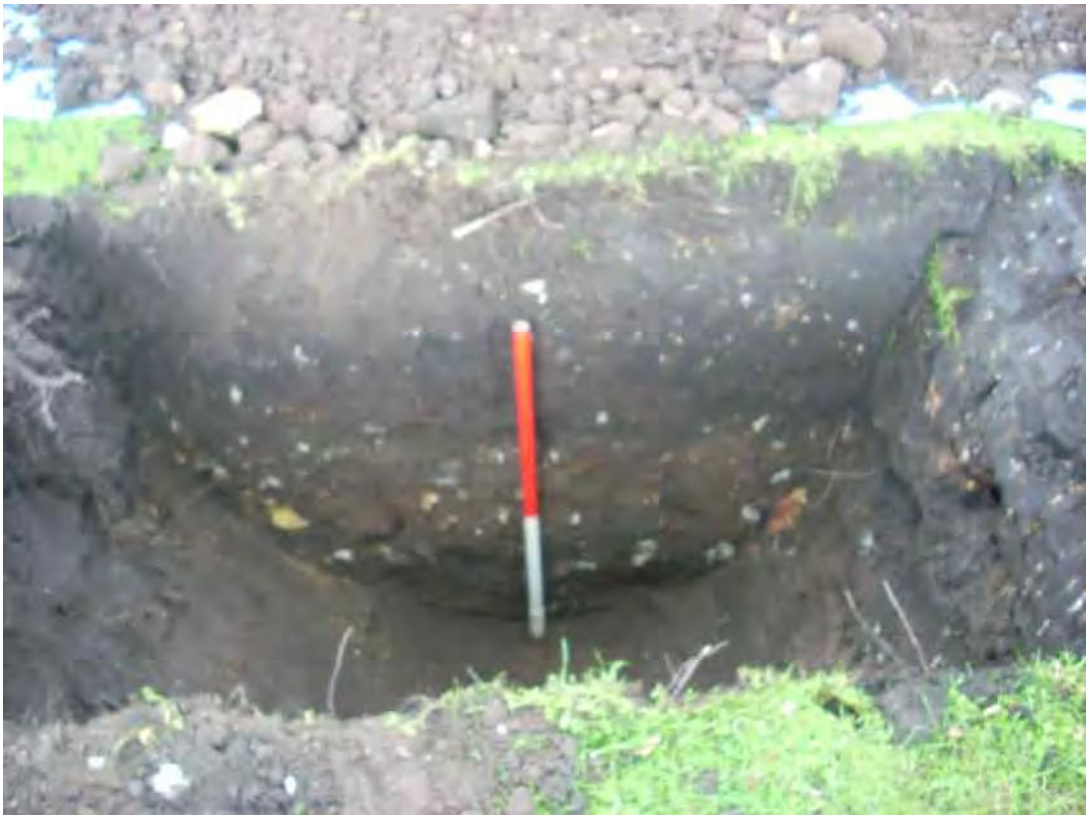
Fig. 12 Section of TP03

3.3.3 Trial Pit 3 (TP03; Fig. 12) was located to the south-east of the prefabricated building on a grass surfaced landscaped area close to large mature trees. Topsoil (TP03/01) was 0.6m deep and overlay 0.4m made ground (TP03/02) comprising soil and rubble. A 0.6m thick dark soil layer (TP03/03) underlay the made ground and overlay natural subsoil (000). The dark soil most likely represents the old ground surface prior to landscaping works and the deposition of made ground. Natural subsoil (000) was coarse sandy gravel with occasional large stones. No archaeological deposits or features were identified.

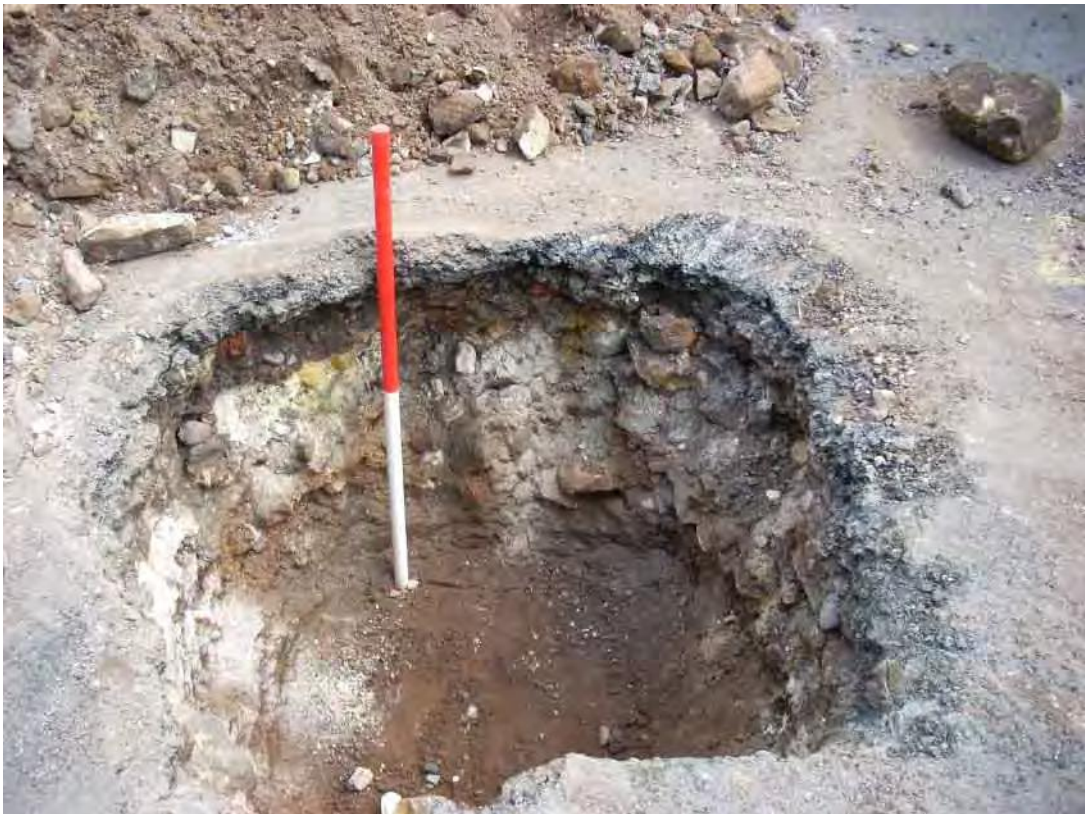
Fig. 13 Section of BH01

3.4.1 Borehole 1 (BH01; Fig. 13) was located to the south-west of St Catherine's House on a tarmac surfaced driveway. The tarmac surface (BH01/01) was 0.1m thick and overlay 0.15m of Type 1 hardcore (BH01/02). This overlay 0.15m of sandstone rubble (BH01/03) which was bedded on a 0.4m thick layer of made ground comprising mixed coarse sand and soil (BH01/04). Natural subsoil (000) was pale coarse sand and was reached at 0.8m beneath the surface.

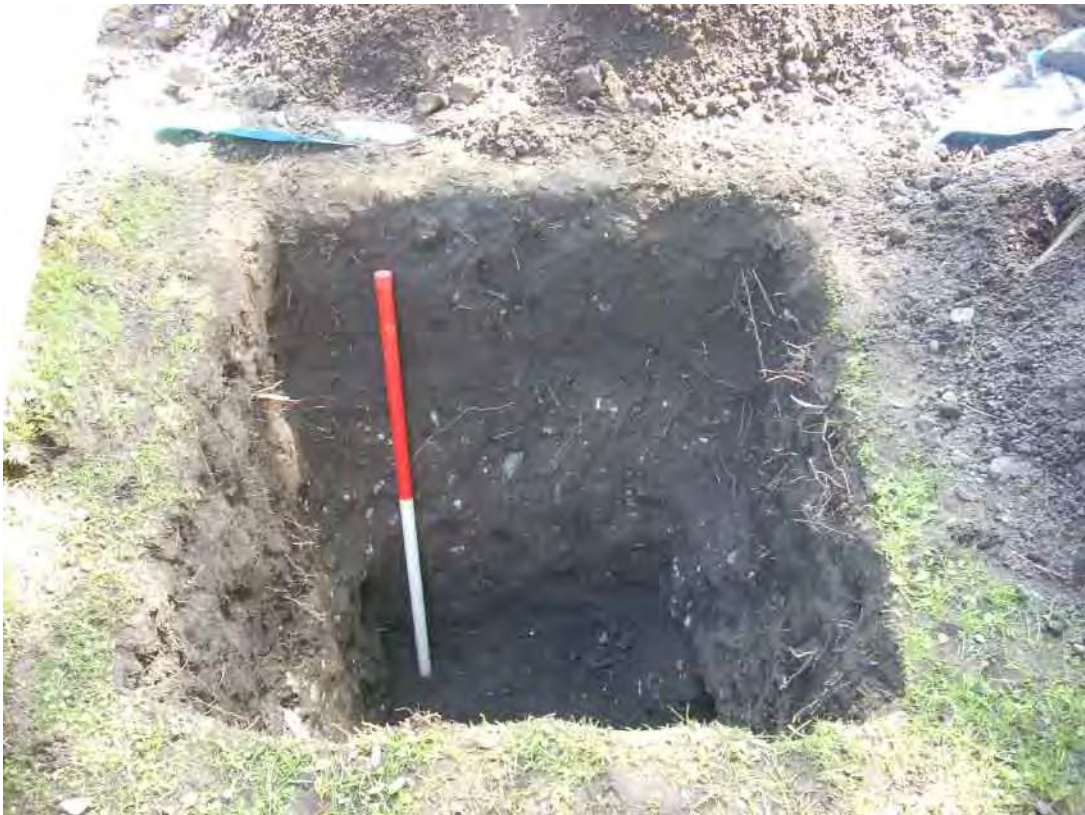
Fig. 14 Section of BH02

3.4.2 Borehole 2 (BH02; Fig. 14) was located to the south of the prefabricated building on a landscaped area surfaced with grass. Topsoil (BH02/01) was 0.45m thick and overlay a 0.5m thick made ground layer (BH02/02) comprising soil and rubble. Dark soil (BH02/03) underlay the made ground to a depth of 0.2m. This layer is likely to be the old ground surface prior to landscaping works. Natural subsoil was reached at 1.15m and no archaeological remains or deposits were identified.
