## **Maybole to Girvan Natural Gas Pipeline, South Ayrshire**

### **Archaeological Evaluation Report No. 1824**

### **Maybole to Girvan Natural Gas Pipeline, South Ayrshire**

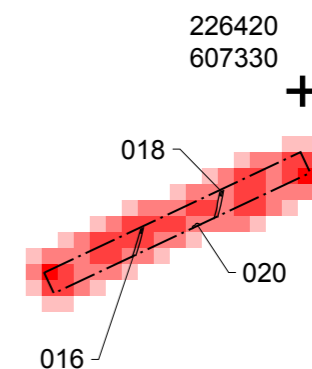
Fig. No: 3 Revision: A

- 4.2.4 The trenches were located to target the possible remains of pits and a burnt mound identified through geophysical survey. The trenches were excavated within a grassy arable field.
- 4.2.5 Trench 3 measured 22.5m by 1.8m and was aligned ENE-WSW. It contained 0.3m of topsoil **(001)** onto natural subsoil **(002)** of mid pinkish-orange sandy clay. Two ceramic field drains **(016, 018)** were identified aligned NNE-SSW. A possible small pit **(020)** was identified in the middle of the trench and half-sectioned; this feature is interpreted as a stone hole due to its irregular nature.
- 4.2.6 Trench 4 measured 22.5m by 1.8m and was aligned NE-SW (Fig. 7). It contained 0.3m of topsoil **(001)** onto natural subsoil **(002)** of pinkish-orange sandy clay. One ceramic field drain **(023)** was identified aligned NNE-SSW.

Title:  
Detailed trench plan Plot 34

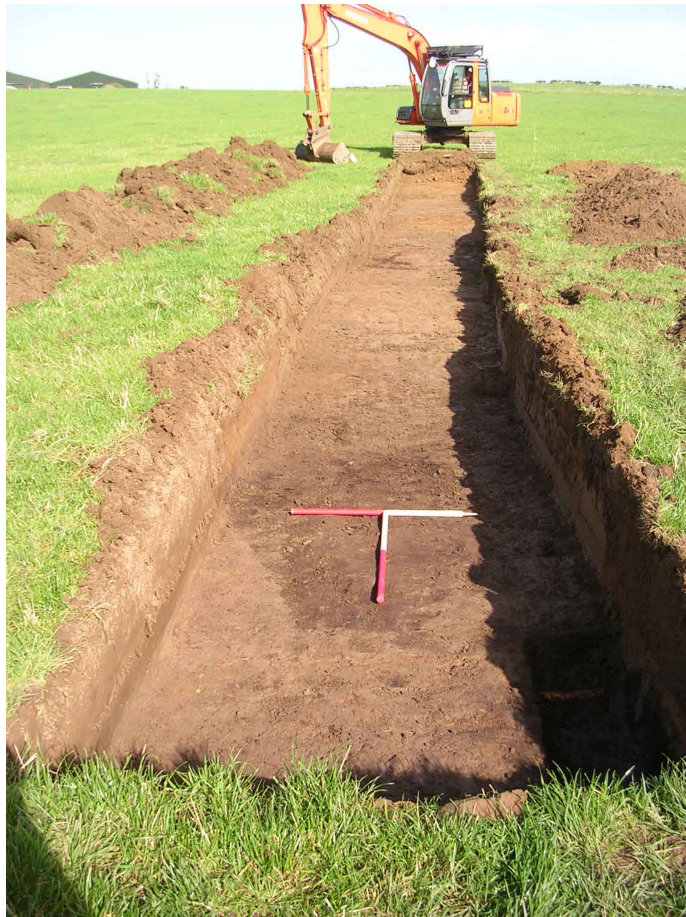
Fig. 5 - Trench 2 from E

- 4.2.3 Trench 2 measured 22.5m by 1.8m and was aligned NE-SW (Fig. 5). It contained 0.3m of topsoil (**001**) onto natural subsoil (**002**) of light orange and grey sandy clay in the north-eastern, upslope, part of the trench. In the south-western part of the trench, topsoil overlay a subsoil deposit (**007**) of mid orange grey brown sandy clay of depth 0.3m. This subsoil deposit extended along the trench for c.9m and overlay a thin deposit (**008**) of brassy orange clayey sand that had possibly undergone iron-panning. This deposit was 0.08m in depth and extended along the trench for c.4m. It overlay a dark brown peaty humic deposit (**009**) of depth 0.2-0.6m which extended along the trench for c.6m (Fig. 6). This deposit was quite waterlogged and contained large amounts of rooty material. It overlay natural subsoil (**006**), a compact light grey gleyed

clay sand banded with compact silty sands. Both **(009)** and **(006)** are possibly the remains of an old watercourse. Two ceramic field drains **(010, 013)**, aligned NW-SE, were identified in the south-western part of the trench and were cut through deposits **006-009** (Fig. 3).

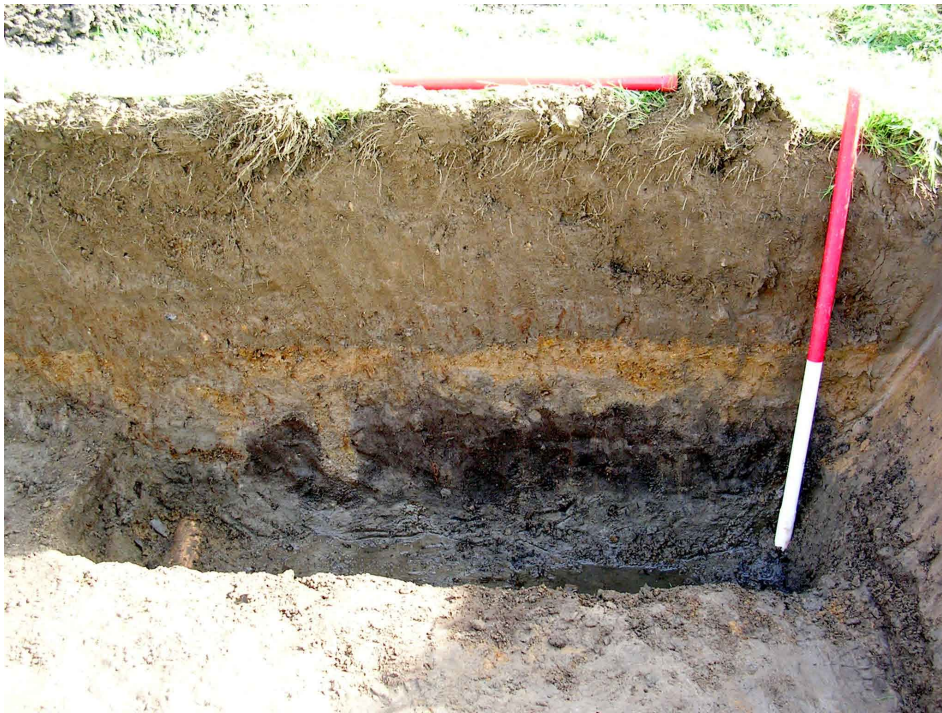
Fig. 6 - Peat deposit in SW end of Tr. 2

- 5.4 In Plots 28/29 the trenches were relocated due to a reroute of the pipeline at this location and so the trenches were not excavated directly over the identified anomalies (possible pits and a burnt mound) but were adjacent to them. These anomalies therefore were not tested. Ceramic field drains were identified and, within Trench 2, a natural deposit of peat was identified in a waterlogged area which may be an old watercourse.

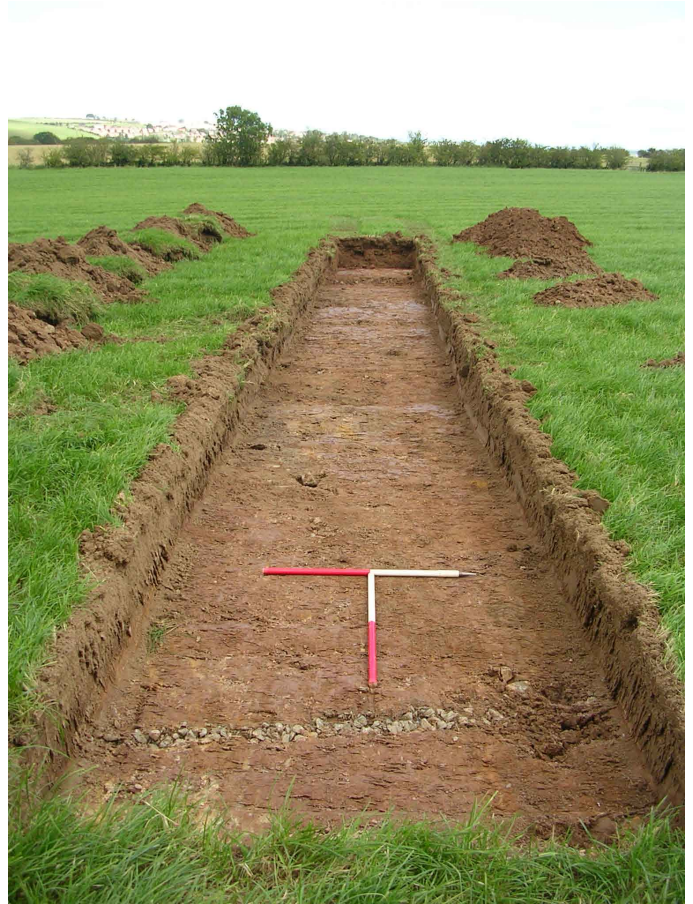
Fig. 8 - Trench 5 from SW

- 4.2.8 Trench 5 was aligned NE-SW and contained 0.32m of topsoil **(001)** onto natural subsoil **(002)** of mid reddish orange brown sandy clay (Fig. 8). Four field drains were identified within the trench **(040, 042, 044, 047)**. These were either filled with Type 1 gravel or with angular quarried stone. Drain **044** also contained a yellow plastic pipe at its base and is the approximate location and alignment of the geophysical anomaly identified for this trench (Fig. 9). A small sondage was excavated in the north-eastern end of the trench to a depth of 0.85m by 3m long to check the natural subsoil.

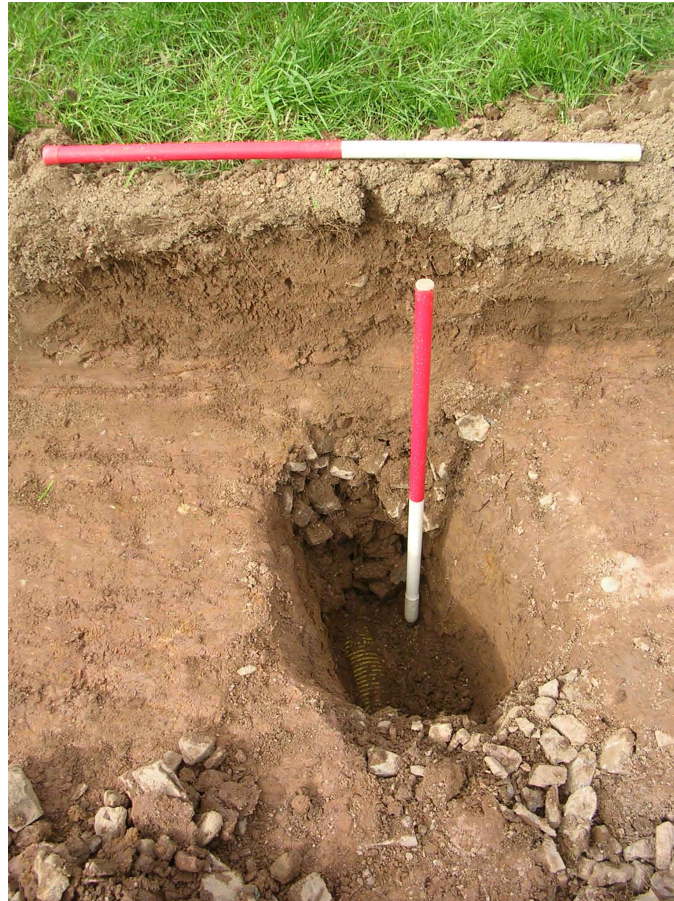
Title: Section through drain [44], Trench 5

043	5	Fill of [043]	Type 1 gravel
044	5	Cut of field drain	Linear, aligned SSE-NNW
045	5	Fill of [044]	Medium angular quarried stone with 10% mixed topsoil and re-deposited natural subsoil matrix
046	5	Pipe in [044]	Yellow plastic
047	5	Cut of field drain	Linear, aligned NNE-SSW
048	5	Fill of [047]	Medium angular quarried stone with 20% mixed topsoil and re-deposited natural subsoil matrix and waterlogged root inclusions
049	7		Stone hole
050	7		Stone hole
051	7		Stone hole
