Whiteside Pipeline Diversion, Bathgate, West Lothian

Archaeological Watching Brief

Report No. 1828

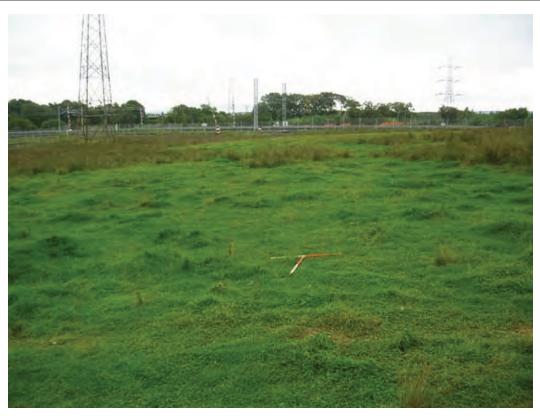
Fig. 2 General pre-excavation view of the site

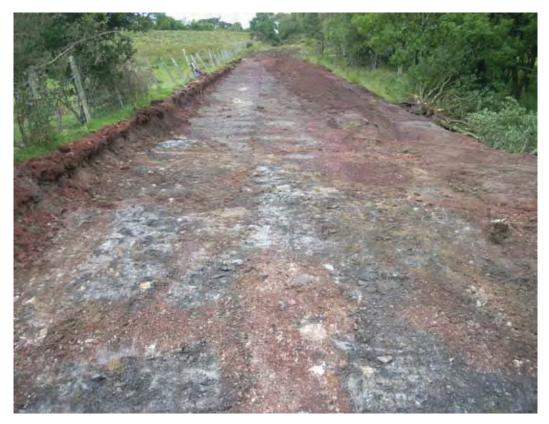
3.2.1 The access track which ran from the B708 to the area of the pipeline diversion on the north side of the Airdrie to Bathgate railway ran along the length of RSK Site 13. This is a former railway embankment which first appears on the Ordnance Survey Second Edition map of 1898. The topsoil (**001**) along the route of the track consisted of 0.1m - 0.2m depth of mid grey-brown sandy silt. This overlaid a railway formation layer consisting of a purple-red gravel, crushed stone and shale (003).

Fig. 3 View of access track with exposed railway formation level on RSK Site 13

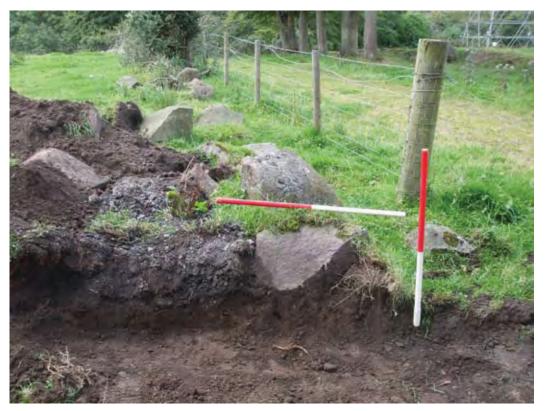
- 3.2.4 A third linear field bank (014) (Fig. 4) was truncated by a 4m wide wayleave for the access track. The bank was 1.2m wide and 0.6m high and consisted of large stones set within a topsoil bank. It is probably the remains of a heavily degraded drystone wall.

Fig. 4 NE-facing section through field bank 014

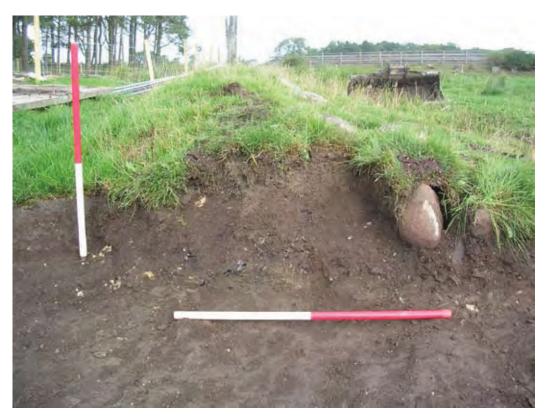
- 3.2.5 A fourth field bank (017) measured 1.4m wide by 0.3m high and consisted of a topsoil core containing flecks of coal and white ceramic inclusions.

Fig. 5 SSE-facing section through field bank 017
