**New Student Accommodation,
Heriot Watt University, Riccarton Campus,
Edinburgh**

**Archaeological Evaluation
Report No. 1831**

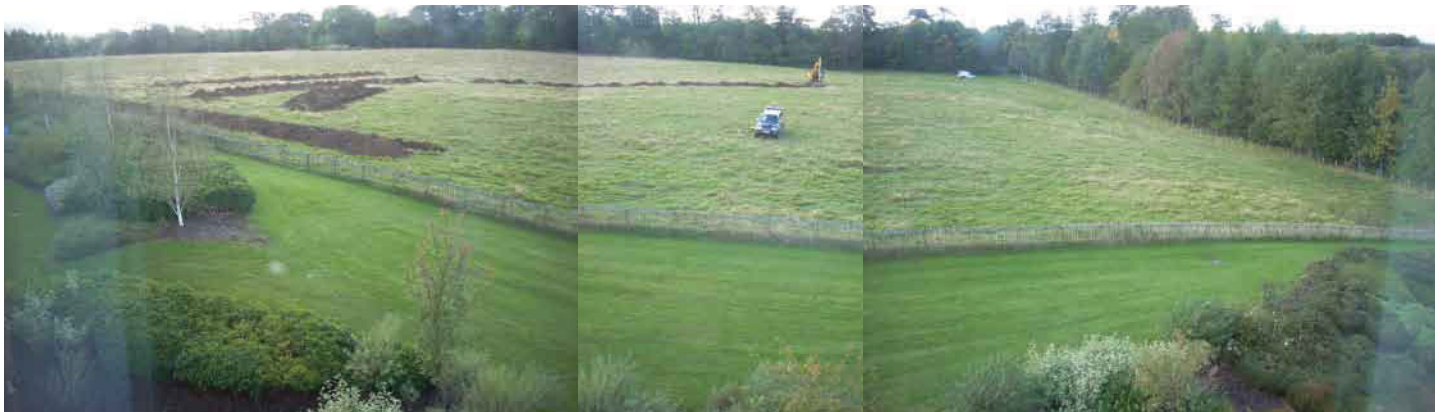
- 3.1.2 Twelve trenches were excavated, covering 1101m² (Fig. 1). This represents slightly over 10% of the 1.05 hectare site.
- 3.1.3 The site (Fig. 2) is currently uncultivated grassland. A moderate north-west facing slope in the north-western half of the site gives way to a slight slope to the south-east. Existing student accommodation lies to the north-east, with shelter belt woodland to the north-west. The remaining boundaries are undefined.

Fig. 2 Panorama of the site from the existing student accomodation to the east

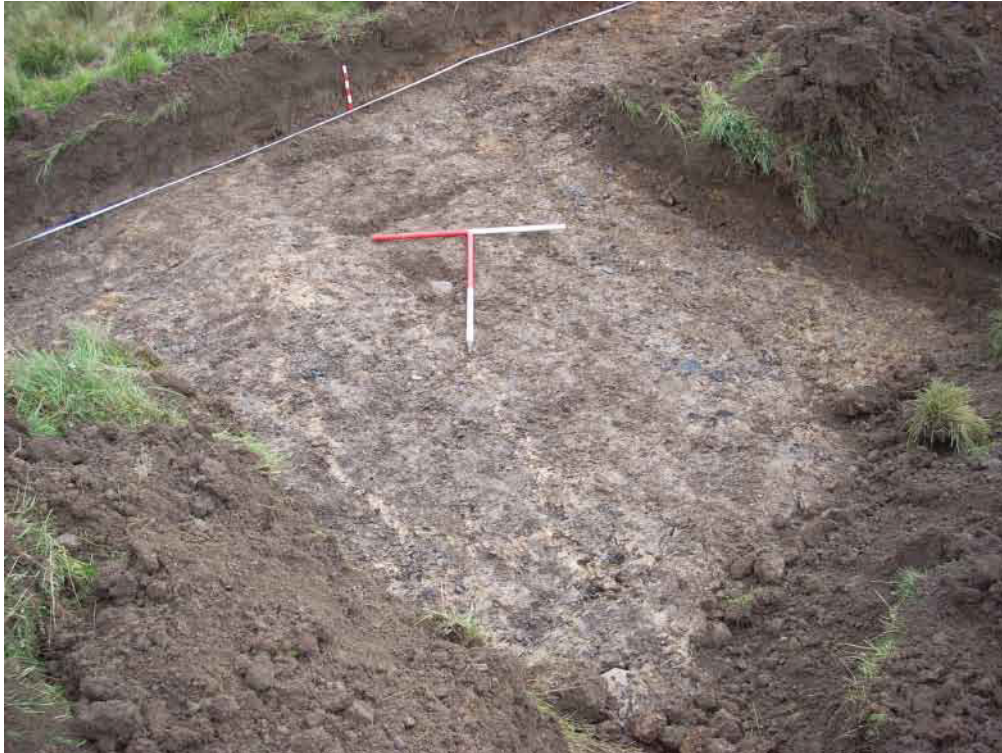
- 3.2.2 Trench 5 (Figs. 1, 3) contained a single furrow (**501**). This was aligned NNW-SSE and measured 1.1m in maximum width and 0.1m in depth. It was filled (**502**) with a yellow-grey-brown clay-silt and was sealed by the subsoil (**002**). No finds were recovered.

Fig. 3 Rig and furrow 501 from the north

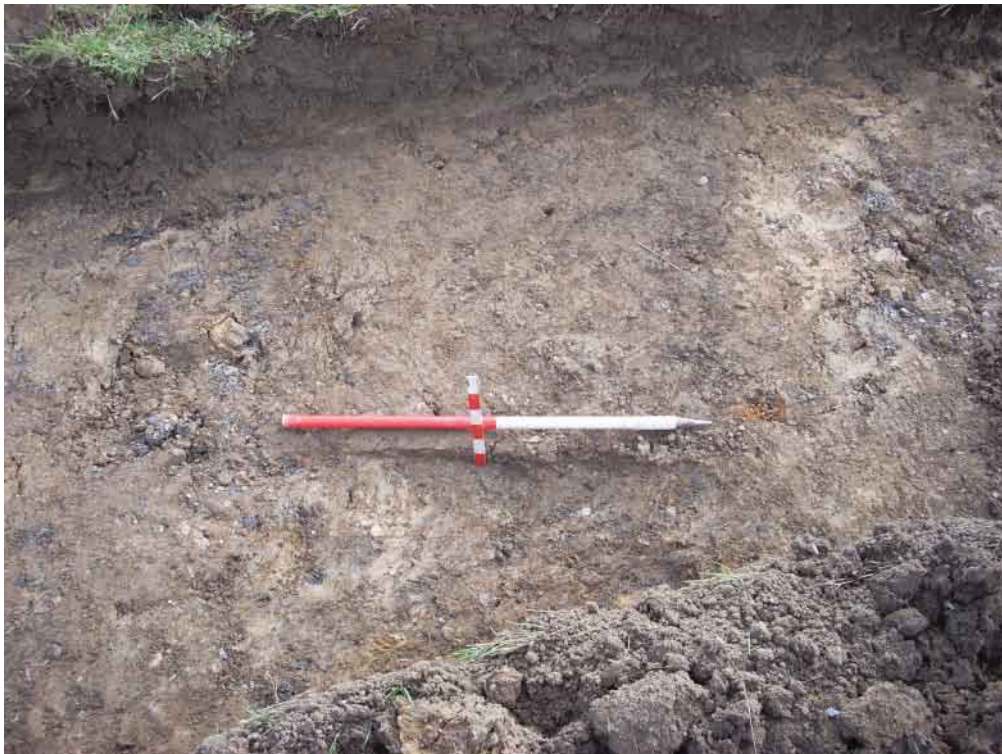
- 3.2.3 Trench 8 (Figs. 1, 4) contained 5 furrows (**800, 801, 804, 806, 808**). These were aligned NNW-SSE and varied between 1m and 2.75m in width. Furrow (**801**) was 0.1m deep. Distances between individual furrows (centre to centre) were around 7m. All the furrow features were filled with a yellow-grey-brown clay-silt and were sealed by the subsoil (**002**) where this was present. No finds were recovered.

Fig. 4 Rig and furrow 801 from the south
