Smeaton Barn, Preston Mains Farm Historic Building Appraisal

Report No. 1838

CFA ARCHAEOLOGY LTD

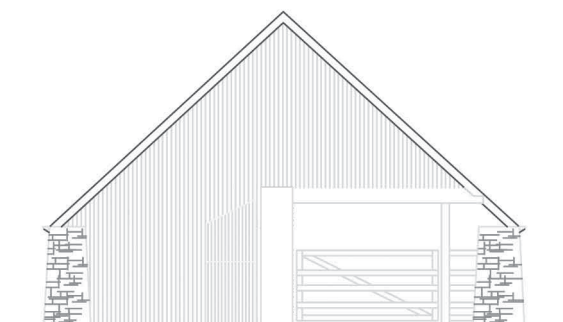
Fig 3c. Existing East Elevation before the timber cladding was removed

- 3.2.3 The east-facing elevation is open-ended with a series of softwood planks attached to the top half of the A-frame roof joist which rests on a softwood timber wall plate carried on two drum piers. Architectural drawings show that at the time that these were produced, the east elevation was boarded with planks with a gated opening situated on the north side of the gable. A plank-

built door was situated on the south side of the partition wall. These features no longer survive.

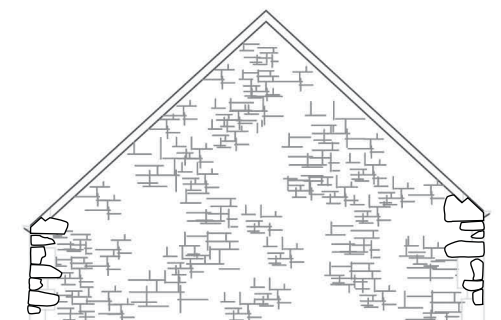
Fig 3e. Existing West Elevation

- 3.2.5 The west-facing elevation comprises the main gable which is pitched and is 1.9m high at the corners and rising to 6m high at its apex. The ridge is covered with sandstone coping stones and the quoins and skewputs are dressed cream sandstone. The gable incorporates both sub-angular and angular whinstone and occasional sandstone (average 0.2m by 0.15m) bonded with lime mortar. Four dressed blocks of Old Red Sandstone have been used to form the apex of the gable. The corners of the gable incorporate two drum piers. The gable has been underpinned with concrete in an attempt to stabilise it.

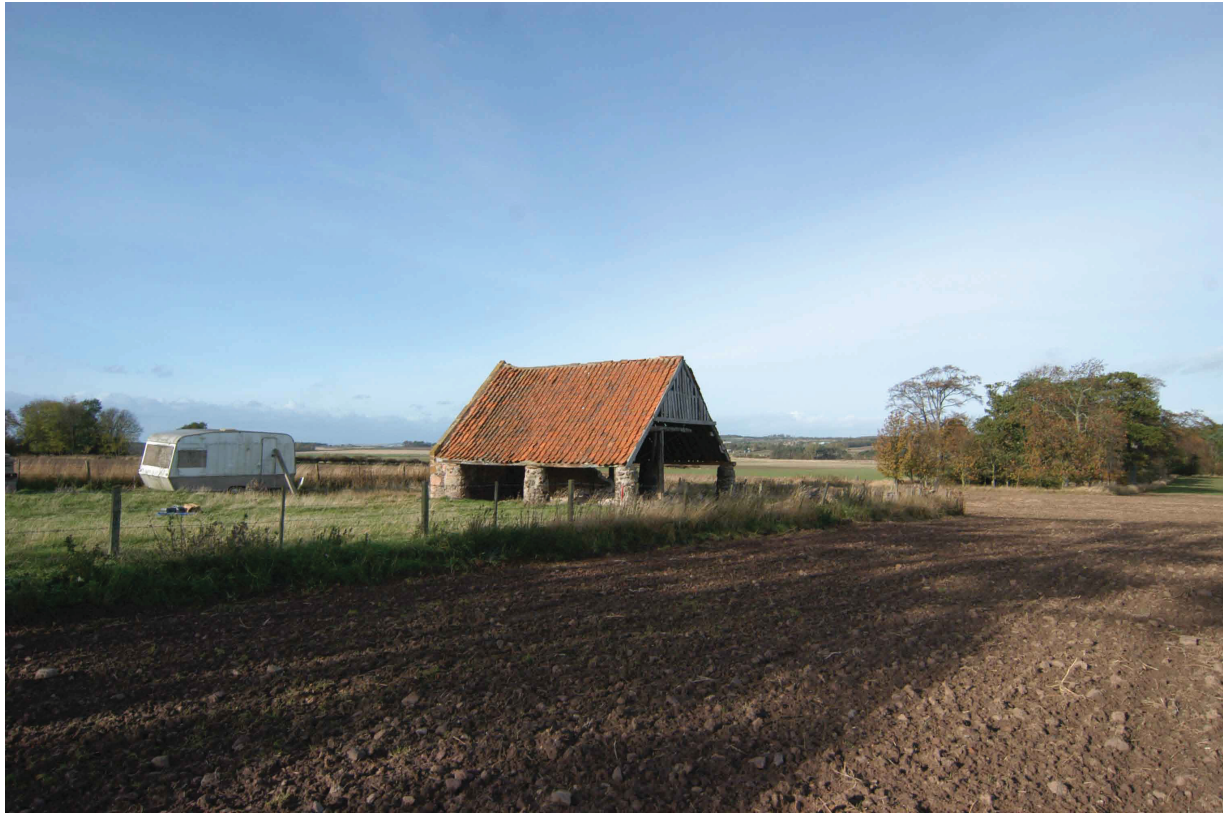
1.1.2 The barn is a single storey detached structure situated within a strip of land currently used for rough grazing (Plate 1). The barn is more or less square in plan and open on three sides. Its principal features include a main rubble-built gable with ashlar quoins and six rubble-built round piers that support the A-frame joists and pantile roof. A partition wall occupies the centre of the barn and this has been partly reduced in length in the recent past.

Plate 1, Smeaton barn in its topographical setting

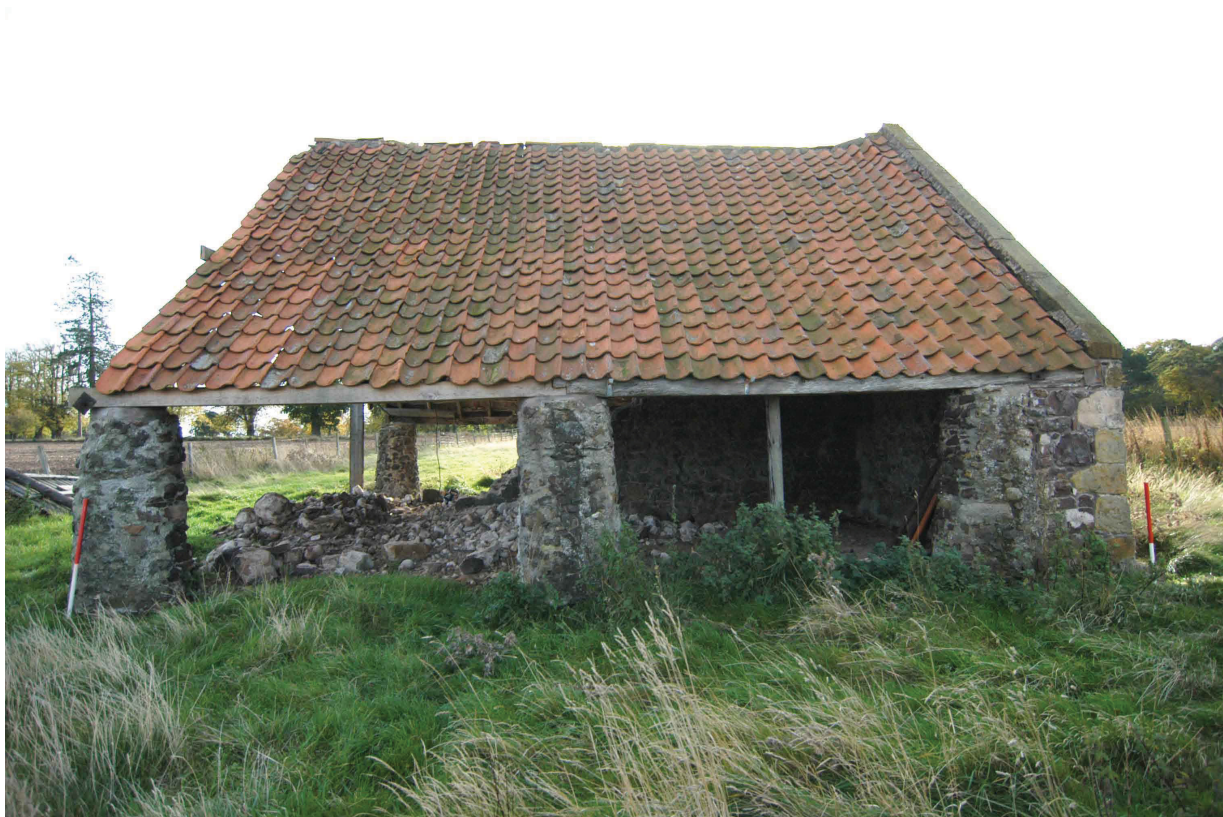
- 3.2.2 The north-facing elevation measures 9m long and has two bays formed between the three drum piers which each support a softwood wall plate which in turn supports the pantile roof. The pier at the west end has been incorporated into the main gable. The piers are 1.6m high and constructed of random rubble and have been underpinned with concrete. The gable ridge has sandstone copings and the ashlar quoins are all yellow sandstone.

Plate 2. North-facing elevation of the barn

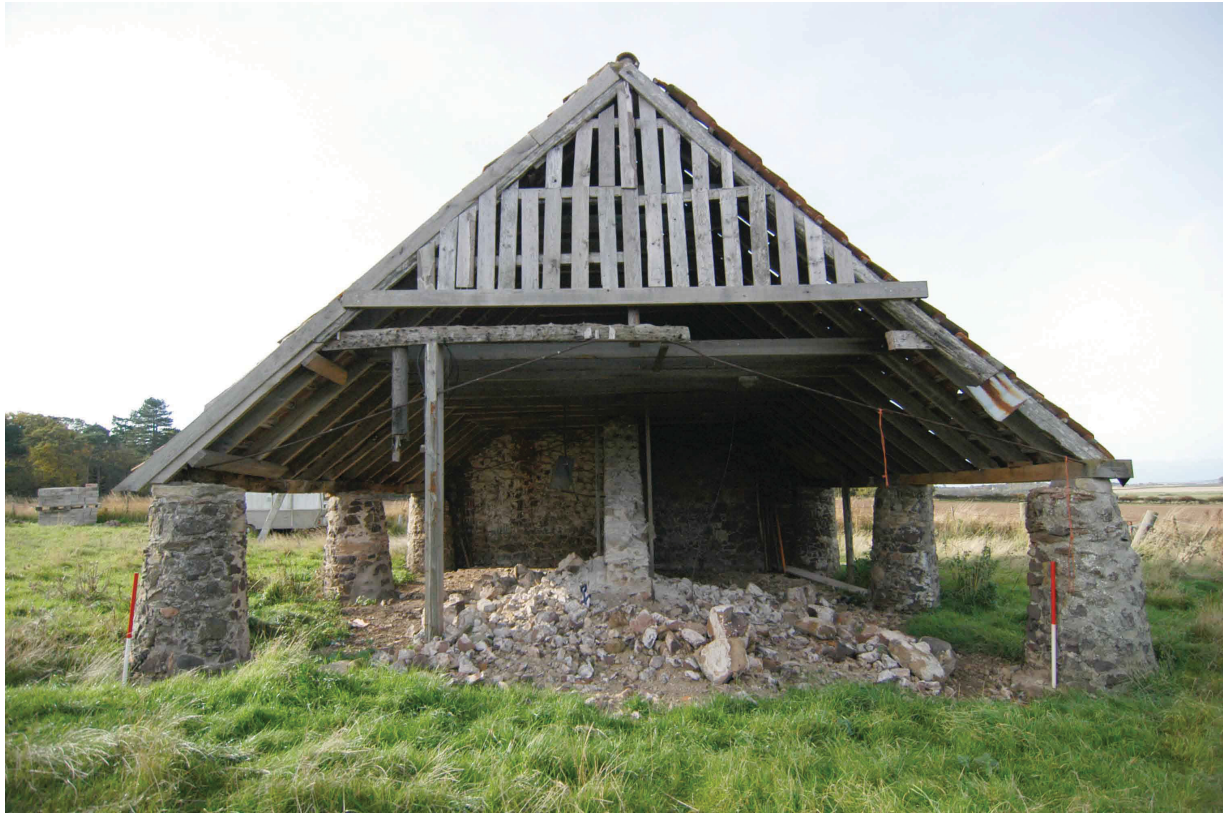
Plate 3. East-facing elevation of the barn

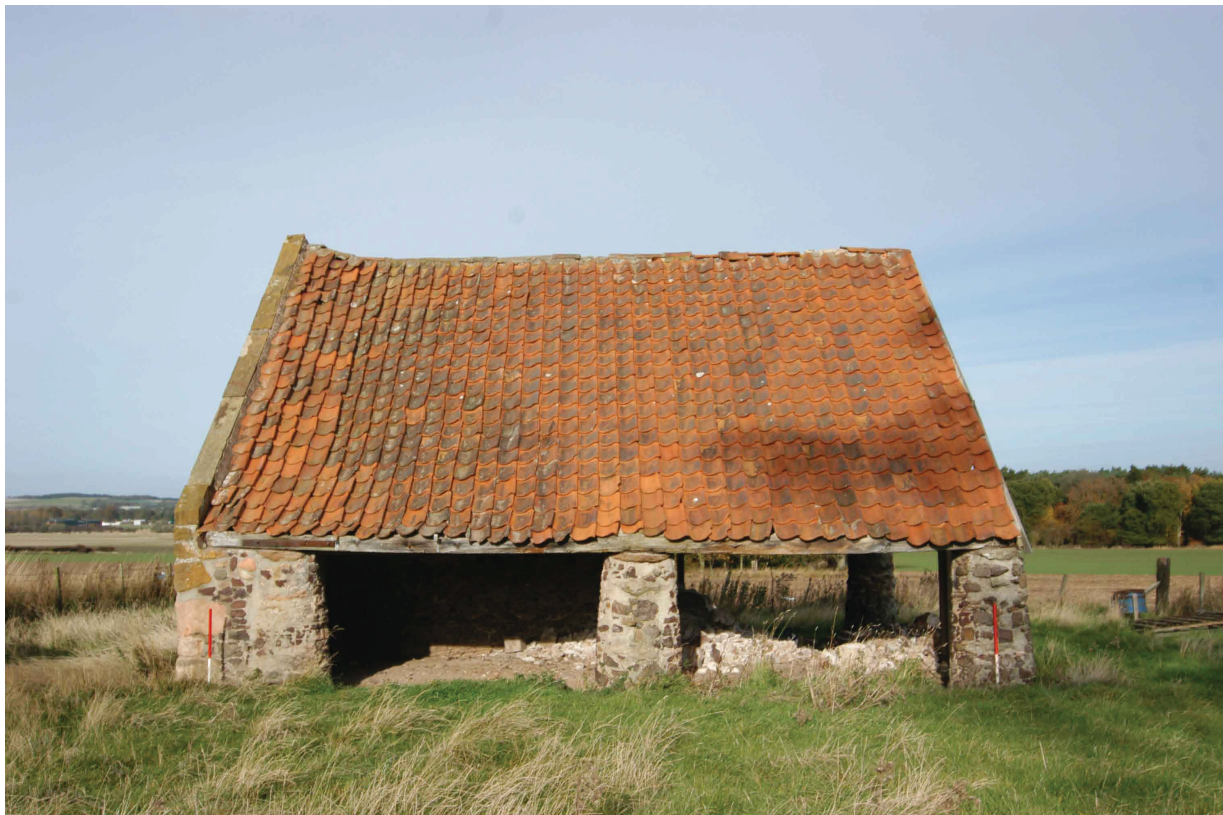
- 3.2.4 The south-facing elevation measures 9m long and has two bays formed between the three drum piers which support a softwood wall plate which in turn supports the pantile roof. The drum pillar at the east end has been incorporated into the main gable. The piers are 1.6m high and constructed of random rubble and have been underpinned with concrete. The gable ridge has sandstone copings and the ashlar quoins are all yellow sandstone.

Plate 4. South-facing elevation of the barn

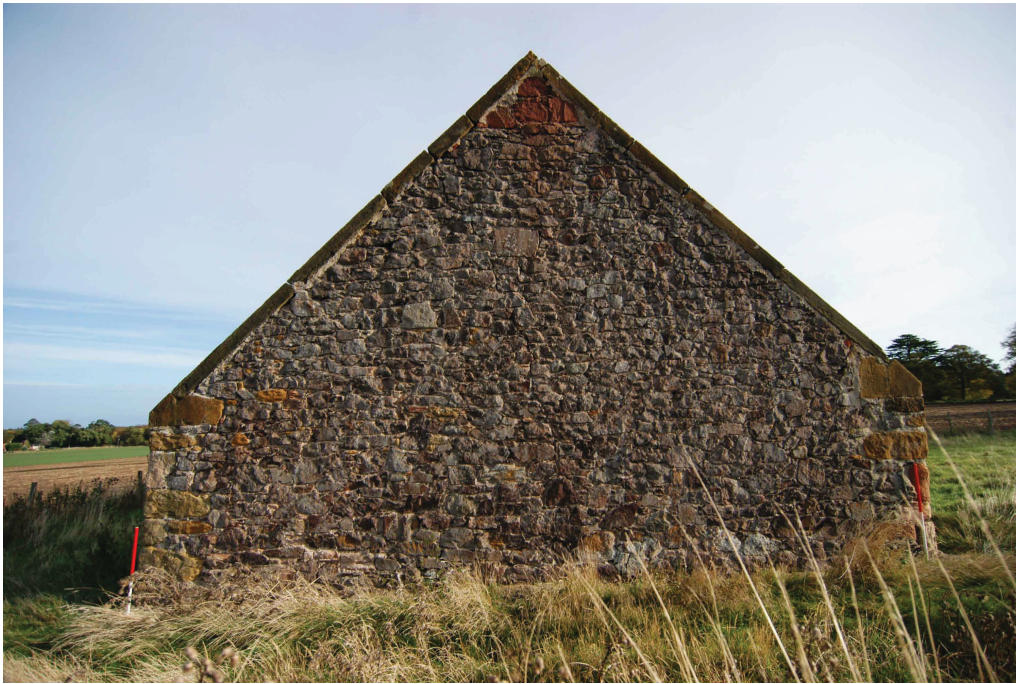
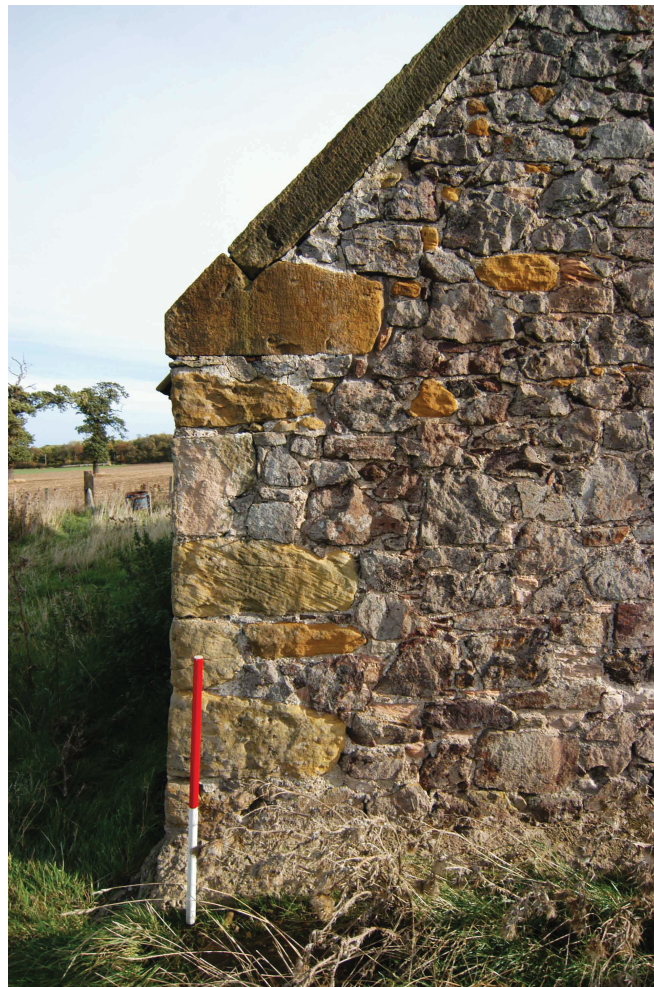
Plate 5. West-facing gable of the barn

Plate 6. West-facing gable, quoin detail

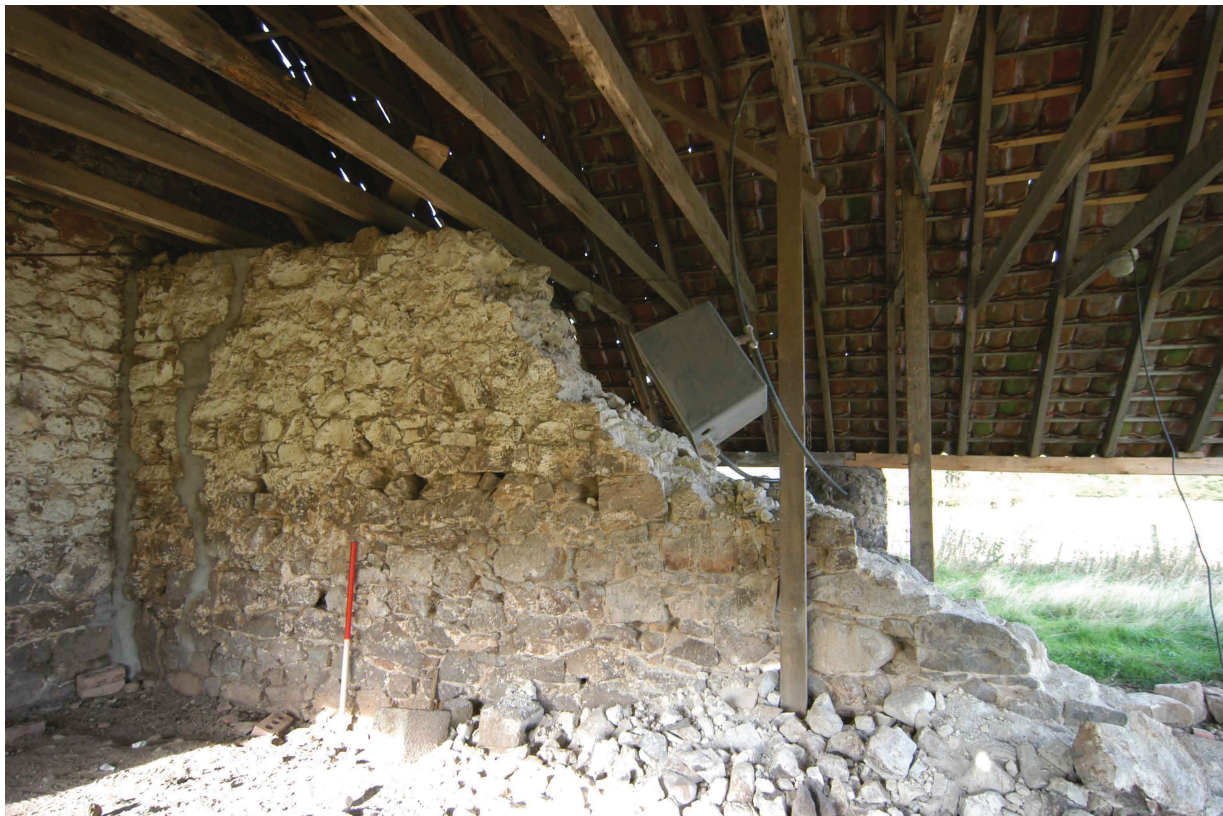
- 3.2.6 The central partition wall measures 6m long and 2.8m high and 0.6m wide. The wall is constructed of random rubble bonded with lime mortar and has been whitewashed. The wall abuts the gable at the west end. At the east end the wall has been reduced in height to about 0.2m. The wall head is 0.1m below the A-frame roof joists. On the south side of the wall, 1m above the floor is a line of crude sockets probably marking the position of wooden stalling.

Plate 7. East-facing interior wall of the west gable and adjoining central partition wall

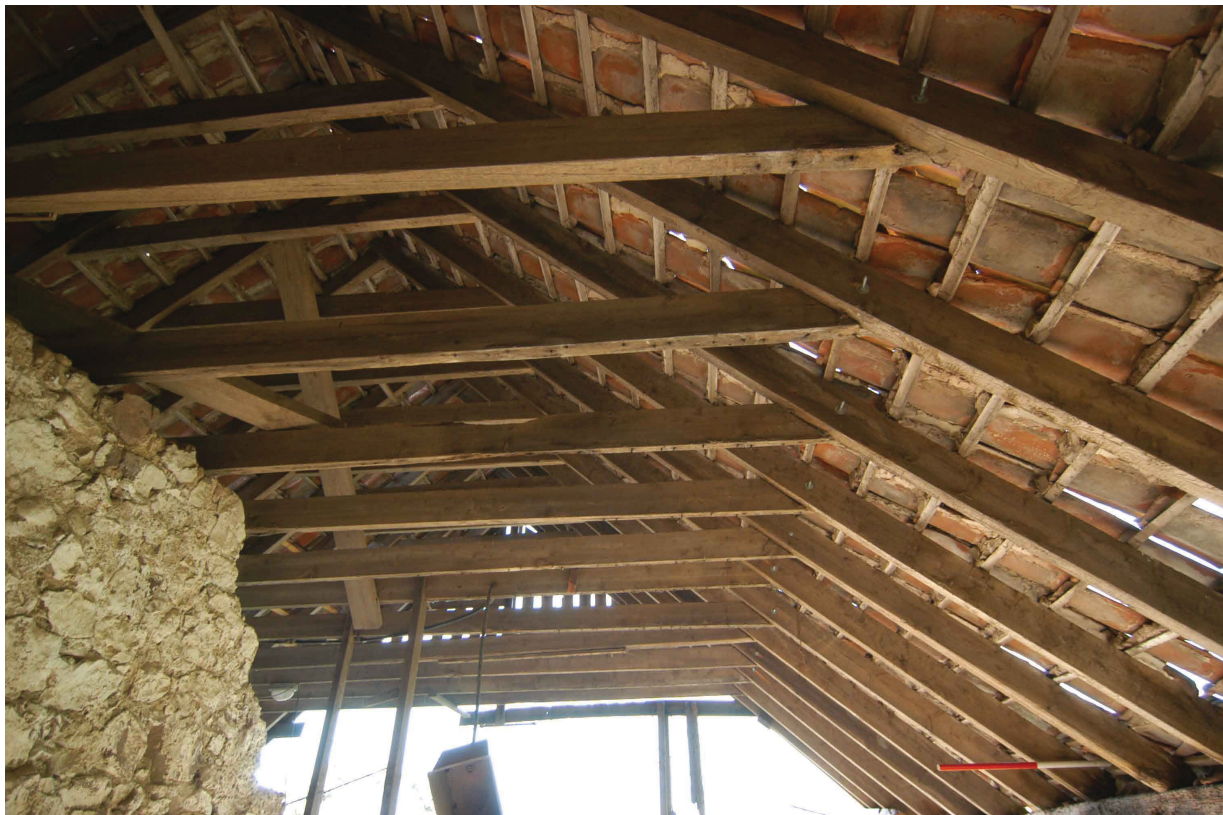
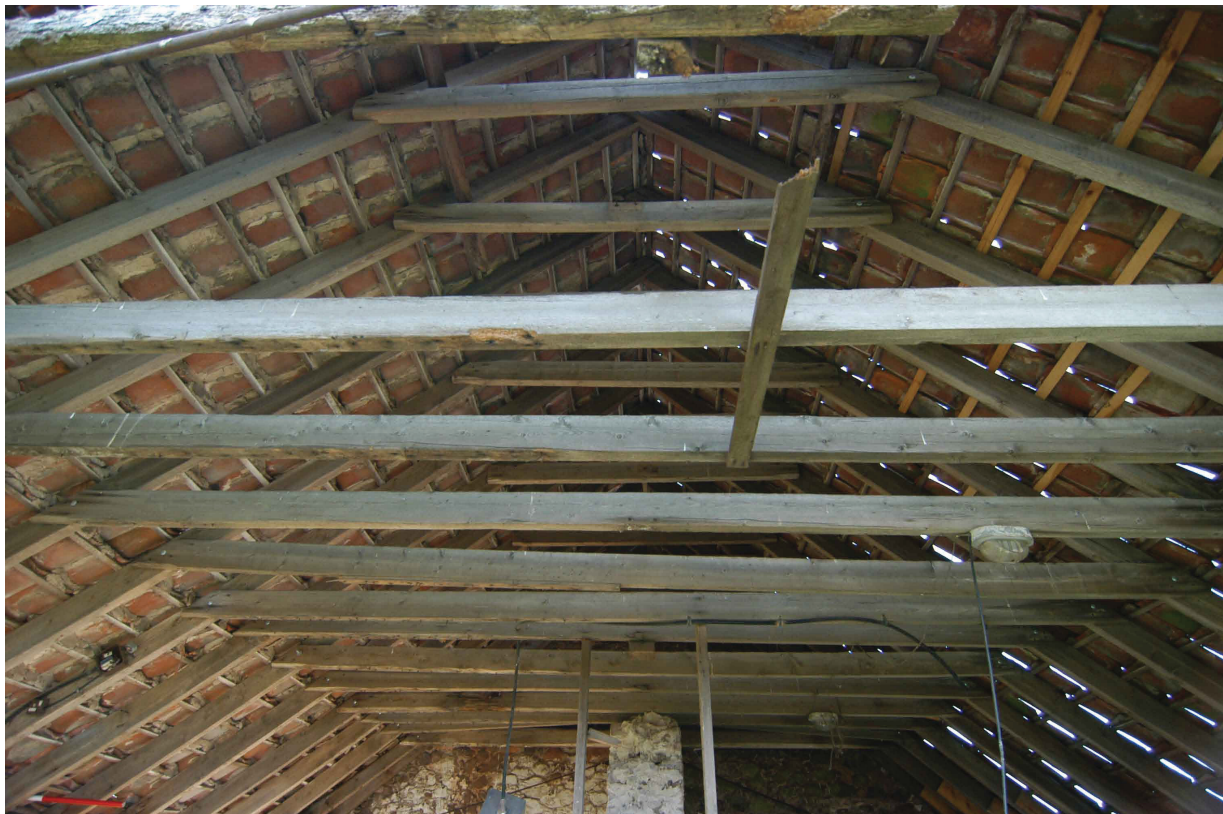
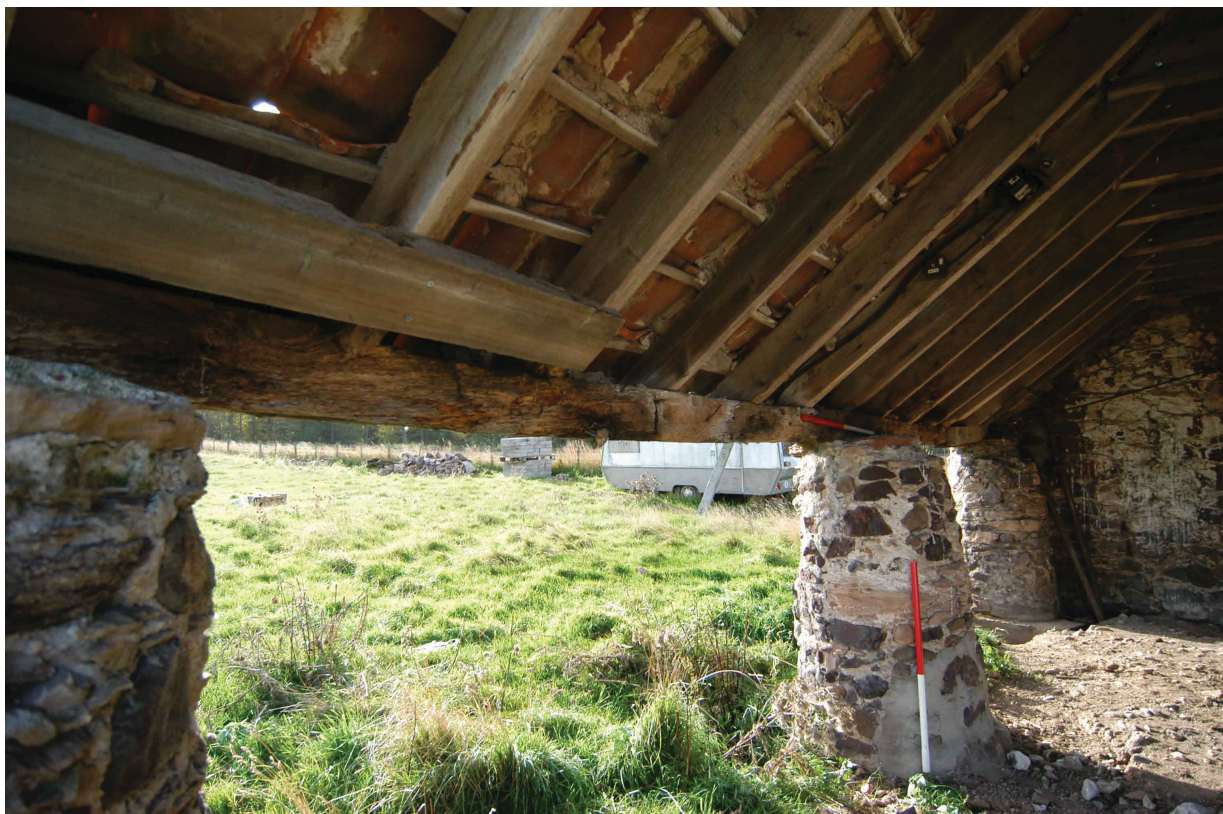
- 3.2.7 The roof comprises thirteen softwood A-frame trusses with nailed scarf-jointed collars. Roof batons run transversely across the rafters which support the pan tiles. The trusses rest directly on top of the timber wall plates which in turn are carried by the drum piers.

Plate 8. South-facing elevation of the central partition wall and scarf-joint details on the tie beam

Plate 9. General view of the A-frame roof joists

Plate 10. North-facing elevation, middle pier and wall plate
