## **Arecleoch Windfarm Grid Connection Archaeological Mitigation Works**

**Report No. 1834**

Author	Stuart Mitchell MA AIfA
Illustrator	Graeme Carruthers MA MAAI&S
Editor	Melanie Johnson MA PhD FSA Scot MIfA
Commissioned by	Scottish Power Power Systems
Date issued	January 2011
Version	0
OASIS Reference	cfaarcha1-90979
Planning Application No	-
Grid Ref	NX 1821 8048 – NX 2376 8600

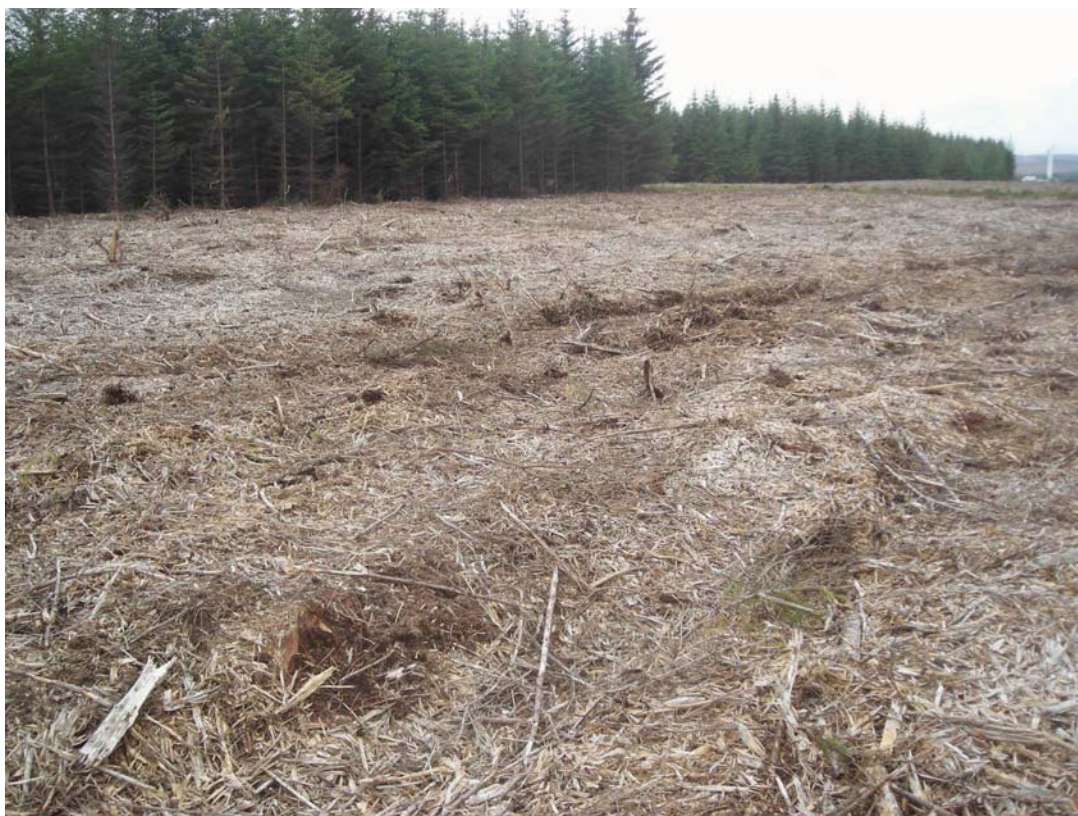
Figure 10: General view of felled area in Arecleoch Forest

- 3.3.1 A post-felling walkover survey was undertaken along the felled wayleave in Arecleoch Forest and on Craiggannochie Hill during August 2010 in clear weather. The felled wayleave in each area had a thick surface covering of brash and mulch (Fig. 10) and the ground had been heavily disturbed by tree furrows. Previously identified sites are listed in Table 1.

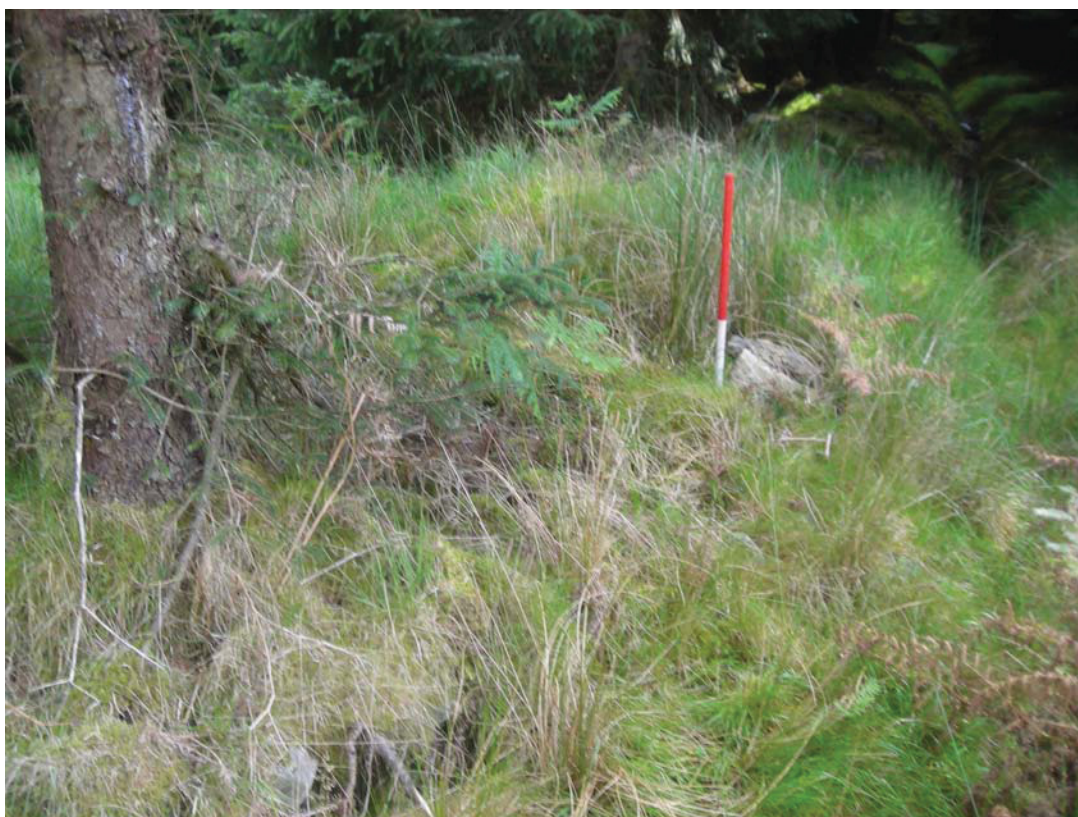
Figure 11: Site 30a

- 3.3.2 Sites 30a and 30b were revealed outside of the wayleave and separated from it by a long dry stone wall. Both sites were as described in the gazetteer although both are heavily overgrown and compromised by forestry planting (Fig. 11). It was not considered necessary to demarcate these sites as they lay outside of the wayleave and were protected by the stone wall.
- 3.3.3 The recorded locations of Sites 30c, 30e and 30g lay within the cable route wayleave, which was covered by a thick layer of brash and mulch. The ground surface had previously been heavily disturbed by tree furrows. No surviving remains of these sites were found.

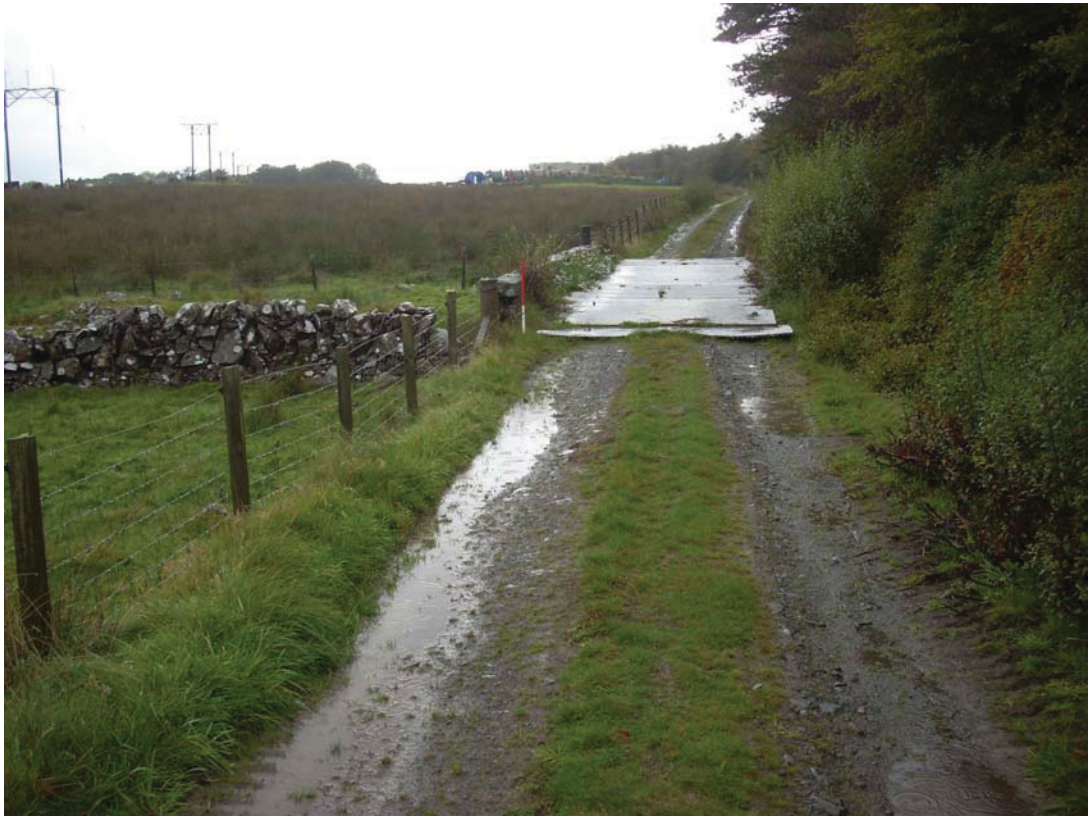
Figure 12: Site 3, bridge

- 3.5.1 Sites 3, 6, 9, 10, 11 and 12 required to be demarcated to prevent damage from construction.
- 3.5.2 It was not possible to mark off Site 3 as this bridge was in use, carrying a farm track over a burn (Fig. 12). This bridge was visited and photographed post construction and no damage had occurred.
- 3.5.3 Site 6, a probable quarry, was buried beneath the site compound and a passing place before it could be demarcated.
- 3.5.5 Site 10, a modern clearance heap containing wooden posts and wire, was pushed aside to make way for a wood pole (Fig. 13). This activity was recorded and no features of archaeological significance were recorded.
- 3.5.6 Sites 9 (a quarry) and 11 and 12 (clearance cairns) were unaffected by construction works.

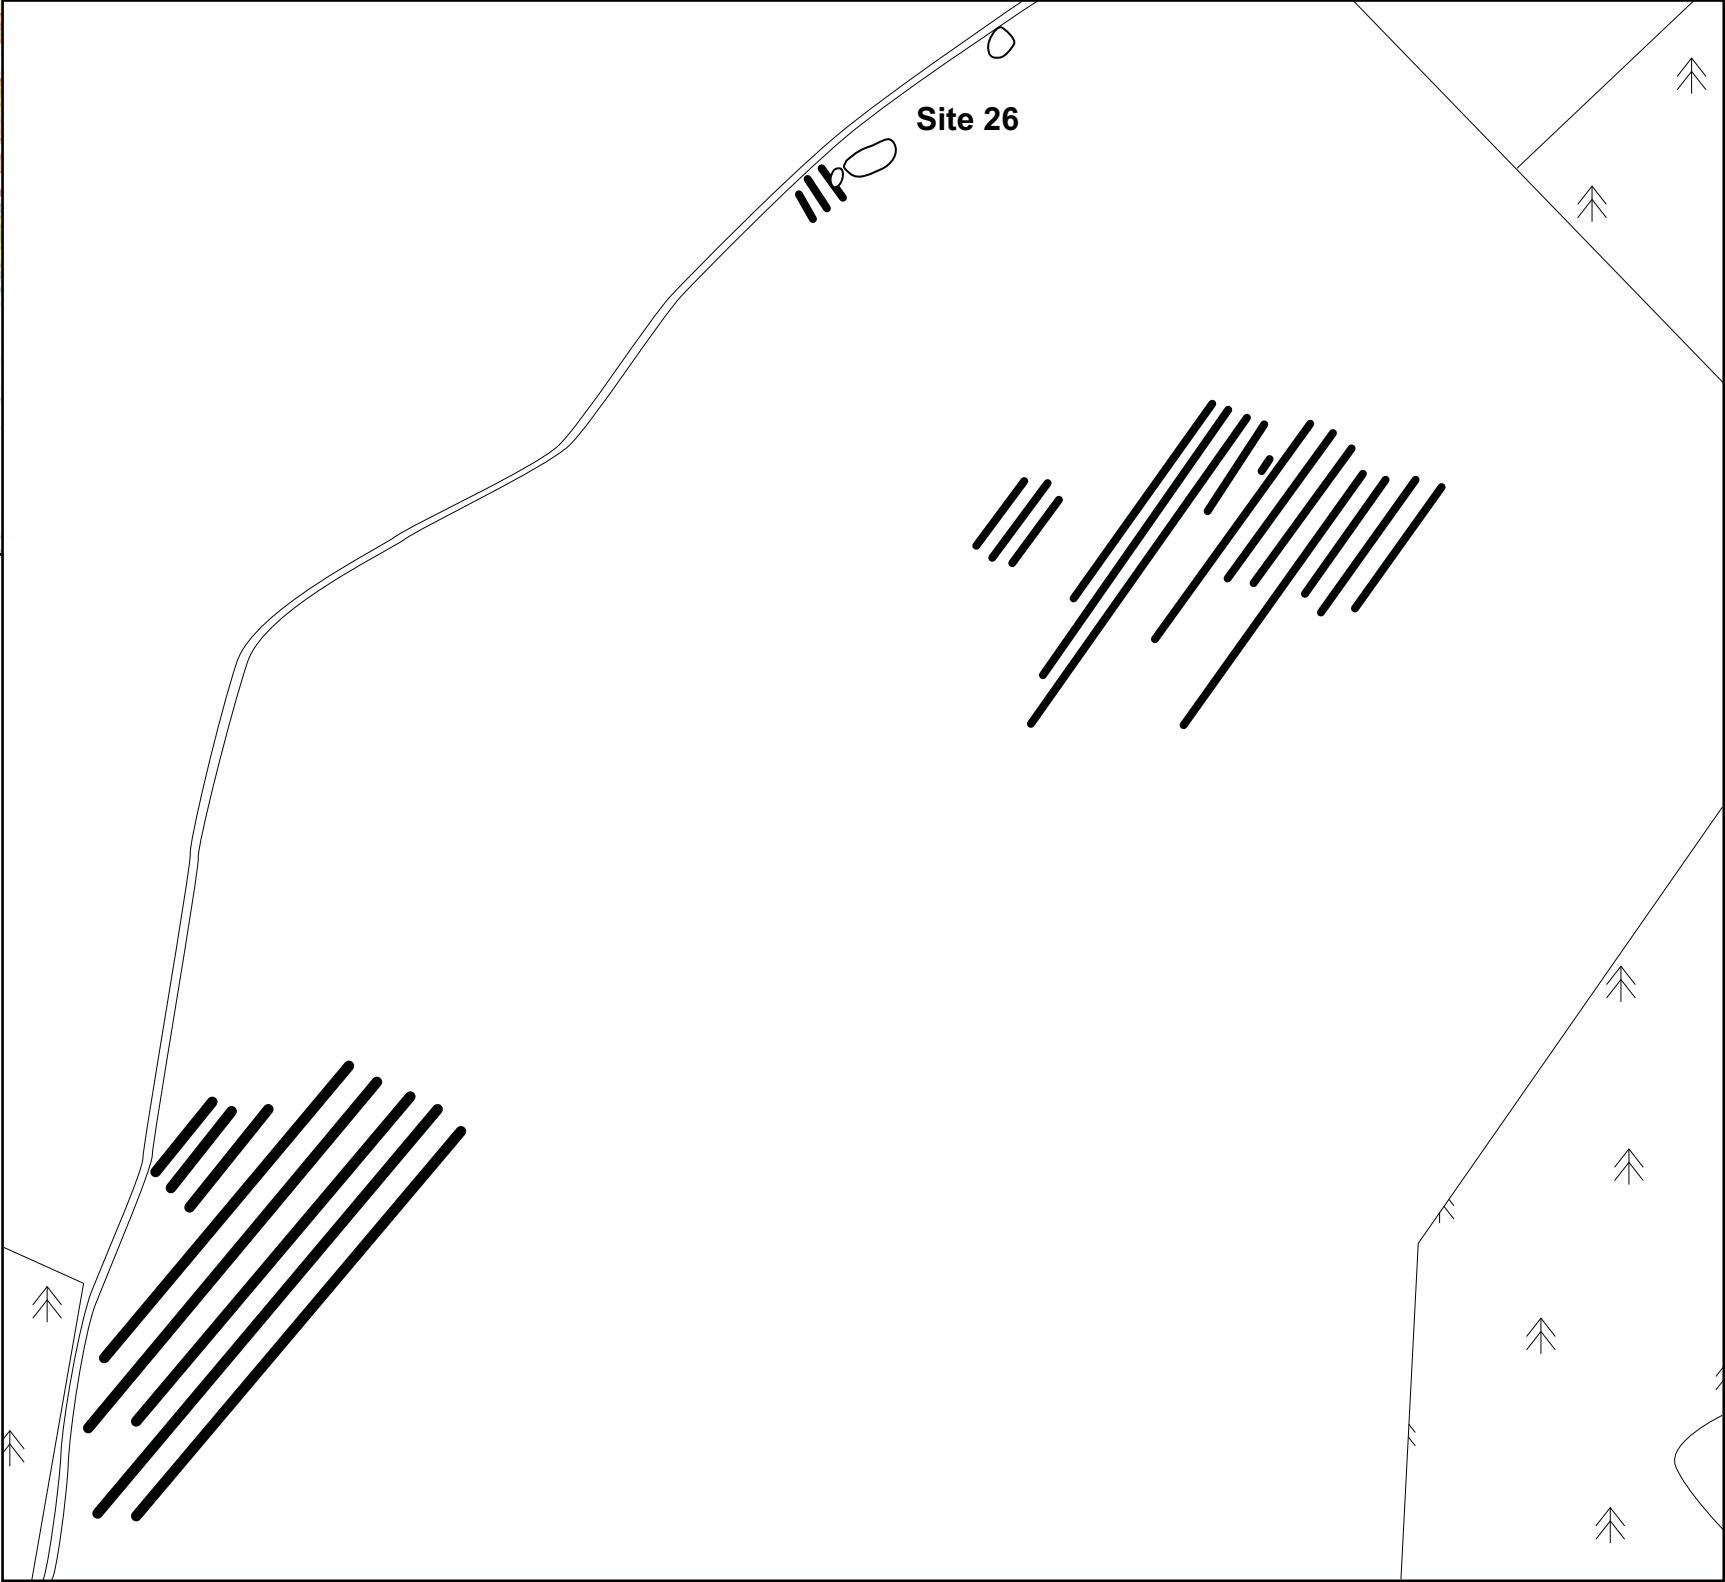
Fig. No:	2	Revision:	A
Title:	Mapped extent of Site 26		
Project:	Arecleoch Windfarm Grid Connection		
Scale:	1:2000 @ A3		
Client:	Scottish Power Power Systems		
Drawn by:	SW	Report No:	1834

- 3.1.1 Site 26 was surveyed in September 2010. The mapped extent of the site is shown on Fig. 2.
- 3.1.2 Most of the rig-and-furrow is imperceptible on the ground, with the better preserved areas being to the north-west of the pylon route and at the edges, closer to the more boggy ground and in areas of greater slope. Occasional clearance cairns were present across the site (Fig. 3).
- 3.1.3 The rig-and-furrow, where preserved to the south-east of the pylon route, measured 2.5m from centre to centre, with a maximum height of 0.2m (Fig. 4). To the north-west of the pylon route the rig-and-furrow measured c.4m centre to centre with a maximum height of 0.1-0.2m.

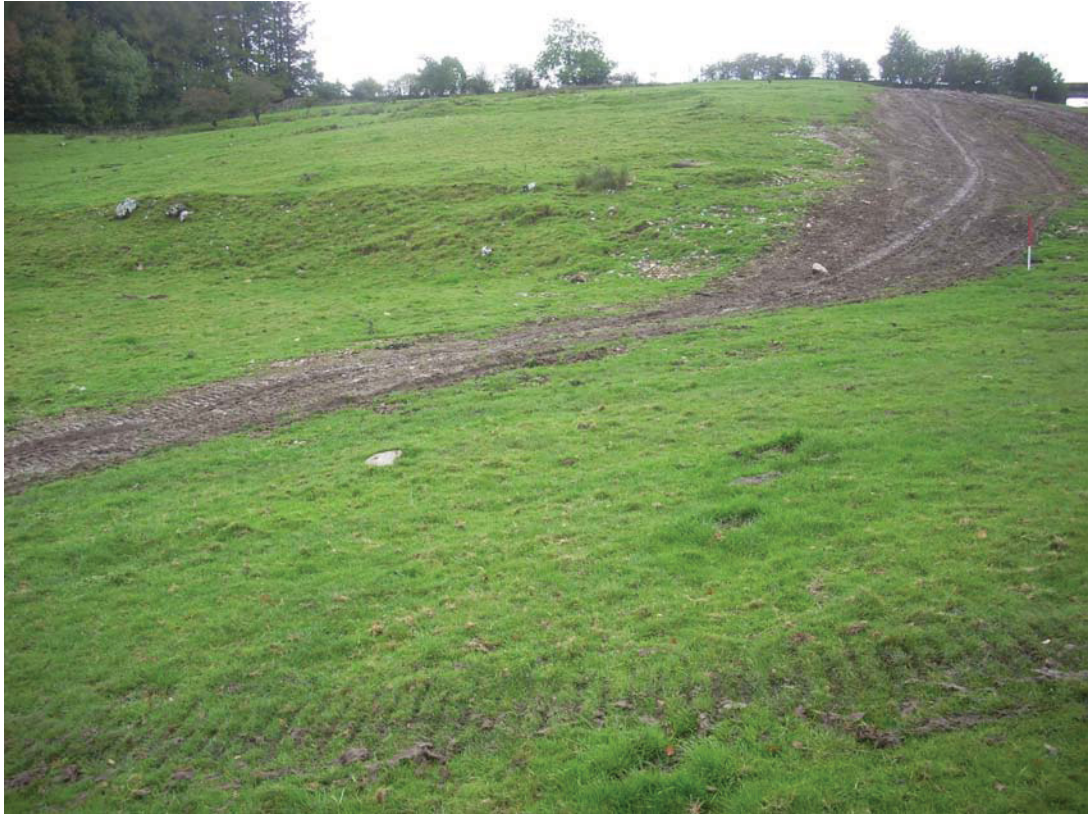
Key:	Fig. No:	9	Revision:	A	Client:	Scottish Power Power Systems

- 3.2.2 Site 21 comprises a rectangular enclosure measuring c.60m by 35m, aligned roughly SE to NW. The enclosure is grassed over. The enclosure is defined by low banks up to 1m high and 3m wide. The bank forming the north-east side of the enclosure extends beyond the enclosure to the south-east as a dry stone wall. It also extends c.16m to the north-west as a low bank, ending on the edge of a gorge falling to the stream. A possible second bank was visible running closely parallel to the north-west extension. The re-routed grid connector cable and access track both cut through these so sections were excavated across both to establish their character. The new cable route by-passed the main enclosure, missing it by c 3m (Fig. 9).

<div>CFA ARCHAEOLOGY LTD The Old Engine House Eskmills Park Musselburgh East Lothian, EH21 7PQ  t: 0131 273 4380 f: 0131 273 4381 e: info@cfa-archaeology.co.uk w: www.cfa-archaeology.co.uk</div>	
	Title:	Site 21 from the NE, showing the cable route on the right and the enclosure on the left							
	Project:	Arecleoch Windfarm Grid Connection							
Scale:							Drawn by: SW	Page No:	Report No: 1834
