**18 Huntly Street, Inverness
Historic Building Survey**

Report No. 1844

1.2.1 The building at 18 Huntly Street comprises the remains of the former Palace Cinema which is the last surviving example of the old Inverness cinemas. It is considered to be of historical importance to Inverness. The building dates from the late 1930s and was last used as The Carlton Bingo Hall. At the time of the survey it was in a semi-derelict state.

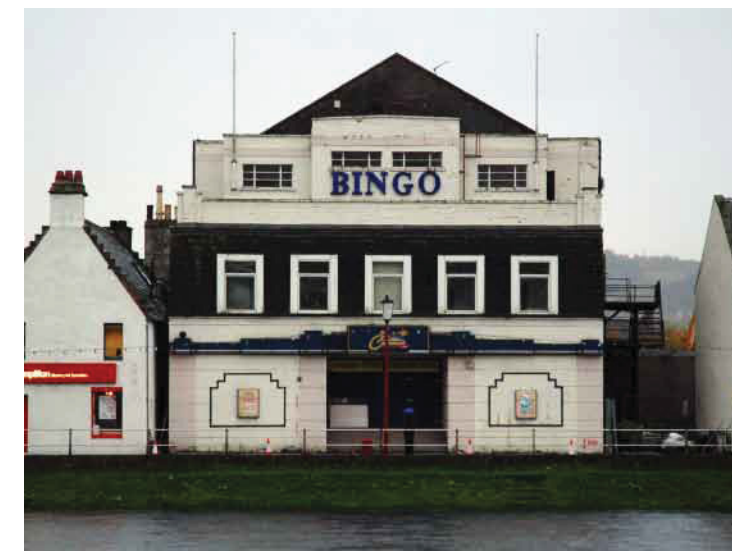
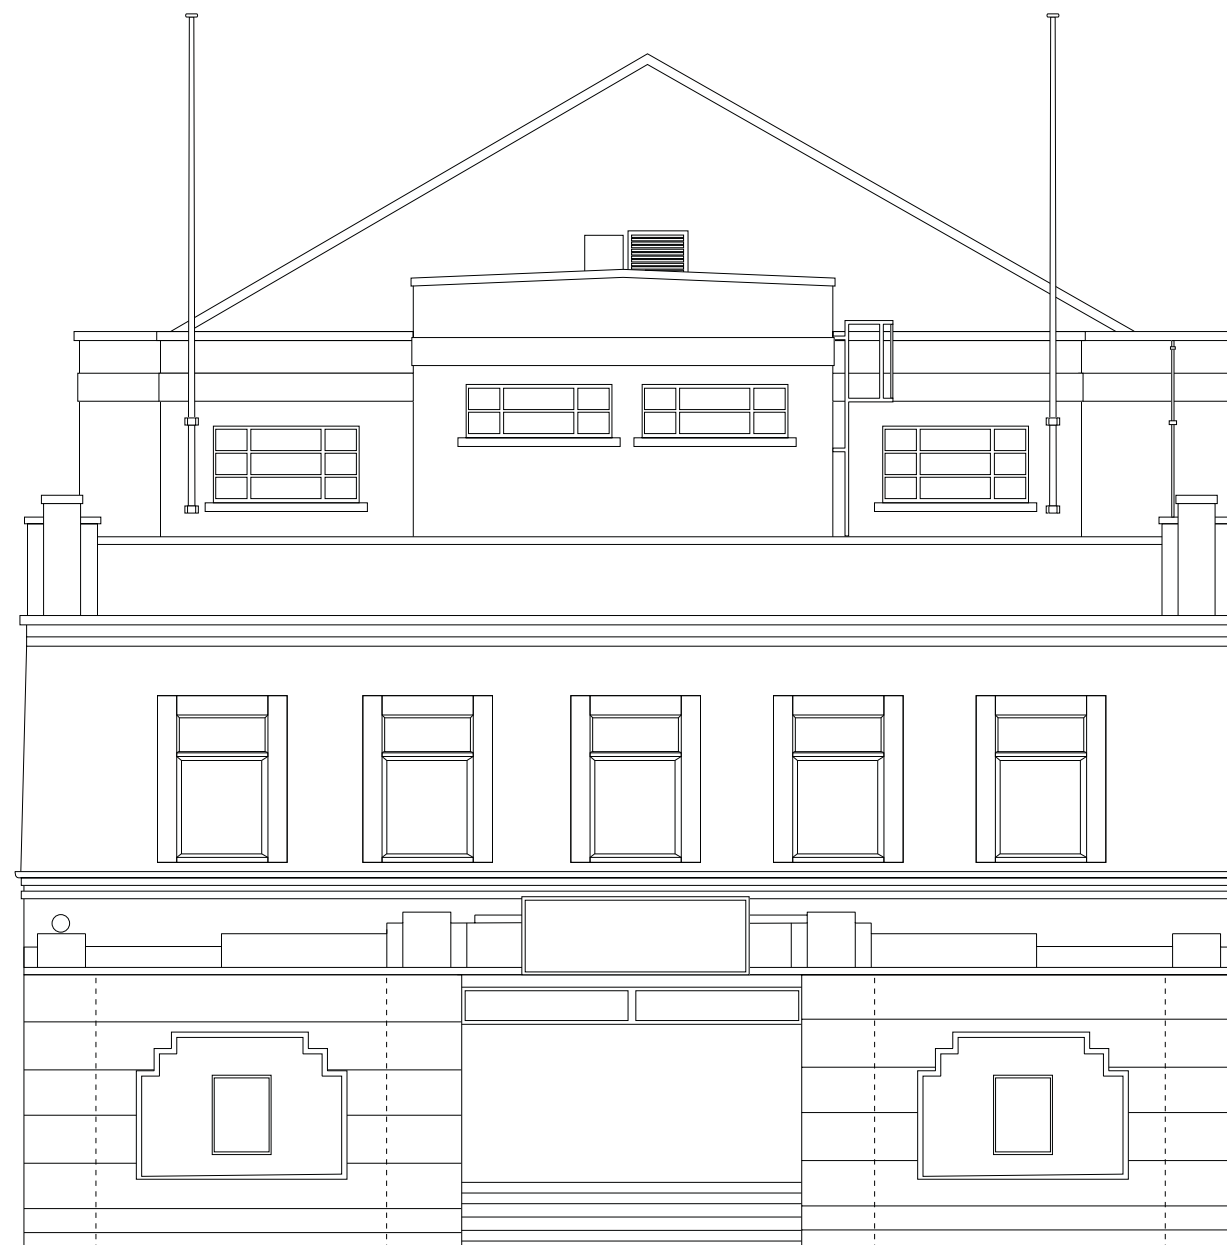
Fig. No: **3** Revision: **A**

Title:
Front exterior elevation drawing and photo

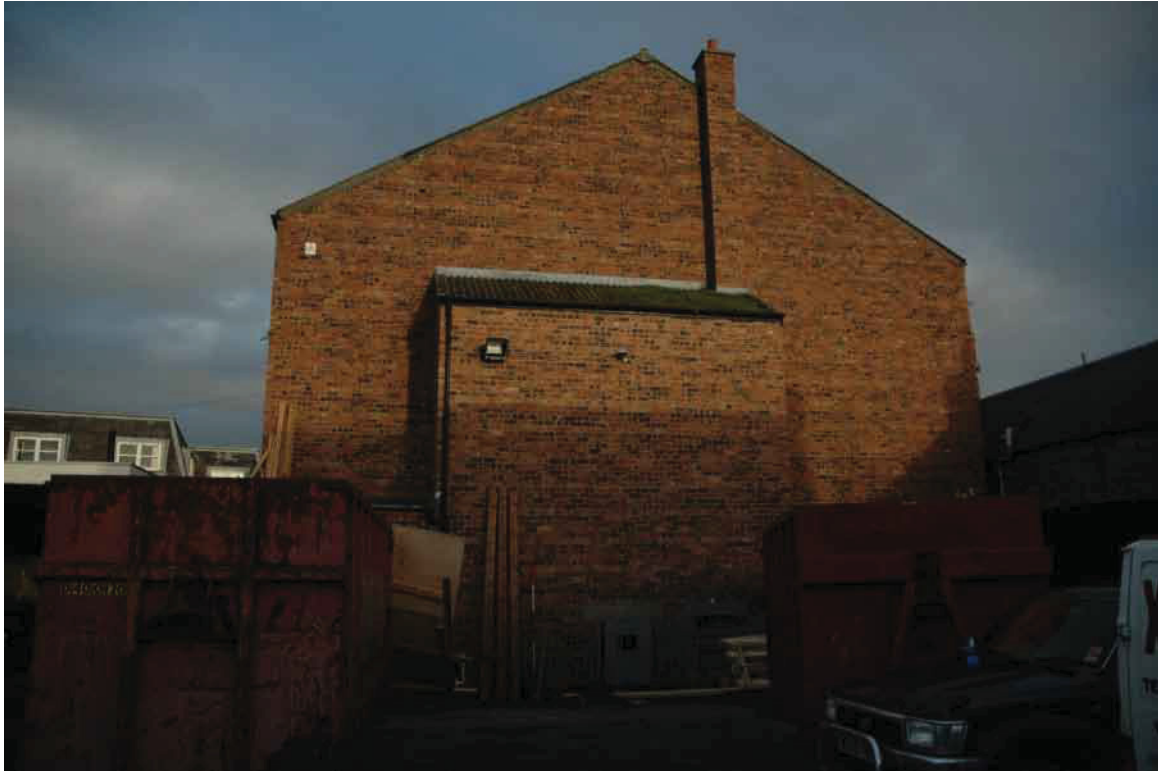
Fig. 4 Rear of building

4.2.1 The building is built of brick and has a rectangular plan with a slightly angled front. It is set at 90 degrees to the street and the River Ness, which the building front faces over. A modern extension (2), possibly dating from the early 1960s conversion to use as a bingo club, extends from the north end of the east elevation. The south-facing elevation (Fig. 3). which forms the front of the building, is rendered and whitewashed and has a central doorway with 1930s art deco architectural features. The top of the frontage has a flat balcony with a low balustrade. A pitched roof gable is set back from the front of the balcony. The sides and rear of the building are unrendered brick (Fig. 4). The east side of the building has an iron fire escape staircase fitted.

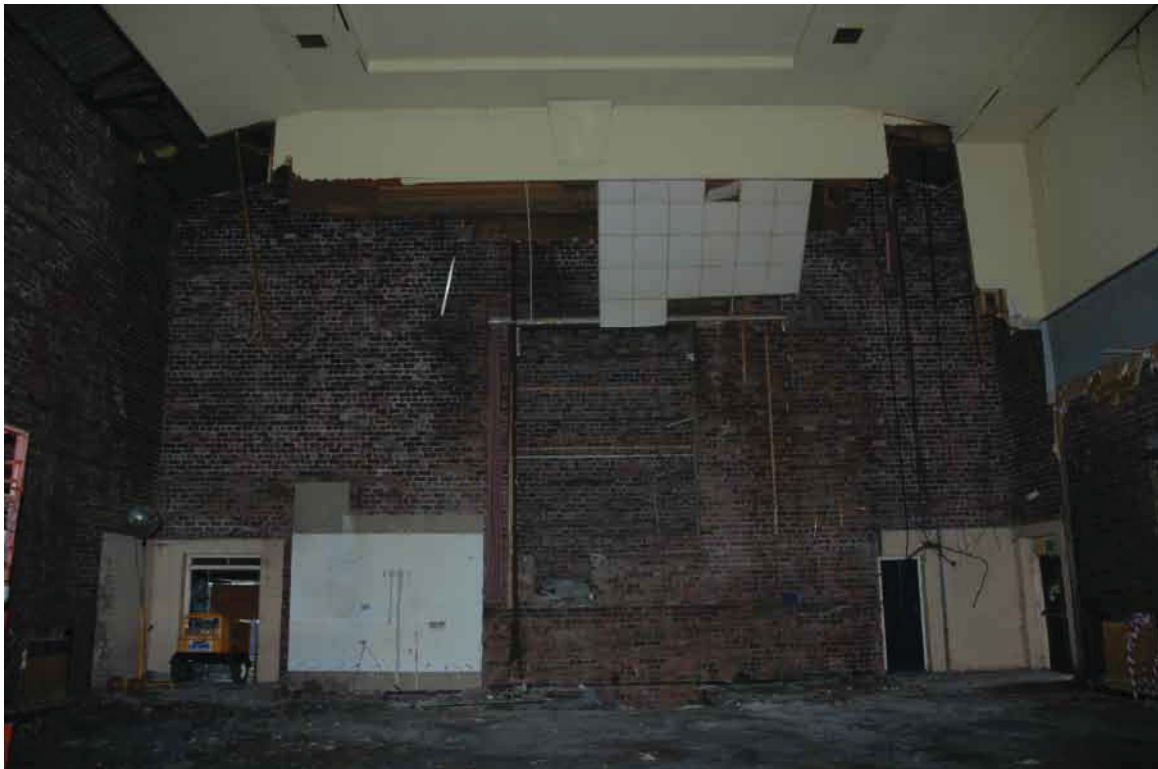
Fig. 5 Interior of main hall (Unit 1) north elevation

- 4.4.4 The bare brickwork of the north and west elevations showed the bond to be English Garden Wall. The north elevation (Fig. 5) had fragments of lath and plaster remaining, and had double fire exit doors at its left hand side and a single cupboard door at its right. It had a centrally placed opening giving access to a recess (3). The east elevation (Fig. 6) was covered by lath and plaster with a dado rail. It had a fire exit door at its left hand side. Two brick piers form three square open bays giving access to an extension (2). Three original cast iron radiators are fitted along the right hand side of the wall. Beneath the balcony, the south elevation featured two double entry doors and third blocked doorway, and two recesses fitted with cast iron radiators. The south elevation (Fig. 7) above the balcony is unfeatured. The west elevation (Fig. 7) had four radiators fitted along its length and five ventilation grilles.

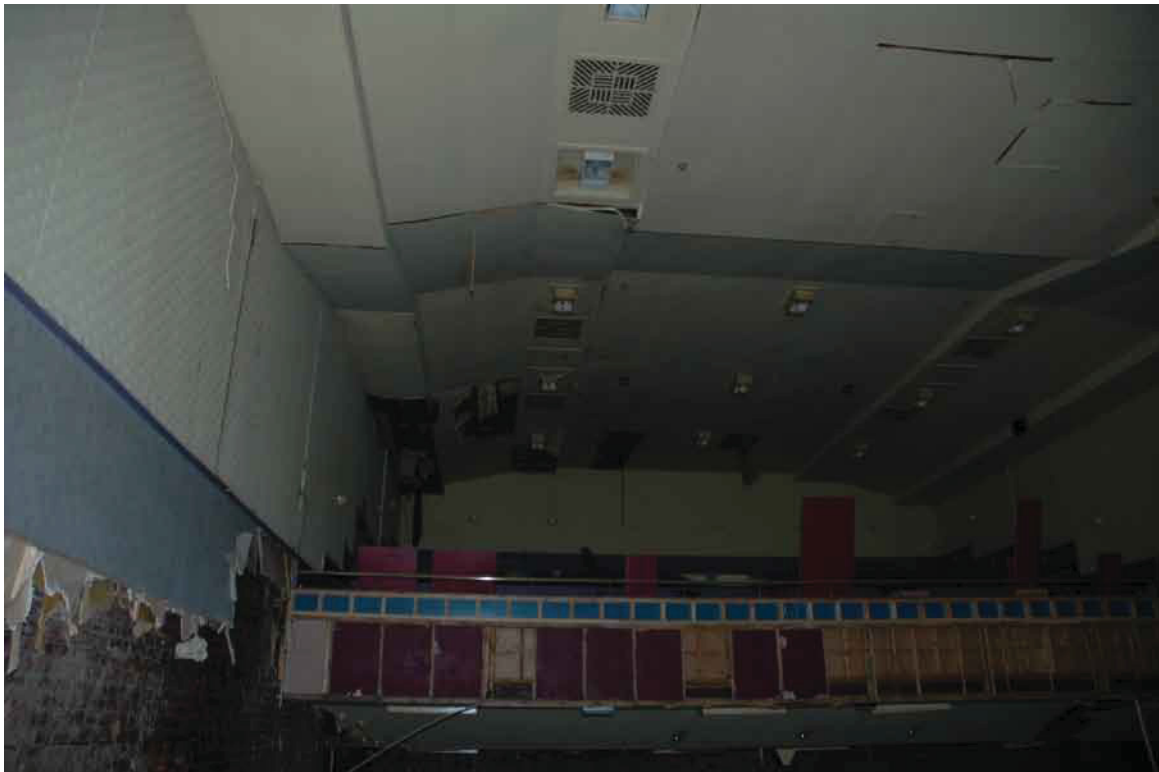
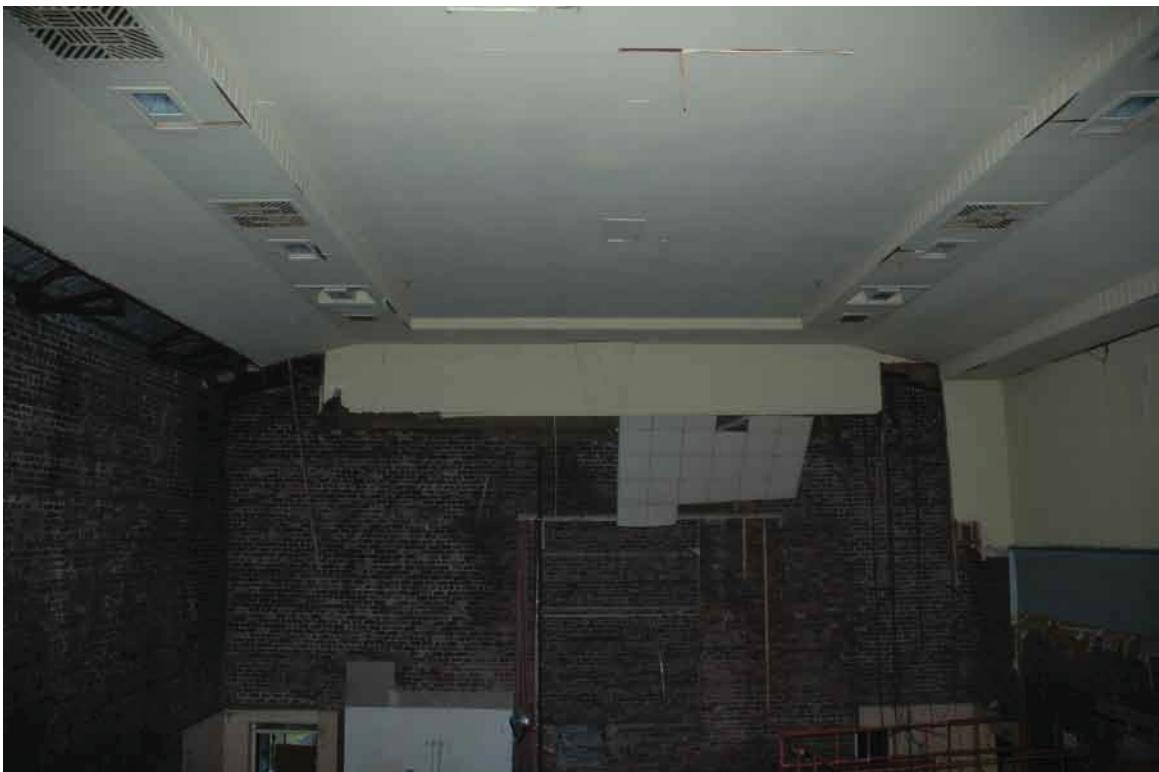
Fig. 8 General view of ceiling in main hall (Unit 1)

- 4.4.3 The plaster ceiling featured decorative squared cornice mouldings, a central plaque over the north elevation and square ventilation grilles were set along the edges (Fig. 8). The ceiling descended from the south end of the hall in two levels split by a ramped section above the balcony (Fig. 9).

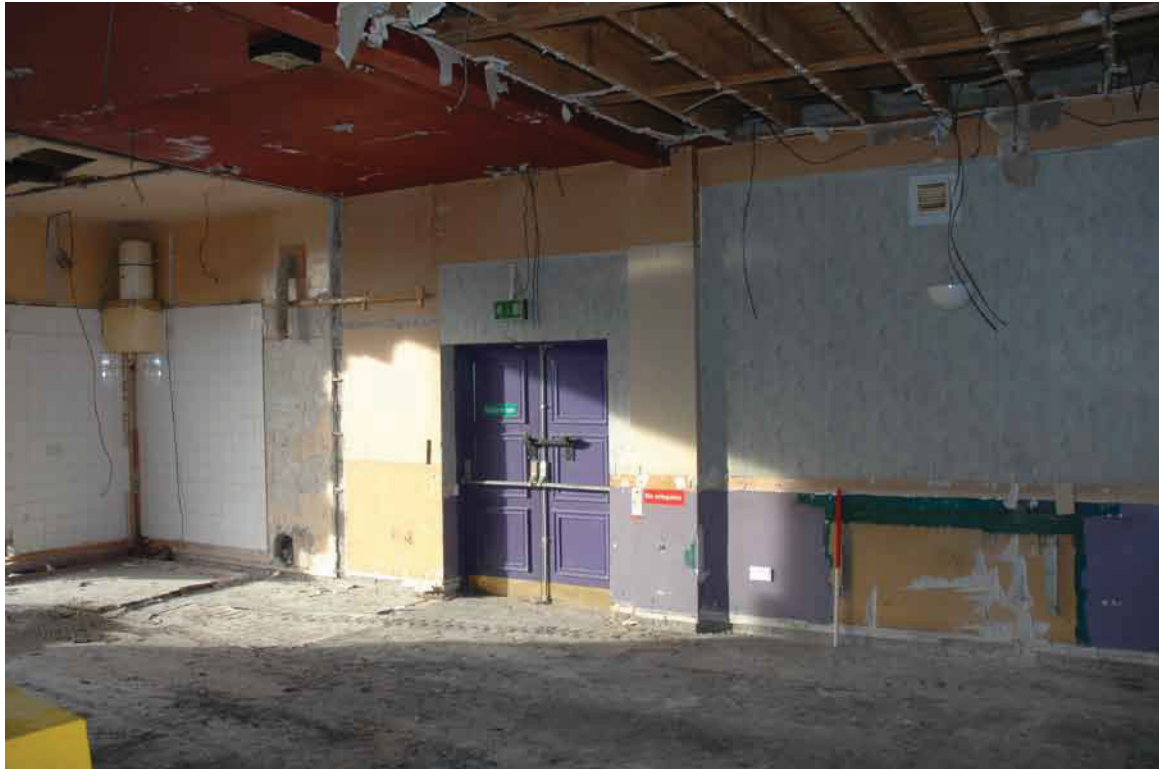
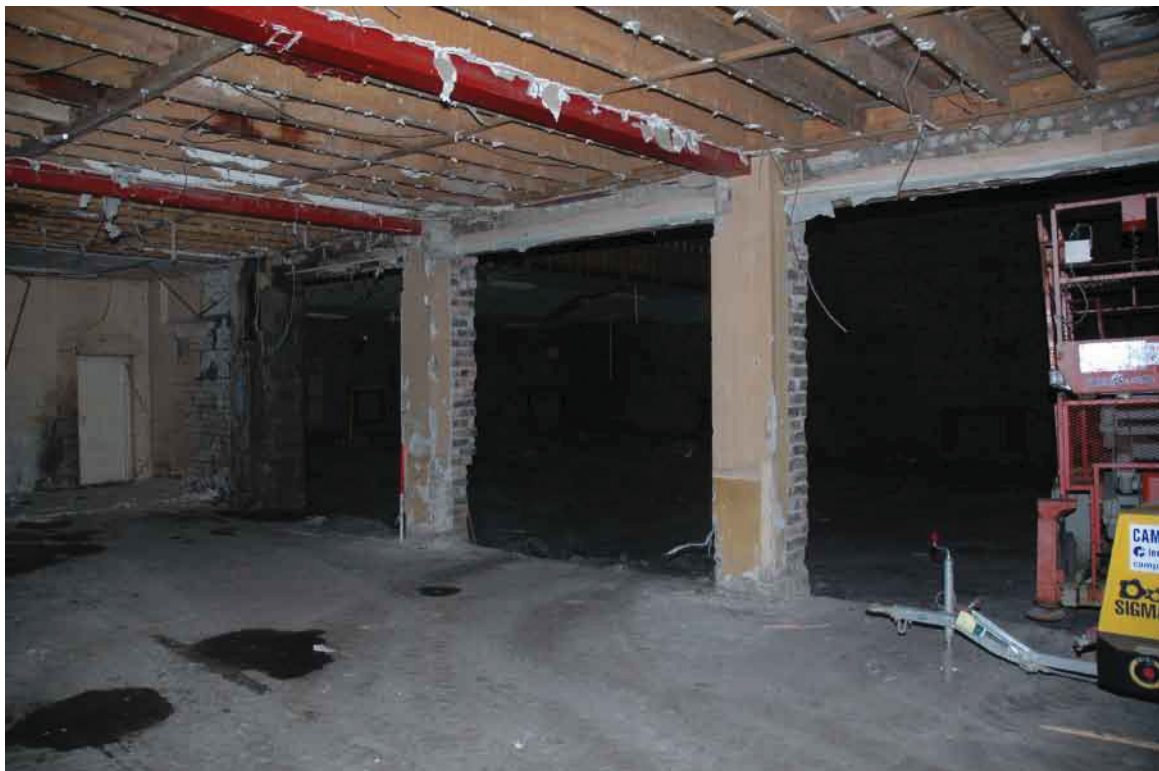
Fig. 10 General view of (Unit 2)

- 4.4.6 This forms an extension (Figs 10 & 11) to the main hall (1), annexed to the north end of the east side of the hall and built out from the main rectangular plan of the building. Internet photographs show that it was used as a bar (www.scottishcinemas.org). The floor is concrete and was surfaced with linoleum, of which a few patches remain. The flat ceiling had been stripped prior to the survey and was built of timber joists resting on sockets in the outer brick wall.

- 4.4.7 The north elevation opened out to the yard. The walls had the remains of white tiling. The east elevation has a tiled area adjoining the north elevation. The tiles border the remains of a brick wall stub which indicate the prior presence of a small cubicle, which was probably a WC, in the north-east corner. Two fire exit doors are present on the wall. Two radiators were also present but had been removed prior to the survey. The south elevation is stepped, the right hand half forming an alcove with a single locked door. The stub of an earlier wall is faintly visible, indicating that the alcove had formed a separate room, possibly a WC. The west elevation opens out into the main hall (1) through the three bays described above.

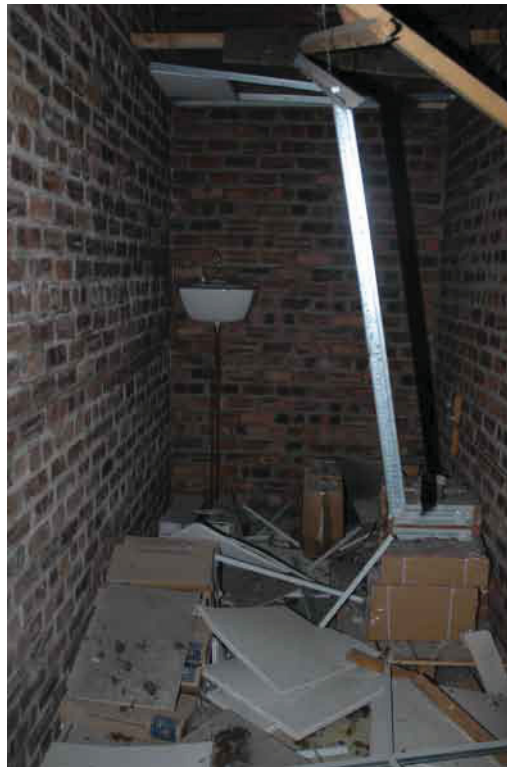
Fig. 12 Interior of (Unit 3)

- 4.4.8 This comprises a recess opening from the north elevation of the main hall (Fig. 12). The floor is 1356mm higher than the floor level of the main hall so it seems likely that it would have been reached by stairs, which are no longer present. It is floored with timber boards and has bare brick unfeathered walls. It has no ceiling; the bare timber rafters being visible. A cistern is fixed to the north-east corner of the room, though no toilet or other fitting is present. The room was filled with boxes of unused bingo tickets. It is likely this formed a rear area or room for the stage.

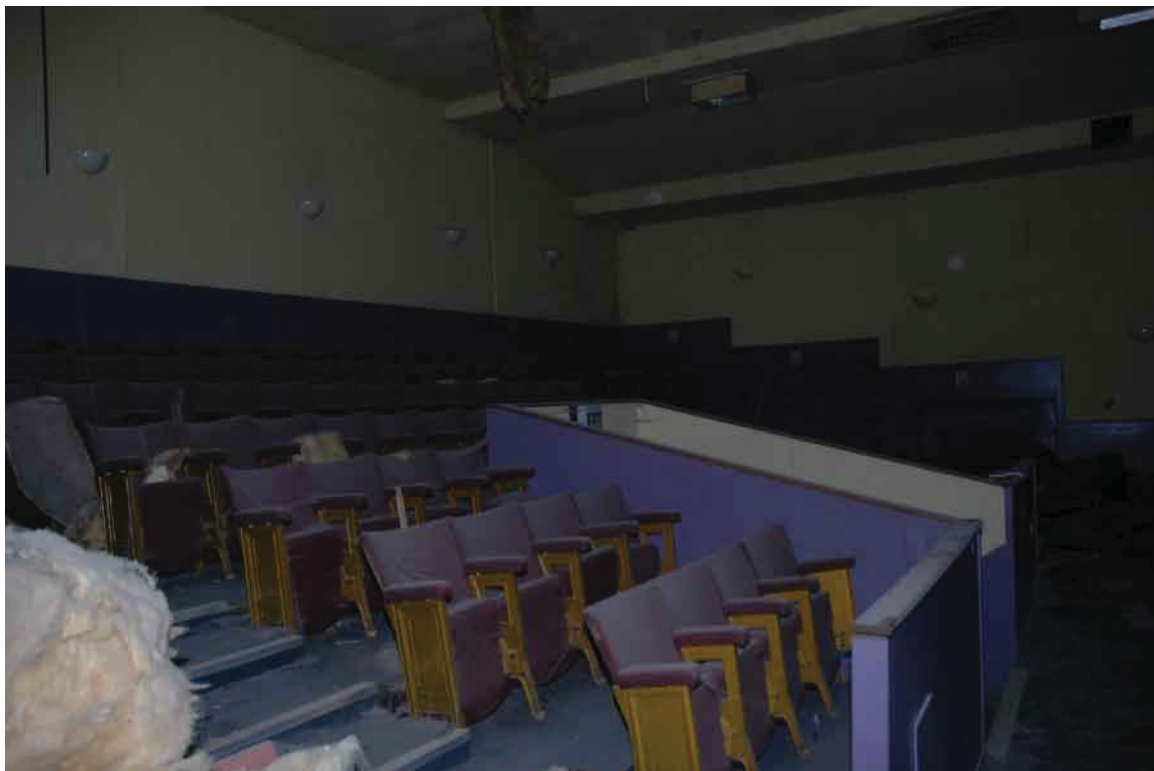
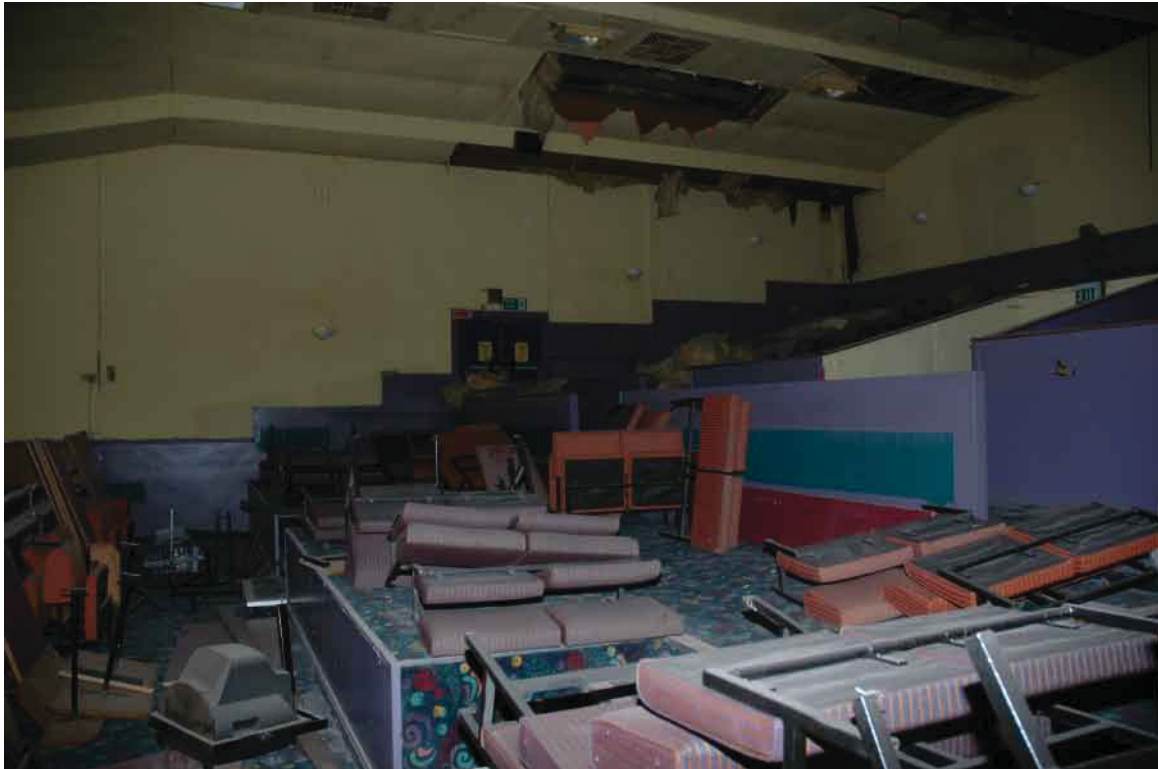
Fig. 13 General view of balcony (Unit 1)

- 4.4.5 The balcony (Figs 13 & 14) extends from the south elevation and occupies the entire width of the hall. It slopes down in stepped seating platforms and is accessed by a central stair which opens to a flat landing running the full width of the balcony and has a fire exit on the east elevation. The balcony is built of timber on an iron girder frame which has the maker's name painted: "Bladen & Co, Glasgow" (Fig. 27). The balcony is carpeted and decorated with a gold-coloured metal rail on the balustrade.

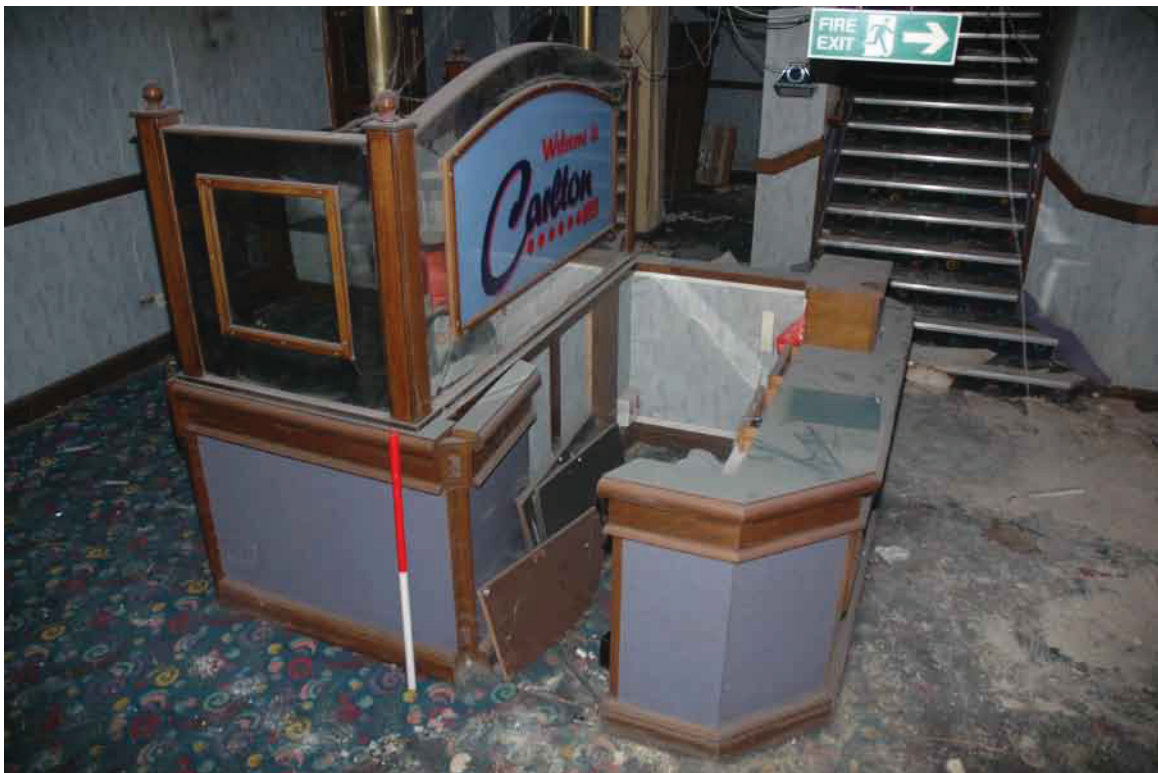
Fig. 15 Ground floor foyer (Unit 4)

- 4.4.9 The ground floor foyer (Fig. 15) represents the main foyer for the building and was accessed from the main front door entrance on Huntly Street and gives entry to the main hall (1) and the first floor. It is roughly T-shaped in plan, with a wide central foyer and two narrower short corridors extending east and west at its north end. A kiosk is centrally situated in the foyer, and probably dates from its use as a bingo hall.

- 4.4.10 The floor is carpeted although much of it was covered in fallen plaster. The ceiling is suspended aluminium panels with inset lighting, although this is a later addition. The original ceiling, visible through gaps formed by fallen panels, is plastered and has decorative cornicing along the edges. The stub of an earlier wall formed by a single row of bricks is visible, showing that a significant layout change was made, probably during the building's transition from a cinema to a bingo hall.

- 4.4.11 The walls of the foyer have a wooden dado rail running around them, and are wallpapered. The north elevation forms the division between the foyer and the main hall, and has two double doors to give access to the main hall. The main east elevation opens to a stairwell leading to the first floor, and contains a door leading to the accounts office. Two timber framed notice boards are mounted on the wall, one either side of the office door, and a timber radiator cover with cast iron radiator is situated by the office door. The south elevation forms the main entrance to the foyer from the street and is fitted with three double doors; aluminium framed and painted glass panels. The main west elevation contains an open alcove (7) which is topped with a timber framed and veneered glass window. To the left of the alcove is a doorway leading downstairs to the catering and utility rooms. To its right is a stairwell leading to the first floor, identical to the opposite stairwell on the east elevation.

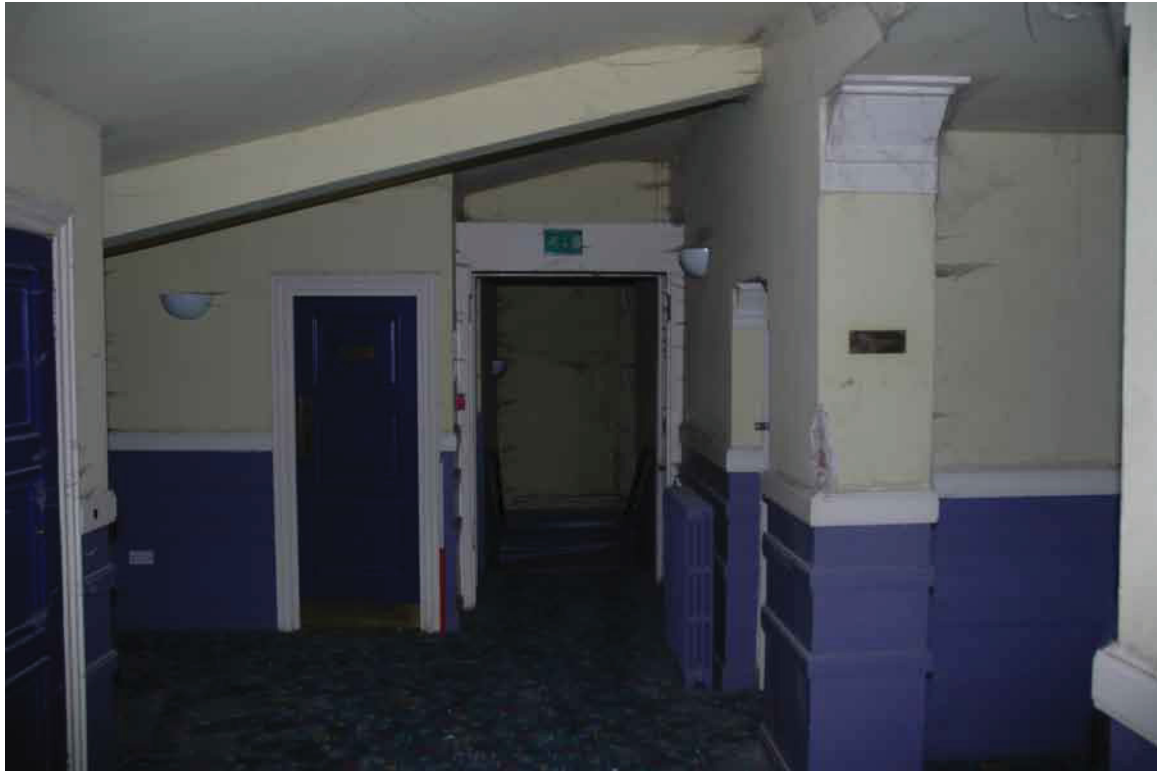
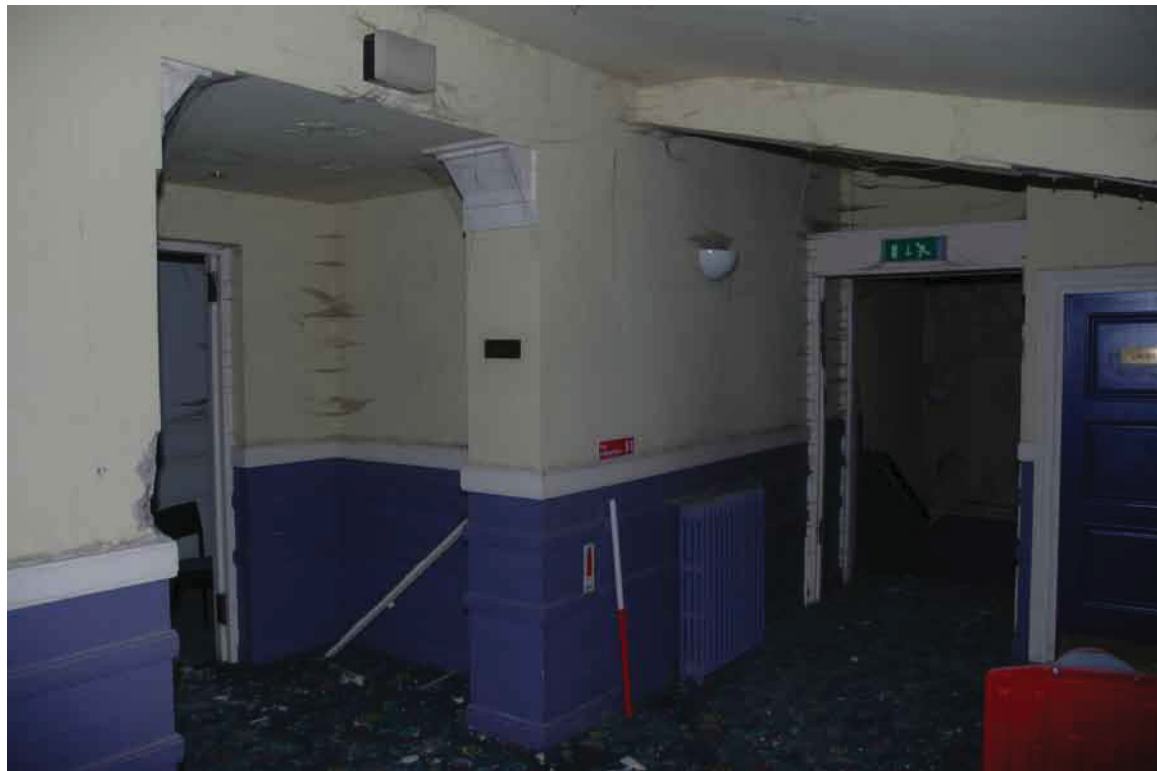
Fig. 16 First floor foyer (Unit 9)

- 4.5.1 The first floor foyer (Figs 16 & 17) is accessed from the ground floor via either of the two stairwells (18). It forms a wide corridor with annexes giving access to the balcony, cupboards, toilets and the first floor offices. The floor is carpeted and the ceiling slopes downwards to the north, this being the underside of the upper part of the balcony. The ceiling is plastered and painted. A dado rail runs around the walls, which are plastered, papered and painted. Many of the angles of door and alcove frames have period mouldings.

- 4.5.2 The north elevation is set back from the main alignment of the foyer and contains the access to the stairs leading to the balcony. Doors either side of the balcony give access to cupboards and utility rooms containing heating and ventilation ducts. The east and west elevations lead to the tops of the either stairs from the ground floor foyer. The south elevation has a central vestibule which leads to a corridor (10) giving access to offices (11, 12) and staffrooms (13, 14). No door fittings were visible separating the vestibule from the corridor but it is assumed that a curtain or other barrier would have been present to separate the public area from the staff area. A door is situated to the left of the vestibule, giving access to a small cupboard and stairwell leading to the projector room on the 2nd floor. A similar door would have been present to the right of the vestibule but has been bricked up and is not visible.

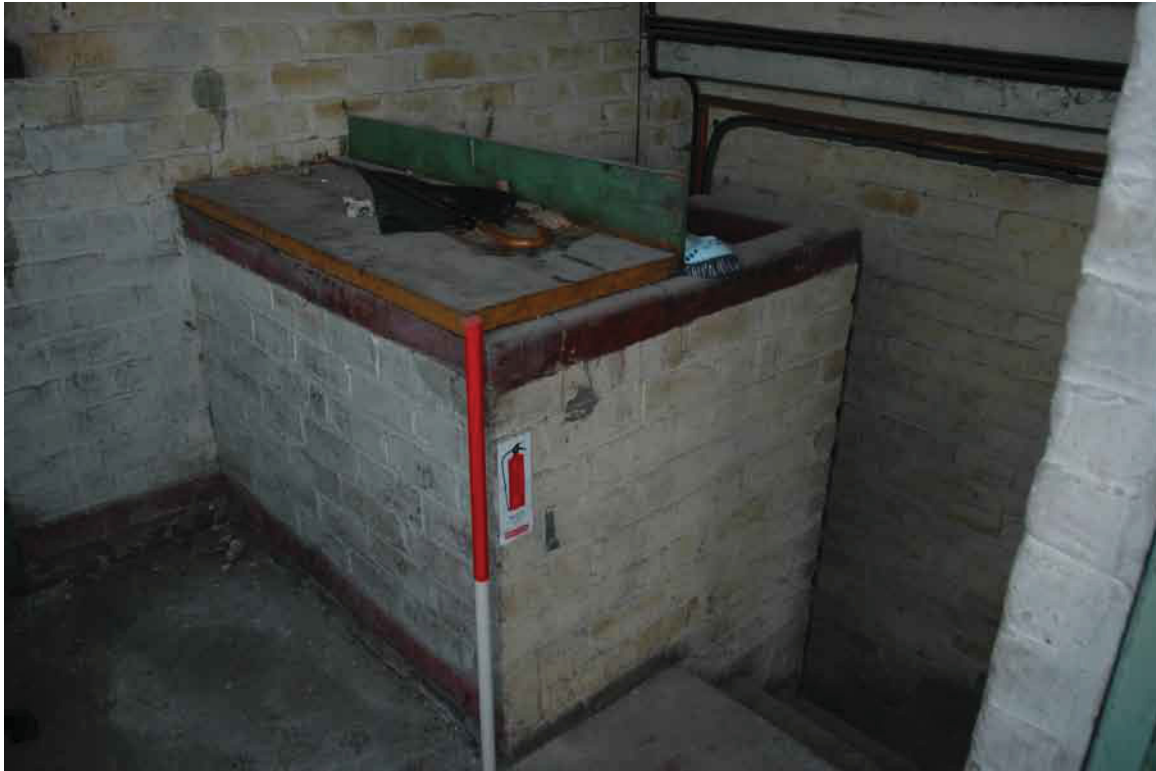
Fig. 18 Second floor landing (Unit 15)

- 4.6.2 The landings (Fig 18) have concrete floors and ceilings and whitewashed brick walls. Both have small utility cupboards, the cupboard off the east landing being used as an electrical and fuse board room. The landing on the east side also has a door which opens outwards onto the roof.

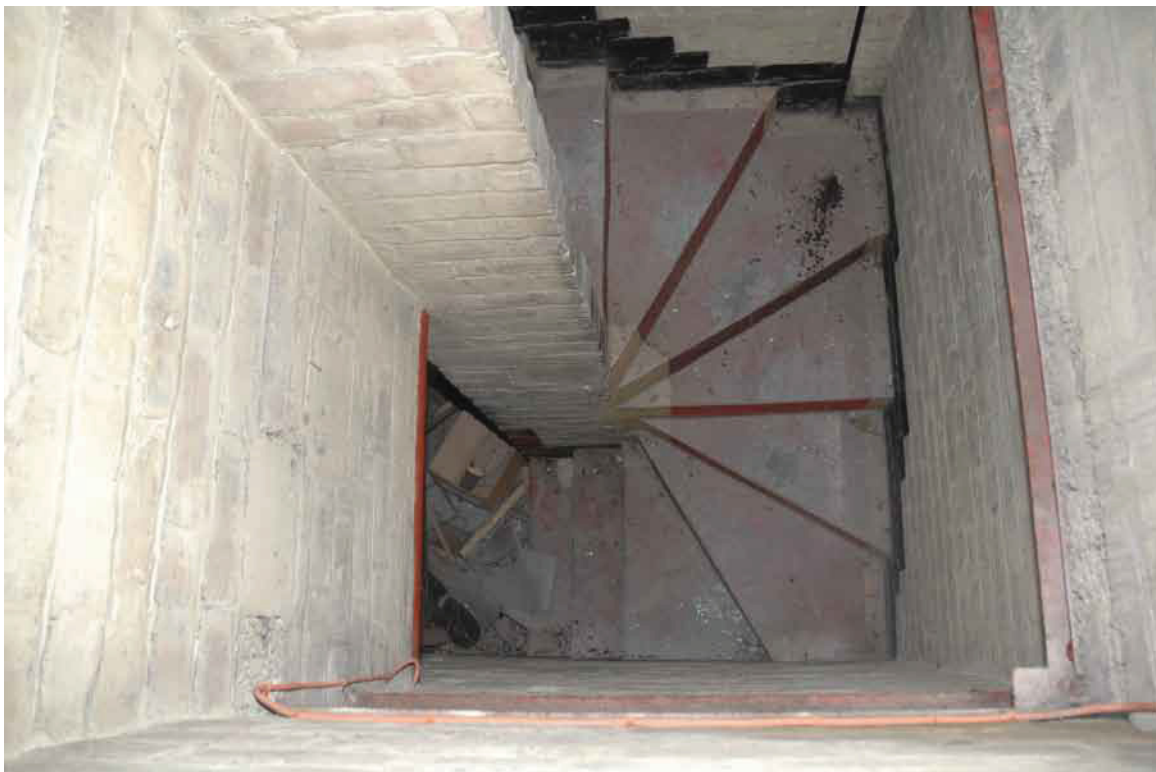
Fig. 19 View down stairwell (Unit 17) from second floor landing (Unit 15)

- 4.6.4 The stairwells (Fig. 19) leading to the second floor each comprise an enclosed narrow concrete stair which exit onto the landings. The bottom of the stair on the west side has been blocked; its doorway on the south elevation of the first floor foyer no longer being visible, however the underside of the stairs are visible in the common room cupboard and the stairs are still accessible from the landing on the west side of the projector room.

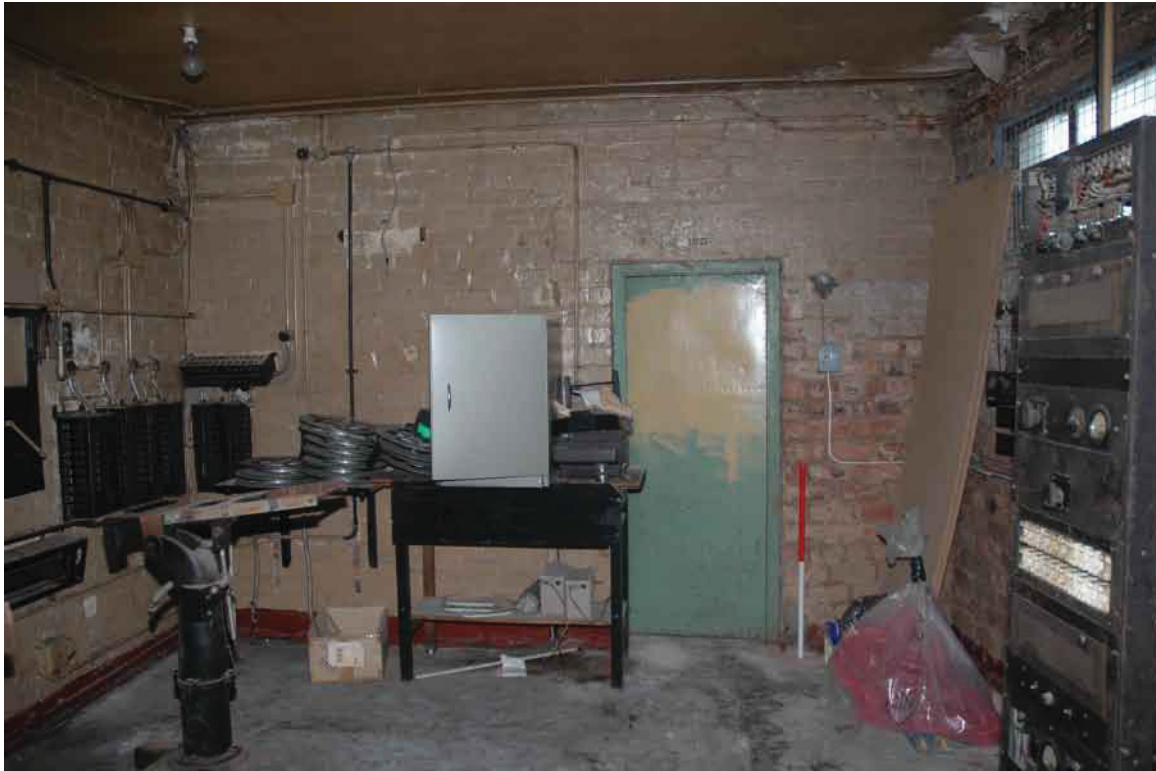
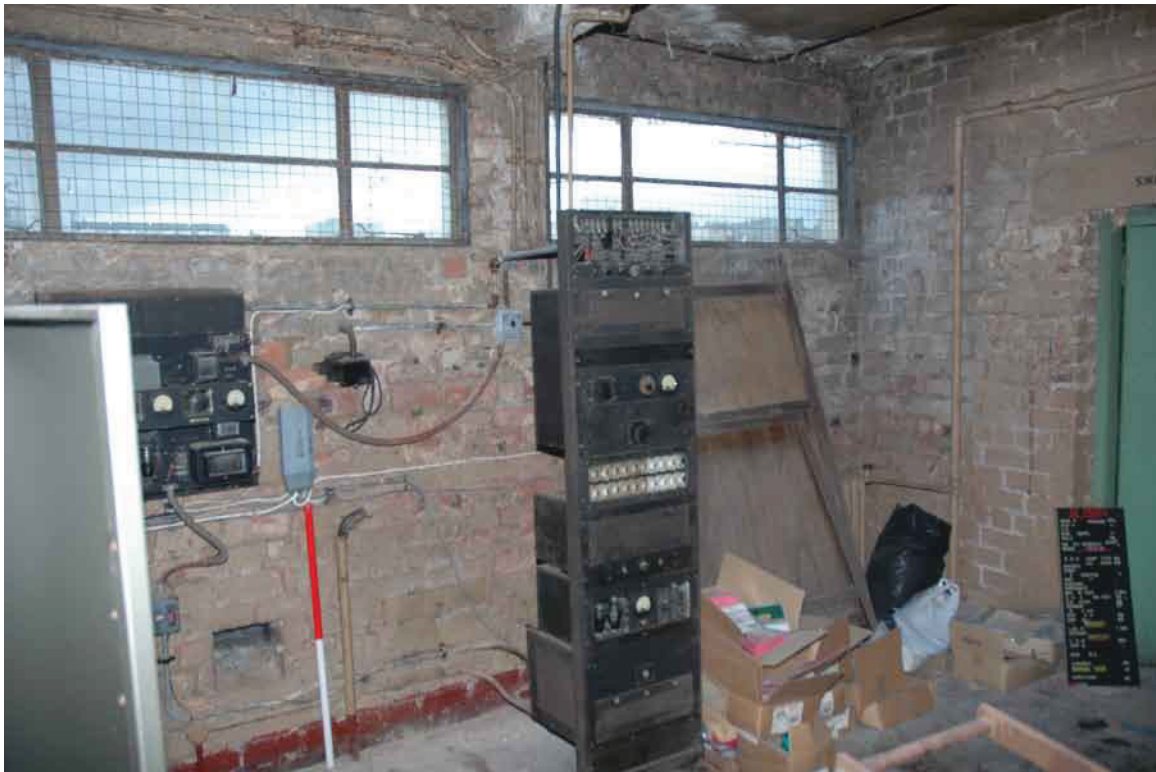
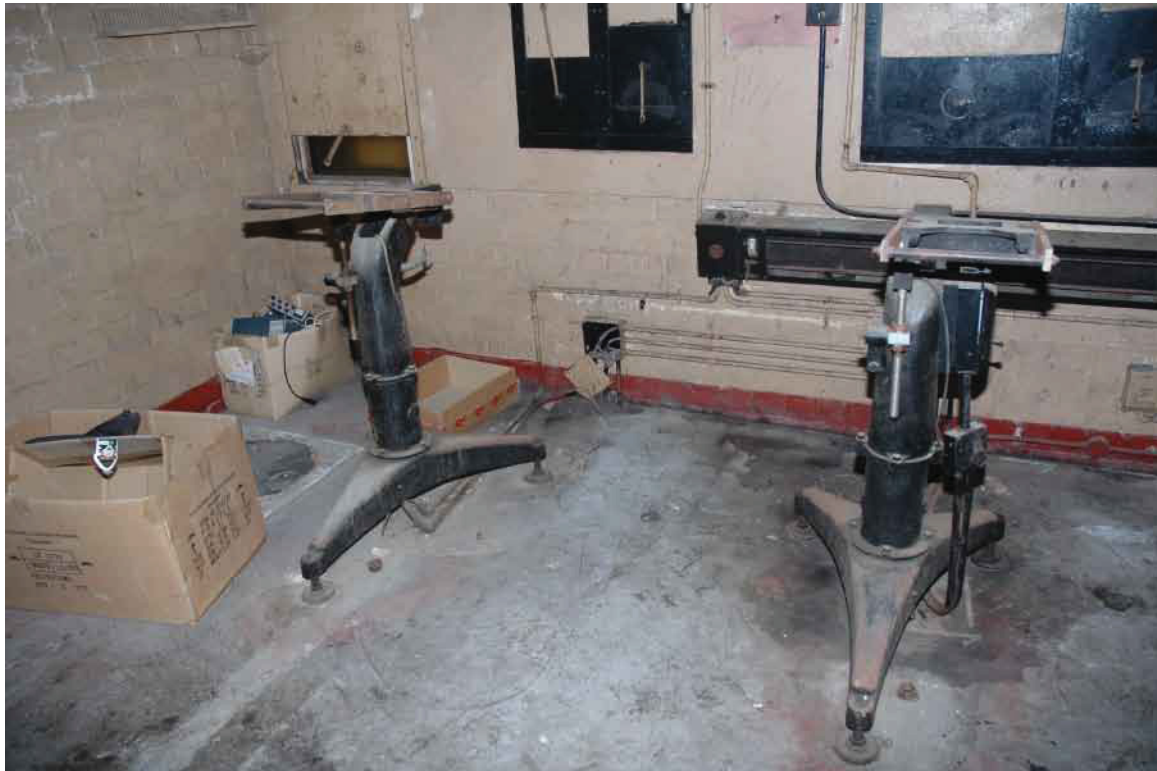
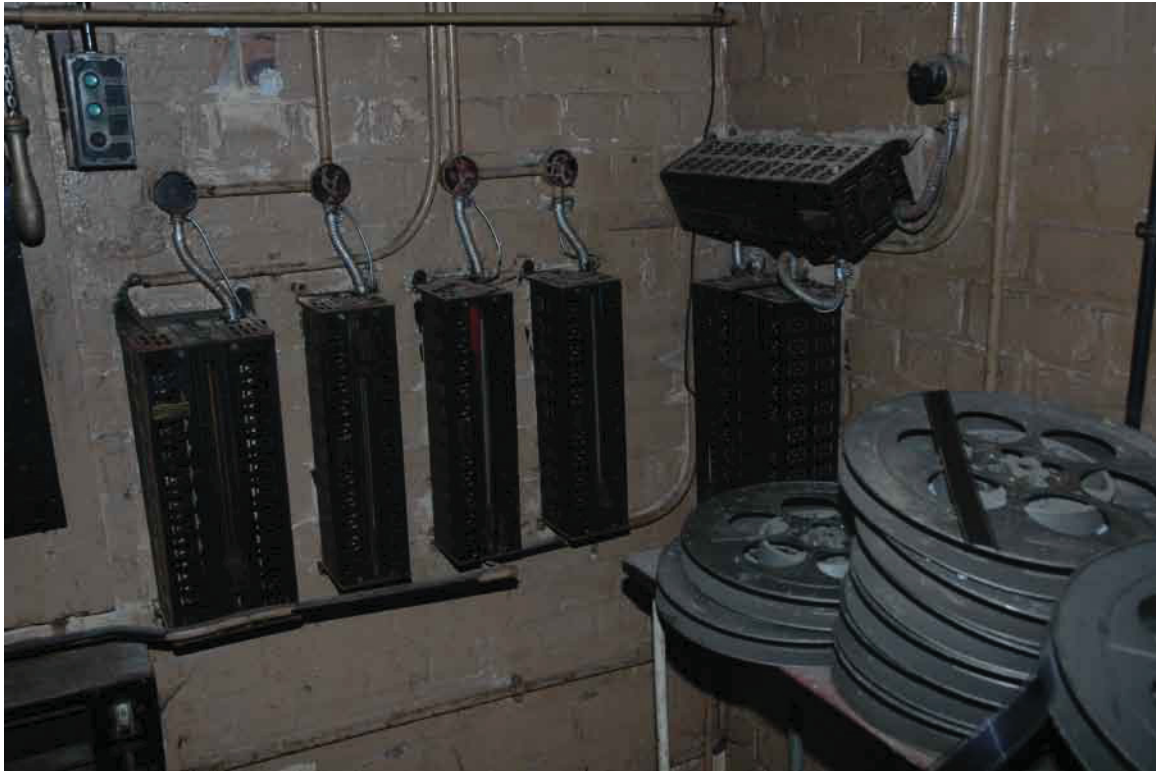
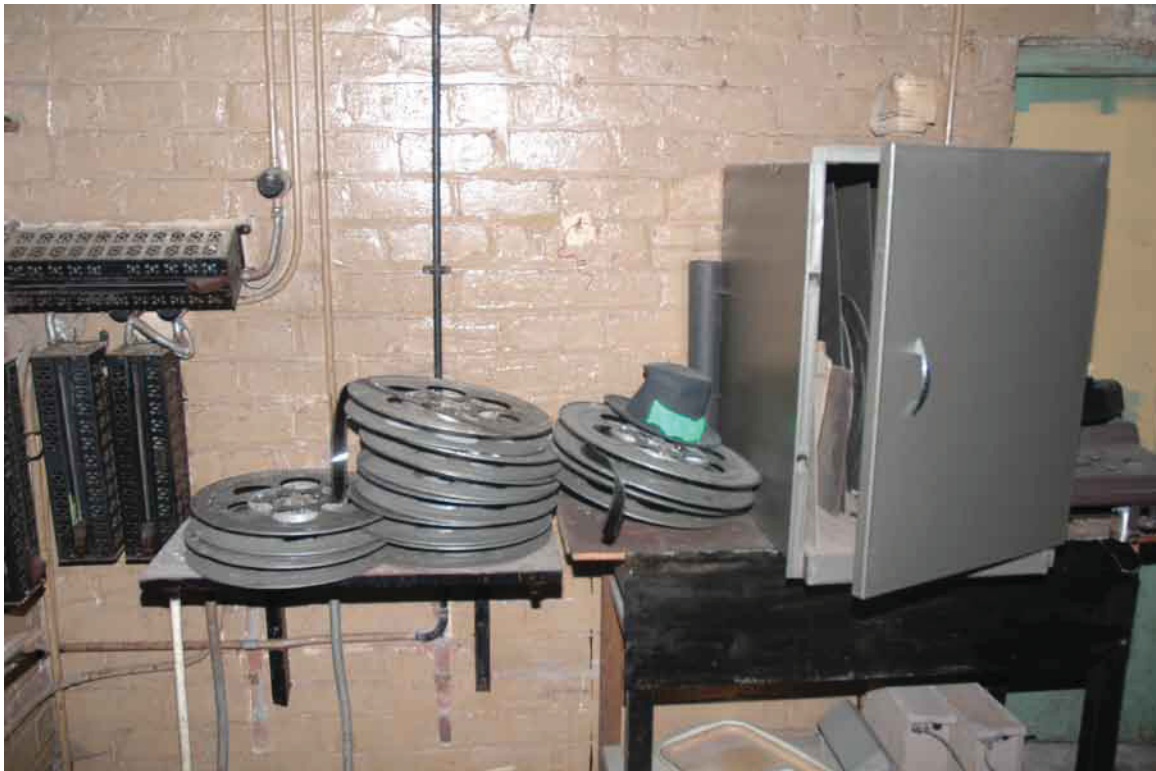
- 4.6.3 The projector room (Figs 20 – 25) is sub-rectangular and contains film and projection equipment from the building's phase of use as a cinema. The floor and ceiling are concrete and the walls are whitewashed or unpainted brick. The room still contains *in situ* fittings associated with the cinema including two projector stands, shuttered projector windows and shutter mechanisms, film reel cabinet and electrical switchgear box. The room had also more recently been used as storage or refuse for seasonal decorations and costumes including Christmas and Halloween. A single reel of film remained in the film reel cabinet, which was retained for further analysis.

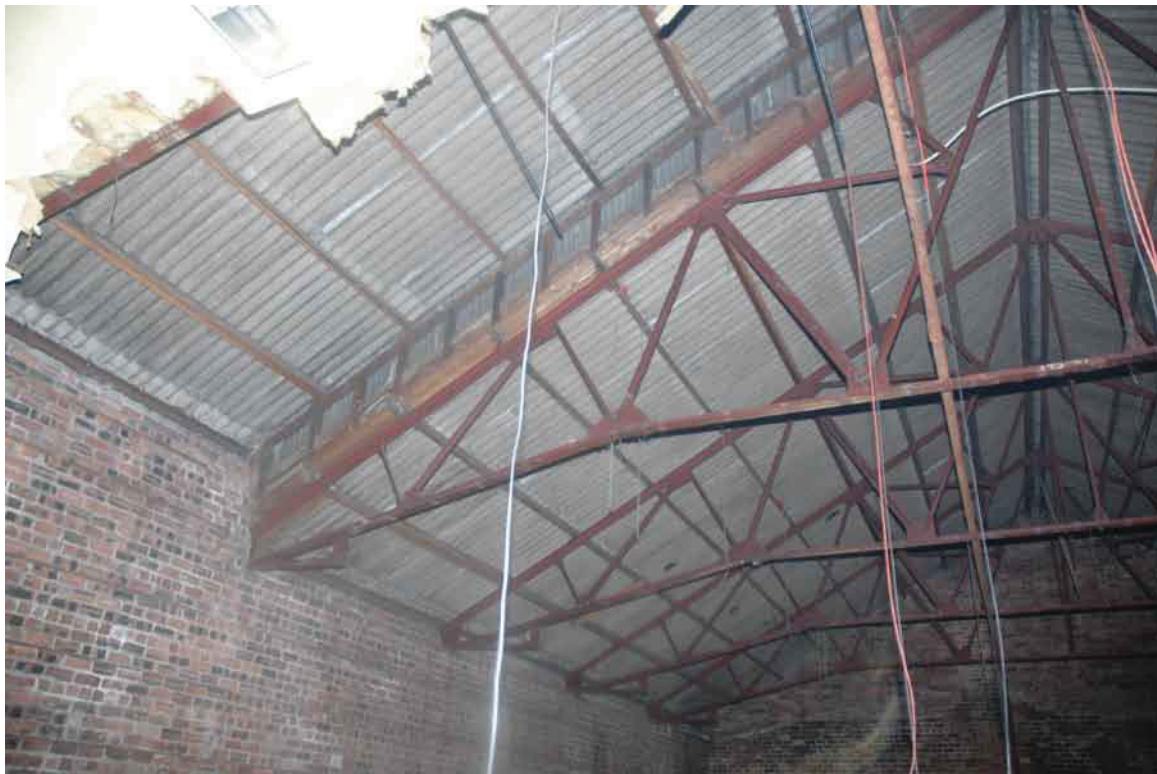
- 4.6.7 The roof (Fig. 26) of the building is panelled with corrugated asbestos and framed by an iron girder coffer-ceiling truss, mounted into sockets at the head of the east and west side walls. For the considerable span of the structure, the truss is constructed of fairly light girders but uses three sets of tension and compression struts on either side to create a strong frame.

Fig. 26 View of roof structure (Unit 20)
