**18 Huntly Street, Inverness
Historic Building Survey**

Report No. 1844

1.2.1 The building at 18 Huntly Street comprises the remains of the former Palace Cinema which is the last surviving example of the old Inverness cinemas. It is considered to be of historical importance to Inverness. The building dates from the late 1930s and was last used as The Carlton Bingo Hall. At the time of the survey it was in a semi-derelict state.

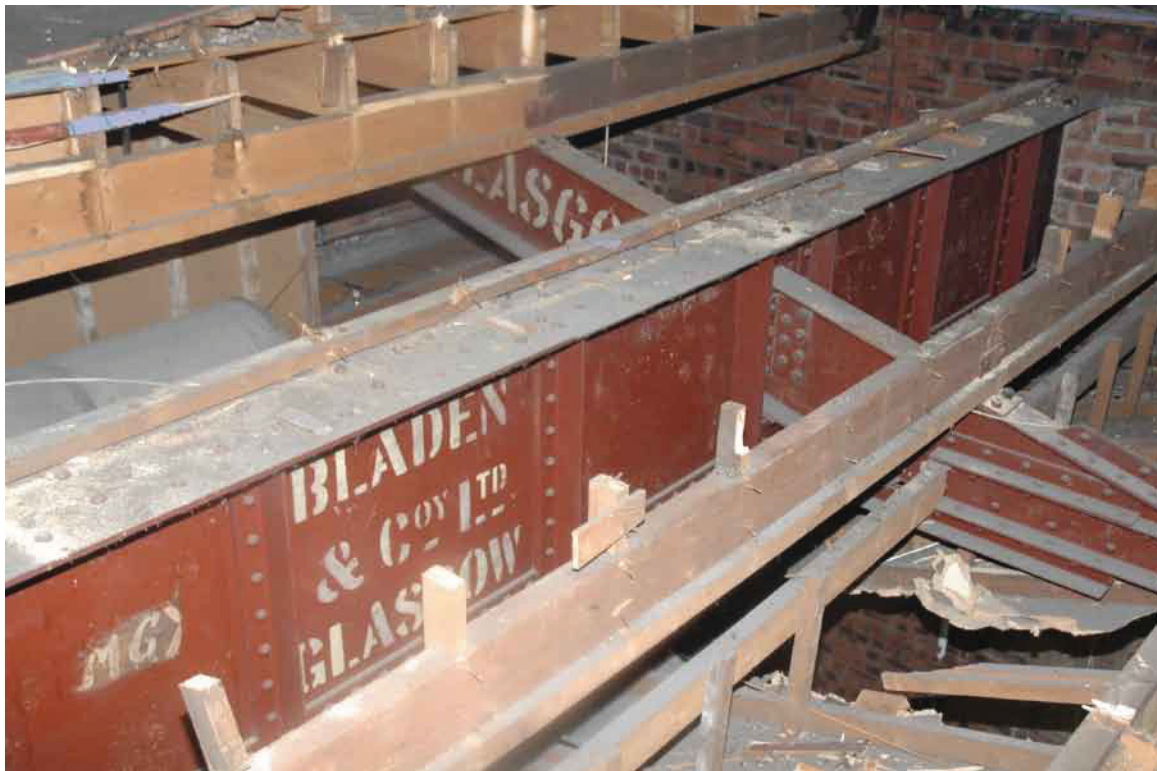
- 4.4.5 The balcony (Figs 13 & 14) extends from the south elevation and occupies the entire width of the hall. It slopes down in stepped seating platforms and is accessed by a central stair which opens to a flat landing running the full width of the balcony and has a fire exit on the east elevation. The balcony is built of timber on an iron girder frame which has the maker's name painted: "Bladen & Co, Glasgow" (Fig. 27). The balcony is carpeted and decorated with a gold-coloured metal rail on the balustrade.

Fig. 27 View of girders within balcony structure (Unit 1)

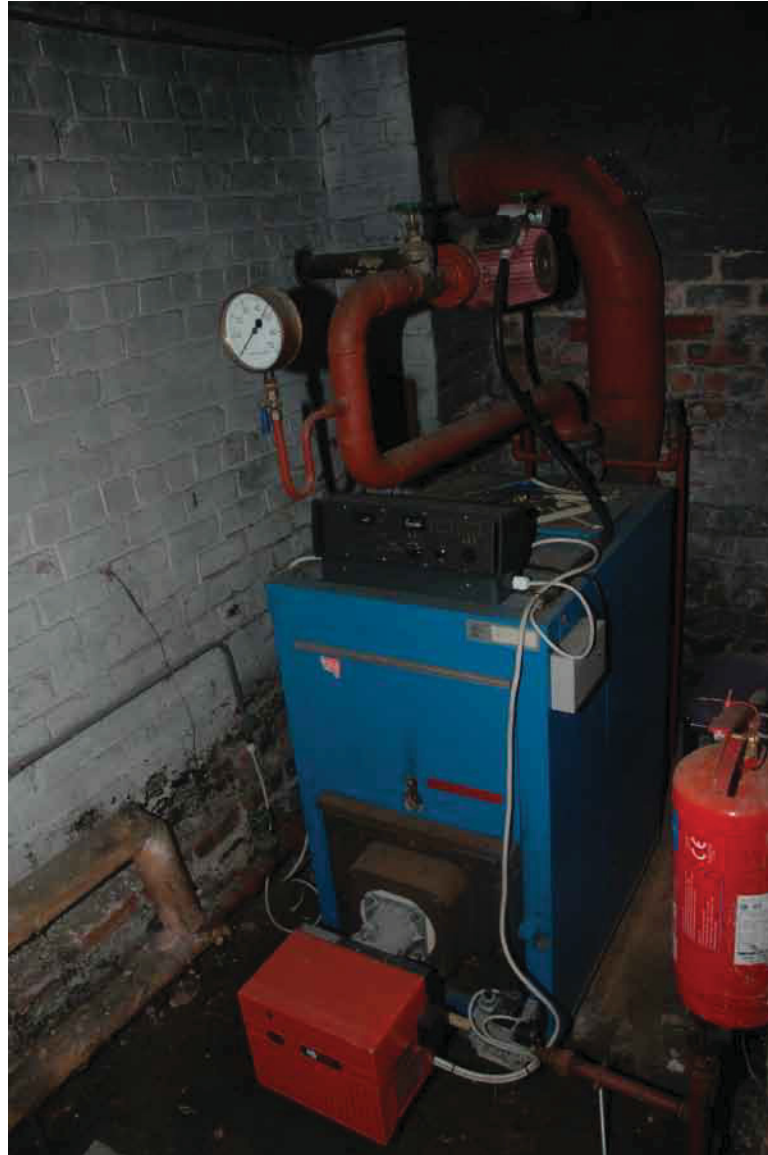
- 4.6.6 The boiler room (Fig. 27) is located on the north side of the building and forms a large brick-built lean-to on the exterior north facing elevation. On the exterior it is roofed with corrugated asbestos panels and has a chimney extending to just above the line of the pitched roof. The interior has a concrete floor and bare brick walls, partially whitewashed.

Fig. 28 View inside boiler room (Unit 19)
