**Former Railway Station, Macmerry,  
East Lothian  
Archive Assessment, Photographic Survey  
and Watching Brief**

**Data Structure Report  
No. 1866**

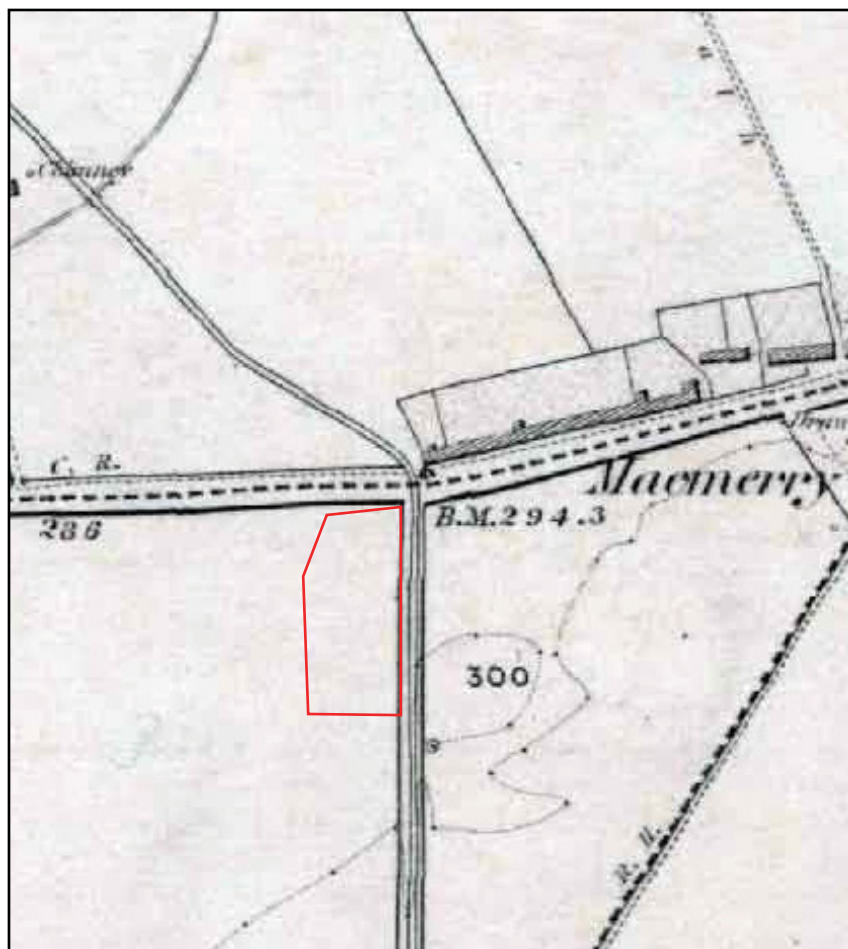
The First Edition Ordnance Survey 6" map of 1854 (Fig. 2A) shows the site to be an empty field with a track running north to south along its west edge which crosses the main road and continues north-west.

Fig. 2a - Site location on 1854 Ordnance Survey map

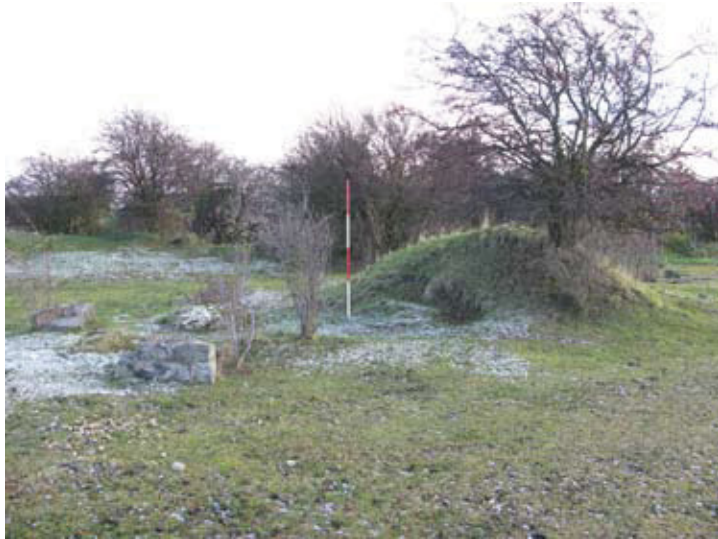
Spoil heaps including one containing sections of track and related debris were present across the site (Fig. 7). The tops of brick piers survived toward the north-west of the area and the overgrown and crumbled remains of a tarmac surface occupied much of the centre of the site.

Fig. 7 - View of spoil heaps from the north-west (Position 8)

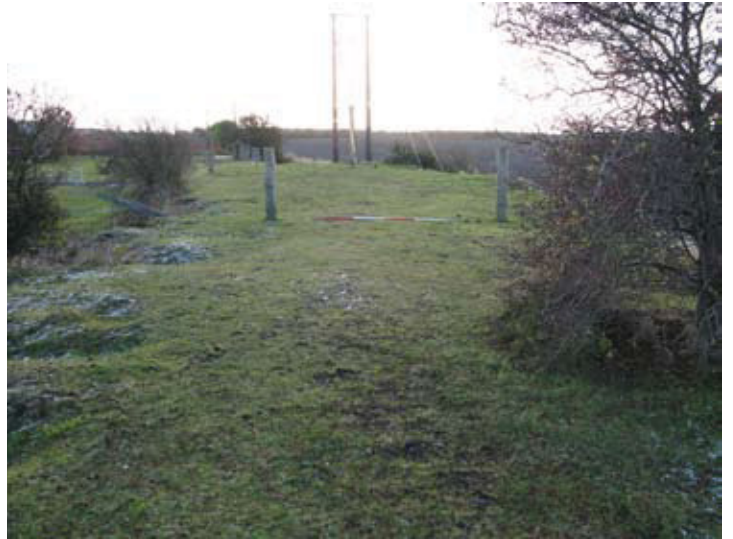
Several elements of the former railway station survived. A platform survived in good condition along the west edge of the area (Fig. 8, 10-11), and the main embankment was visible running for the entire length of the development area (Fig. 9) down the east side of the site, although it was heavily overgrown with self seeding trees, brambles and other vegetation. The remains of a brick structure were visible on the embankment (Fig. 12).

Fig. 8 - View along platform from the north (Position 12)

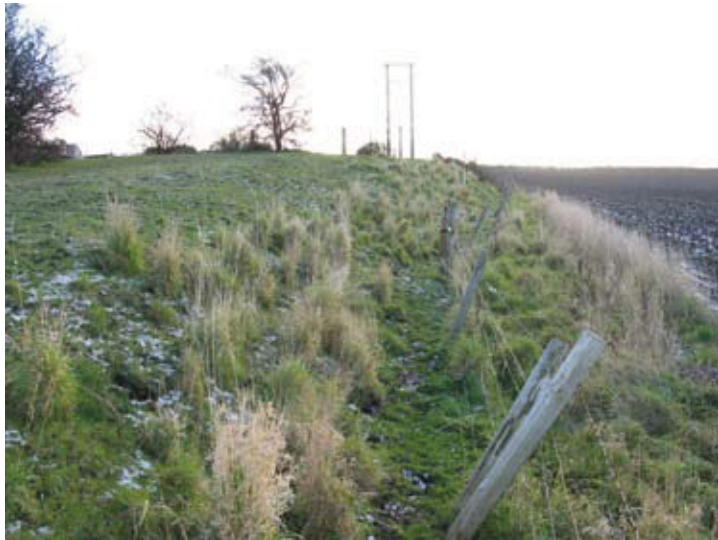
Fig. 9 - View along embankment on west side of former station (Position 14)

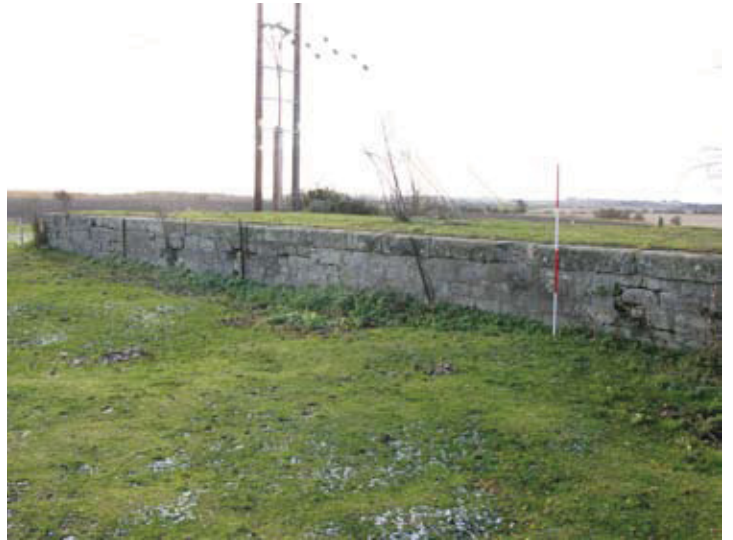
Fig. 10 - View of railway platform (Position 17)

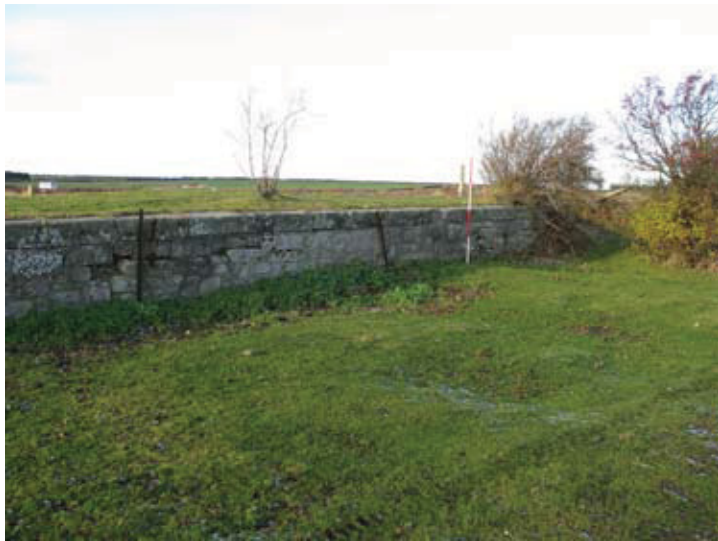
Fig. 11 - View of railway platform (Position 18)

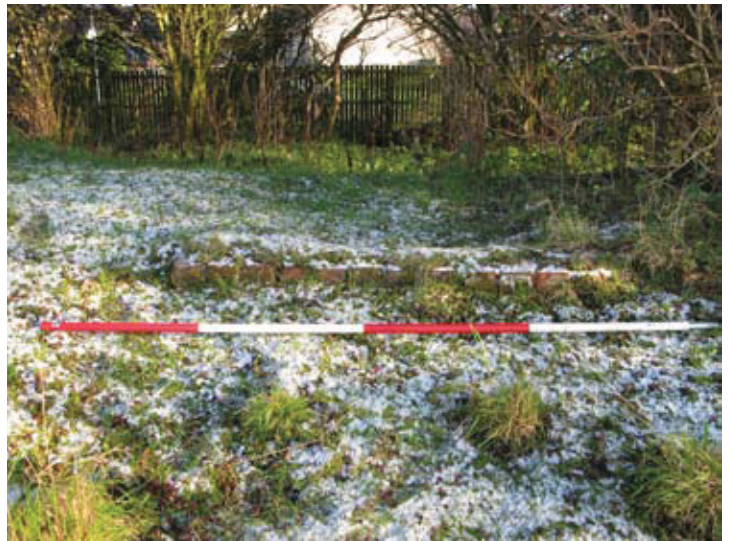
Fig. 12 - Brick structure in situ on embankment (Position 21)

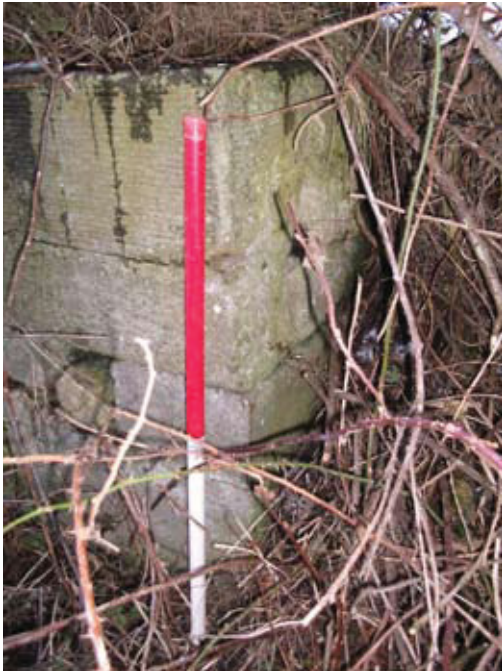
Fig. 15 Detail of railway platform stonework

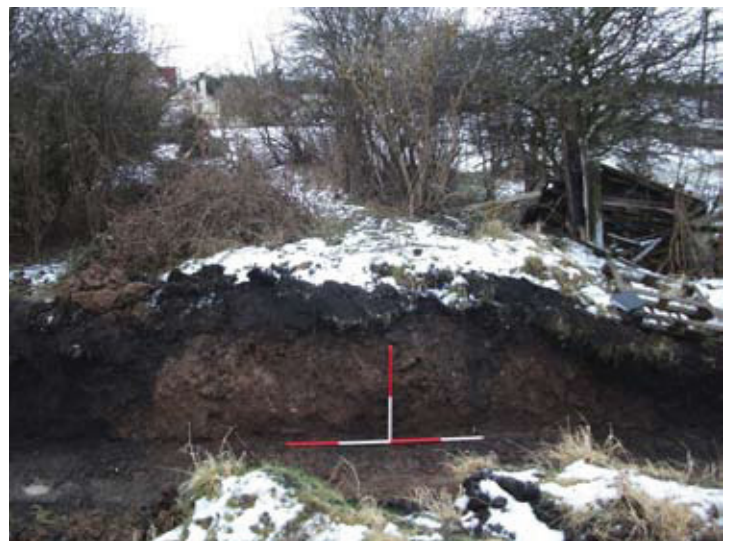
Sections cut through the embankment showed it to be built from a 1.1m high and 5.6m wide clay core underlying c. 0.4m of accumulated topsoil (Fig. 16).

Fig. 16 North-facing section through railway embankment

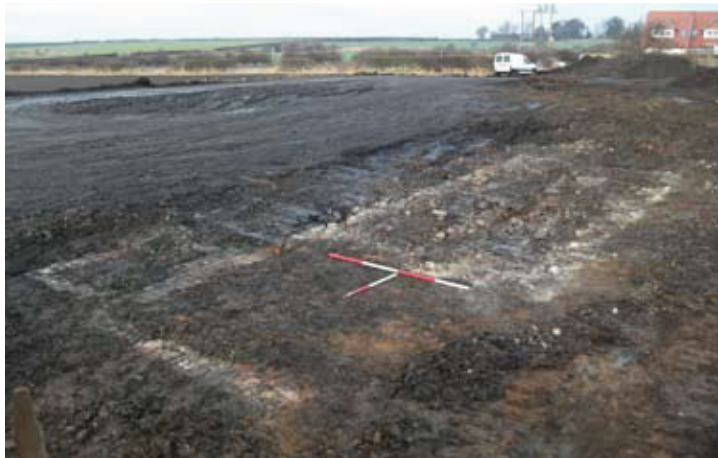
Wall footings were revealed mid-way along the main platform and situated on its west side (Fig. 4, 17). They formed a rectangular footprint built from sandstone blocks and measured 8.25m by 3.7m with 0.5m thick walls. A brick-built extension was butted against its south end, forming a 3.35m by 2.85m structure which opened out to the east.

A smaller brick footing was situated on the west side of this, measuring 1.45m by 2.5m. A ceramic drain stub was revealed within the smaller brick structure, indicating that it may have been a toilet.

Fig. 17 Structure A from the south-east

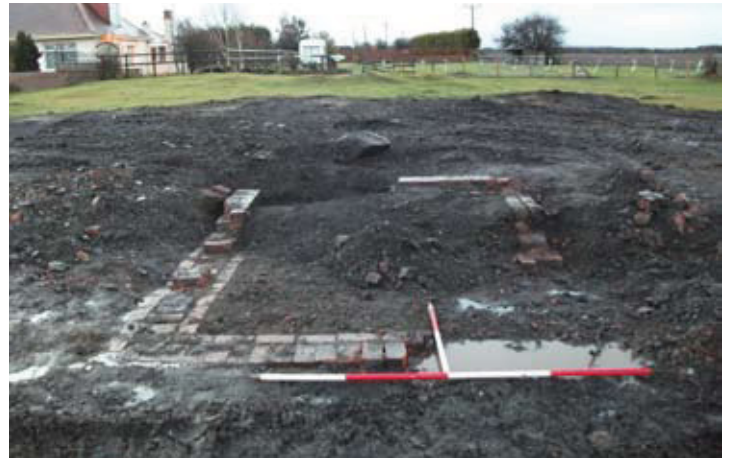
The remains of a small sub-square brick-built structure surviving up to four courses high were revealed (Fig. 5, 18). The structure measured 3.5m by 3.1m and was dry constructed with no bonding material evident. Possibly it was the remains of a storage

bunker; the insubstantial build would suggest it did not have any load bearing purpose.

Fig. 18 Structure B from the north

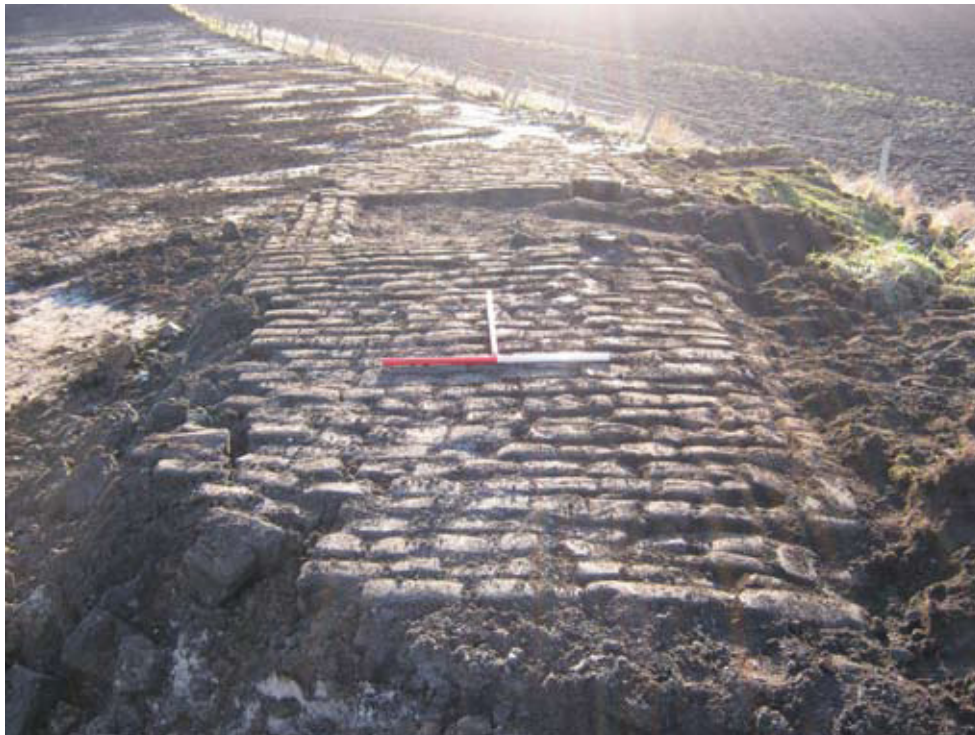
The remains of a cobbled surface were uncovered towards the north-west edge of the development area, situated on the edge of the embankment (Fig. 19). It measured 8.5m by 2.85m but had been damaged or robbed so may have extended further. A square gap infilled with soil and ash was set into the centre of the surface. The cobbles were set on a bedding layer of sandy clay and a lime mortar-rich clay matrix.

Two associated brick-built piers, measuring 1m square and 0.5m deep, were set into the slope of the embankment. Their substantial build indicates that they acted as shear keys for the cobbled surface.

No trace or indication of any upstanding structure was revealed and it seems likely that the cobbled surface formed an uncovered area of hard standing for storage or movement of materials, although it is unclear exactly what.

Fig. 19 - Structure C from the north

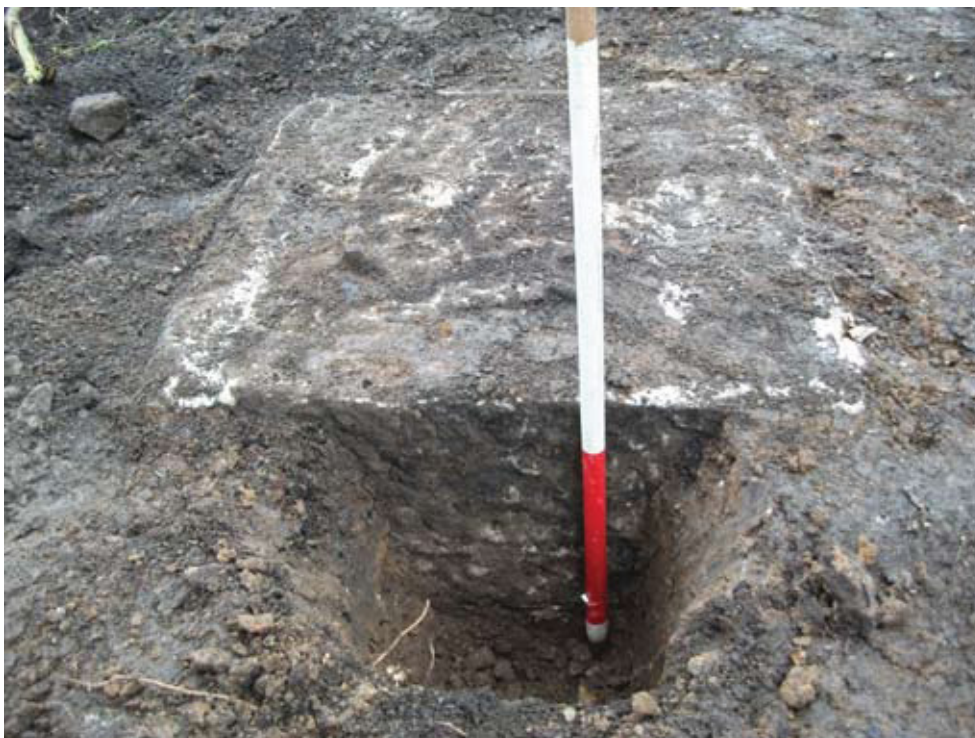
A single large dressed sandstone block was found set into the surface of the clay core of the railway embankment (Fig. 20). It measured 1m square and was 0.4m deep. It had two parallel rows of four bolt stubs set into the upper surface. It most likely was a holding-down block for a platform structure, although it did not appear to be substantially rooted enough for any heavy lifting or supporting use.

Fig. 20 - Structure D from the south
