**Clyde Wind Farm Cable Route:
Site 20, Near Crawford,
South Lanarkshire**

**Archaeological Excavations
Report No. 1807**

Author	Stuart Mitchell MA AIfA
Illustrator	Graeme Carruthers MA MAAIS
Editor	Melanie Johnson MA PhD FSA (Scot) MIfA
Commissioned by	Scottish Power Energy Networks
Date issued	February 2011
Version	3
OASIS Reference	cfaarcha1-94108
Planning Application No	N/A
Grid Ref	NS 9634 1864

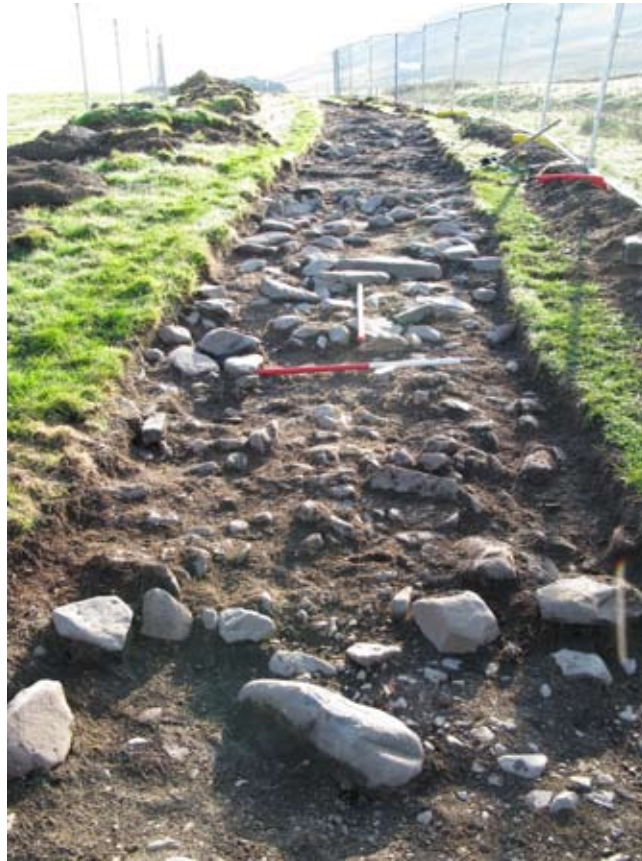
Fig. 15 General view of stone spread (134)

- 3.2.7 A large spread of stones (**134**) was situated downslope of the Roman Road, covering an area measuring c.7m long and the full width of the trench (Fig. 15). It comprised medium and large sub-angular stones and cobbles, and included a possible cup-marked stone. It was set directly onto the natural subsoil surface. The old ground surface layer visible under the road was not present.
- 3.2.8 The spread had no clear form or shape; its continuation could be faintly traced outwith the trench but without any definitive clarity. The stones were not densely packed like the Roman Road foundation layer, and mostly lay in a single layer up to 0.2m thick (Fig. 16). It was sealed by the surface turf and topsoil. It is suggested that this may have been a stockpile, dumped by stone gatherers delivering stone to the road builders at convenient intervals along the road's route.

- 4.3 A large spread of stones was excavated downslope to the road. This had no structure and the stones were loosely spread. It is not entirely clear what it is, although it is clear that the stones have been imported and dumped, so it is possible that the spread represents a stockpile of material for road building or maintenance.

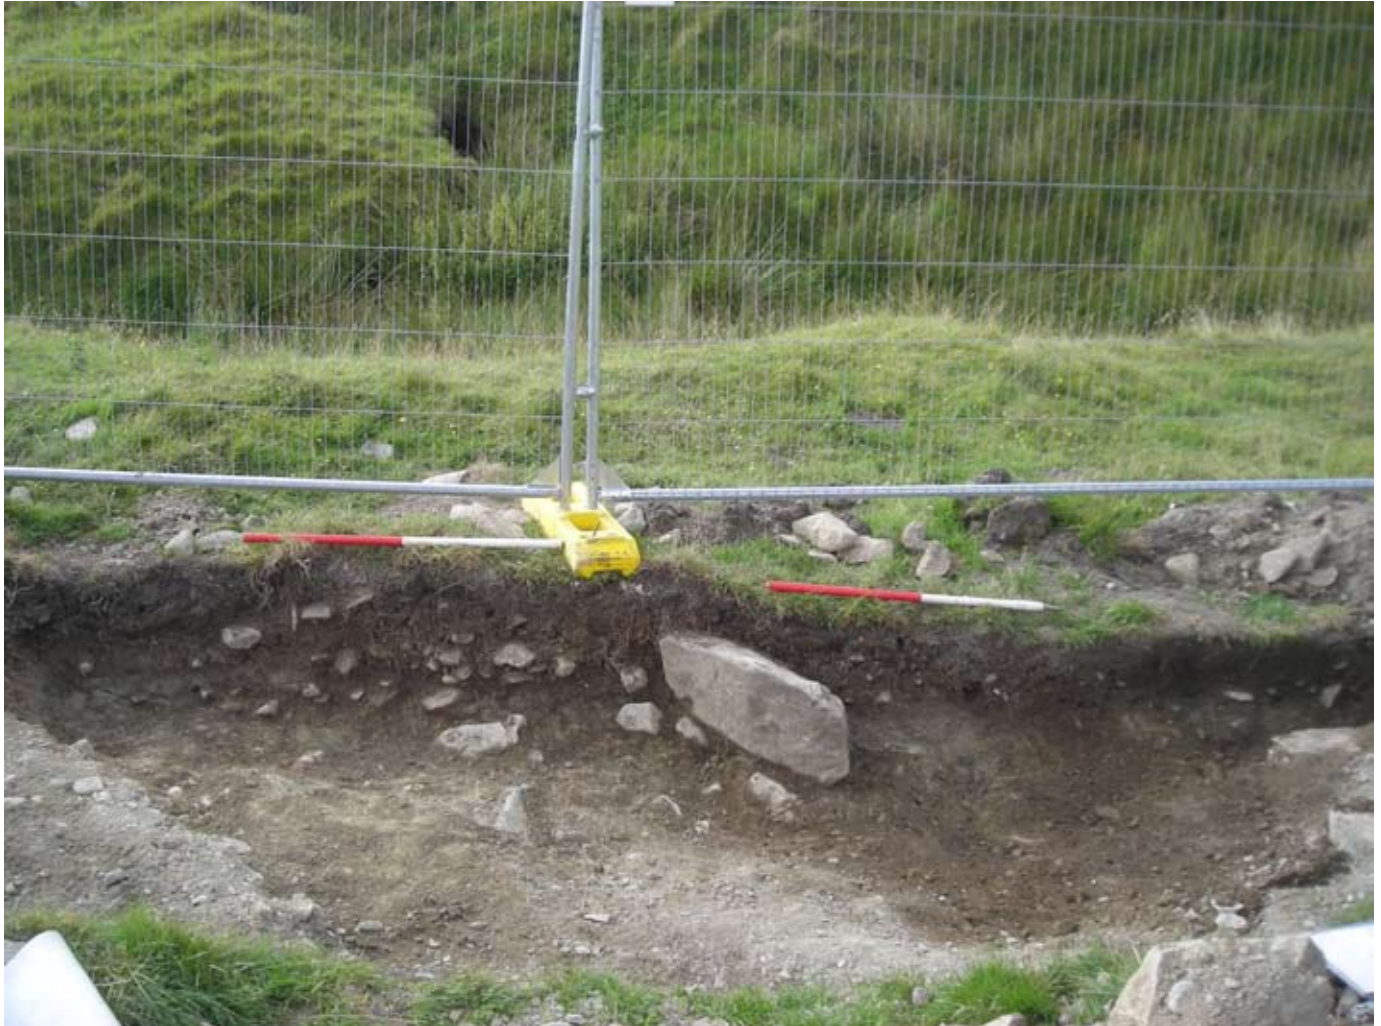
Fig. 17 Section of (130)

- 3.2.9 An irregular feature which crossed the trench downslope from the road and the spread was sectioned and shown to be part of a probable pit. The cut (**130**) was 2.3m wide and 0.4m deep with shallow sides and a flattish base (Fig. 17). A single large boulder was situated in the base, and the fill (**131**) comprised dark brown silt. It appeared to continue as a linear cut to the north-west although this was very shallow and irregular and is probably a result of groundwork around the pit at its time of excavation. A mound of gravel and soil (**136**) lay nearby, sealed by topsoil; most likely upcast from the pit. The purpose of the

pit is not entirely clear, although it seems most likely to be a quarry for gravel or small stones. It could also be a refuse pit although the uniform nature of the fill and its similarity to the overlying topsoil do not suggest this.

- 4.4 Part of a possible pit lay within the trench. Excavation showed it to contain a single large in situ boulder, too large for use in the Roman road, thus it is interpreted as a possible quarry pit. While it would appear to be a simple matter to source stones from the nearby river Clyde, the inclusion of what appear to be cup-marked stones in the road and the spread point to robbing stones from earlier monuments and structures, thus a pragmatic methodology for sourcing stones may be reflected here.
