Dalgig Farm, New Cumnock, East Ayrshire Archaeological Evaluation

**Data Structure Report
No. 1863**

Author	Stuart Mitchell MA AIfA
Illustrator	Leeanne Whitelaw BSc MAAIS
Editor	Melanie Johnson MA PhD FSA Scot MIfA
Commissioned by	Kier Mining Ltd
Date issued	February 2011
Version	0
OASIS Reference	cfaarcha1-94193
Planning Application No	06/0538/FL
Grid Ref	NS 558 129

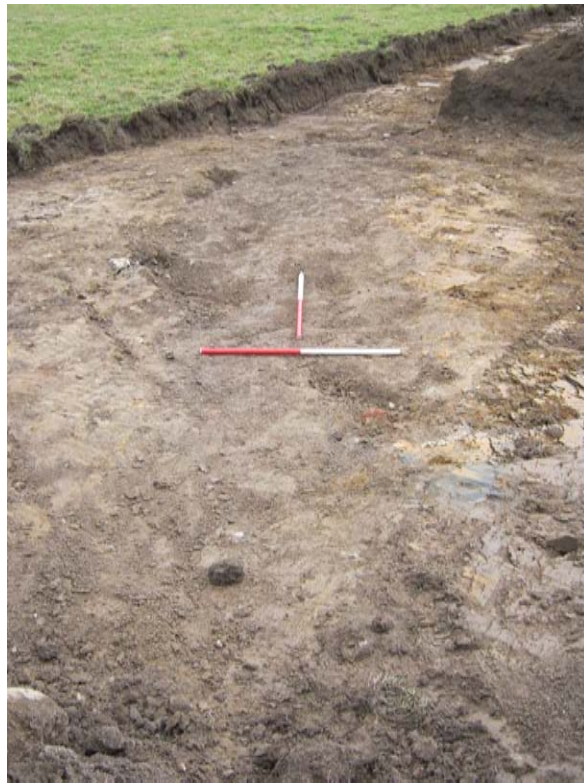
A 1.2m wide linear ditch (**201**) was revealed in Trenches 1, 2 and 3 (Fig. 2). Trench 2 was boxed out to give sufficient view of the ditch's character. A section showed the ditch to be 0.25m deep with sloping sides and a slightly concave base (Fig. 3). The fill (**202**) was compact grey silt indistinguishable from the base of the topsoil. Several fragments of 19th century pottery were recovered from the fill. Most pottery fragments came from a depth within the fill which was sufficiently secure to suggest that the

Fig. 2 Ditch (201) pre-excavation

ditch was not of great or significant antiquity. It is likely to have been a ditch dug for drainage as it was aligned at roughly 45° to the slope.

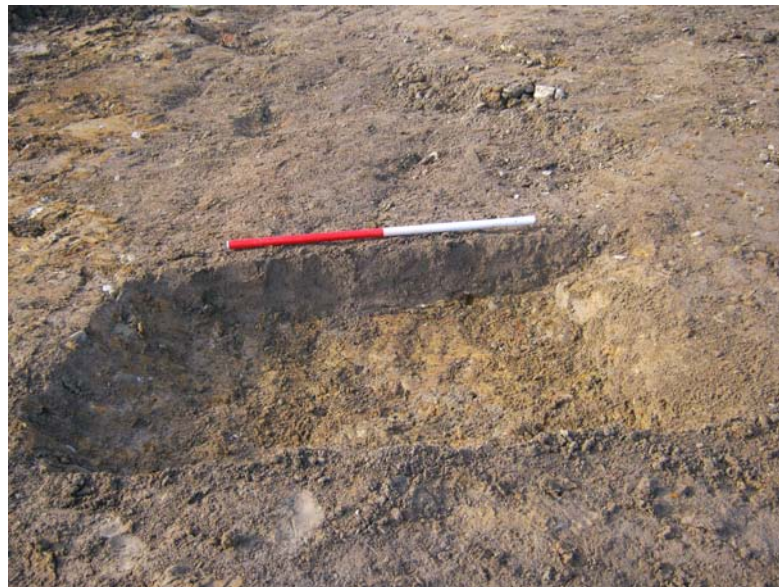
Fig. 3 Ditch (201) in section

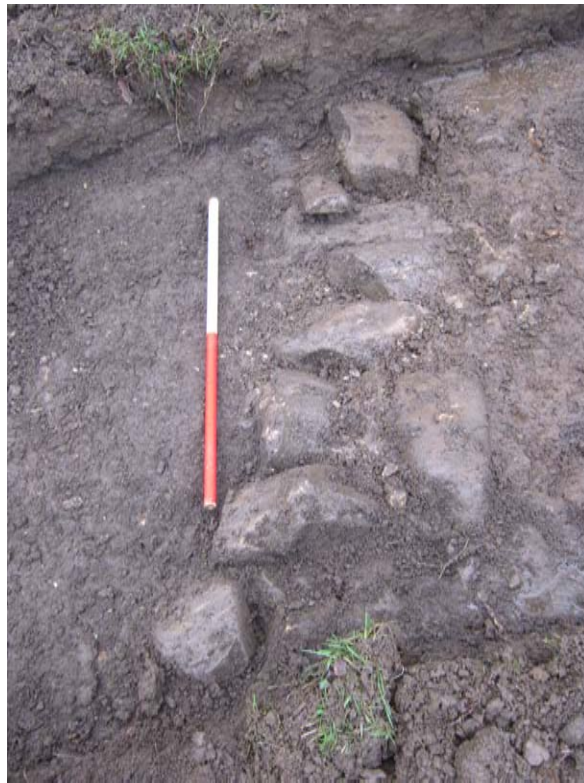
The footing of a garden wall (2201) was revealed in Trench 22 (Fig. 4). It comprised a single surviving course of loose rough stones set onto the surface of the natural subsoil. No mortar residues were identified so it is likely that the shallow foundation and the dry construction of the footing, if not the former wall, indicate an insubstantial and decorative garden wall.

Fig. 4 Wall footing remains (2201)

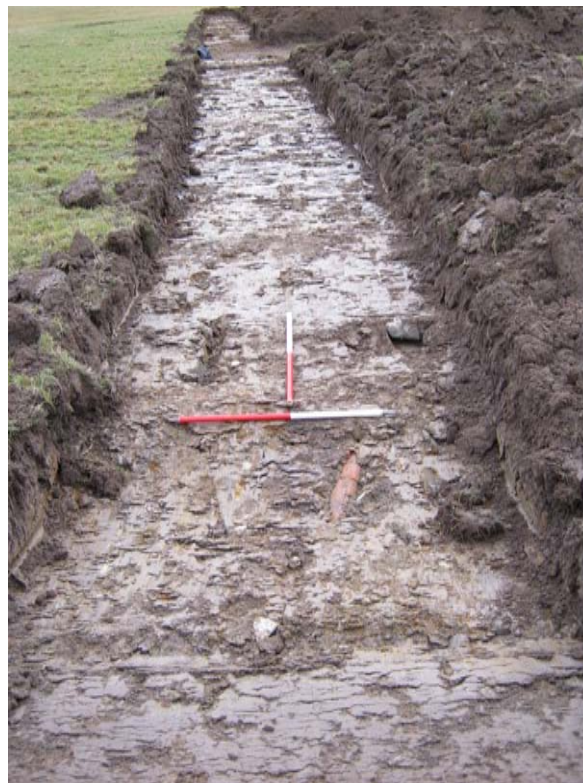
Fig. 5 Trench 2

Trenches 1 to 16 were excavated on an exposed gentle slope with a south-east facing aspect, situated on the edge of the floodplain of the river Nith. Natural subsoil (**000**) was orange to pale grey sandy clay with frequent gravel and stones and occasional large rounded boulders. Topsoil (**001**) in the trenches varied from 0.3m to 0.4m thick. No archaeological remains or deposits were discovered in any of those trenches except Trench 2, which contained a linear ditch.

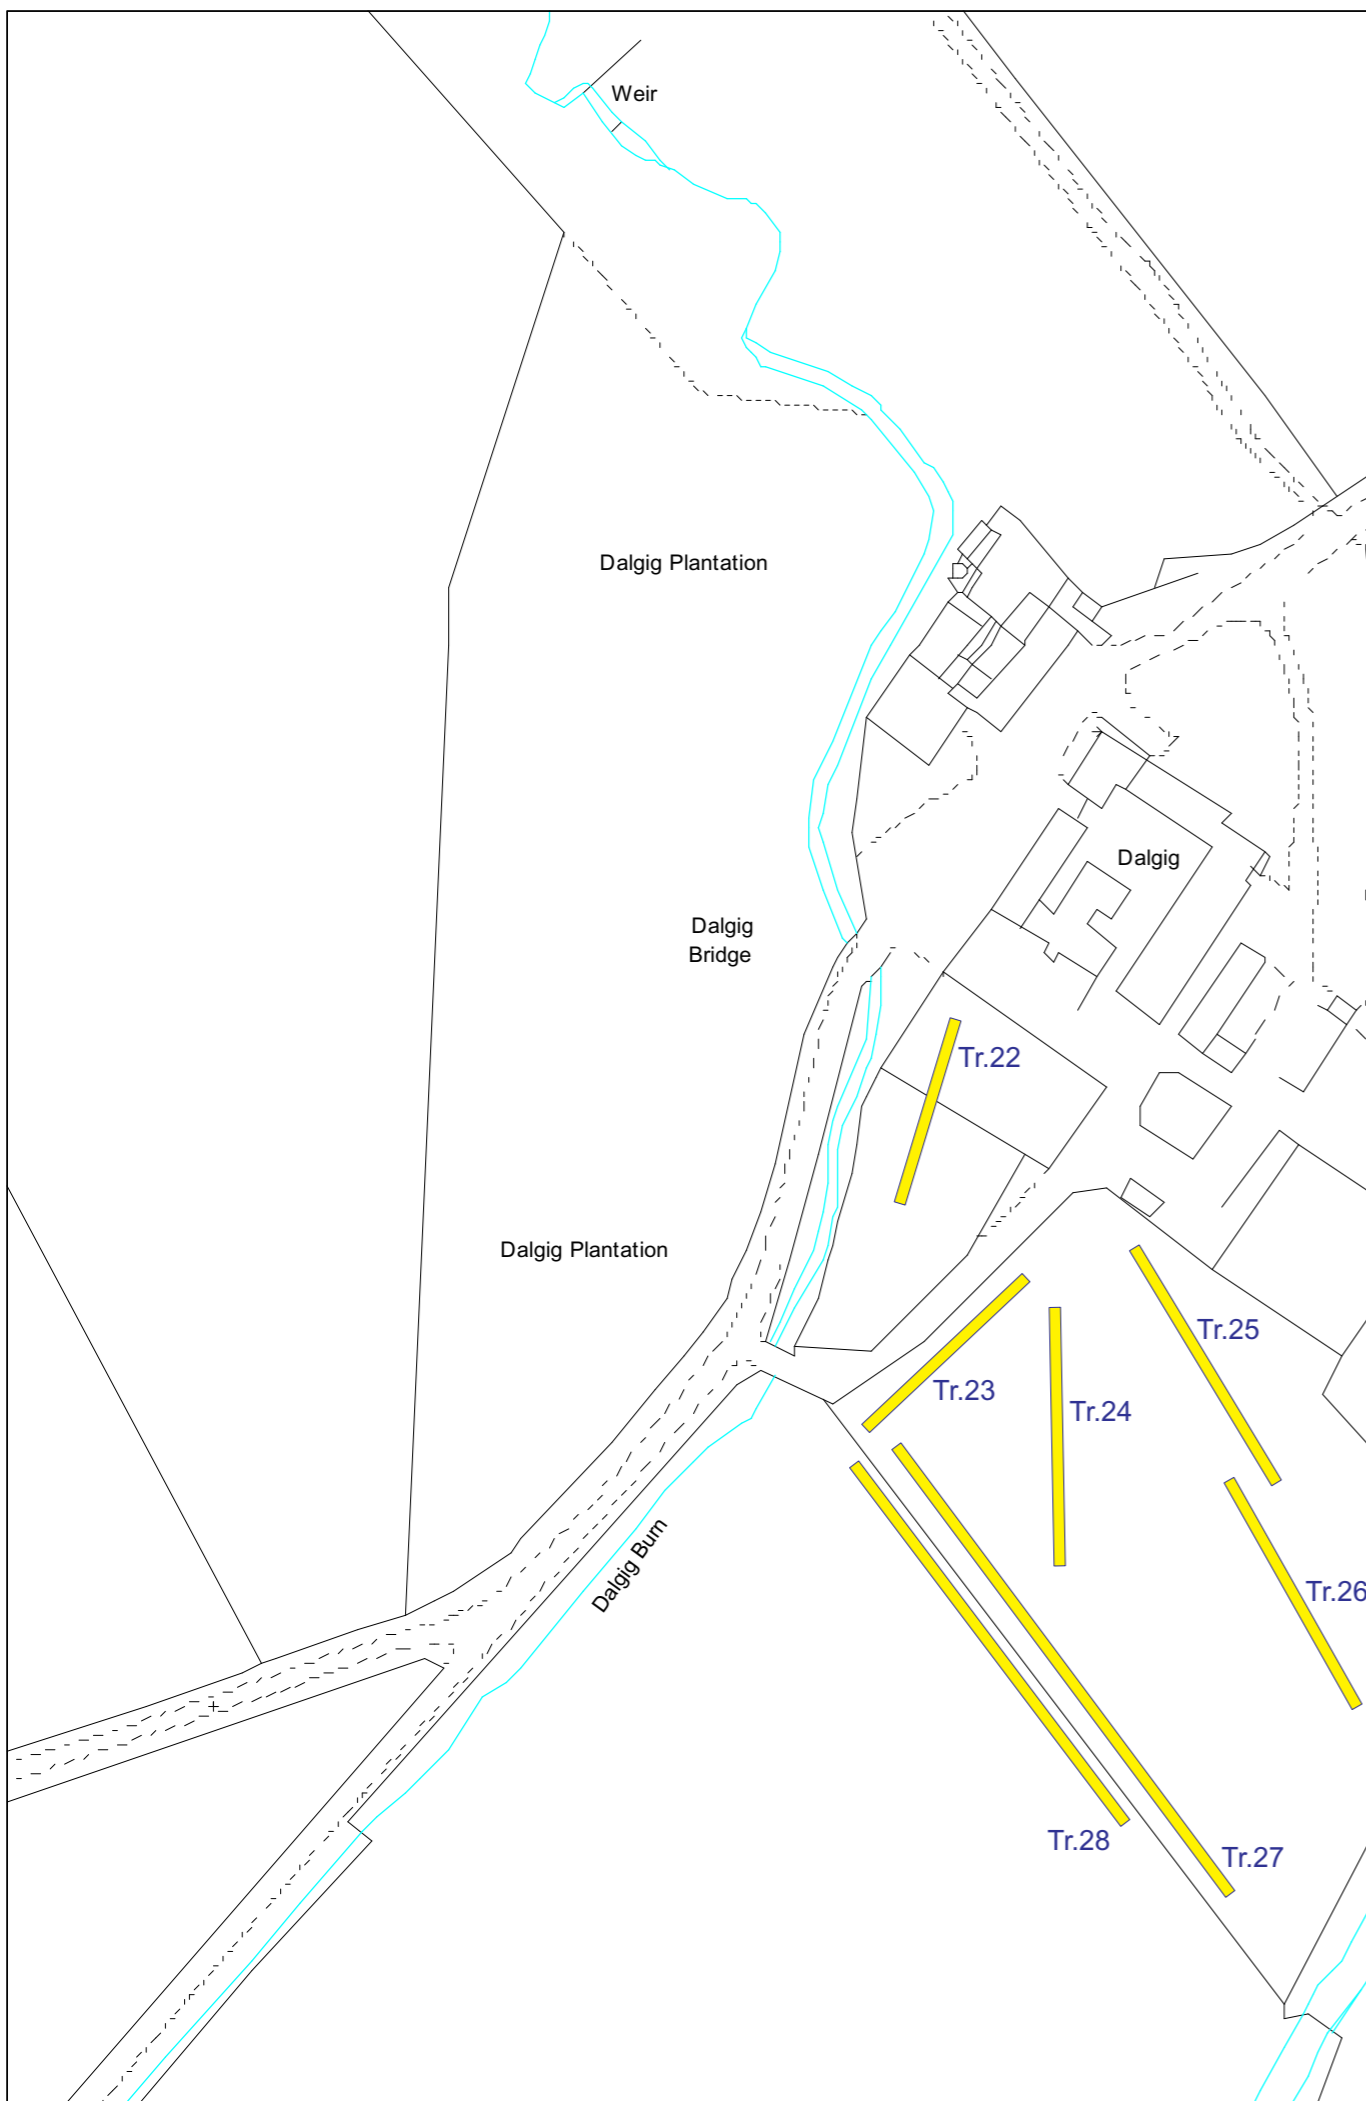
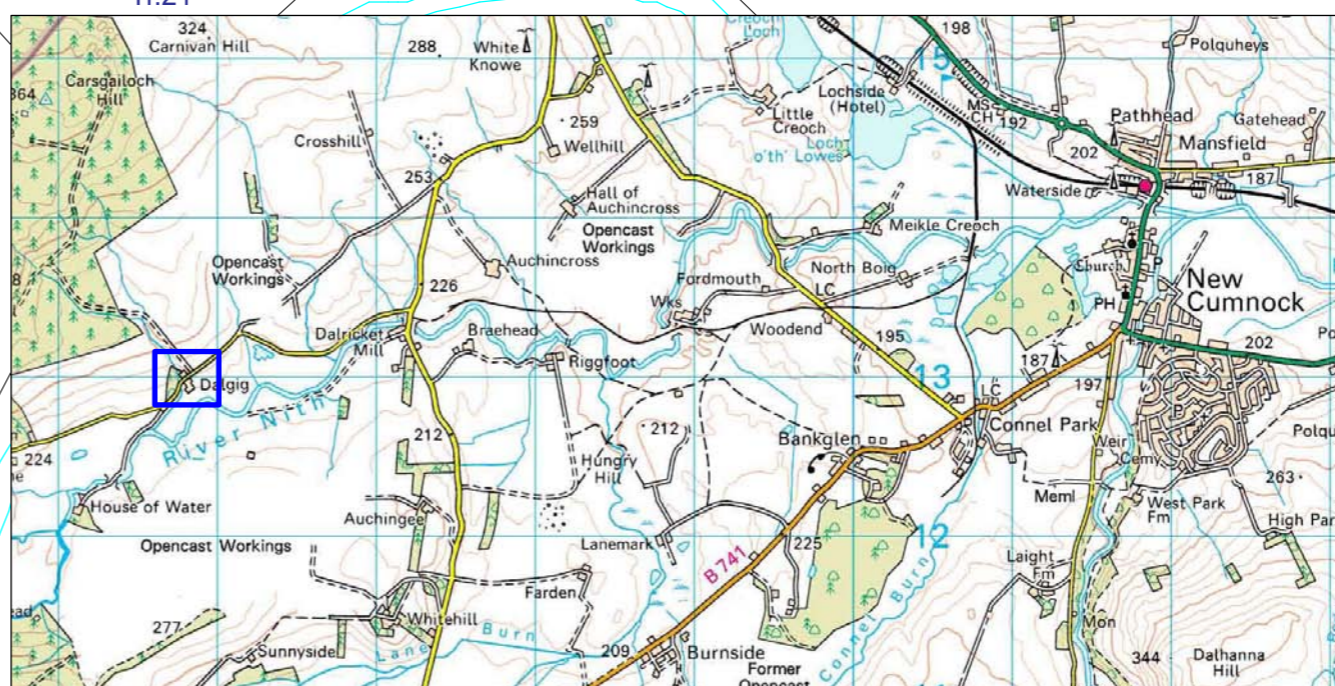
Fig. No: 1 Revision: A

Title: Site plan with trench layout

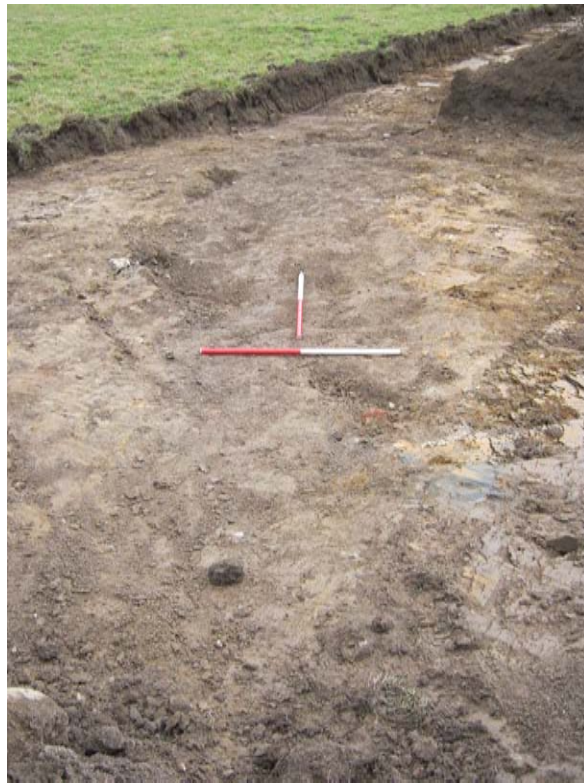
A 1.2m wide linear ditch (**201**) was revealed in Trenches 1, 2 and 3 (Fig. 2). Trench 2 was boxed out to give sufficient view of the ditch's character. A section showed the ditch to be 0.25m deep with sloping sides and a slightly concave base (Fig. 3). The fill (**202**) was compact grey silt indistinguishable from the base of the topsoil. Several fragments of 19th century pottery were recovered from the fill. Most pottery fragments came from a depth within the fill which was sufficiently secure to suggest that the

Fig. 2 Ditch (201) pre-excavation

ditch was not of great or significant antiquity. It is likely to have been a ditch dug for drainage as it was aligned at roughly 45° to the slope.

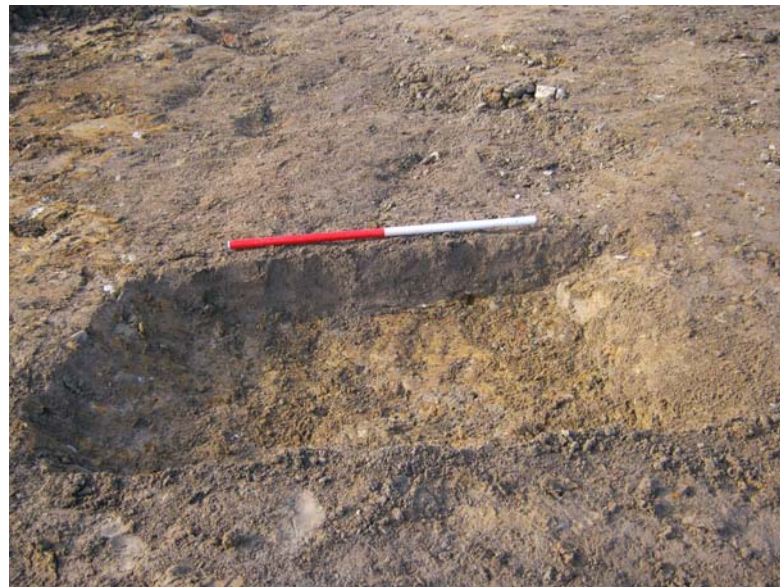
Fig. 3 Ditch (201) in section

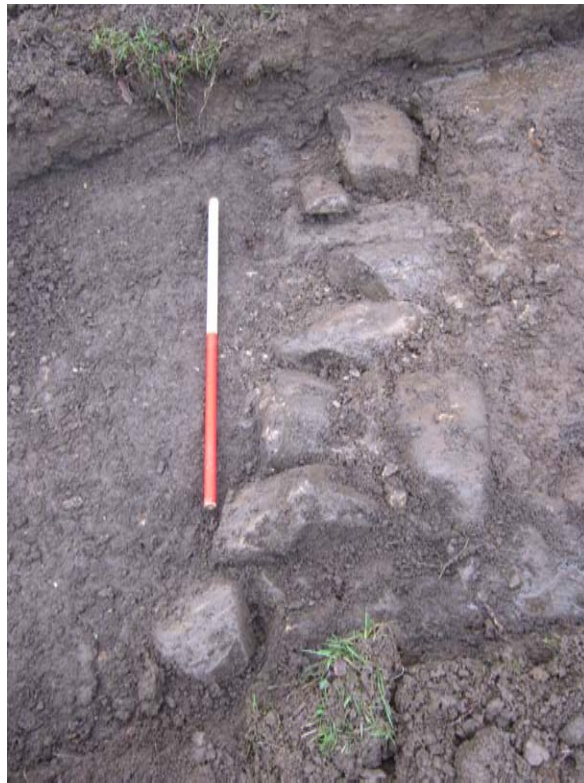
The footing of a garden wall (2201) was revealed in Trench 22 (Fig. 4). It comprised a single surviving course of loose rough stones set onto the surface of the natural subsoil. No mortar residues were identified so it is likely that the shallow foundation and the dry construction of the footing, if not the former wall, indicate an insubstantial and decorative garden wall.

Fig. 4 Wall footing remains (2201)

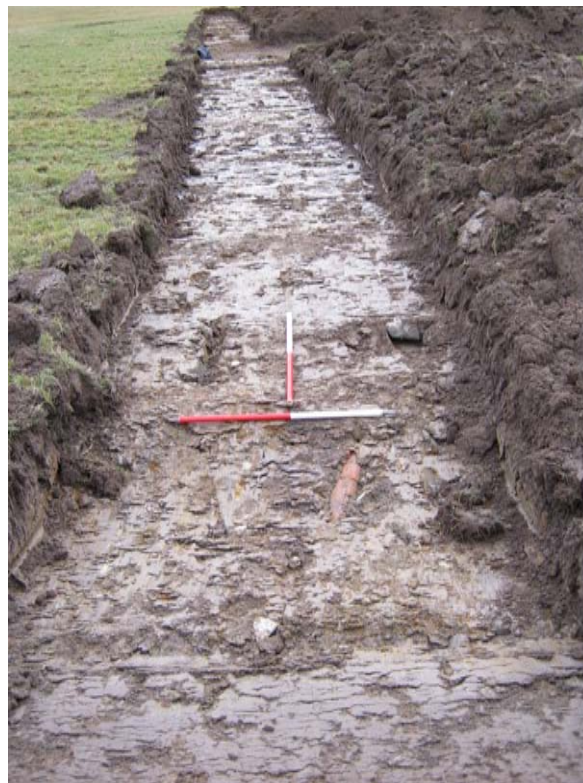
Fig. 5 Trench 2

Trenches 1 to 16 were excavated on an exposed gentle slope with a south-east facing aspect, situated on the edge of the floodplain of the river Nith. Natural subsoil (**000**) was orange to pale grey sandy clay with frequent gravel and stones and occasional large rounded boulders. Topsoil (**001**) in the trenches varied from 0.3m to 0.4m thick. No archaeological remains or deposits were discovered in any of those trenches except Trench 2, which contained a linear ditch.
