## **Dalgig Farm, New Cumnock, East Ayrshire Archaeological Evaluation**

### **Data Structure Report**

**No. 2023**

Author	Magnus Kirby MA FSA Scot AIfA
Illustrator	Graeme Carruthers MA MifA
Editor	Melanie Johnson MA PhD MifA
Commissioned by	KIER Mining Group
Date issued	March 2012
Version	1
Planning Application No	06/0538/FL
Grid Ref	NS 5577 1295

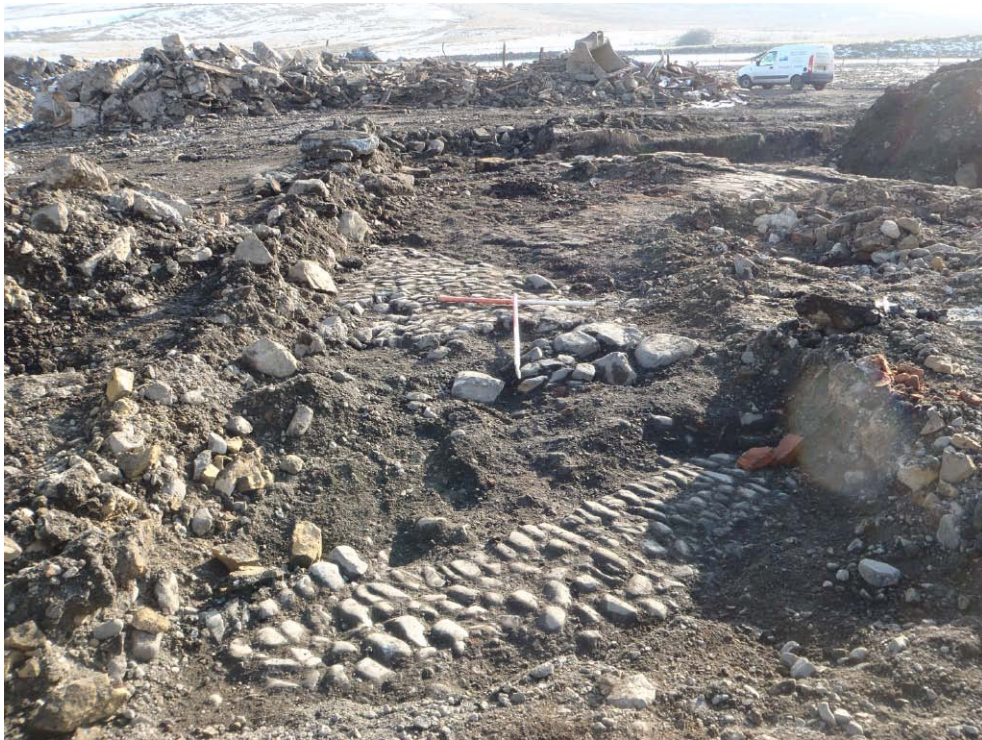
Fig. 7 Trench A showing cobbles 008 and brick surface 009

Fragmentary remains of cobble (008) and brick (009) surfaces were identified within the NW end of Trench A (Fig. 2 and Fig. 7). Some of the bricks were stamped 'LANEMARK' indicating that they were manufactured at the nearby Lanemark Brickworks. The surfaces sat on top of made ground (003) containing a high proportion of crushed ceramic field drain fragments. The fact that the surfaces overlay the made ground would indicate that they were fairly recent and are likely to represent the same phase of usage as the current buildings.
