**Old Belses Farm, Near Ancrum,  
Scottish Borders**

**Historic Building Survey**

**Report No. 1854**

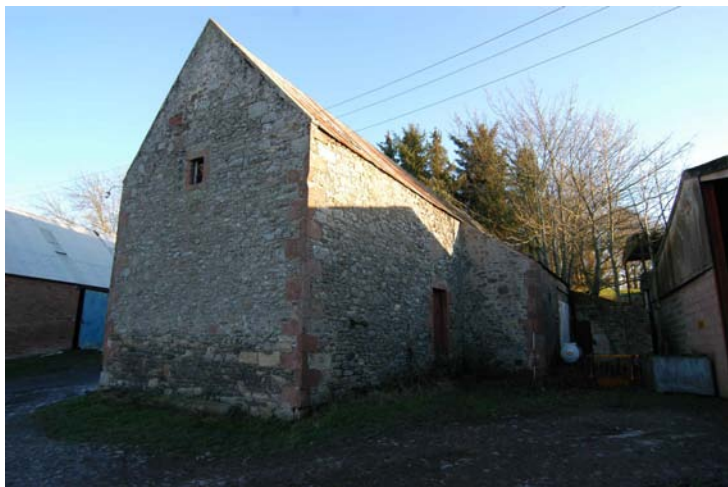
Plate 15-Building, 4, south-west facing elevation and northwest-facing gable

On the rear south-west-facing elevation there is single doorway at the west end of the main block (Pl.15). Adjacent to the doorway is an exhaust pipe associated with the interior grain silo (see below). A rubble-built outshot building is present with dressed sandstone surrounds and a cat-slide roof. A single doorway provides access to the outshot building. Attached to the outshot building is a roofless brick-built lean-to which houses a gas storage tank.

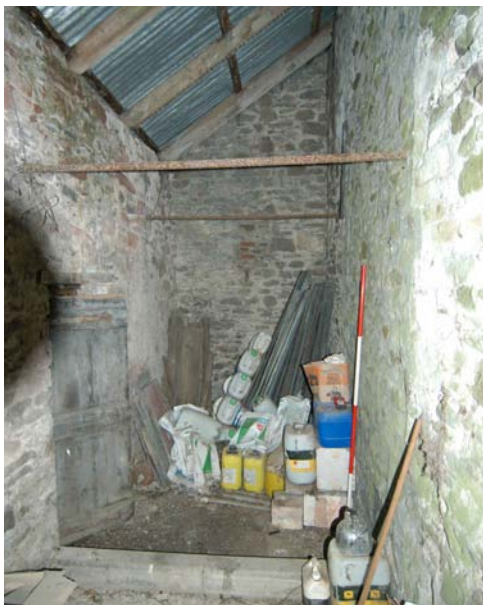
Plate 17-Building 4, interior of rear outshot building, roof detail

The interior of the outshot building (Pl.17) has cement-pointed rubble walls and is featureless with the exception of a blocked opening on the north-west facing elevation (Plate 18). The opening is situated 1.5m above the floor and measures 1m wide and 0.5m high and is blocked with five courses of red brick. The top of the opening has a segmented stone relieving arch and appears to be of some antiquity. It appears that the outshot building functioned as a wheel house when the building was a watermill. The outshot building is depicted on the First Edition Ordnance Survey map with a lade entering its south-west end. The covered wheel house would have made most efficient use of the water supply and drove a overshot wheel with water running over the top. Water-supply would have been via a wooden launder or trough.
