## **Carlinwell Standing Stone, Airlie, Angus**

### **Archaeological Investigation and Re-erection**

**Report No. 1875**

Author	Melanie Johnson MA PhD FSA Scot MifA with a contribution by Derrick Lyall
Illustrator	Leeanne Whitelaw BSc MAAIS
Editor	Bruce Glendinning BSc PGDip MifA
Commissioned by	Historic Scotland
Date issued	March 2011
Version	0
OASIS Reference	cfaarcha1-96094
Grid Ref	NO 3208 5025

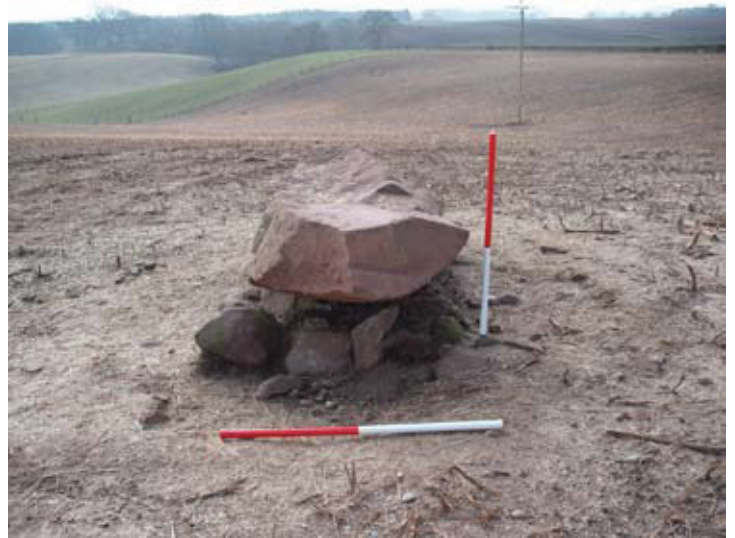
The prone stone was photographed and its position surveyed (Fig. 2-3) prior to it being moved to one side, away from the excavation area (Fig. 4).

Fig. 3a - View of prone stone in relation to exposed socket and packing stones from the north-east

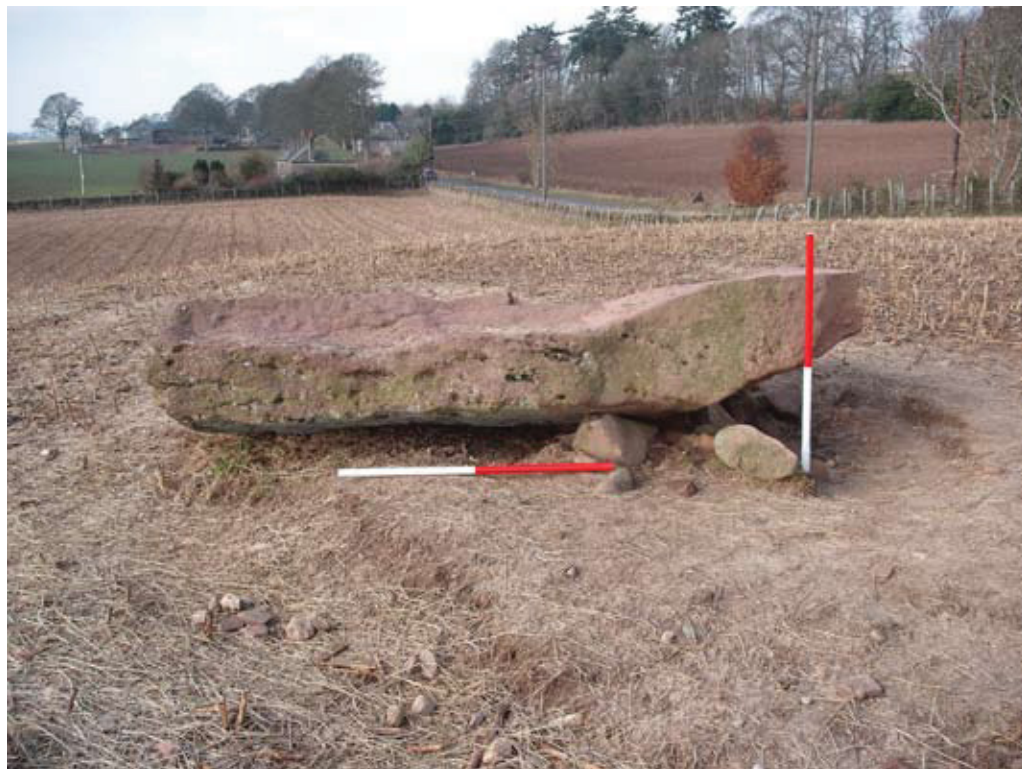
Fig. 3b - View of prone stone in relation to exposed socket and packing stones from the south-east

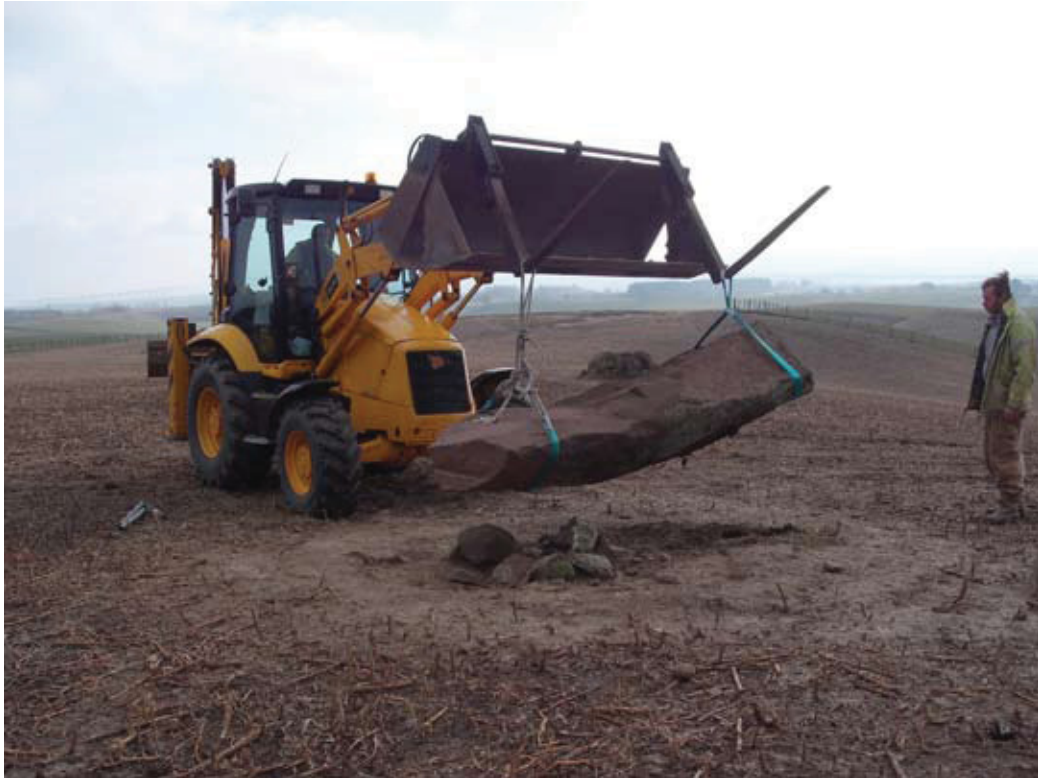
A scale plan was produced of the stone's prone position and a photographic record undertaken. The stone was then moved out of the way of the excavation area using a JCB 3CX type machine. The stone was moved no more than 5m to one side. This work was supervised by the stone masons.

Fig. 4 - Stone being moved prior to excavation

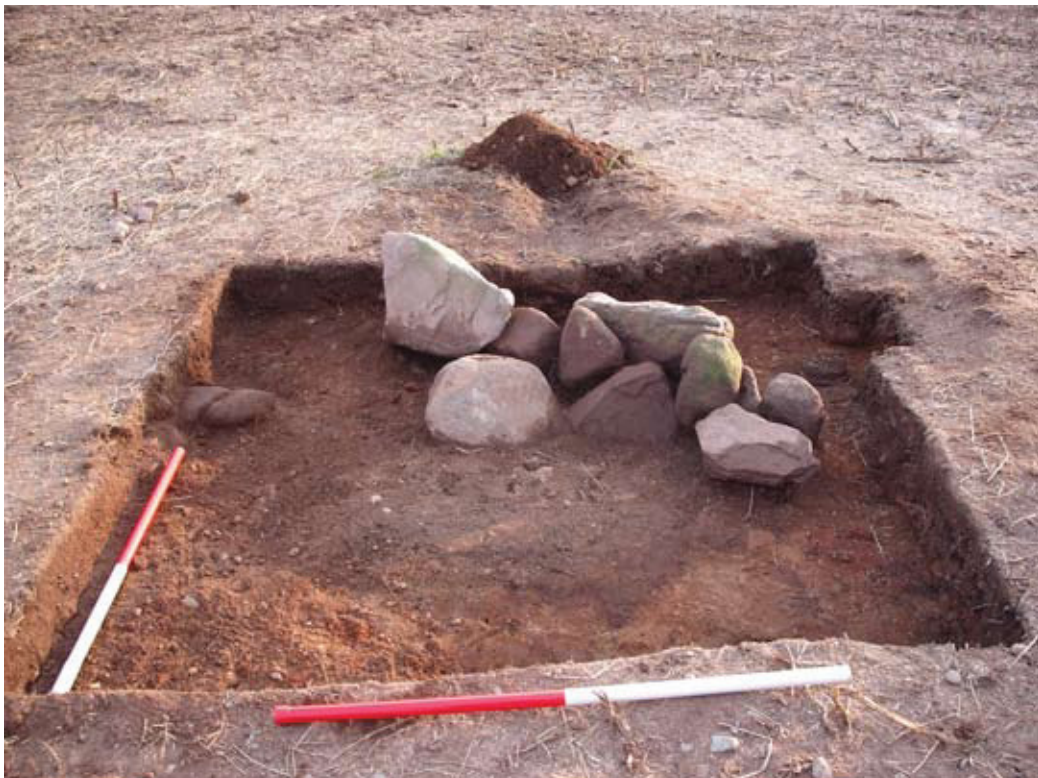
A trench measuring 2m by 2m was excavated, centred on the surface remains of the socket. Large packing stones were visible on the south side of the socket, protruding through the topsoil (Fig. 5).

Topsoil (**001**) was very stony and was shallow, measuring between 0.12m and 0.22m deep within the trench. The topsoil at the base of the toppled stone was very compacted from animal trampling. Natural subsoil (**000**) was orange sands and gravels. Some disturbance from animal burrowing was noted on the east side of the trench.

Fig. 5 - View of trench from north-east with topsoil removed

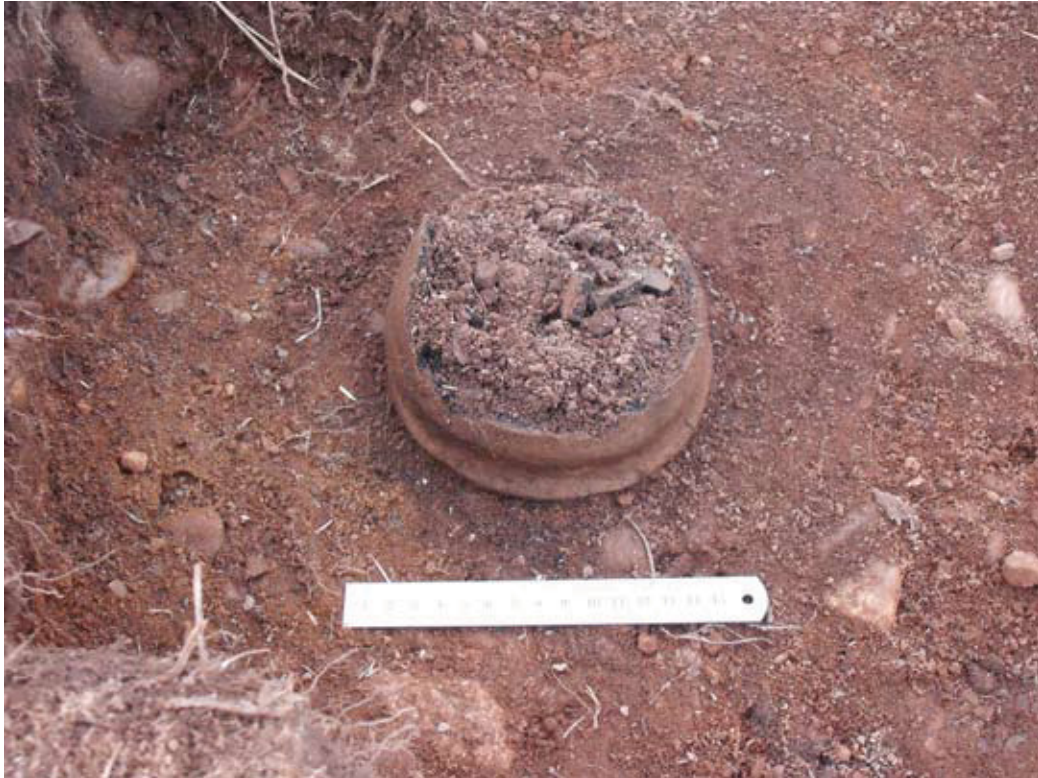
The urn was inverted and lay directly on the base of the cut (Fig. 6). The base of the urn was missing, probably due to ploughing action as the depth of topsoil over the vessel was only 0.1m. The urn was removed with its contents in place.

Fig. 6 - Urn SF1 prior to removal

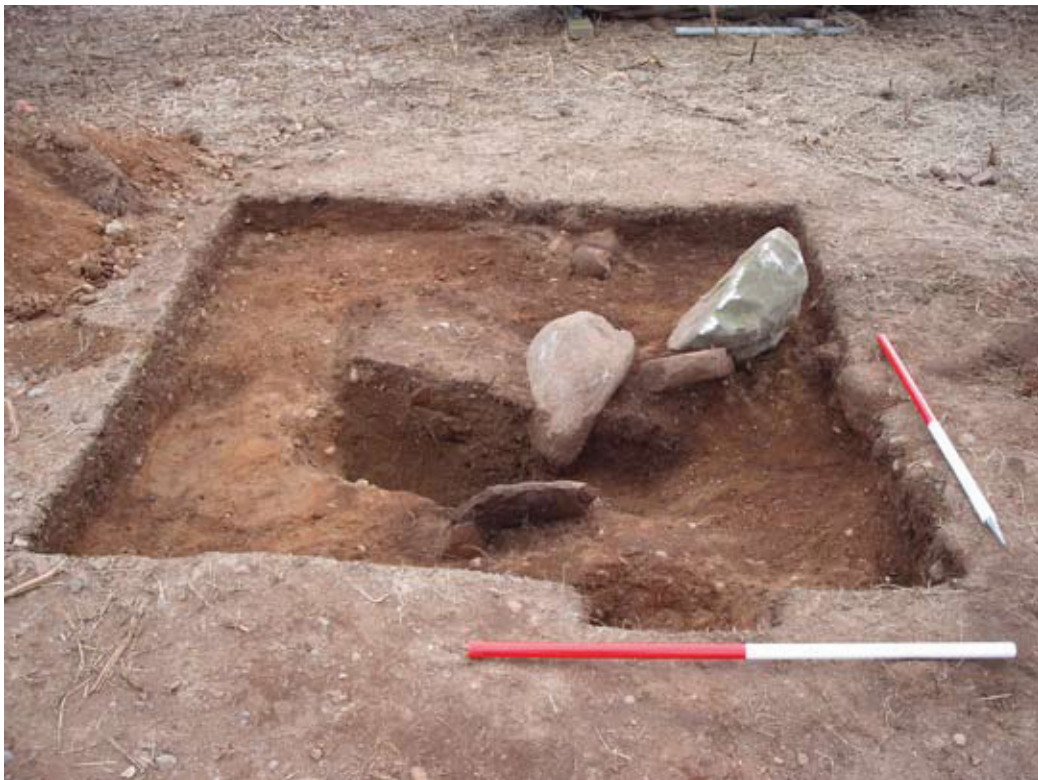
There appeared to be a re-cut to the pit on the south side, forming a shallow ledge on the south side of the socket measuring 0.7m by 0.4m in plan. The fill of this re-cut was indistinguishable from the rest of the pit's upper fill (**006**).

This re-cut appeared to contain the majority of the large packing stones (Fig. 7) and was possibly an attempt to shore up the stone and prevent it from toppling as the stone

had a significant lean to the south, the side where the packing stones were found. There was a noticeable absence of packing stones in the remainder of the socket.

Fig. 7 - Socket (002) half-sectioned from north-west, with SF2 visible and pit 003 fully excavated

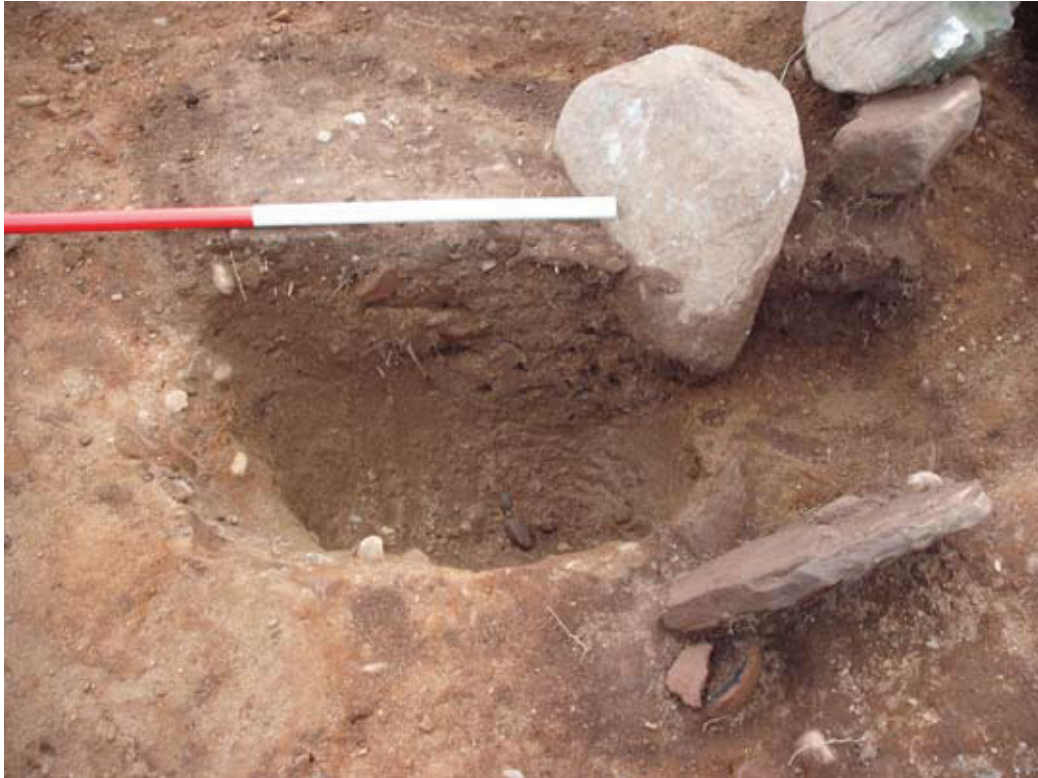
The pit and the vessel it contained were disturbed by a large flat packing stone which lay at an angle across the pit (Fig. 8). Collected behind this angled stone was a deposit (**005**) of possibly disturbed cremation material from pit **008**.

Fig. 8 - Section of socket (002) and pit 009 in plan with SF2 visible

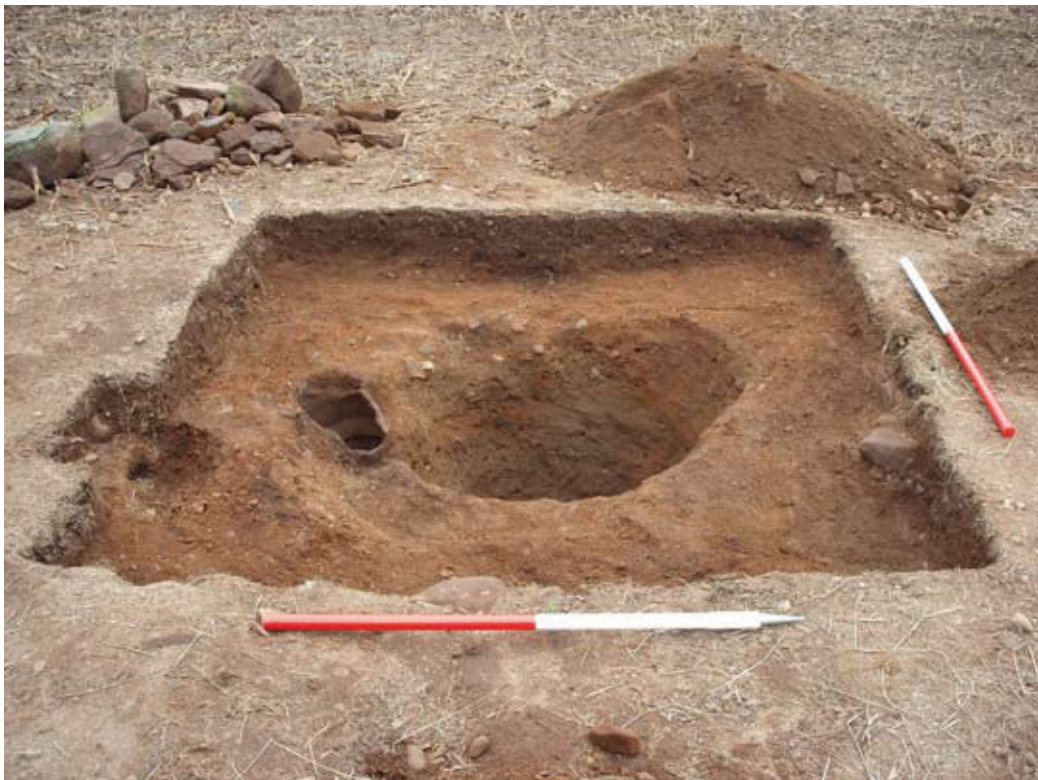
A pit (**008**) containing a cremation urn (SF2) was recorded on the west side of the socket (**002**) (Fig. 9). This pit measured 0.21m deep. It is not clear whether this pit cut or was cut by the socket (**002**) but on balance it seems more likely that **008** cut **002**.

Fig. 9 - Fully excavated socket (002) from south-west with SF2 visible

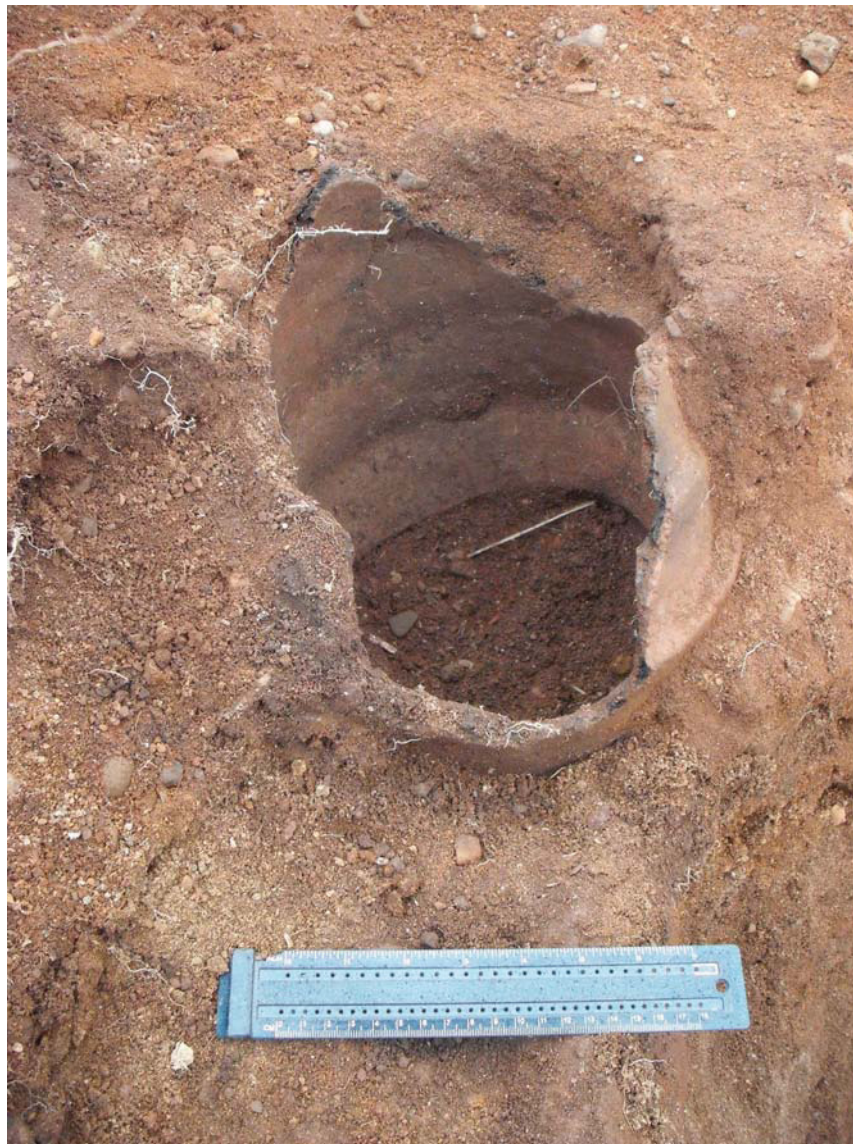
The vessel was inverted and lay directly on the base of the pit; it was at a slight angle within the pit rather than completely vertical, leaning towards the west (Fig. 10).

The vessel's contents were removed in three spits and sampled. There was an increasing quantity of burnt bone towards the rim of the vessel. Sherds from the lower wall of the vessel were found in the upper spit, where they had been pushed by the packing stone.

Fig. 10 - Urn SF2 prior to removal

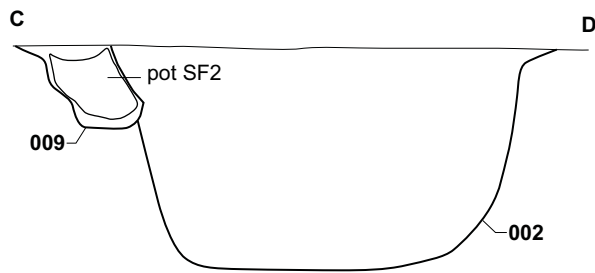
Fig. 13 - Profile of pit 002 and 009

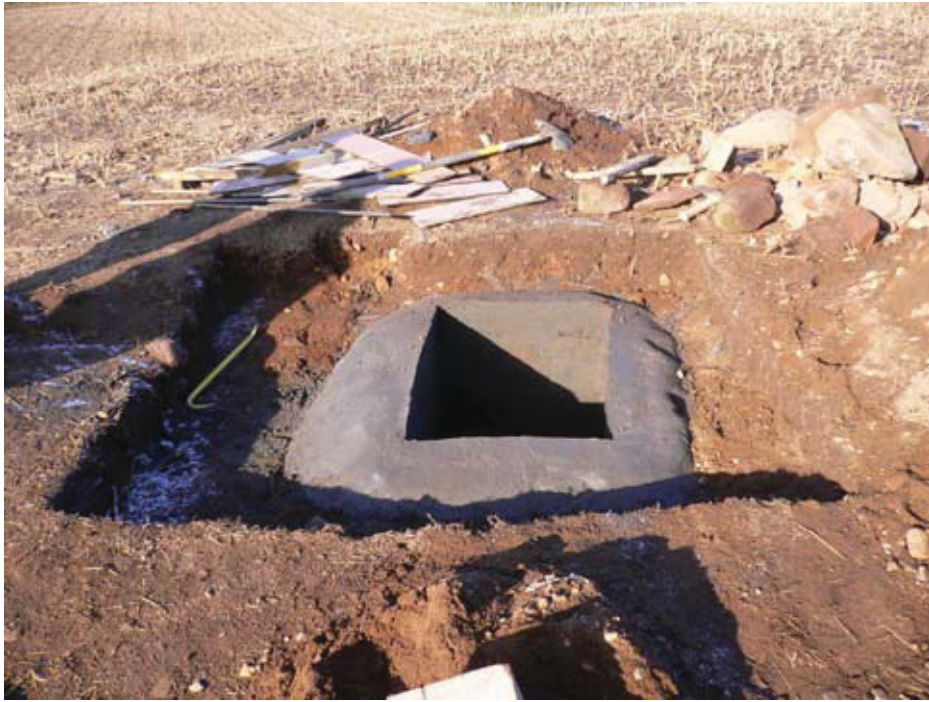
Fig. 15 - Prepared concrete socket

The original socket required enlarging to take the concrete ring for the re-erected standing stone. A square pit was excavated into the subsoil, centred on the existing socket and measuring 1m by 1m by 1.5m deep. Concrete was poured into a shuttered sleeve to form a square socket for the stone to be inserted into (Fig. 15). The concrete was backed up on the southern side to provide additional reinforcement on the weaker side.

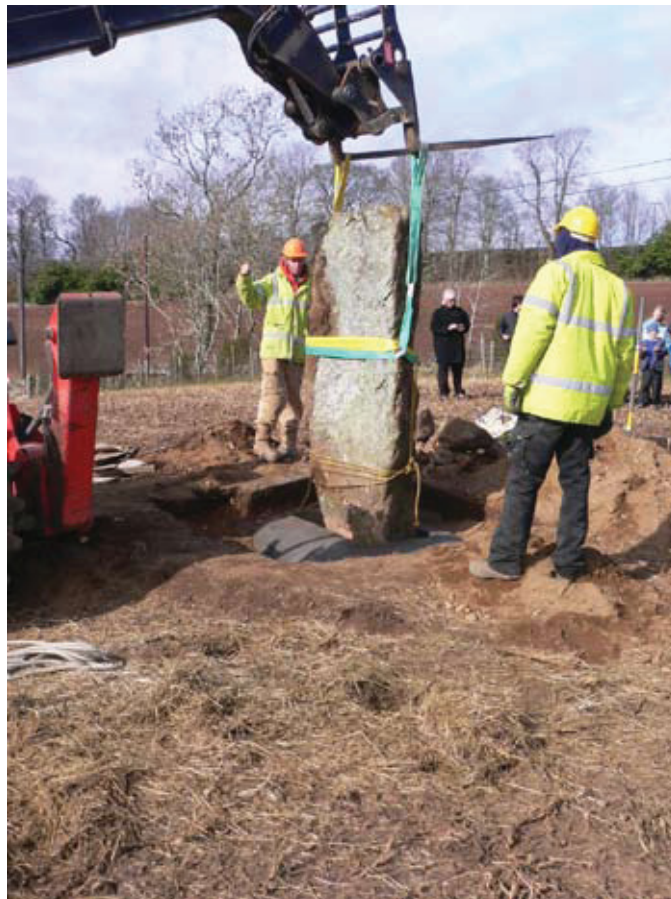
Fig. 16 - Manoeuvring the stone into the concrete sleeve

The stone was hoisted upright using straps and a mechanical excavator. Once upright it was lowered into the shuttered socket taking care not to damage the concrete sleeve (Fig. 16). The stone's orientation was verified and once the stone was in the sleeve at the correct orientation, the socket was packed with stones which had been excavated from the original socket (Fig. 17). By doing this, the integrity of the standing stone will not be compromised as the packing stones hold the standing stone in its socket without touching the concrete sleeve and allows water to drain into the subsoil away from the stone, preventing saturation, while ensuring that the stone is held firmly in place. The weight added to the stone from its new socket will also keep it upright and prevent any movement.

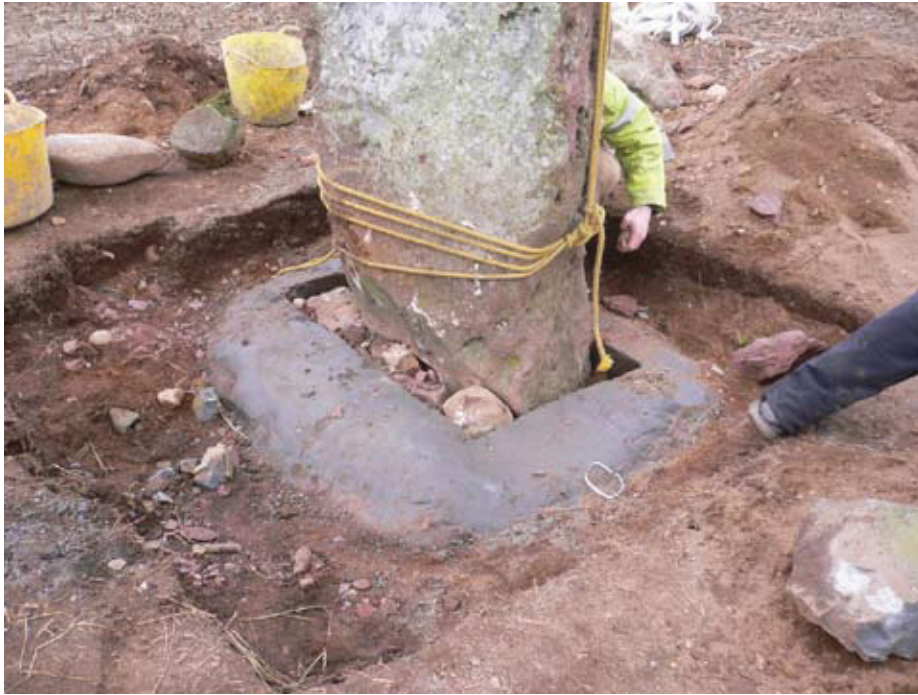
Fig. 17 - Packing stones within new socket

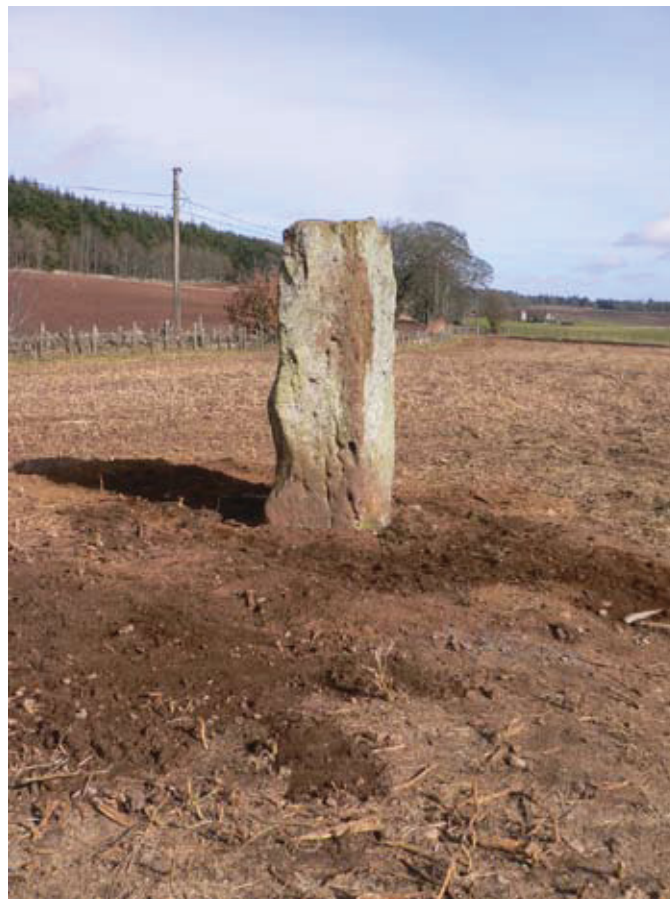
Fig. 18 - The re-erected stone

Once the stone was firmly packed in place, the strain was released on the straps, and the socket and trench were backfilled with soil (Fig. 18).

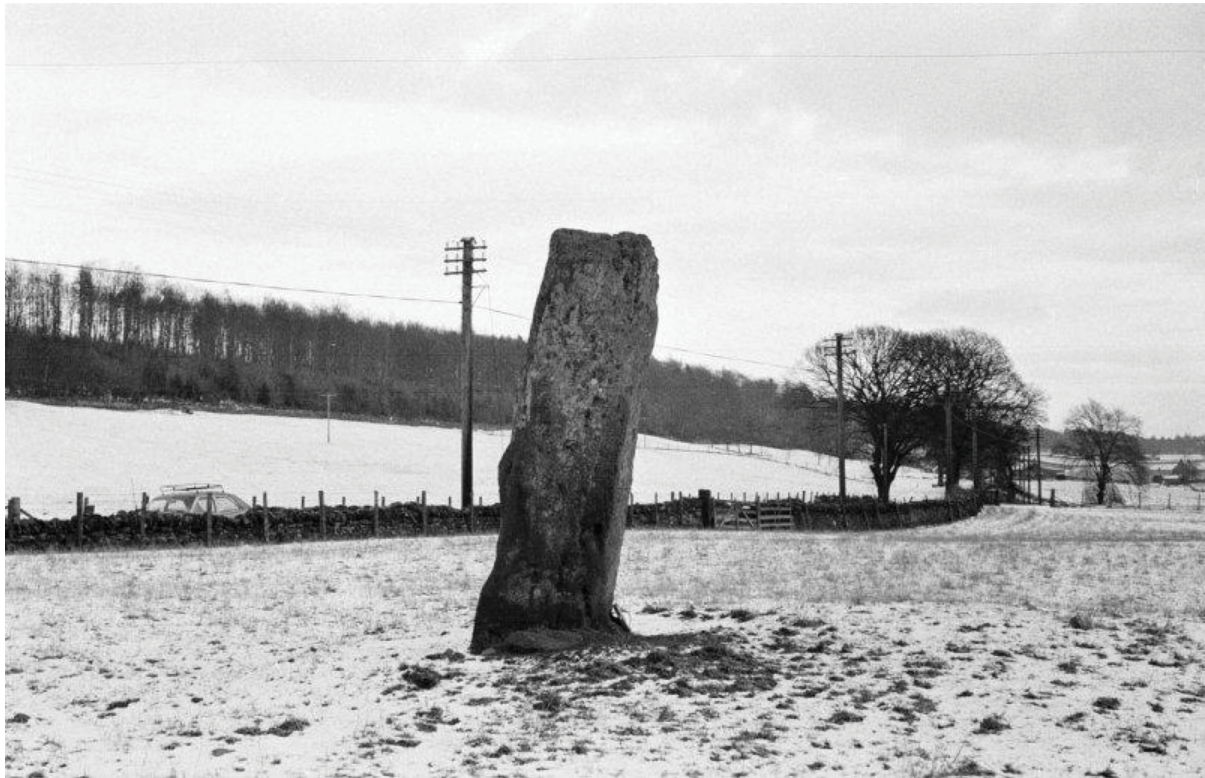
The available photographs show the stone had a significant lean to the south prior to its toppling in January 2010 (Fig. 19).

Fig. 19 - View of stone in 1977 (copyright RCAHMS)
