**Saltcoats Farm, Saltcoats Road,
Gullane
East Lothian
Report No. 1878**

Author	Michael Cressey BA MSc Phd MIFA FSA Scot
Illustrator	Leeanne Whitelaw BSc MAAIS
Editor	Sue Anderson BA MPhil MifA PGDip FSA Scot
Commissioned by	David Inglis
Date issued	April 2011
Version	0
OASIS Reference	cfaarcha1-97656
Planning Application No	10/00889
Grid Ref	NT 48730 82255

This report presents the results of a standing building appraisal carried out by CFA Archaeology Ltd (CFA) in March 2011 at Saltcoats Farm, Saltcoats Road, Gullane, East Linton, East Lothian (NGR NT 48730 82255, Fig 1). The project is based on a Written Scheme of Investigation approved by East Lothian Council.

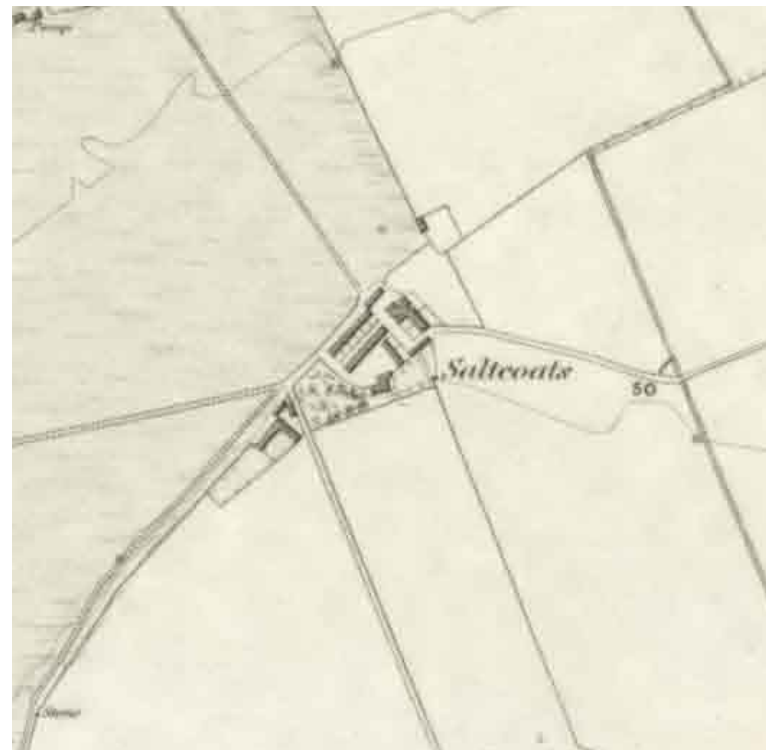
Fig. 2c - Ordnance Survey 1863 First Edition 6-inch Haddingtonshire Sheet 4

The 1863 First Edition Ordnance Survey map (Fig 2c) shows Saltcoats with a rectilinear range on the north-west side of the farm and a six livestock enclosures on the south side of the building. To the south of these, another rectilinear range is shown with a detached building more or less at right angles to it. At the south end of a cart track is another detached building. On the north-east side of the steading there is a larger block-form structure(s) with outshot buildings at the north-east end. Two stock enclosures are shown on the west side and a single enclosure is shown on the east side. A farmhouse is situated on the south side of the steading.

The cartographic and aerial photographic evidence (Fig 2c-d) shows that Unit 7 continued as far as the south elevation of Units 10 and 20, and that it had a hipped

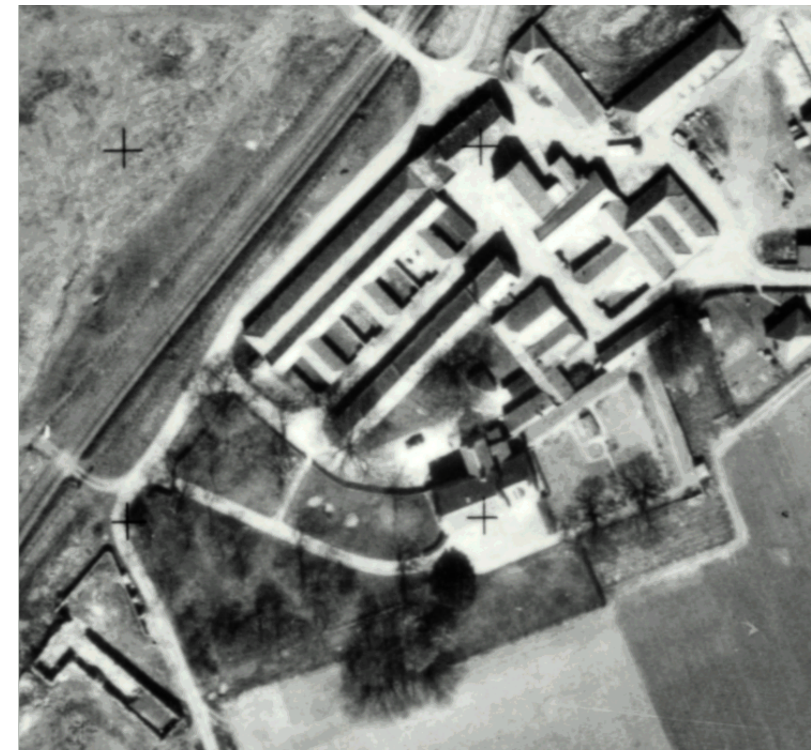
Fig. 2d - 1962 Aerial Photograph

The 1883 Second Edition and 1907 Third Edition maps show no radical change in building layout with only minor building development carried out between these years. The 1957 Revised Ordnance Survey map shows that all the buildings were roofed. This certainly persisted as late as 1962 according to the aerial photographic record (Fig 2d).

Unit 1 is a former T-shaped rubble-built roofless animal house with surviving gables (Fig 4b-c) and north-facing elevation (Fig 4d). On the south side of Unit 1, there is a large crew yard or walled stockyard with gate piers (Fig 4b). The interior of this building and the crew yard are now very overgrown. The building was intact according to the 1962 aerial photograph (Fig 2d).

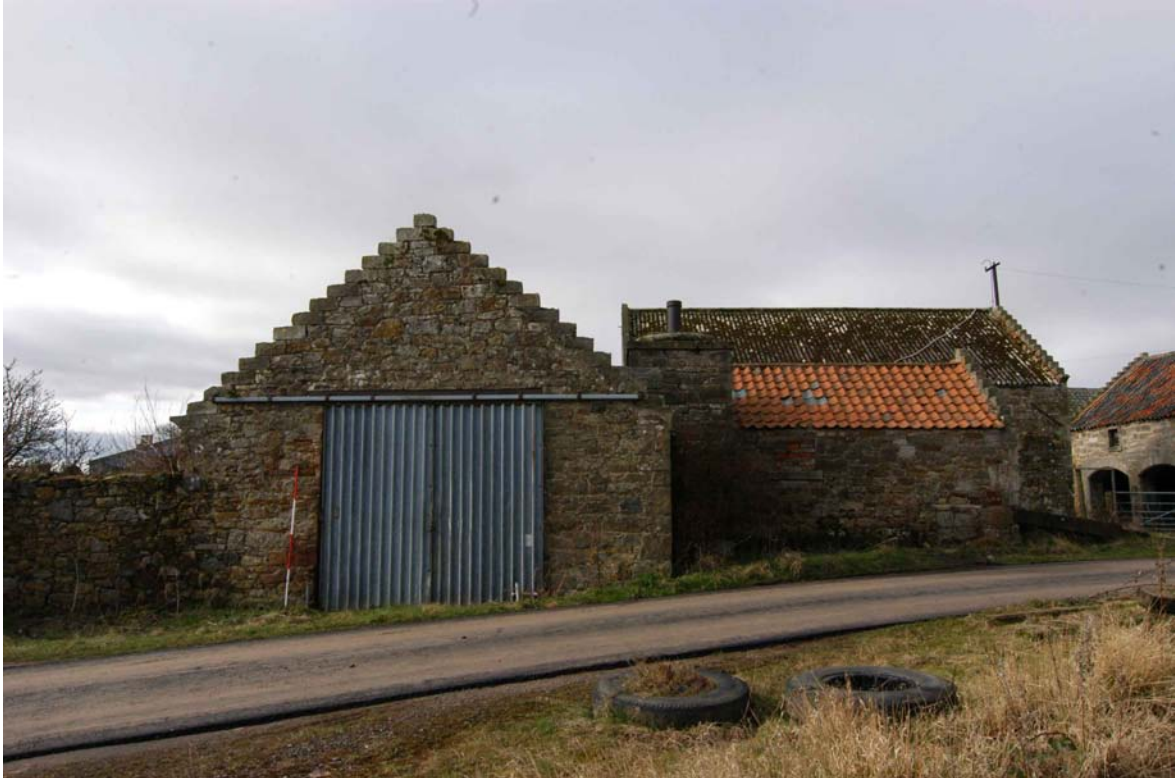
Plate 1 - Units 2 and 4, north-facing elevation

Unit 2 comprises a single workshop with a corrugated asbestos roof. The building is constructed using cream-coloured coursed sandstone rubble with ashlar dressings. The north and south-facing gables are crow-stepped (Fig 4b and 4d). The north-facing gable has a large galvanised sliding door at its centre (Plate 1, Fig 4d). On the west

This single-storey building with a pantile roof constructed of sandstone rubble with ashlar dressings (Plate 1). The north elevation incorporates two blocked windows, one blocked with red-brick and the other with four large blocks of sandstone. The west-facing elevation is crow-stepped and has a central plank-built door (Fig 4a). The north-facing elevation contains a series of rybatts for a doorway, and a break in the roofline incorporates Welsh slate suggesting that a cat-slide roof was present over a small lean-to (Fig 4d). This was demolished when a concrete loading ramp was constructed against the elevation. The interior of this building was not accessible. It is presumed that it served as a small boiler house associated with the adjoining chimney which now only survives to base height.

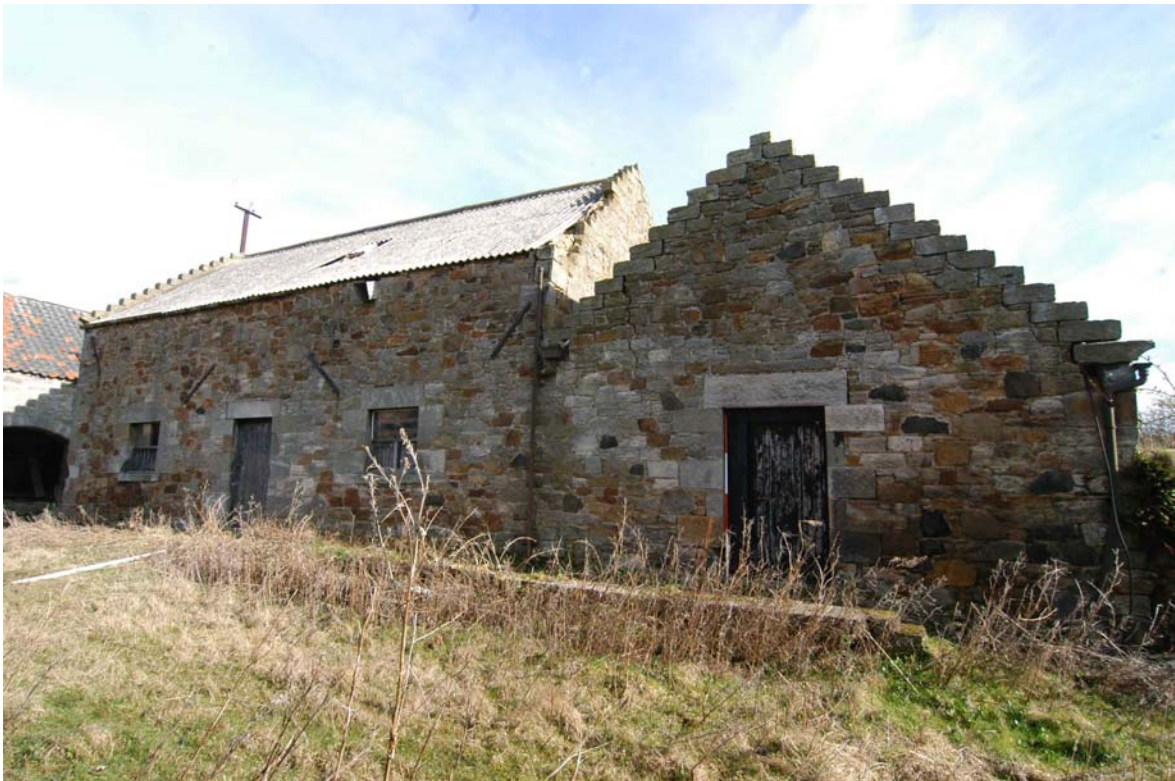
Plate 2 - Units 2 and 4 south-facing elevation

This one-and-a-half storey building is rubble-built with ashlar dressings (Plate 3, Fig 4b). The roof is corrugated asbestos with crow-step gables. The north-facing elevation has a blocked doorway which is partially hidden by a concrete loading ramp (Plate 3, Fig 4d). A window opening is present on the west side of the doorway. A large loft window is blocked by red brick (Plate 3). The west-facing gable is featureless except for the fine ashlar quoins. On the south-facing elevation there is a central plank-built door and two windows, all with dressed surrounds (Plate 2, Fig 4b). The south elevation adjoins the south gable of Unit 2 (Plate 2).

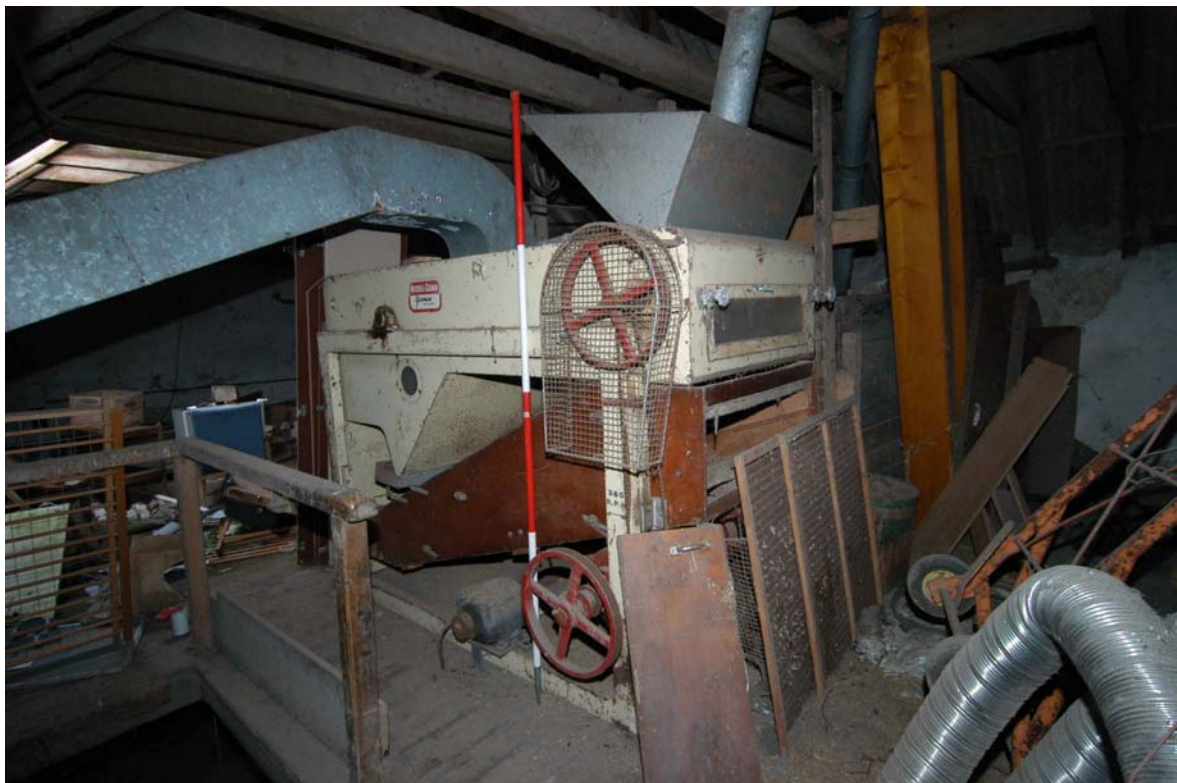
Plate 4 - Unit 4 loft, a Yeoman grain cleaner c. 1965

The National Archives, Kew, online database for agricultural machinery was consulted to establish the relative date of farm machinery at Saltcoats. The database provided a record relating to a Yeoman grain pre-cleaner which is housed in the loft of Building 4. The leaflet dates the machine to c.1965.

Within the south-facing wall, at the north-east corner, there is a square opening into a concrete grain hopper. This is a 20th-century feature that is associated with the aforementioned loading ramp on the north side of the building. The internal south-facing elevation also contains a small wooden hatch set within a timber frame. The rest of the walls are featureless. Adjacent to the loft staircase is an electric-driven grain-cleaning machine (Plate 4) which is connected to a series of grain chutes in the

roof space. The machinery was manufactured by Mitchell, Colman and Co. Ltd, London and dates to about 1965. The apparatus cleaned grain of chaff and other extraneous contaminants prior to its sale for flour making or malting.

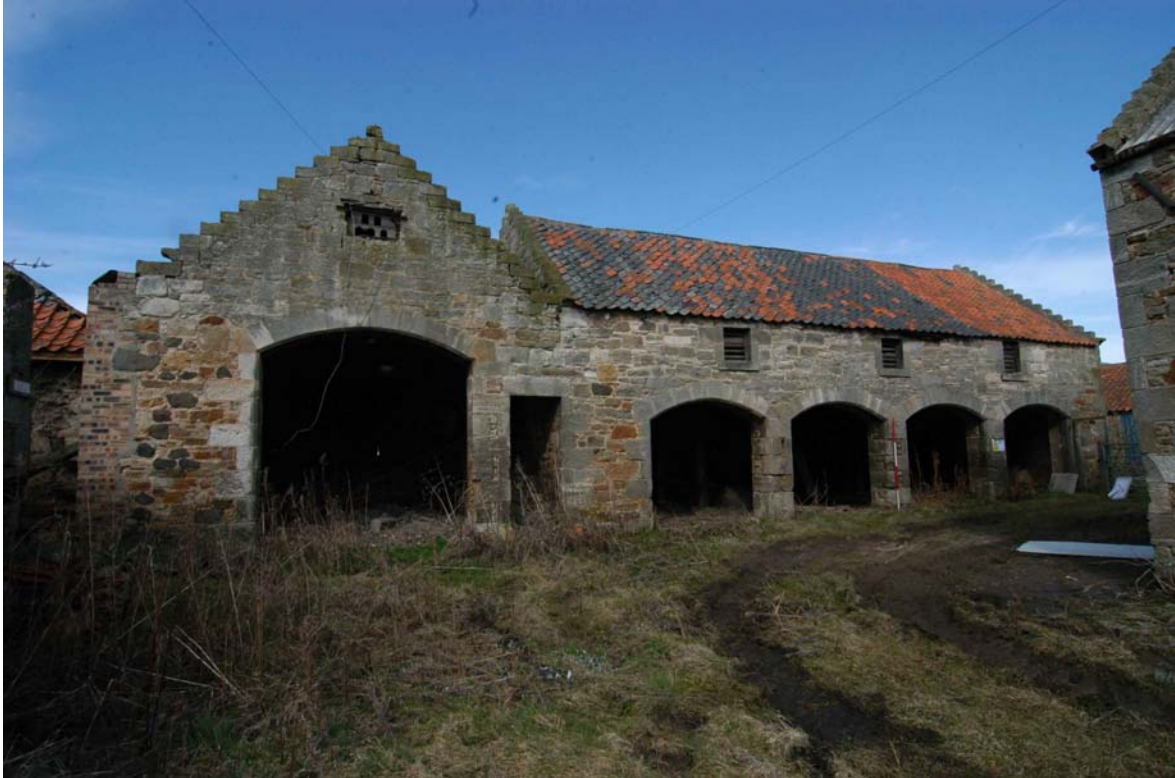
Plate 5 - Unit 5 and 6, Cartshed and portico

The cartshed (Plate 5) is rubble built with ashlar dressings (Figs 5a-b). The roof is pantiled and the gables are crow-stepped. The east-facing elevation has four segmented arched openings (Fig 5b). The arch piers measure 0.6m x 0.6m and are chamfer-moulded on both the interior and exterior (Plate 6). The west-facing elevation has three blocked rectangular windows on the ground floor and three blind square windows on the loft floor (Plate 7, Fig 5a).

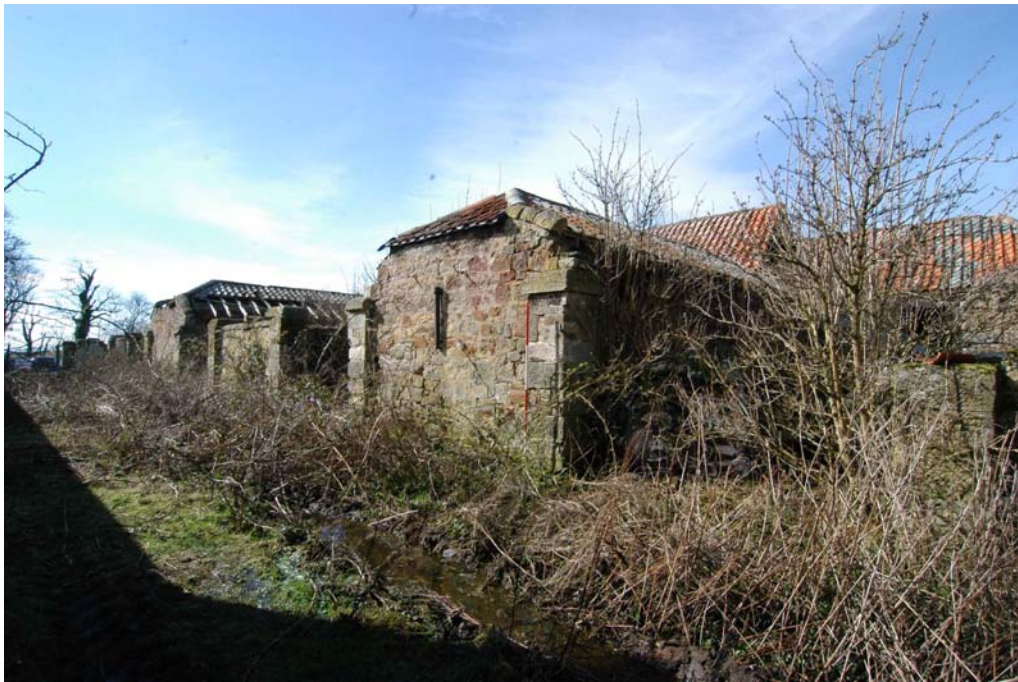
Plate 9 - Units 14 and 15 cattle courts with stall roofs in situ

Six cattle courts (Units 10–15) are present on the east side of Unit 9 and these are square walled enclosures with an entrance flanked by gate piers on the east side (Fig 3). Each court had a covered feed stall with a pantile roof supported on timber A-frame trusses. These have been demolished with the exception of two situated at the east end of the court complex (Plates 9–10).

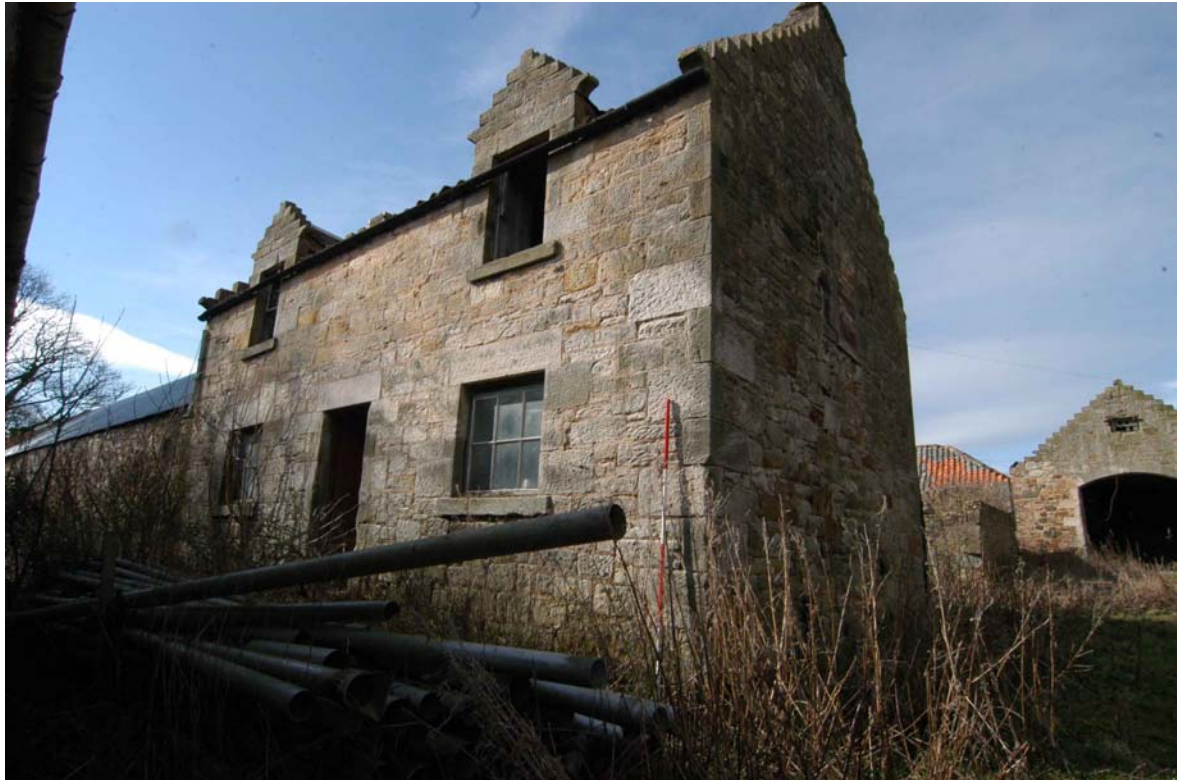
Plate 11 - Unit 16, farmhouse, east-facing elevation and crowstep gable

Unit 16 comprises a stone-built farmhouse that adjoins Units 17–20 (Fig 3, and 6a-b). The house is a single storey structure with crow-step gables with ashlar dressings (Plate 11). The east-facing elevation comprises coursed sandstone with tight joints, ground and first floor windows and a central doorway. The first floor windows are surmounted by crow-step pediments (Plate 11). The rear of the building (west-facing elevation) is cruder, comprising random rubble with a central doorway and a blind rectangular window on its south side (Plate 12).

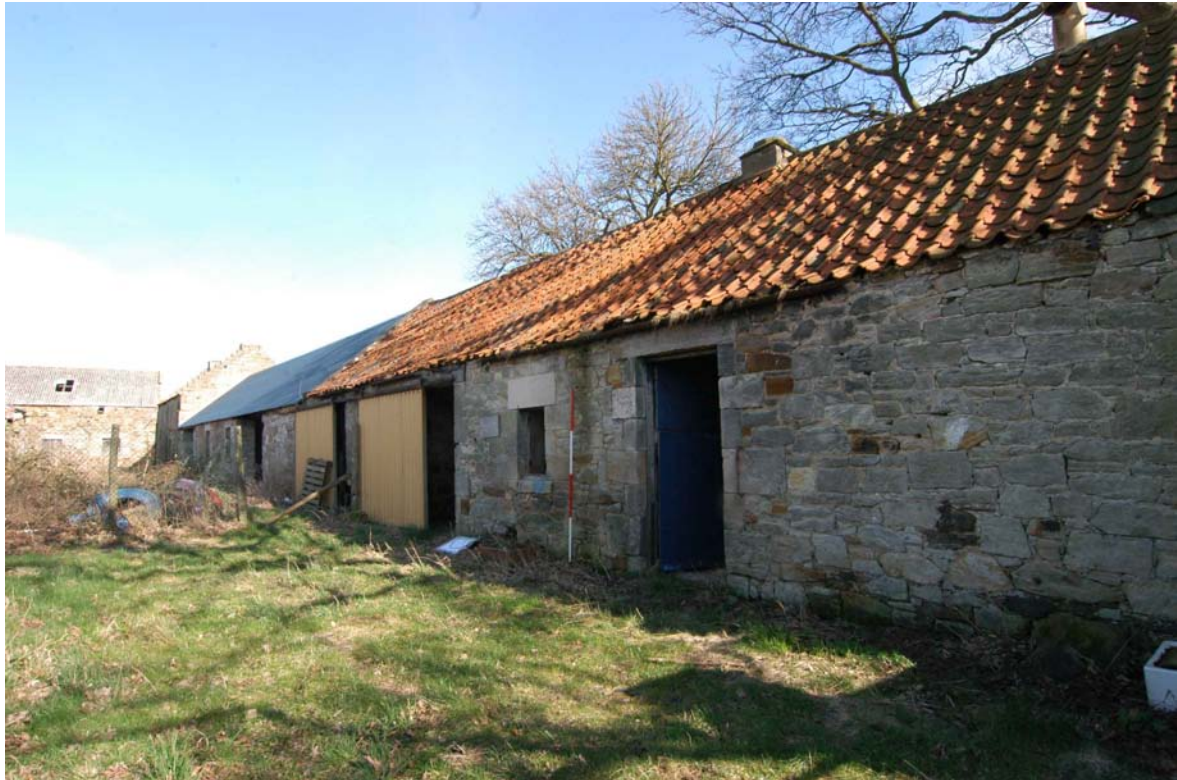
Plate 13 - Units 17-20, animal houses, west-facing elevation

Unit 19 (Fig 6a, Plate 13) was last used as a stable. The shed is accessed by a sliding door on the west-facing elevation. The exterior walls are rubble built with ashlar dressings. The interior north-facing wall has a small fireplace and entrance into the adjoining unit (Unit 20). A plank-covered ceiling is present. A single window is present on the west-facing elevation. Half the walls have been whitewashed, which corresponds with the position of a horse stall which was situated opposite the doorway on the north side of the stable. A small window is present on the south side of the door (looking out). The roof trusses are A-framed resting on the wall heads (Fig 6c).

Unit 20 (Fig 3, Plate 13) is another small stable which is a continuation of the rectilinear range and has a crow-step gable at the south end. The stable has a traditional stable door flanked by a plain rubble wall with ashlar dressings (Fig 6a). The interior is lit by a small square window on the west-facing elevation. The floor is laid with white engineering bricks and the north-facing wall has two square wooden-lined vents. Although no stalls are present (eg loose-box with trevis), there are several tethering rings on the north-facing elevation. This part of the range was probably used as a small calving shed prior to its use as a stable.

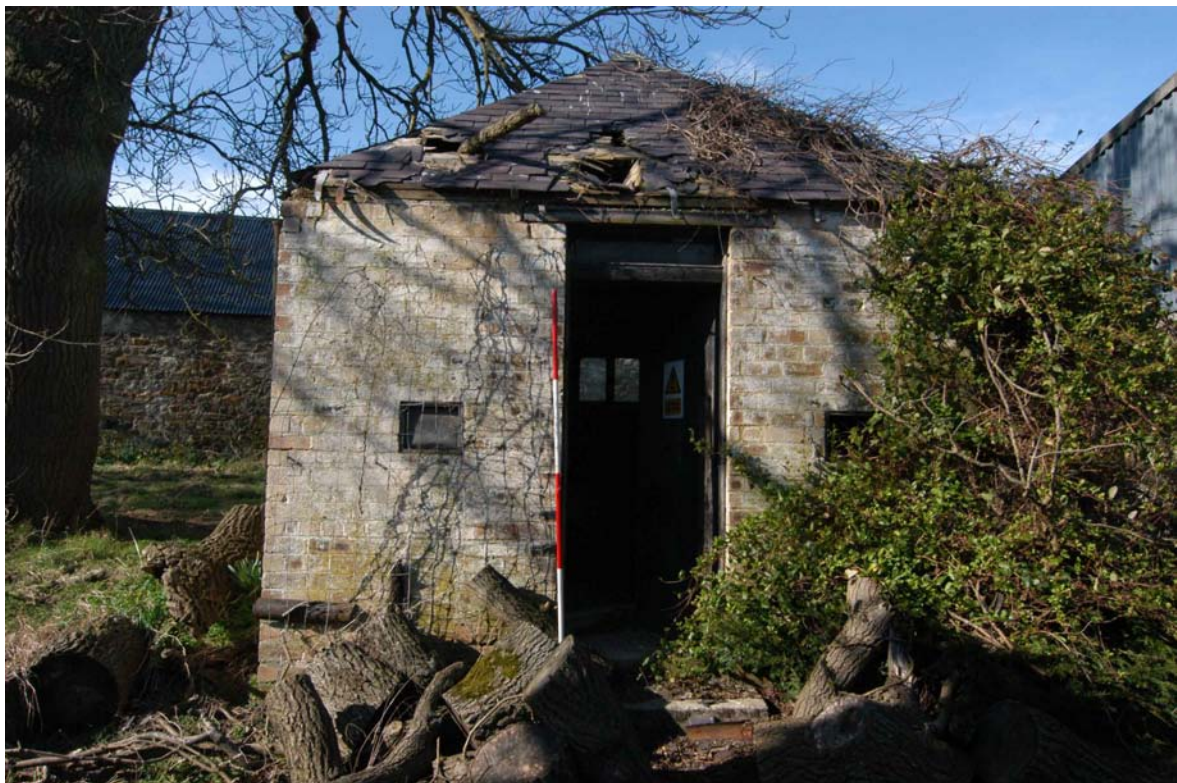
Plate 14 - Unit 21, the dairy belonging to the new farmhouse

Unit 21 is a small brick-built dairy (Fig 3, Plate 14) situated on the south side of the steel repair shop (Unit 22). The building is lit on the west and north-facing elevations, the entrance door is on the east-facing elevation. The south-facing elevation is vented. The roof is hipped slate.
