**Archaeological building recording at
the former Westcliffe Hospital
Turnhurst Road
Stoke-on-Trent
NGR SJ 86715 53090**

Planning ref.: SOT/52209

Site Code: WCH11

Report No. 336

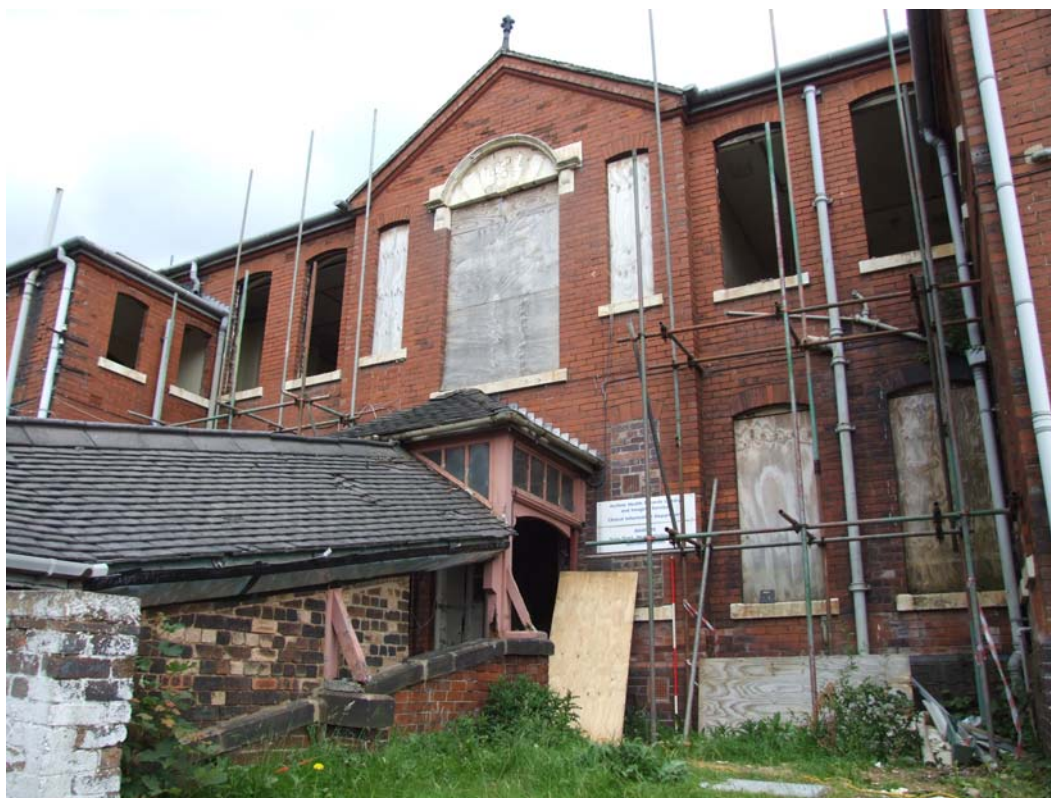
PLATE 5

5.2.2 The west elevation of the central block of Building 1 served as the principal entrance to the building and also provided some decorative focus (Plate 5). The centrally-located entrance bay was pedimented and projected forward slightly of the rest of the block. The entrance itself was concealed behind a wooden open-sided porch with a hipped plain-tile roof, the terminus of the covered walkway which linked Building 1 to the 1893 infirmary, Building 3 and Building 4. The main doorway within, approached *via* a couple of stone steps, was topped by a semi-circular pediment with dentilated decoration. The pediment was inscribed with the word 'INFIRMARY' (Plate 6). More visible, the first-floor window located above the main doorway also had a semi-circular pediment at its head, in this case inscribed with the date 'AD 1906' (Plate 7). In contrast to the formal west elevation of the central block, the east elevation was asymmetrical in design, with a pair of narrower windows that presumably related to the layout of rooms within (Plate 8).

The pedimented entrance bay central to the west elevation of Building 1 (scale: 2m).

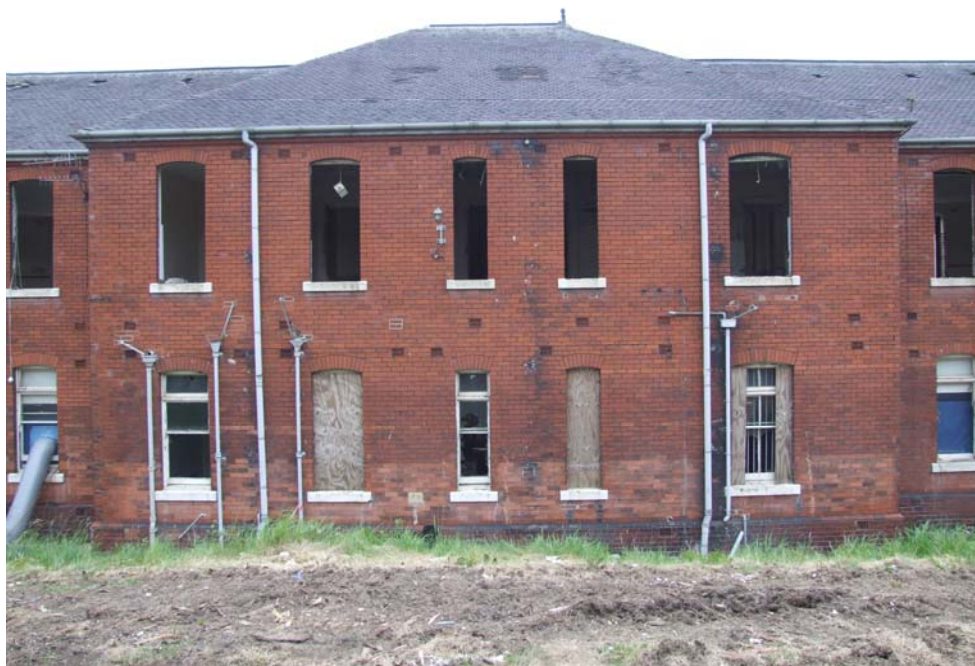
PLATE 8

The rear elevation of the Building 1 central block.

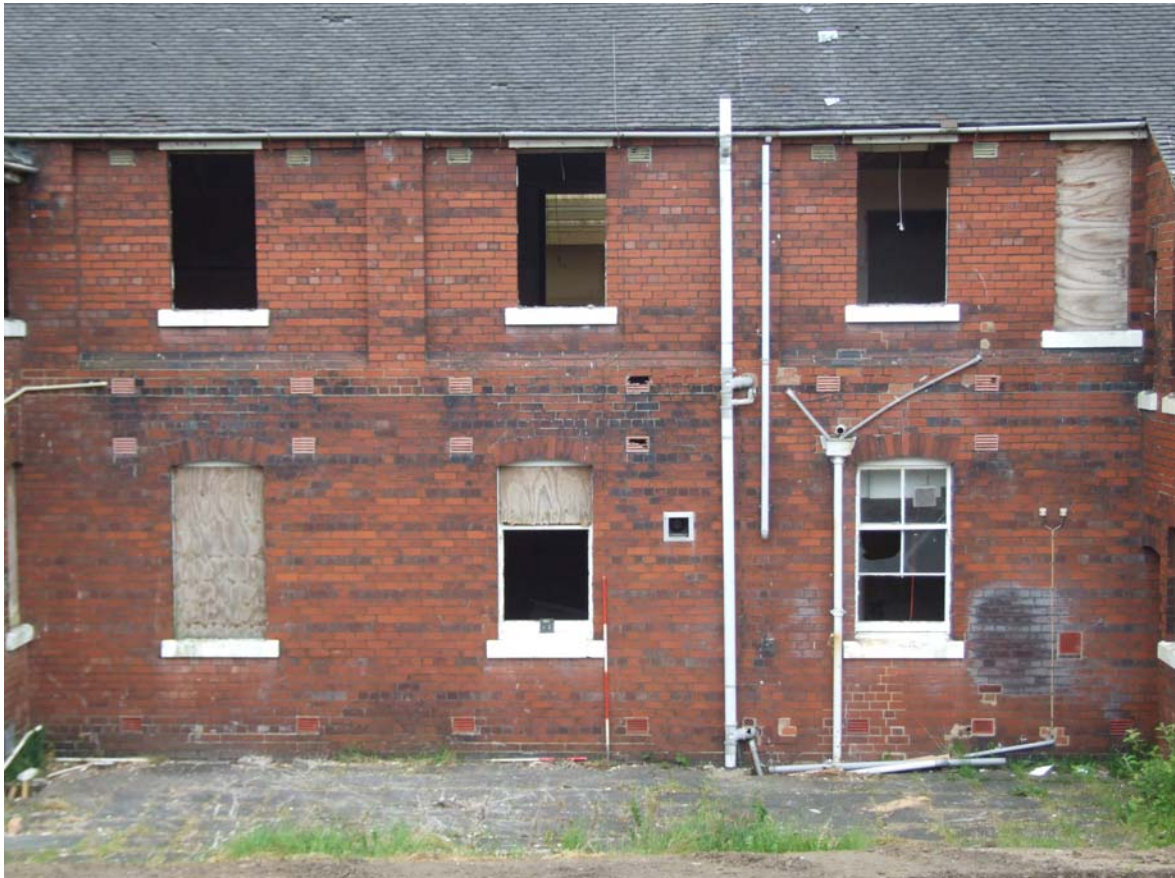
PLATE 14

5.3.2 The ground floor windows had stone lintels, painted white, and segmental-arched heads. The first-floor windows were set within recessed panels and had plain stone sills and lintels, both painted white (Plate 14). The original window frames were wooden-framed 2/4 pane sliding-sashes, but many had been removed and some replaced with modern upvc frames. As in Building 1, pairs of ceramic vents were located above and below each window. The first-floor windows at the front (west elevation) were, however, obscured by an enclosed veranda which extended the length of the building (Plate 15). The veranda was of steel and had been enclosed with plywood sides, incorporating a continuous band of windows, and a corrugated plastic roof. The veranda opened onto a high-level walkway at its northern end, connecting Building 2 to Building 1. A single-storey structure with a brick plinth and plywood board walls was located below the north end of the veranda.

The windows on the rear elevation of Building 2 (scales: 1m, 2m).

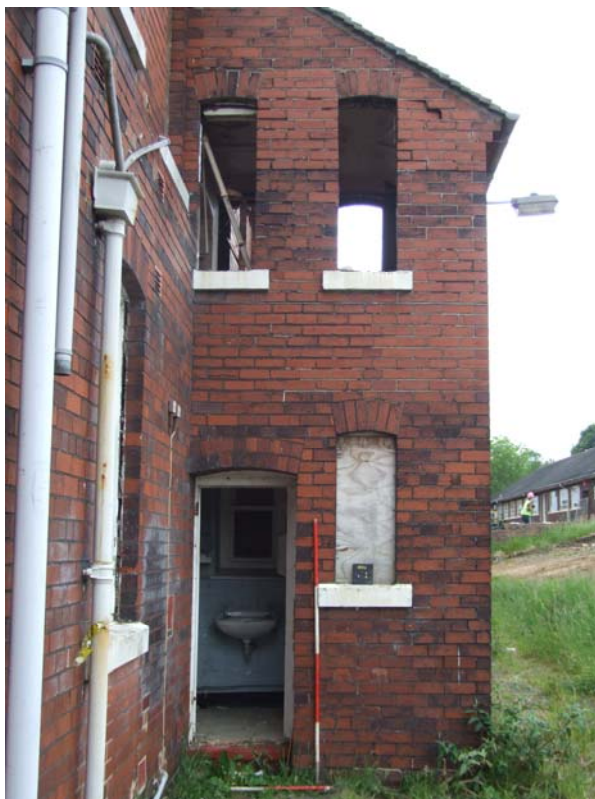
PLATE 17

with a segmental-arched head on its south side, although those on the outer towers had been bricked up. The doorway to the central tower had been left open and gave view of a tiled entrance lobby, with a wash basin, to the west and a WC cubicle to the east (Plate 17).

The door in the south side of Building 2's central tower (scales: 1m, 2m).

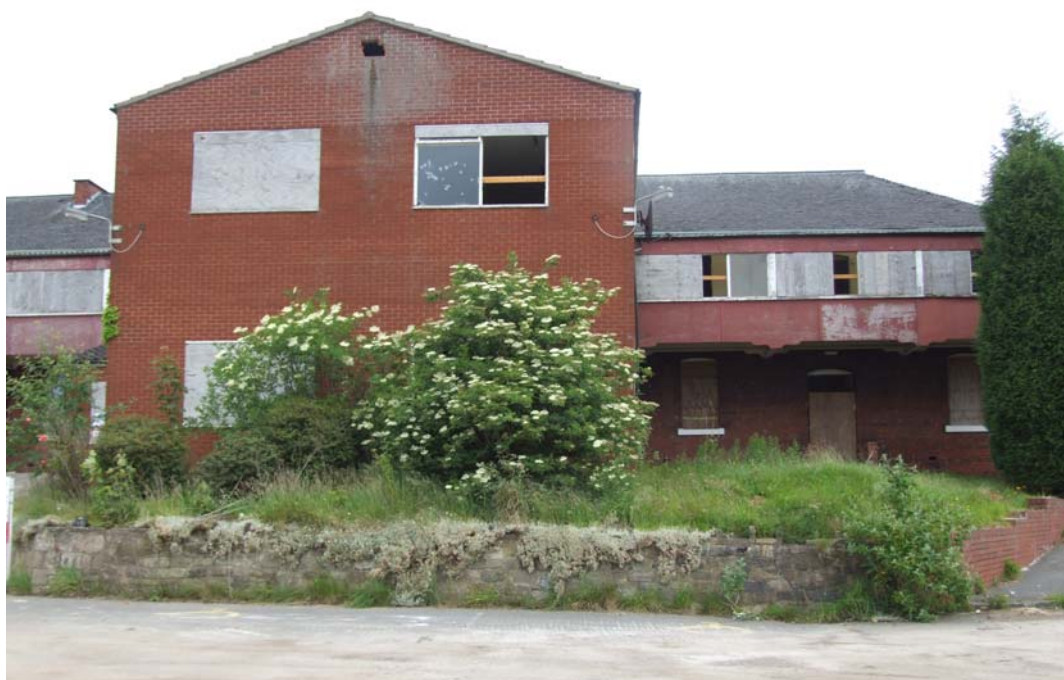
PLATE 18

5.3.5 Building 2 had been extended with the construction of a two-storey block on its west side (Plate 18). The new block was built against the veranda, towards the south end of the west elevation, so that it formed a separate but linked annex to the main building. A single-storey section, built in front of the main entrance, formed a lobby between the main building and the extension. The extension was constructed with red bricks in a stretcher bond and had a pitched roof covered with grey clay roman-tiles. The extension windows were wooden-framed casements with wooden sills. The double doors on each side of the single-storey lobby had been removed.

The extension built on the west side of Building 2.

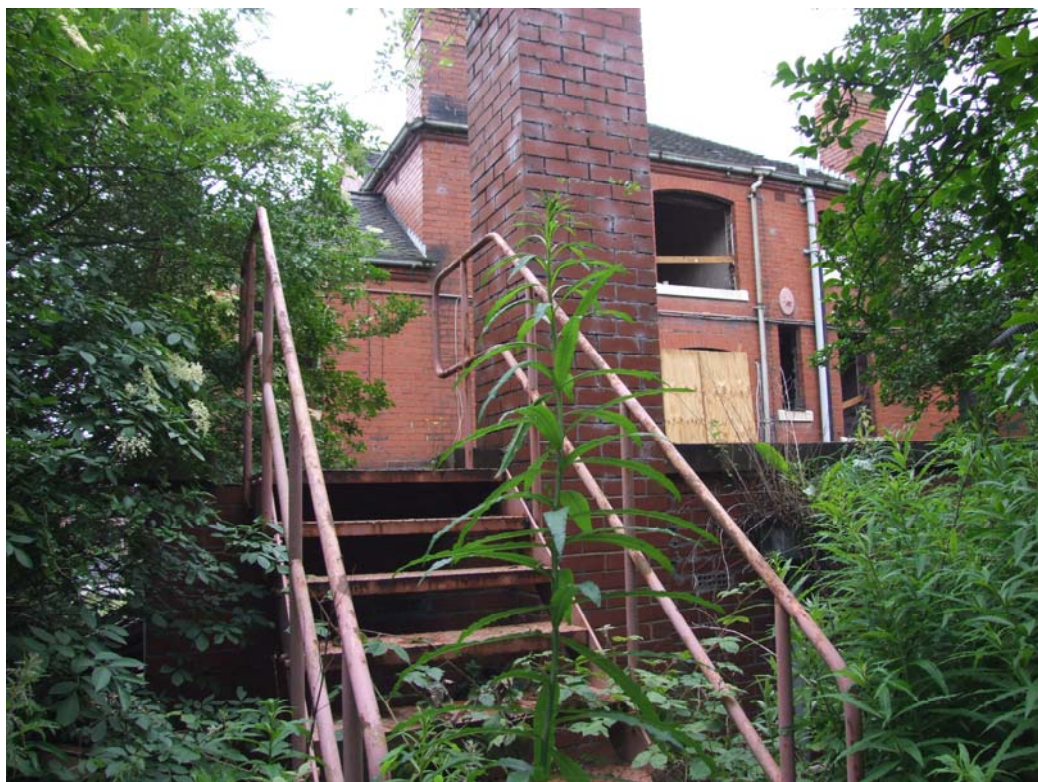
PLATE 24

had been altered. A metal flight of steps ascended from the bank at the rear of the building up onto the extension roof (Plate 24).

The stairs up to the extension roof on the east side of Building 3.

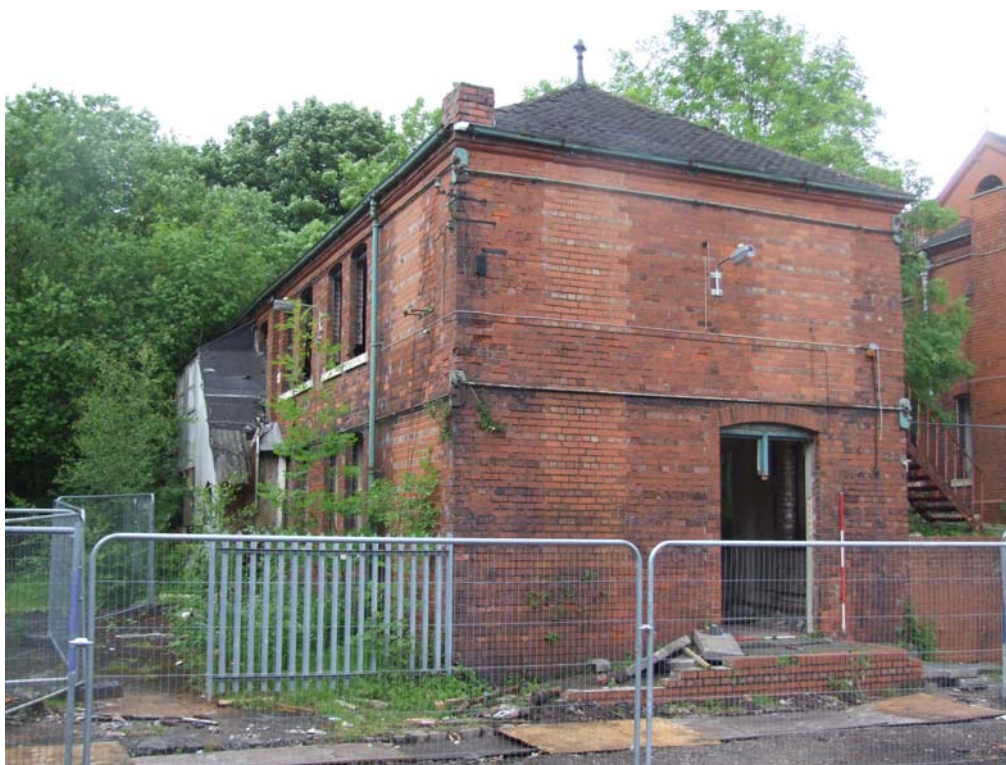
PLATE 29

5.5.1 Building 4 was a rectangular two-storey building (Plate 29) with the remains of a single-storey extension to the rear (east side) of the building. It was constructed with red bricks in an English garden-wall bond and had a moulded brick eaves course. The roof was hipped and covered with grey clay plain-tiles. Fleur-de-lys finials decorated each end of the roof ridge and chimney stacks, probably reduced in height, were visible at the north-east and north-west corners of the building. The windows were arranged in pairs down each long elevation and had segmental-arched heads and plain stone sills, painted

Building 4 looking south east (scale: 2m).

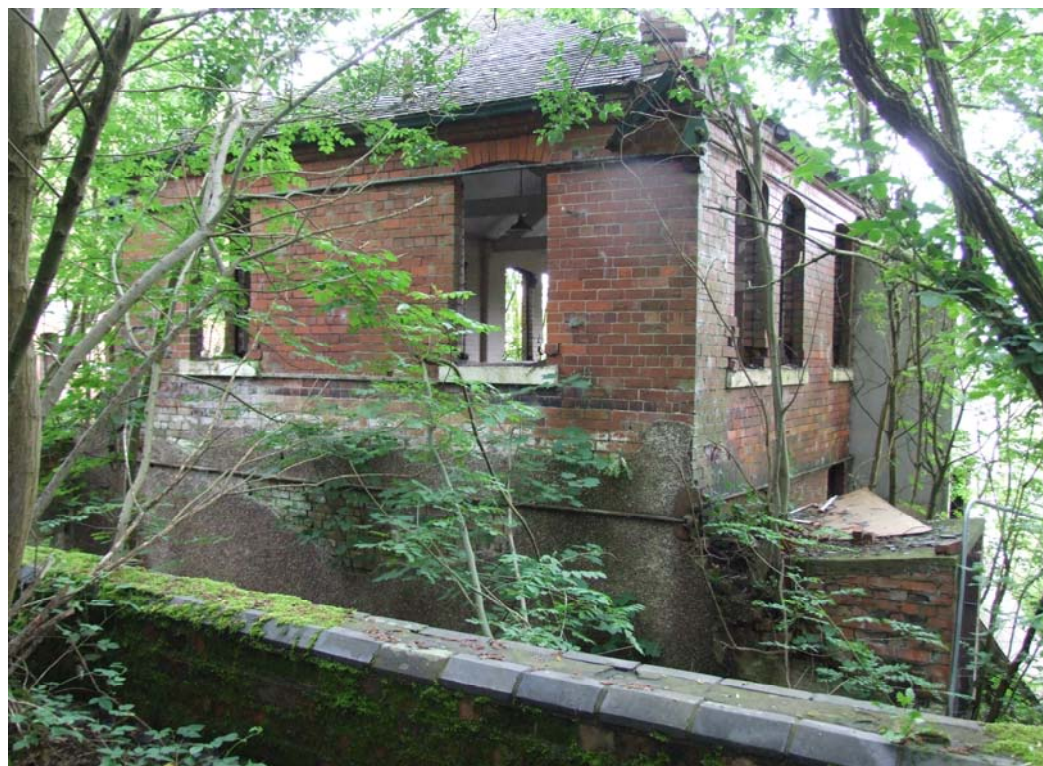
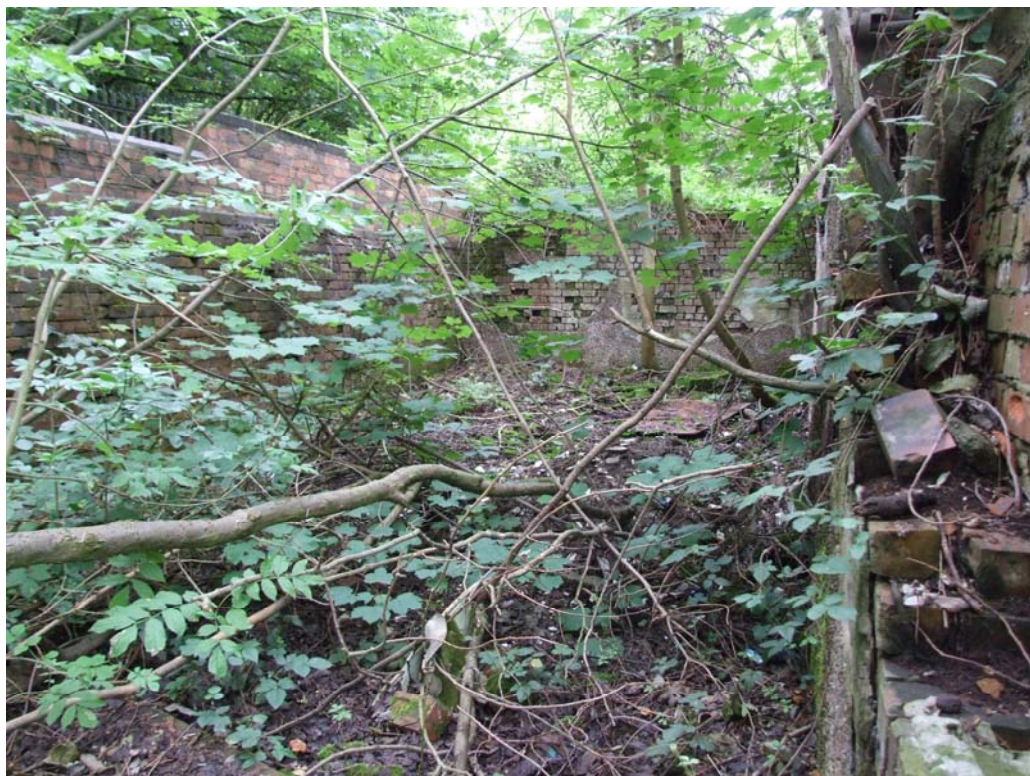
5.5.2 The single-storey extension to Building 4 remained merely as an enclosure at the rear of the building (Plate 32 & 33). The roof had been removed and the interior space had become overgrown with vegetation. The surrounding brick walls had been reinforced to retain the higher ground on the east and south sides of the extension. A smaller extension, in the form of a brick porch with a sloped concrete roof (Plate 32), was evident at the east end of the original building's north elevation. The arched-head of an original window could be seen above the porch and this had presumably been adapted as a doorway.

The extension at the rear of Building 4, looking west.

The extension at the rear of Building 4, looking south.

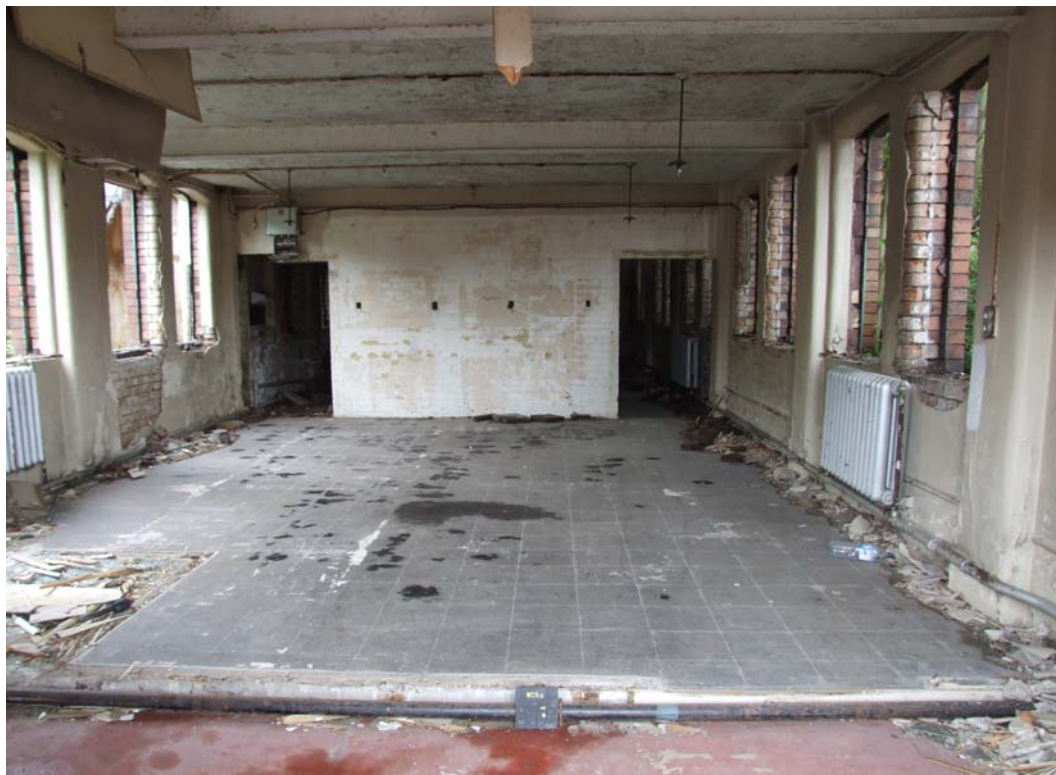
PLATE 34

were drawn. It could be seen that the ground-floor rooms had plastered walls, a tiled floor and that the ceilings were supported in steel I-beams (Plate 34). The first-floor room was open to the eaves, leaving the King-post roof trusses exposed (Plate 35).

The ground floor of Building 4, looking east from the main door.

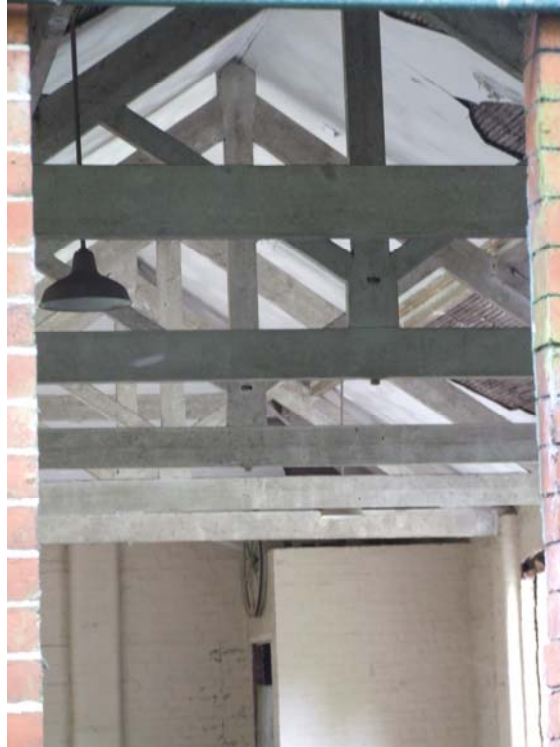
PLATE 35

The roof trusses visible in the first-floor room of Building 4.

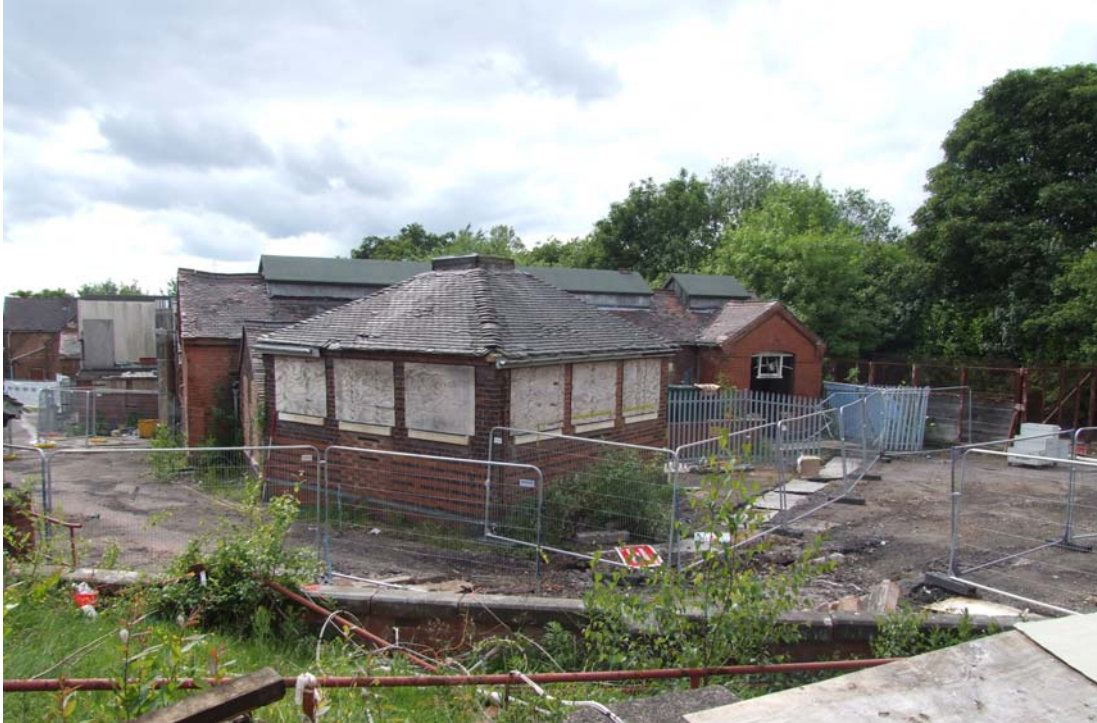
PLATE 36

5.6.1 Building 5 was a largely single-storey, multiphase building, comprising several adjoining blocks (Plate 36) and latterly used as a boiler house and workshops. Access was restricted to the south, east and west side of the building.

Building 5 looking west.

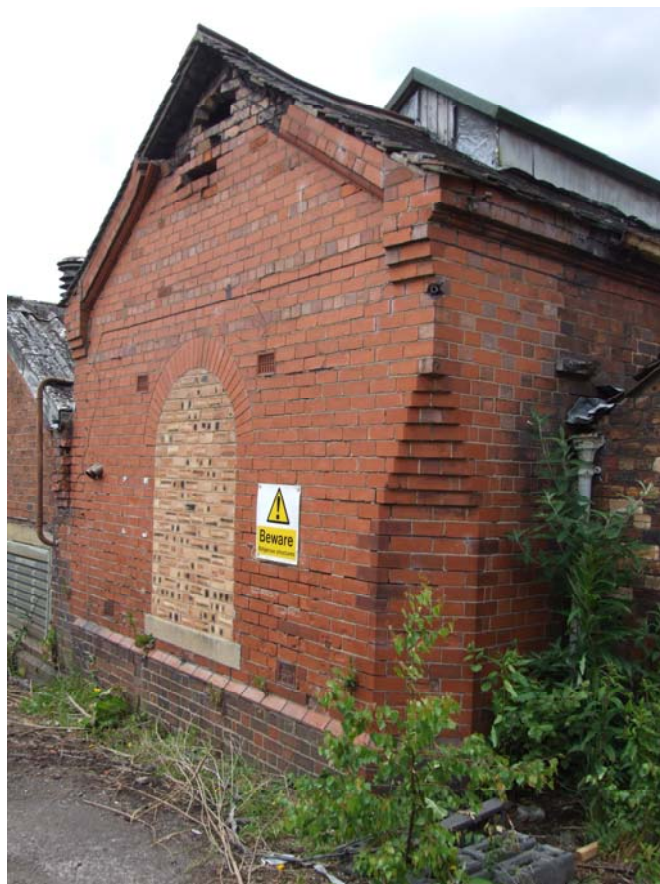
PLATE 37

5.6.2 The earliest element of the building appeared to be the former Power House block. The Power House was a rectangular north to south aligned block constructed with red bricks in a Flemish bond and had a moulded brick eaves course. The block had been extended to the south slightly, aligning it with the adjoining Smithy/Pump House (Plate 37). A small projection had also been added to the east side of the block at its northern end (Plate 38). Both of these additions were constructed in stretcher bond and with a slightly redder brick. The block had a pitched roof, clad in blue/grey clay plain-tiles, and incorporated louvered vents, although these had been boarded over. The original windows, on the east side of the block had segmental-arched heads, but these had all been bricked-up or had been converted to doorways (Plate 38). The head of a blocked window visible at the south end of the east elevation above the roof of the Softener Room block (Plate 39) indicated that this element was a later addition to the building. Access to the Power House block was *via* a single doorway in the eastern projection. The door was flanked by a pair of windows, with which it shared a segmental-arched head. The door had been removed, but the wooden frame of a hopper-light, which would have been located above the door, remained. Two new doors had been inserted in the east elevation of the block, the northernmost adapting a former window aperture. A blocked door with a semicircular-arched head, and formerly adapted as a window with the insertion of a concrete sill, was also visible in the south elevation of the block (Plate 37).

The extended south end of the Power House block.

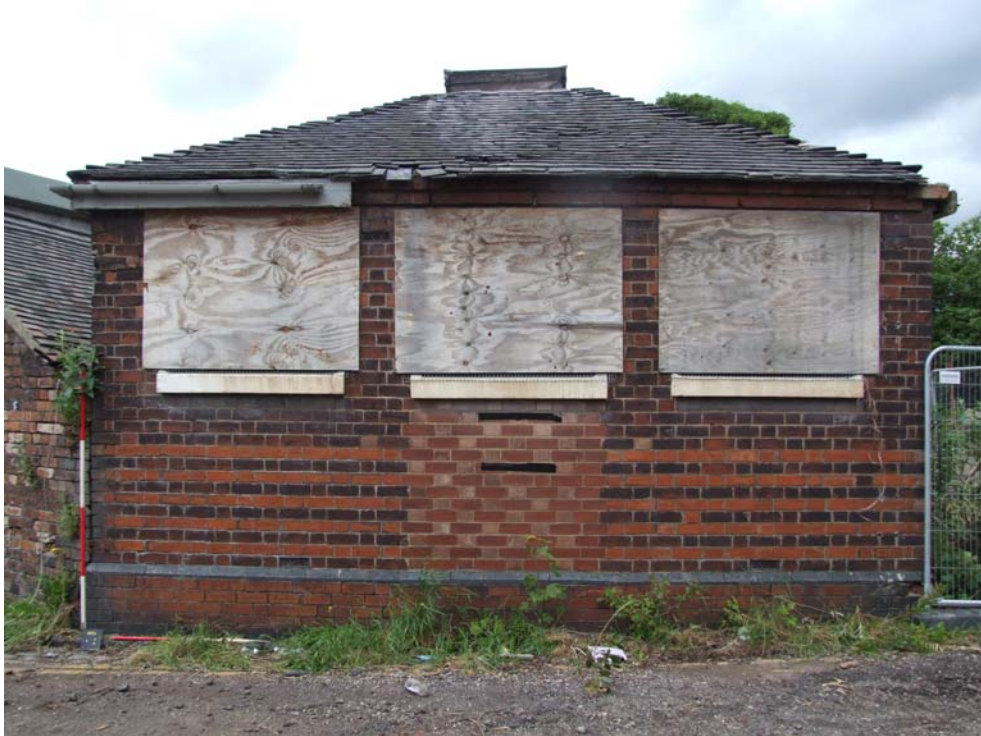
PLATE 43

blue canted bricks, and a projecting eaves course (Plate 43). The roof was hipped and clad with plain grey clay tiles. A square vent was located at the apex of the roof. The windows had all been boarded over, but their plain stone sills were still visible. The windows on the south-west elevation had, however, been bricked-up, presumably as a result of the construction of the adjoining block (the Softener Room on the c.1950 plan of the building). The entrance to the block was placed centrally in the north-west elevation and was flanked by two windows (Plate 44). It took the form of a double-framed, ledged-and-battened door with a rectangular fan-light above and a plain stone lintel.

The south elevation of the Fitting Shop (scales: 1m, 2m).

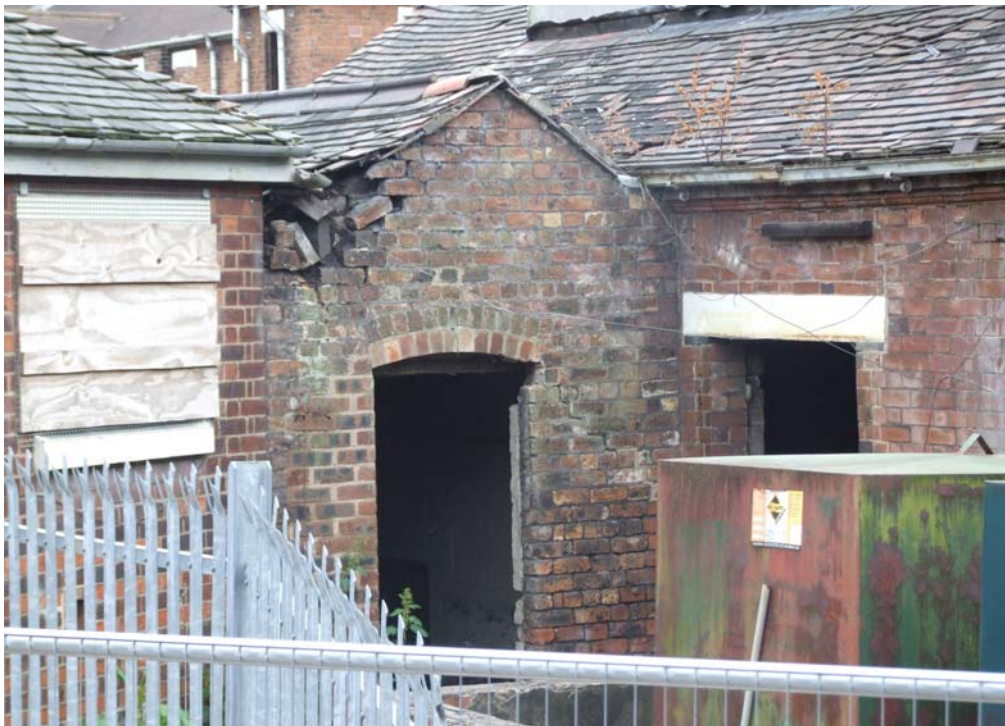
PLATE 46

5.6.7 The Softener Room was built between the Fitting Shop and the Power House, post-dating both (See **5.6.2** and **5.6.6**). The block was constructed with reddish-brown bricks in an English garden-wall bond and had a pitched roof covered with grey clay plain-tiles. Two bricked-up windows in the south elevation had segmental-arched heads and plain stone lintels (Plate 45). The doorway to the block was located in the north elevation and also had a segmental-arched head (Plate 46).

The north elevation of the Softener Room.

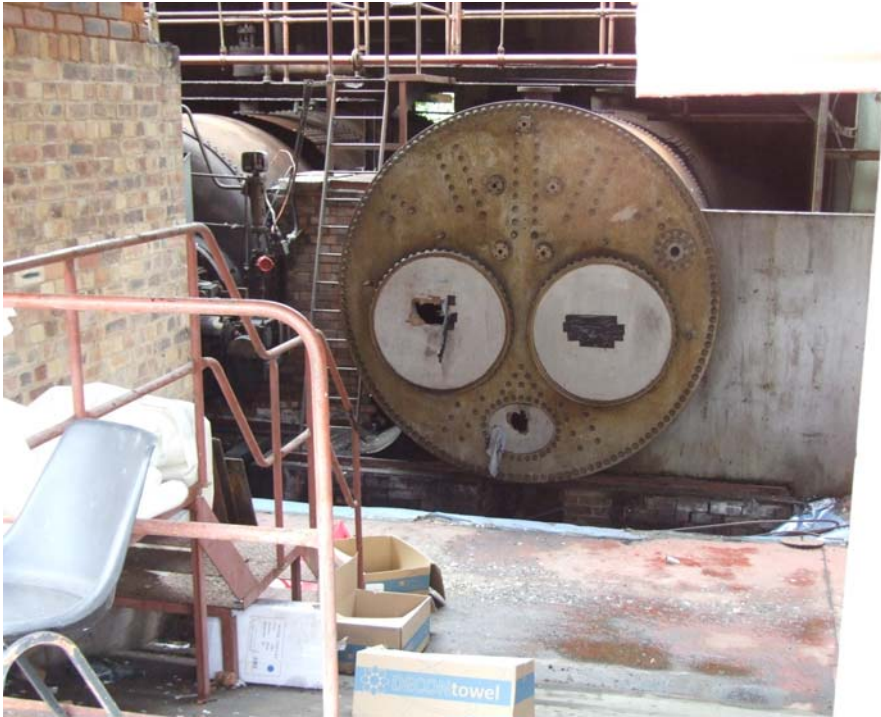
PLATE 49

5.6.8 The c.1950 plan of Building 5 (Fig. 10) indicated the uses of each block as described above. The plans show that there was through access between the blocks with the exception of the Boiler House and the Fitting Shop, which were each self contained. The Power House and the Pump Room blocks were both subdivided, with an Engineer's room at the north end of the former and a Smithy at the north end of the latter. Otherwise each block was open plan. Steps depicted at the south end of the Power House and Pump Room indicated that they were split level or had basements. Some view of the Power House and the Boiler House was possible at the time of survey. It could be seen through open doorways that the walls and ceiling of the Power House were lined with tongue-and-groove boarding. A free standing fuse and switch-gear panel was located towards the north end of the main room (Plate 47). A void at the south end of the room opened onto a tiled basement area which was accessed *via* metal stairs (Plate 48). The view through the easternmost roller-shutter door indicated that the large boilers were still *in-situ* (Plate 49).

The interior of the boiler house looking north.

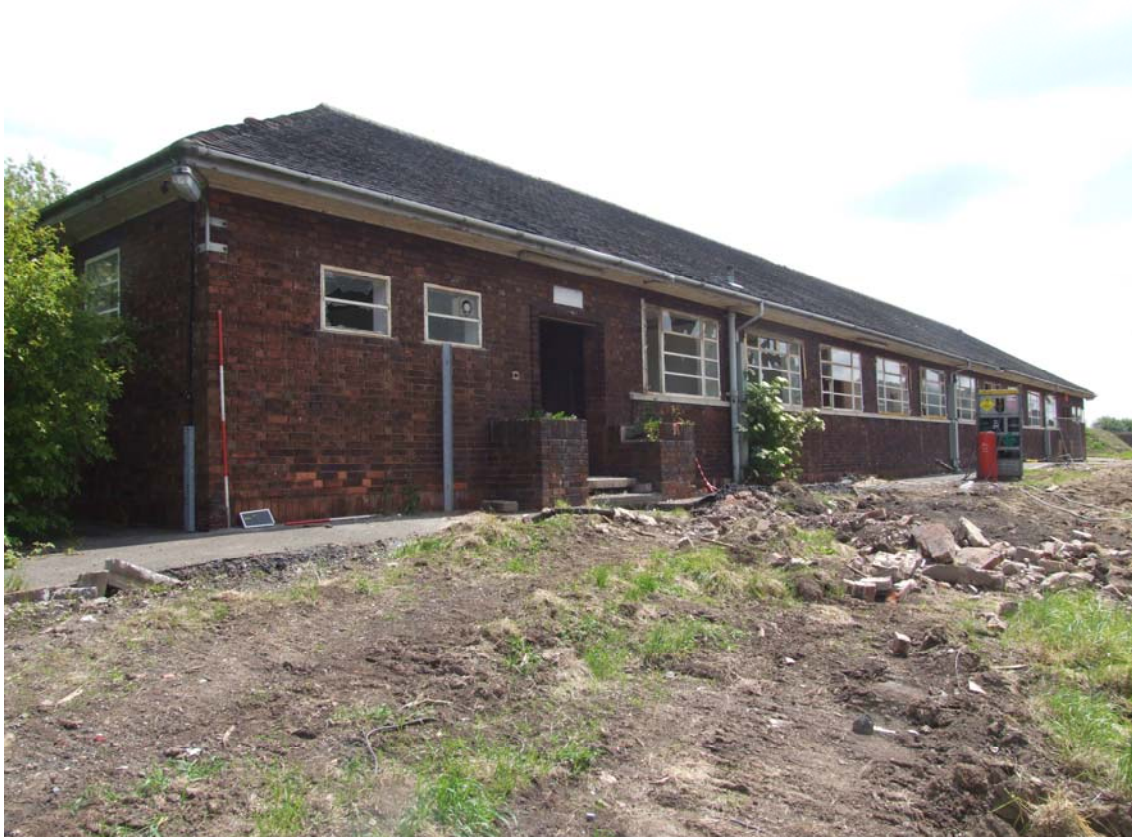
PLATE 50

5.7.1 Building 6 was a single-storey rectangular block built with reddish brown bricks in a monk bond and had a plinth course consisting of soldier bricks (Plate 50). The roof

The west elevation of Building 6 (scales: 1m, 2m).

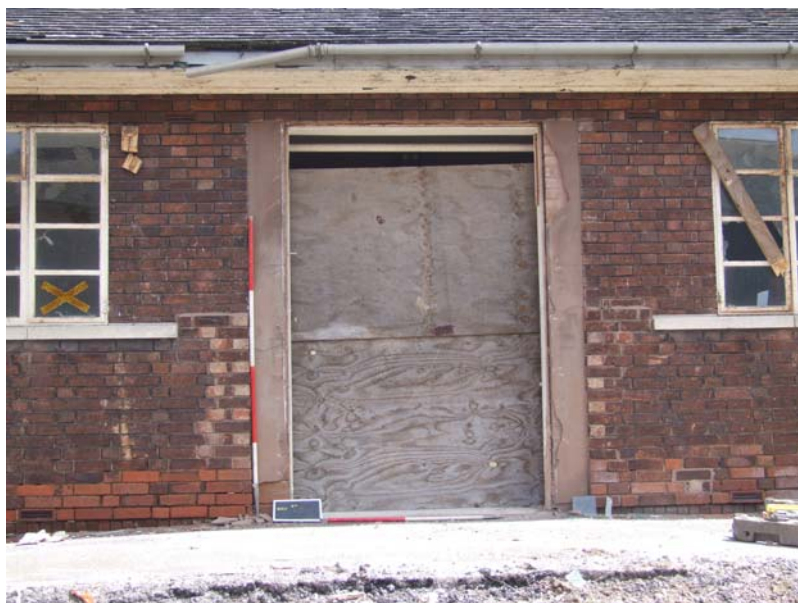
PLATE 54

was hipped and covered with plain grey clay tiles. A brick chimney stack was visible on the east side of the roof towards the north end of the building. The original windows were all metal-framed casements. Wide windows ranged down each long side of the building and were linked by a continuous concrete sill. Smaller, higher-level windows were located at each end of the long elevations and at the north and south ends of the building. The smaller windows in the south elevation (Plate 51) and at the south end of the east elevation had been re-fitted with wooden-framed casements. Repair to the brickwork on the east elevation indicated that the southernmost wide window had been replaced with three smaller wooden-framed windows (Plate 52). The building was accessed on its western side through one of three doorways; one located just the south of centre and the others towards each end of the elevation. Those doors located towards each end of the elevation had canted brick surrounds and concrete sills. The northernmost of these was flanked by brick-built planting boxes (Plate 53). Scars to either side of the southernmost door indicated that it had also formerly been flanked by planting boxes. The door located towards the centre of the building had a wooden lintel. Repaired brickwork to either side of the door indicated that it had been converted from a window (Plate 54).

The inserted door in the west elevation of Building 6 (scales: 1m, 2m).
