Archaeological Watching Brief

The Queen's Hotel

489 Etruria Road

Report No. 442

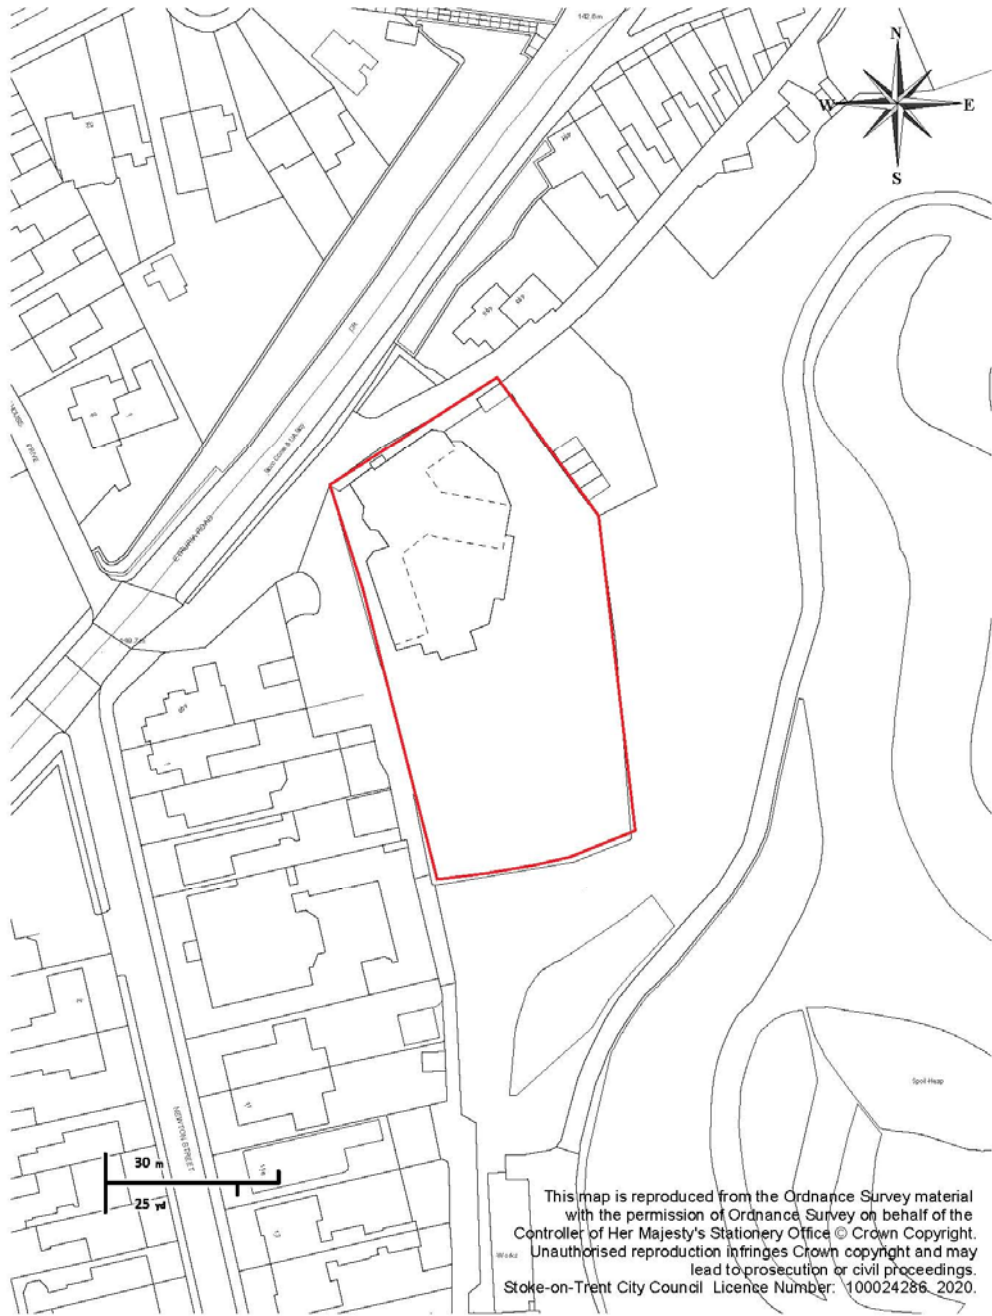
FIG. 2

Map showing the Queen's Hotel with the site boundary outlined in red. The dashed line represents the altered structure of the building after demolition of the single storey extension.

1.2 The site is bordered to the north by Etruria Road, running on a north-east to south-west alignment. To the west is a lane which provides access to the rear of the houses on Newton Lane. To the south and east is a wooded area (Fig.2).

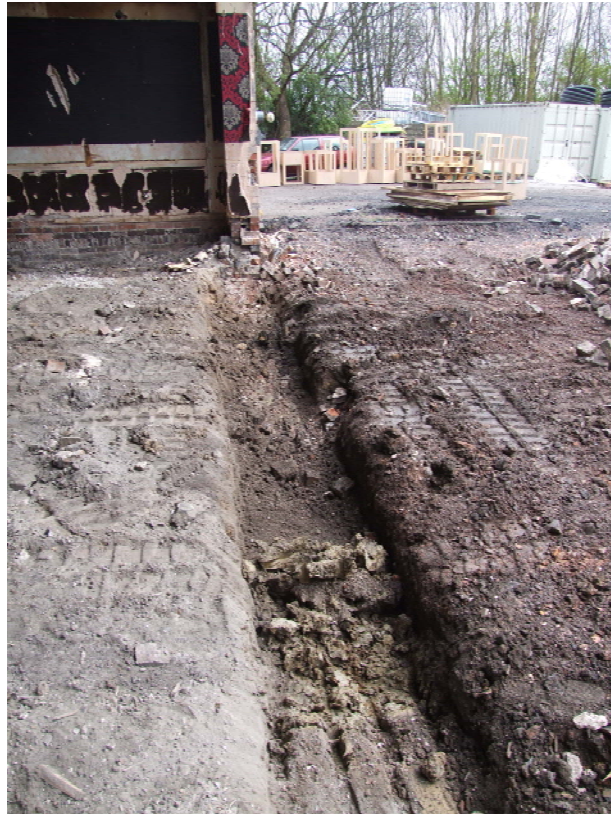
PLATE 1

Foundation trench within the former single-storey extension, facing south east

5.1 The watching brief observed the excavation of foundation, drainage and service trenches associated with the new residential development. Some of these trenches were located within an area that was formerly occupied by the single-storey extension of the public house (Fig. 8) which had already been demolished and the floors removed when the watching brief began. These trenches were 0.70m wide and ranged between 0.70m and 0.90m in depth (Plates 1-3). No archaeological features were observed in any of these trenches. The soil profile within the footprint of the former building comprised two layers. The uppermost (112), was a grey brown fine ashy silt containing occasional brick and tile fragments c.0.50m thick. Underneath this was (113), a greyish yellow clay, probably the natural clay, visible to the base of the trench.

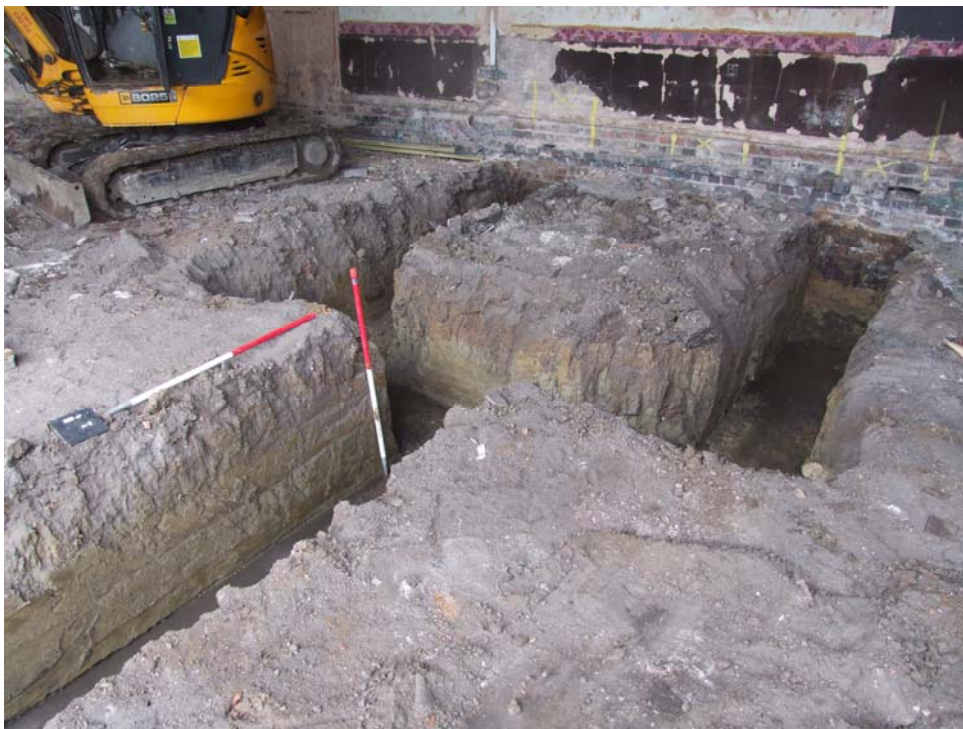
PLATE 2

Drainage trench showing the soil profile, facing north west (scales: 1.00m)

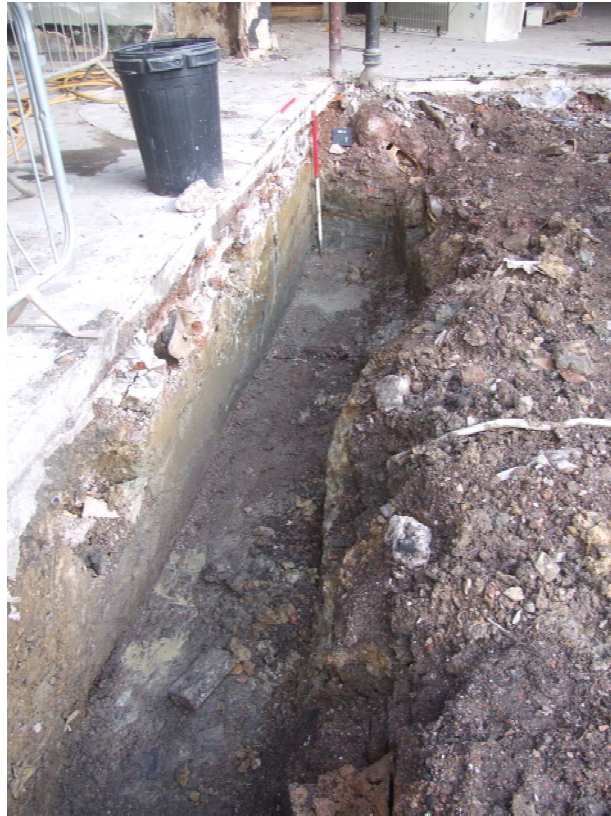
PLATE 3

Foundation trench showing the soil profile, facing west (scales: 1.00m)

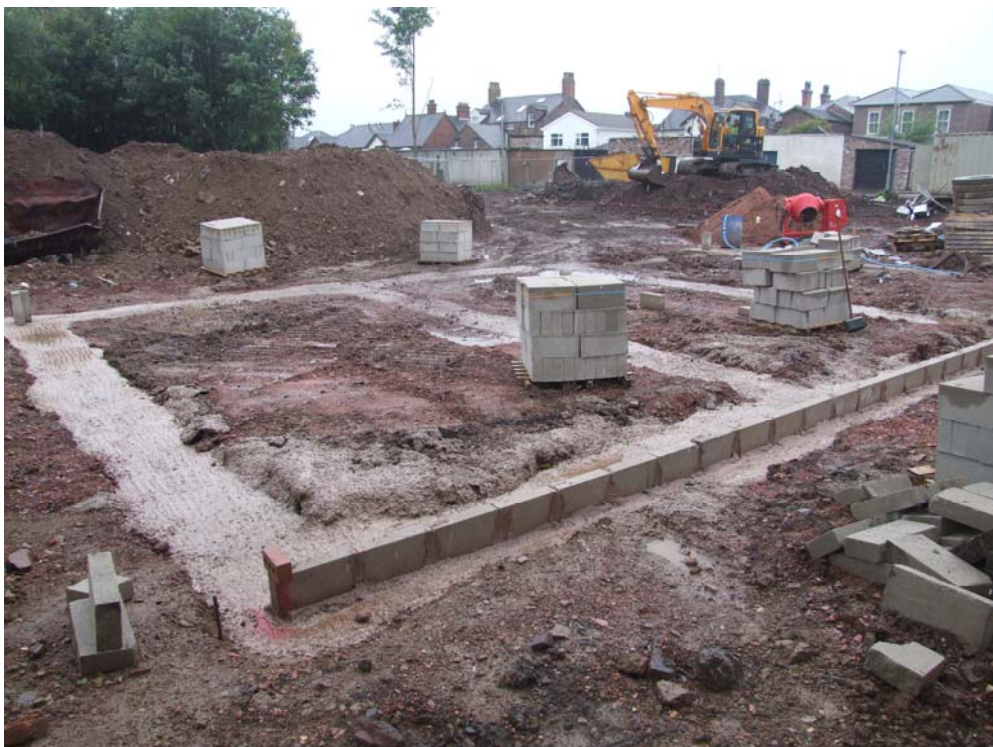
PLATE 4

5.2 The trenches dug for the remaining residential units yielded little archaeological material (Fig.9). It was not possible to see into the trenches in group A as they had already been filled with concrete without the monitoring archaeologist being present (Plate 4).

Foundation trenches A filled with concrete, facing south west

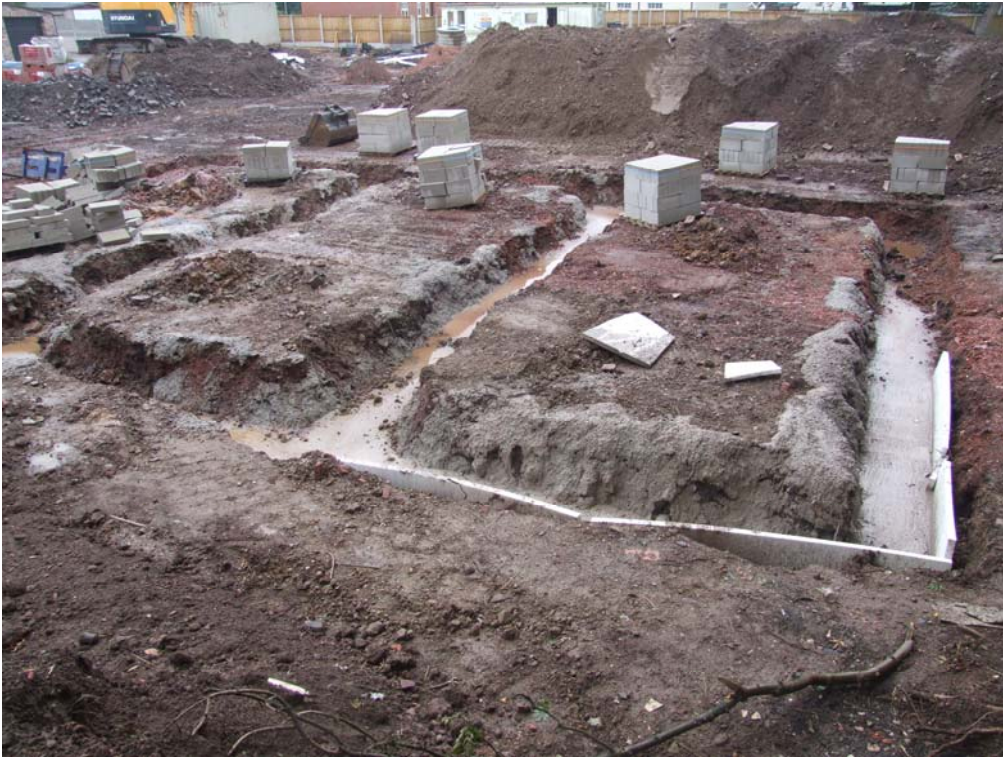
PLATE 5

5.3 The trenches in group B had been filled to a depth of 0.40m with concrete but at least some of the soil profile was observable above this level (Plate 5) and comprised (100) a tarmac hardstanding layer of around 0.06m deep which overlaid a made ground layer (101) consisting of silty crushed brick and brick fragments around 0.50m thick. The lowest layer observed was (102), a sticky yellow-grey clay, possibly natural.

Foundation trenches B partially filled with concrete, showing soil profile, facing north

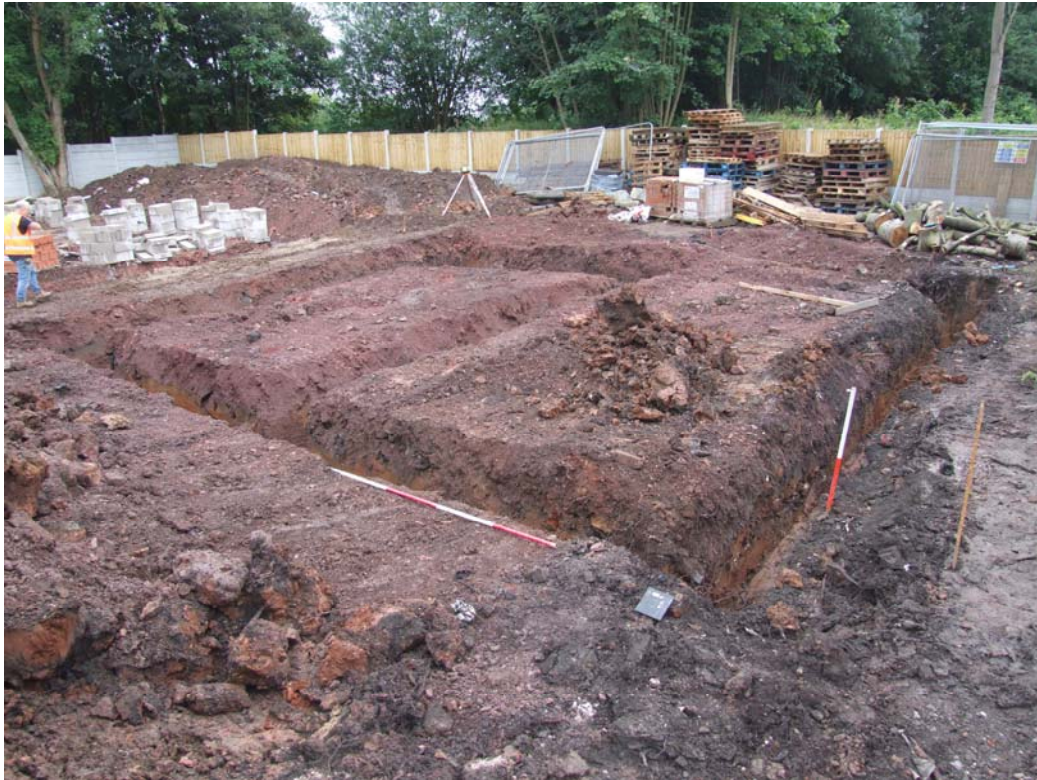
PLATE 7

5.4 The above-mentioned soil profile was similar in the trenches of group C (Plates 6 & 7). This comprised (101) to a depth of 0.60m and (102) to a depth of 0.15m-0.20m thick, possibly representing an interface layer. The lowest horizon was (103), a reddish-brown clay which appeared to be the natural subsoil. The trenches in group C were dug a little deeper (a maximum of c.1.50m) than elsewhere on site, due to the presence of tree roots. The western trench was a little siltier than elsewhere, possibly due to the tree roots. A saggar-filled linear feature (104) was observed in the south-facing section of the southern trench. This was c.0.20m in depth and sat just below (102). When this feature was cut through in the course of digging the north-south aligned trenches it was revealed to be c.0.20m wide. This is most likely to be a French drain.

Completed foundation trenches C, facing south east (scales: 1.00m & 2.00m)

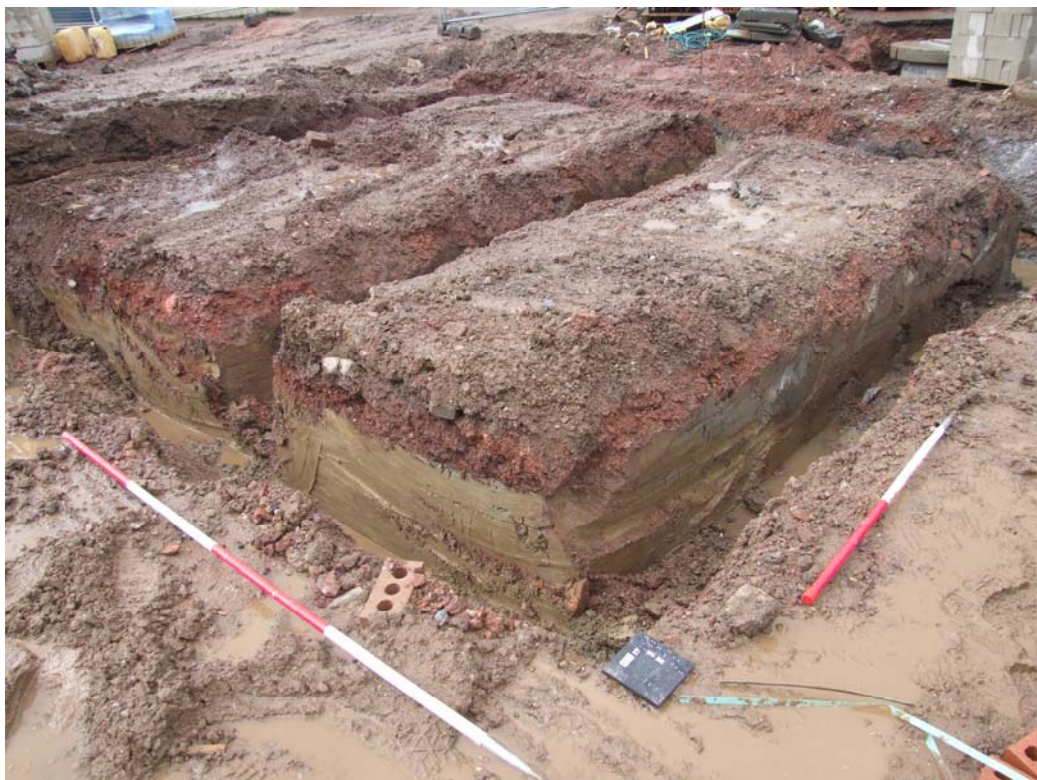
PLATE 8

5.5 The trenches in group D were c.1.20m deep and exhibited a similar soil profile as seen elsewhere on site (Plate 8), with (101) to a depth of c.0.30m and (102) to a depth of c.0.20m. Underneath this was (110), a layer of yellowish-brown clay although this was observed at the base of the trenches and could represent a variation of the natural clay. Towards the south and east of the plot (102) petered out and (101) was directly above (110).

Foundation trenches D, facing south west (scales: 1.00m & 2.00m)

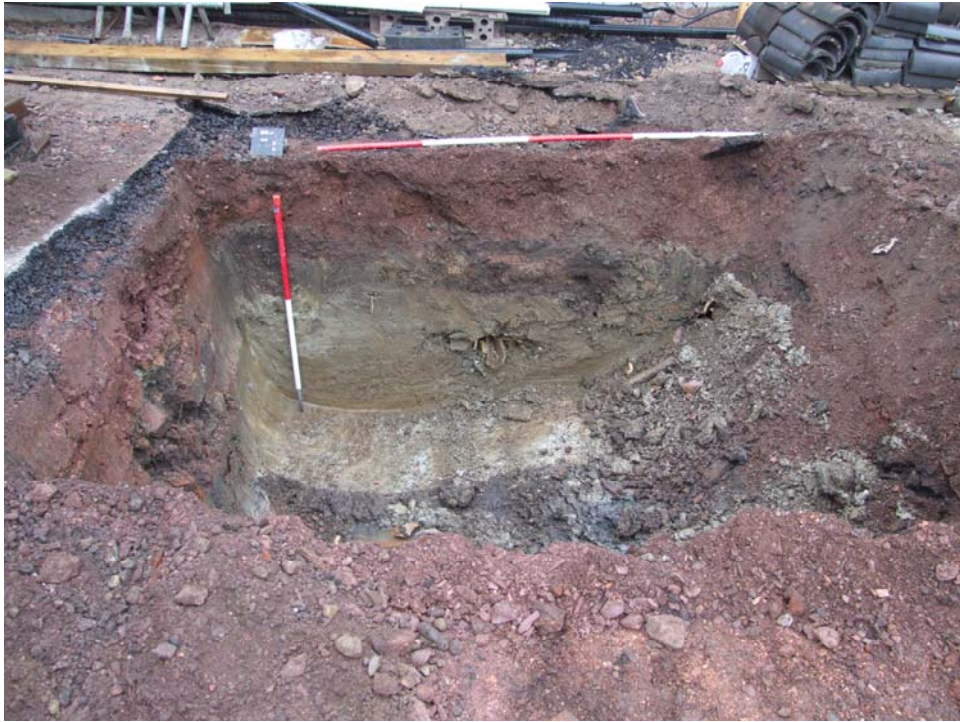
PLATE 9

5.6 The excavation of a large man hole (c.2.00m square and c.1.30m deep) at the north-west corner of the site, labelled E on Figure 9, revealed a similar soil profile as encountered across the rest of the site, with (100) being 0.35m deep, the interface layer (102) being 0.30m deep, (103) the natural clay persisting to the base of the trench. Two cuts were evident in this trench: cut (107) was an east-west cut central to the trench, 0.55m wide and at least 1.00m deep. This had a lower fill of very dark brown silt at least 0.40m thick (108) and an upper fill of silty brick rubble (109). This feature contained a ceramic drain of c.0.20m in diameter (Plate 9). (105) was a north-south aligned cut c.0.40m wide and 0.35m deep. This cut was encountered immediately below the interface layer at 1.04m east of the west side of the trench (Plate 10). This was filled with fragments of saggars and is probably another French drain (106).

Manhole trench E showing soil profile and drain (109), facing north (scales: 1.00m and 2.00m)

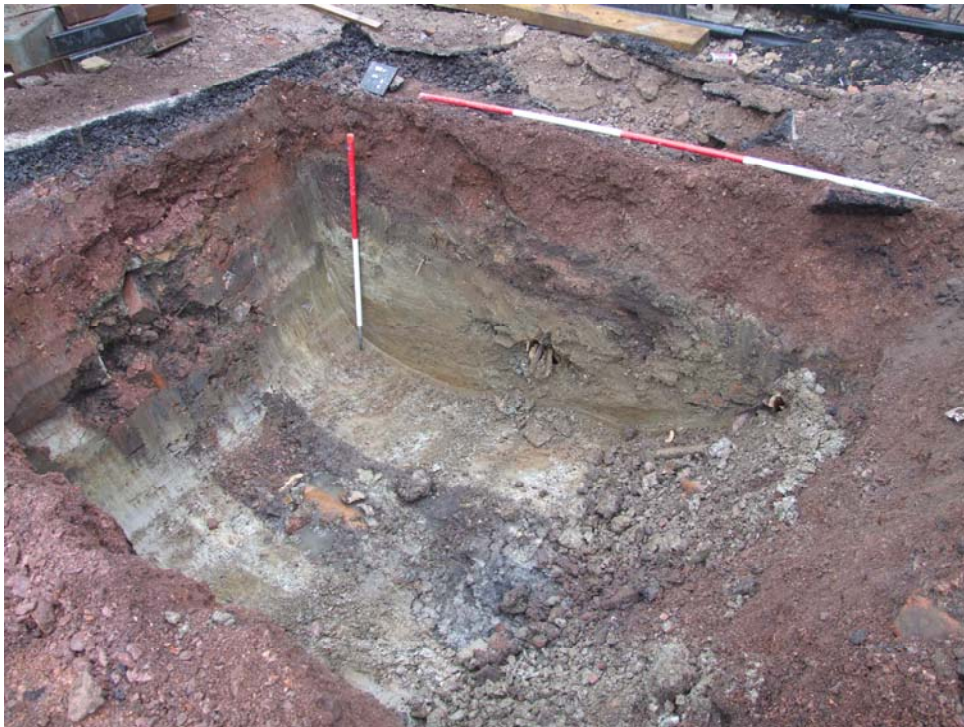
PLATE 10

Manhole trench E showing soil profile and drain (106), facing north west (scales: 1.00m and 2.00m)

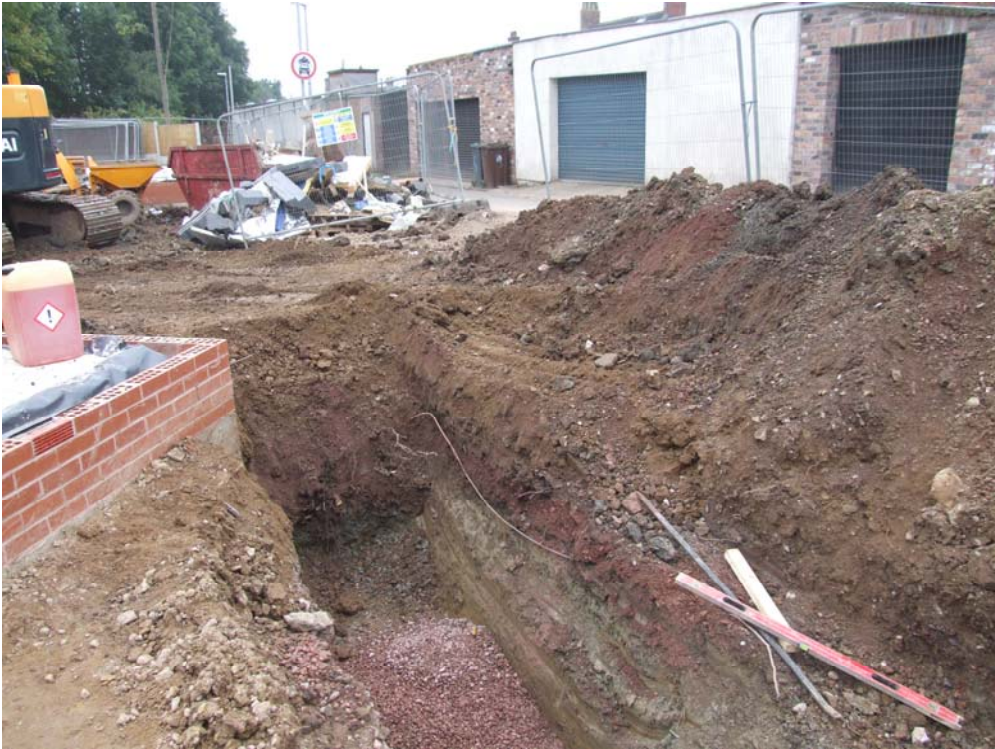
PLATE 11

5.8 The excavations for the main drainage run, labelled G on Figure 9, comprised trenches of 1.20m in width and c.1.60m deep. They revealed a soil profile (Plate 11) comprising (101) to a depth of c.0.20m, (102) to a depth of c.0.15m, overlying the natural clay which was observed to the base of the trench (110). Feature (111) comprised a layer of crushed saggars (Plate 12), presumably the base of a further French drain, c.0.35m thick. This feature was observed between (102) and the natural clay (110). As seen elsewhere on site where there were many tree roots present, in this case in the east-facing section of the trench, the soil was noticeably siltier.

Drainage trench G showing soil profile, facing south west (scales: 1.00m and 2.00m)

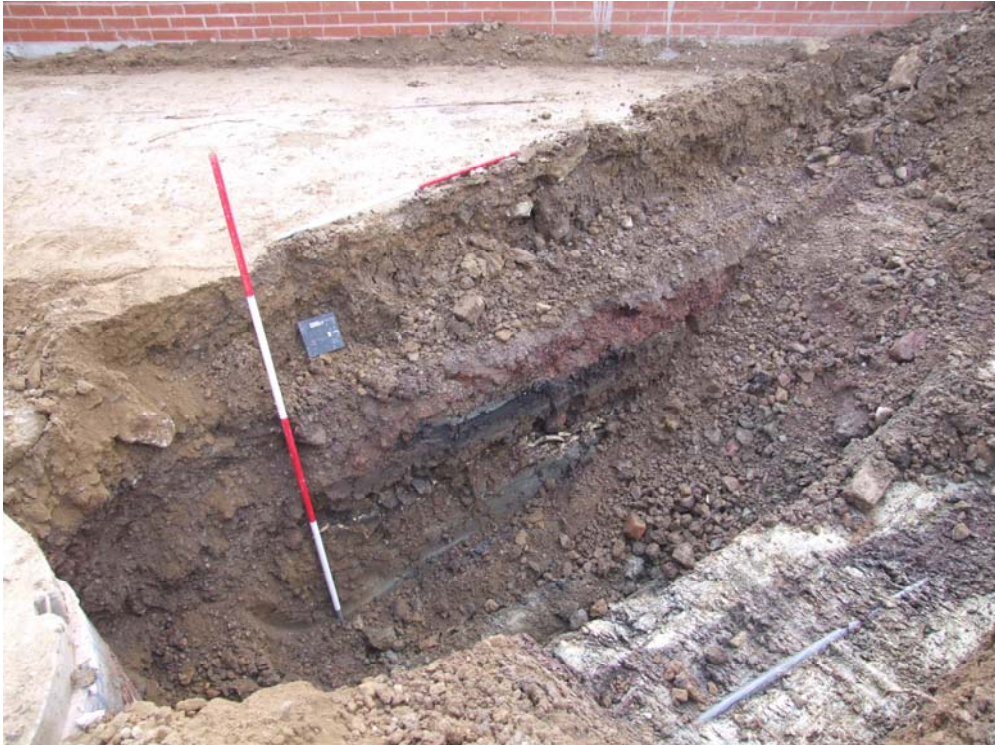
PLATE 12

Drainage trench G showing soil profile and drain (111), facing east (scales: 1.00m and 2.00m)
