**Archaeological Building Recording of
Buildings 18, 19, 20 & 21
Chatterley Whitfield Colliery
Stoke-on-Trent
Staffordshire
NGR SJ 8841 5323**

Site Code: CWCBH08

Report No. 244

February 2009

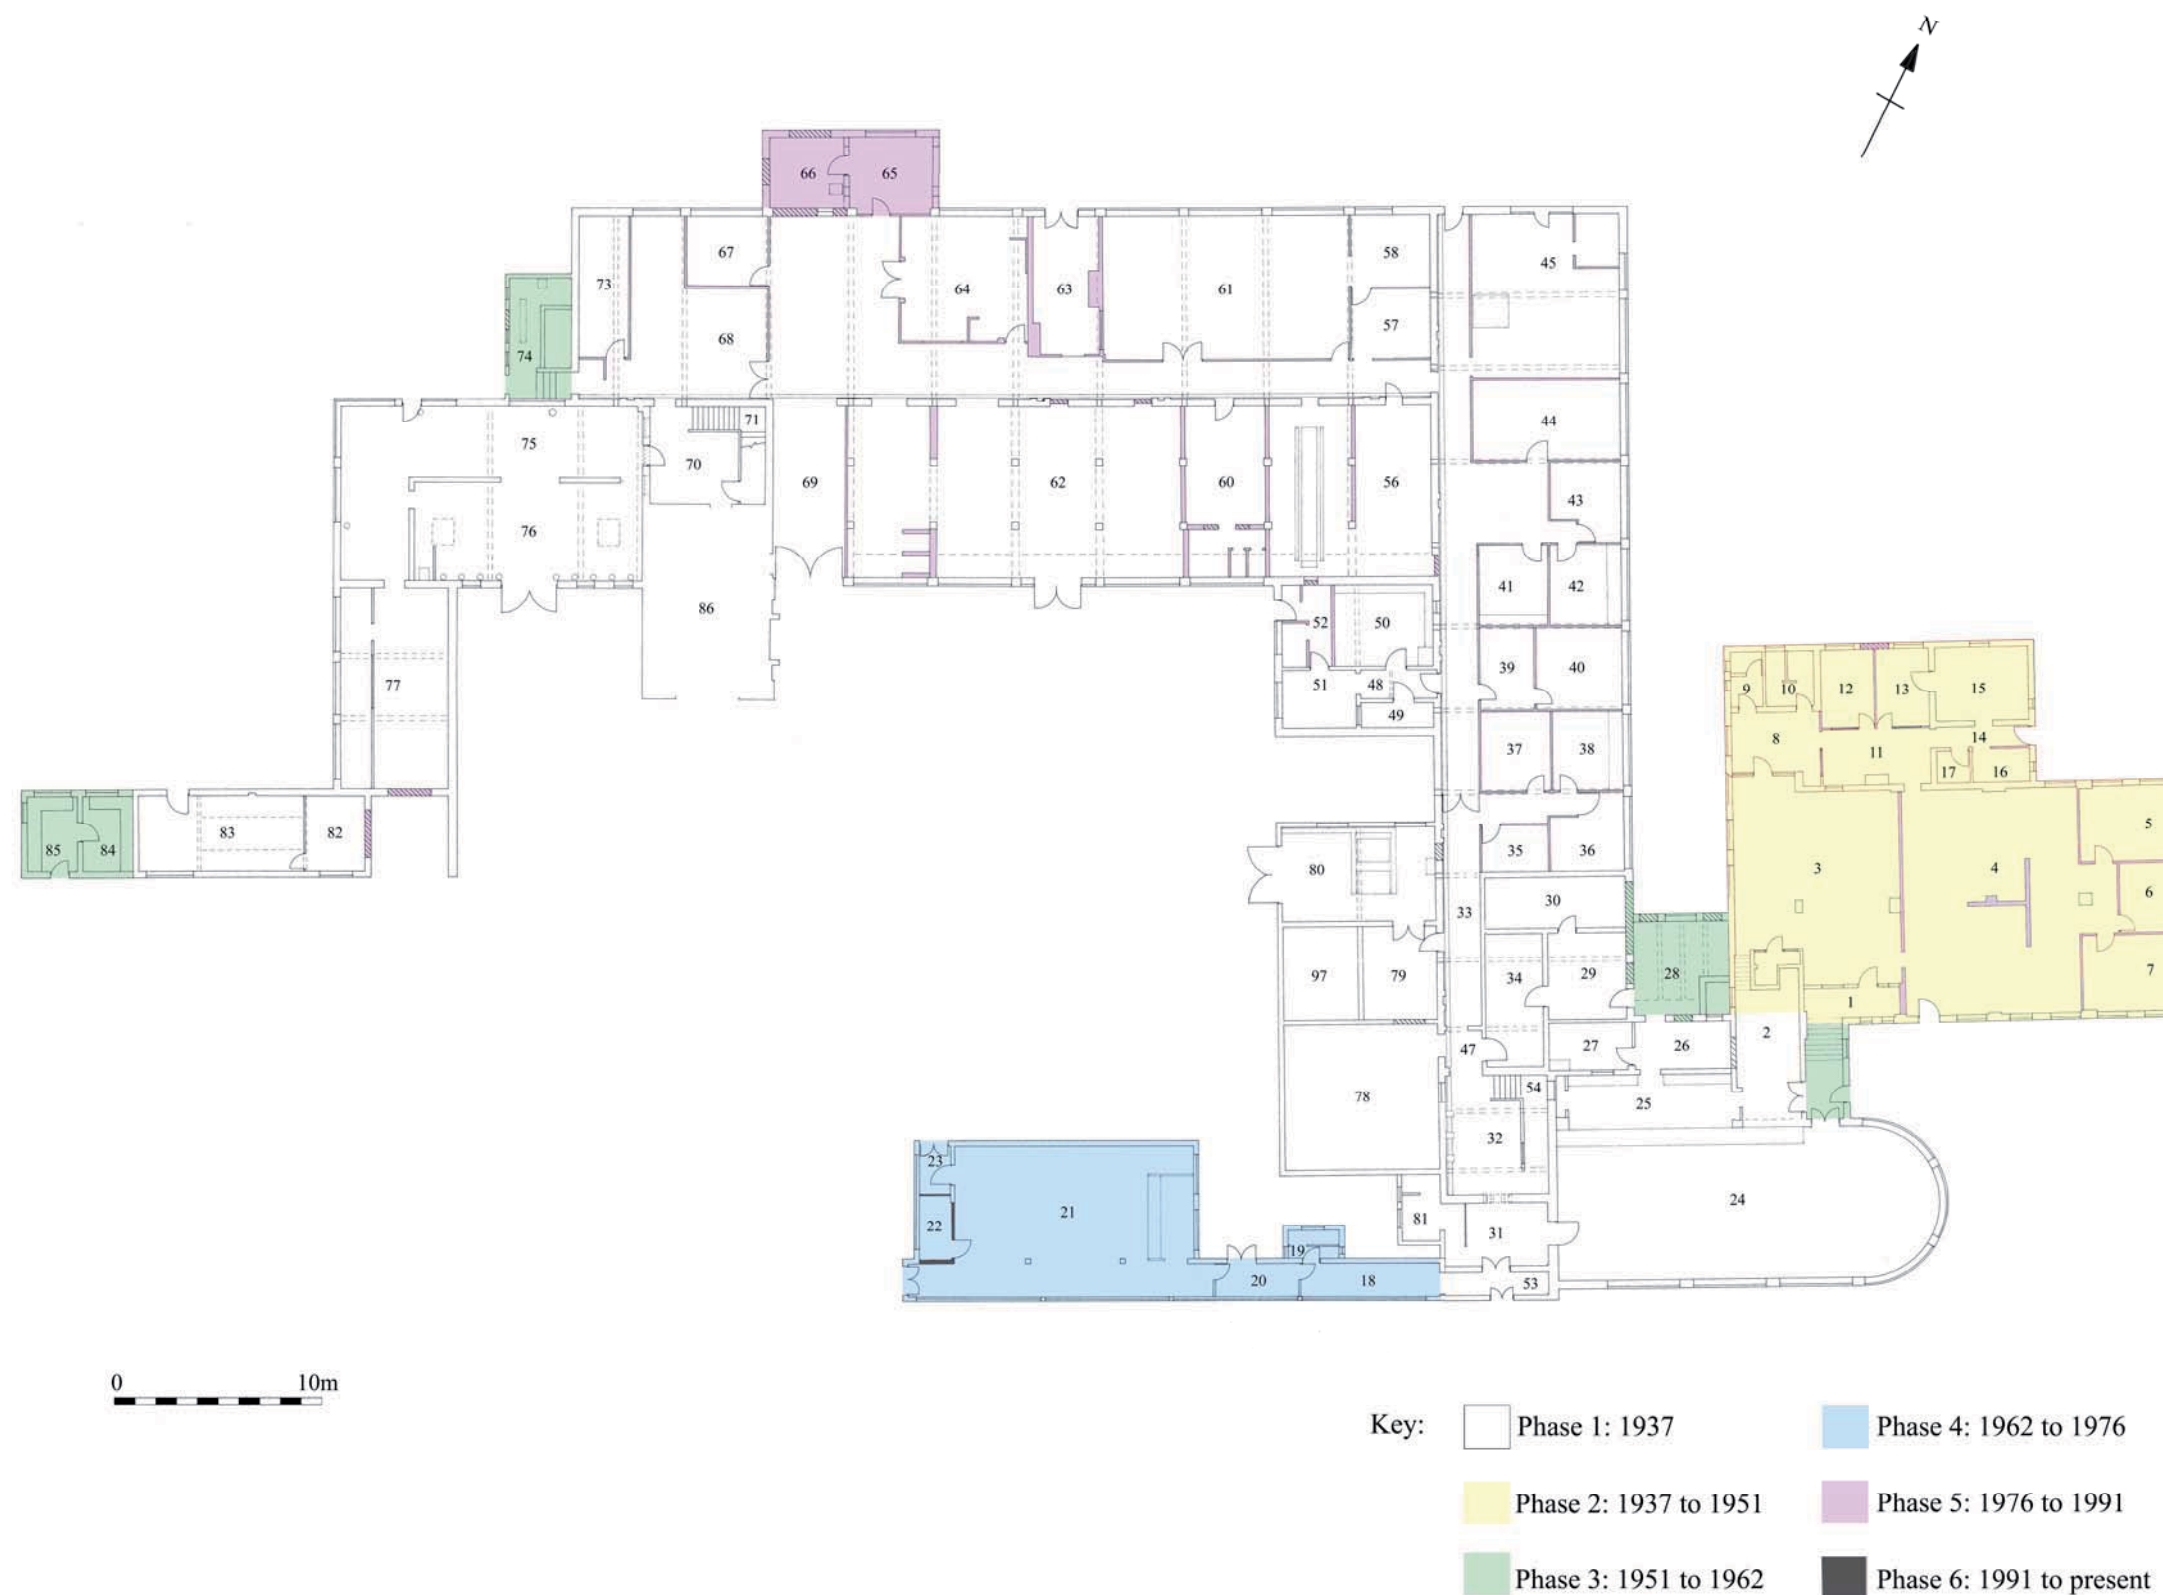
FIG 16
Phase plan

6.1.1 The Baths and Canteen buildings were the first parts of the complex to be built, initially appearing on the 1937 OS map (Fig.3) and officially opened in 1938 by the Miners Welfare Committee (Plate 30). By the time the baths complex had been built at Chatterley Whitfield, the Miners Welfare Committee had a dedicated architects department with experience gained and basic plans formulated for the design of such buildings (The Twentieth Century Society 2008). The two important principals in such buildings were to keep the clean and dirty, or pit, areas separate and to have an efficient, congestion-free flow of people through the building. Other welfare facilities were usually grouped in the same complex as the baths (International Collieries Study). At Chatterley Whitfield the Canteen was situated by the clean entrance at the southern end of the east range, for use by the miners before or after work and no doubt also served as a social gathering point, as well as providing food and drink. A medical centre was also provided, originally located in the single-storey section of the eastern range and including an ambulance bay within room 80 (G. Oakes pers. comm. 2008).

6.1.2 Within the Baths the basic layout was identical on both floors and is well illustrated by the layout seen on the first floor during recording work. As far as is known there was no differentiation between the ground and first floors at Chatterley, but in some other collieries the older men used the facilities on the ground floor and the younger men used those on the first floor (1929 Miners Welfare Annual Report: Harrington Colliery Baths, Cumberland). The miners arriving at work would have entered the baths via the clean entrance (porch 53) and gone to their allocated locker in the clean locker rooms (the area occupied by rooms 35 to 45 on the ground floor and room 90 on the first floor) (Figs. 16 and 17). Here they would have changed out of their clean clothes, collected soap and towels and progressed to their pit lockers (in room 88 on the first floor and the corresponding area on the ground floor), which were in the same relative position as their clean lockers, to change into their work clothes and deposit the soap and towels for later use (G.Oakes pers. comm. 2008). The lockers used in both areas were of the double-tiered variety, first introduced in 1928 as a space-saving measure (1928 Miners Welfare Report: Pithead baths – The installations at Park and Mainsforth Collieries) and were originally connected to the heating and ventilation system by means of ducts so that clothes would be warmed and dried (G. Oakes pers. comm. 2008); an improvement to

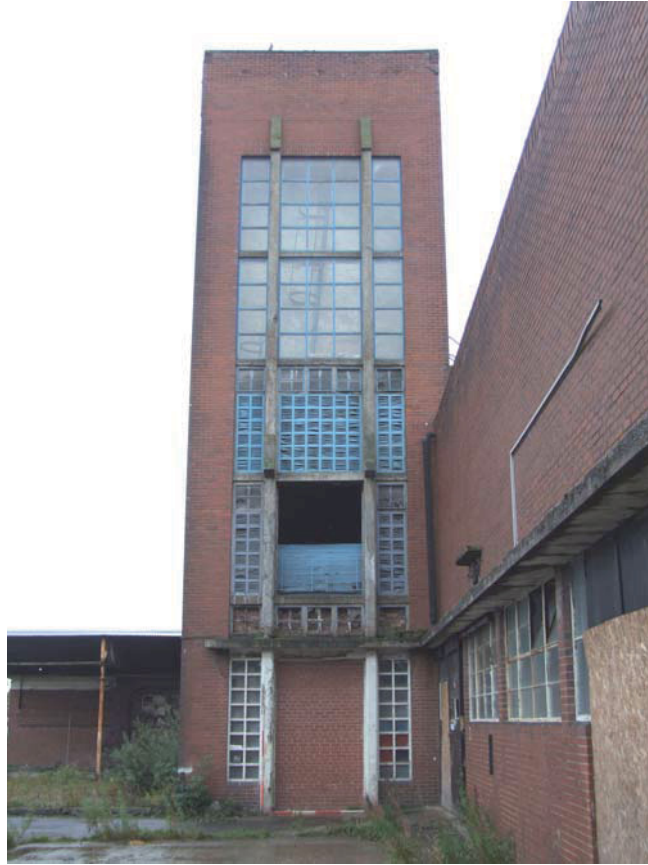
PLATE 3

frames had been replaced with wooden examples. Windows at first-floor level are confined to the stairwells and are also metal-framed casements. The windows in the eastern elevation of the tower have concrete lintels and sills and projecting mullions between each section of window (Plate 3). The doors located on both the north and south sides of the building are within the continuous band formed by the windows, sharing the same concrete lintel as the windows. One wooden double door had been inserted into the first floor in the northern elevation, but by the time of recording any stairs had been removed.

The plenum tower, eastern elevation

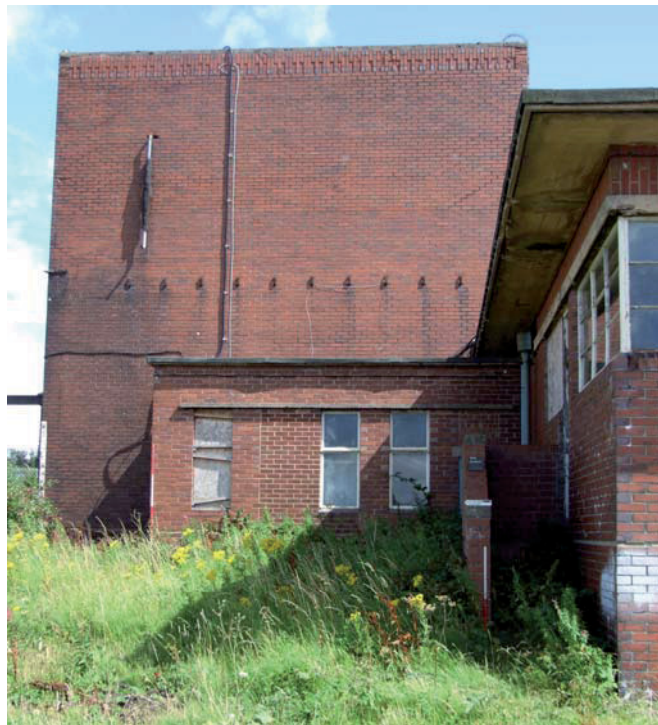
PLATE 4

5.2.2 Three extensions have been added to the Baths; a small extension to the northern side of the north range, a sub station at the western end of the north range (Plate 4) and a photographic suite on the western end of the western single-storey wing (Plate 5). All are constructed with a red/brown brick in stretcher bond with flush mortar jointing and are fitted with wooden-framed casement windows. The northern extension has a two-storey section with a flat felt-covered roof and a single-storey section with a pitched roof, also covered in felt. The sub station and the photographic suite both reflect the design of the original part of the Baths to a greater extent than the northern extension, with an overhung roof on the photographic suite and a canopy over the windows in the sub station.

The sub-station, western elevation

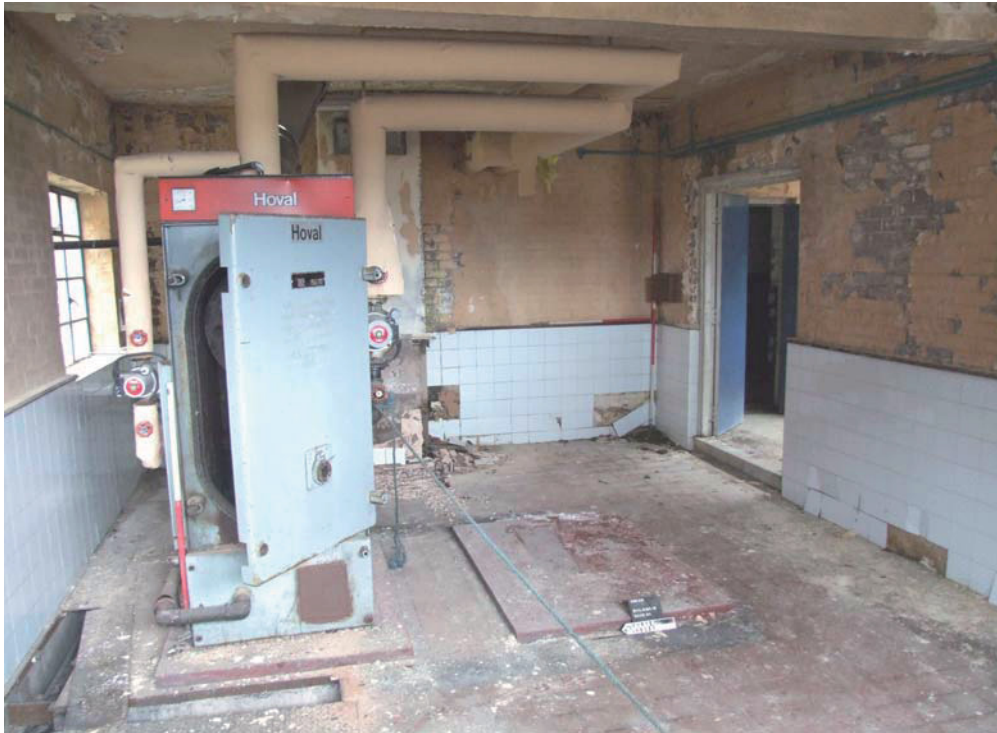
PLATE 13

5.2.4 The single-storey section of the eastern range, containing rooms 78, 79, 80 and 97, is accessed from the western side of corridor 33 at its southern end. Unfortunately the keys had been lost to room 78, indicated as a female changing room on the door, and to room 97, accessed through room 78, and attempts to gain access otherwise were unsuccessful. Room 79, to the north of 78, is a plain space with plaster walls painted peach and little evidence to suggest its original use. A blocked doorway in the southern wall shows that it had originally been connected to room 78 while the plans produced as part of WS Atkins' condition survey in *c.*2000, indicate that the room had once been one with room 86. Room 80 to the north is accessed via room 79, although a bricked up doorway in the eastern wall, visible only in corridor 33, suggests that this room had formerly featured a separate access point from the corridor. An external double door in the western side of the room suggests that it may originally have required vehicular access. The floor in this room is at a lower level than in room 79 and has been finished with red ceramic tiles. The room has most recently been used to house a large boiler in the south-western quarter and the chimney flue on the east wall appears to be associated with this (Plate 13).

Room 80 in the Baths, looking north

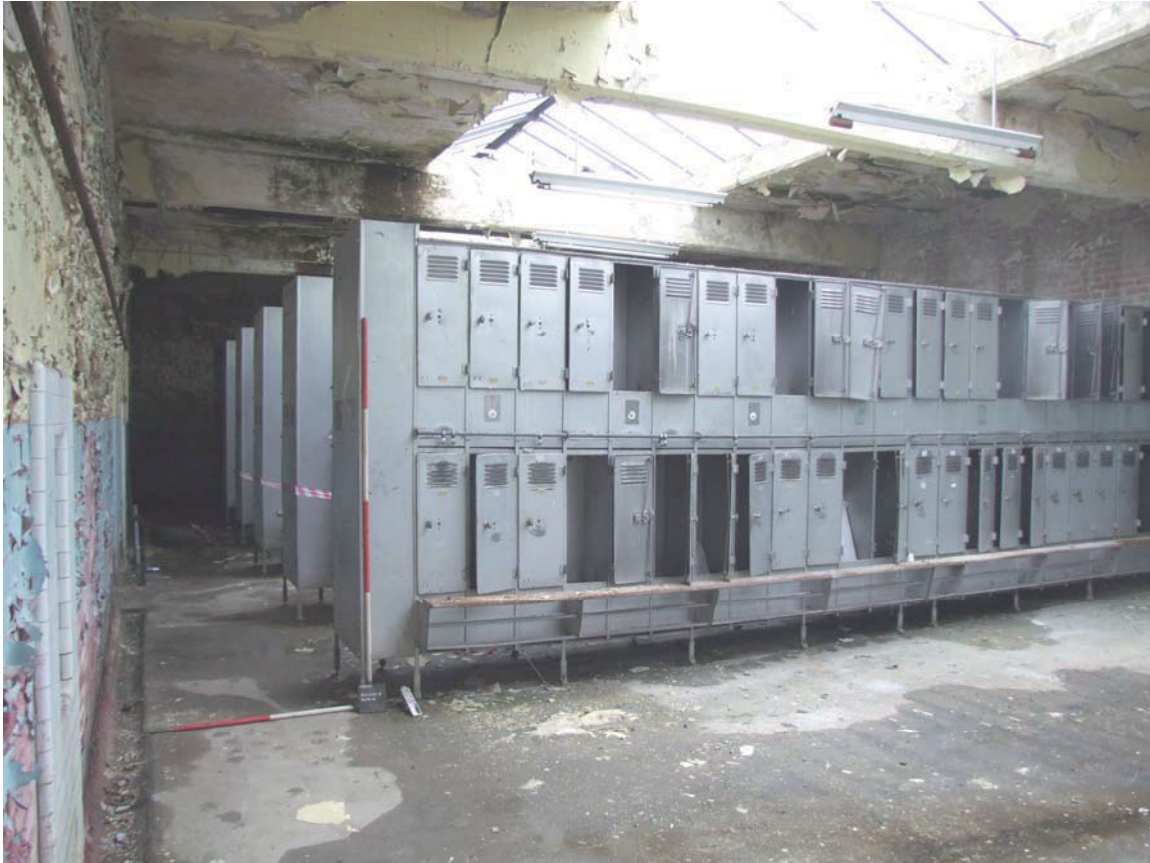
PLATE 17

5.2.12 The first floor of the Baths has the same basic layout as that of the ground floor but has undergone less alteration. The first floor of the eastern range is reached from the stairs (54) at the southern end of the wing. These terminate in a landing (93) finished in the same blue glazed bricks as the stairs and fitted with a row of three drinking fountains on the northern wall. The eastern range remains as an open area comprising just one

large room (90), lit by a central skylight (Plate 17). As on the ground floor, the floor slopes down towards a drainage channel that extends the length of the room on its western side. Five glazed brick niches with attachments for fitting hose pipes are ranged along the western wall. A metal box attached to the western wall was identified as a dispenser for foot powder (G. Oakes pers. comm. 2008) (Plate 18). The room is further furnished with nine banks of double height galvanised steel lockers ranged east to west across the room (Fig 12). Each locker was numbered on a coloured plate of blue or green, now so faded as to be barely discernible.

Room 90 in the Baths, looking north

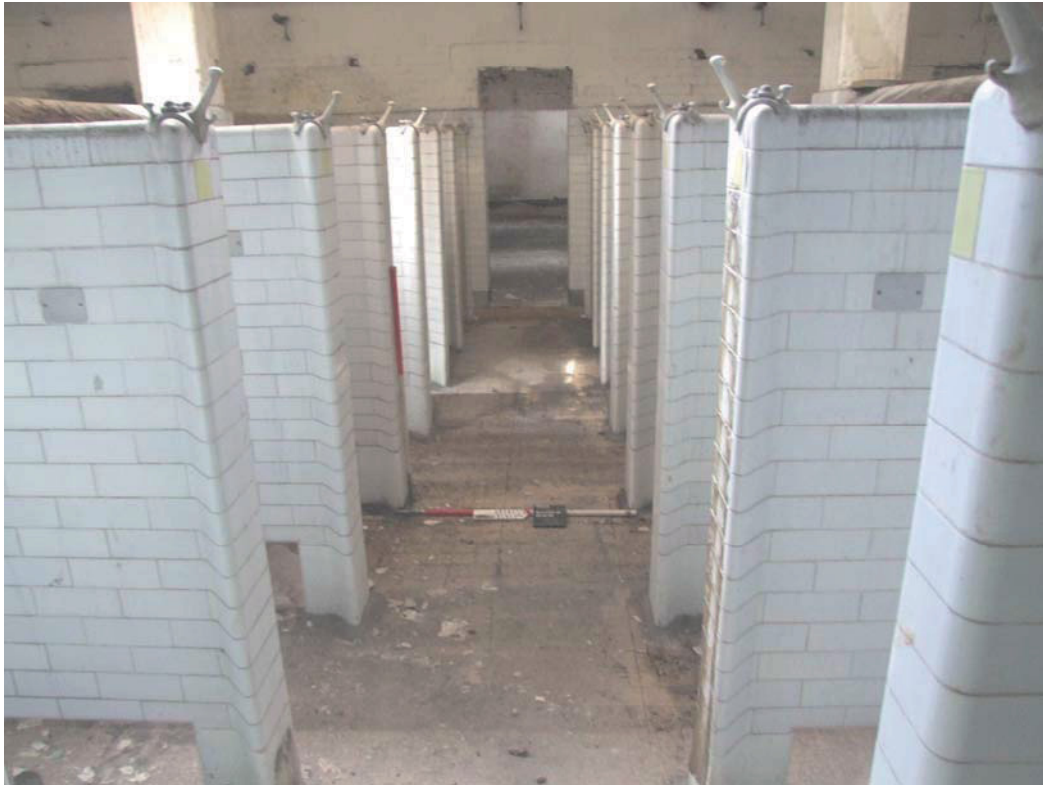
PLATE 21

5.2.14 The northern range is divided into two main rooms, room 88 to the north and room 89 to the south, both lit with skylights. Access to both rooms is either via room 90 to the east or the stair landing (87) at the western end of the building. Access between the two rooms is also possible via a row of eight doorways in the separating wall. Room 88 is similar to room 90, having a floor that slopes down to a drainage channel on the southern side of the room and glazed brick niches fitted with water pipes in the southern wall. Although the room is unfurnished, the similarities with room 90 may suggest that it had also been used as a locker room. In room 89 the north side of the room has a slightly sunken floor and is fitted with eight bays, each divided into fourteen shower cubicles. The divisions between each cubicle are constructed with white glazed bricks and each is topped with a three-pronged ceramic hook (Fig 13, Plate 21), of the same design as those

seen on either side of the doors in rooms 56, 60 and 62. The bays are marked with coloured tiles at each end. Two bays are marked with blue tiles, two in yellow, two in green and two in red. These corresponded with the coloured number plates on the lockers and it was intended that, in order to reduce congestion, the men should only use showers with a colour corresponding to their locker (Evening Sentinel 1938, 7).

Shower bays, looking north
