**Archaeological Evaluation
on land off
Ridgway Road,
Hanley,
Stoke-on-Trent,
Staffordshire
NGR SJ 8858 4645**

Planning Application No.: SOT/48034/RES

Report No. 238

December 2008

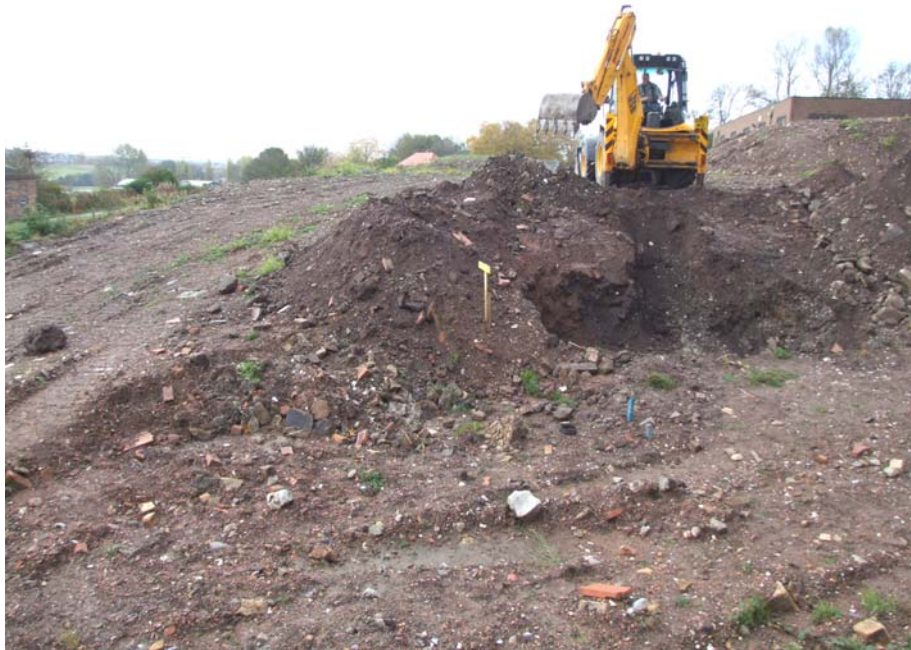
PLATE 1

General view of trench being excavated, facing south.

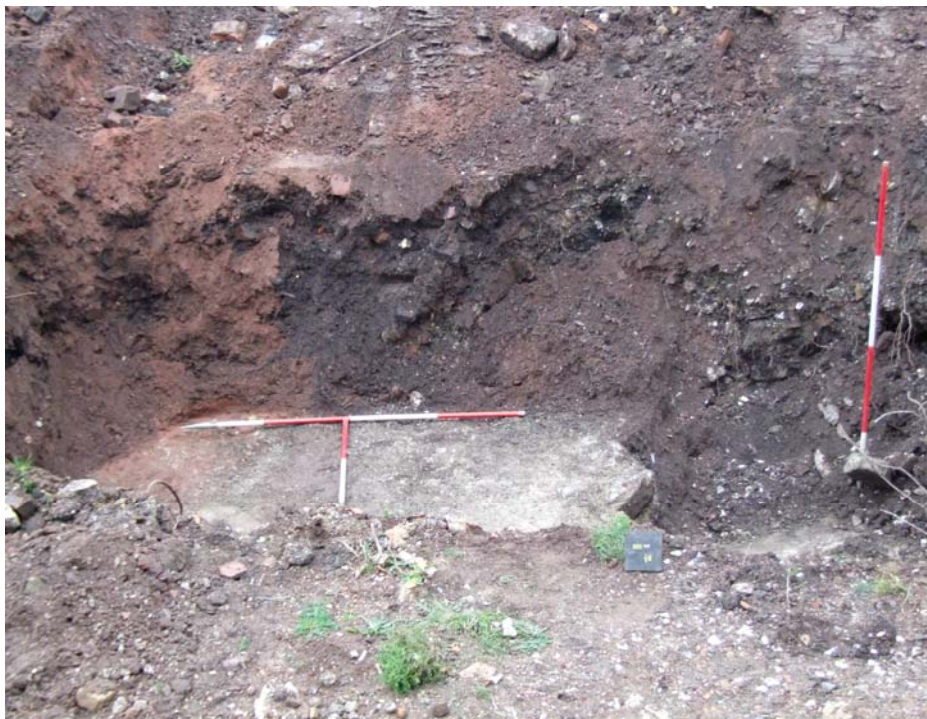
PLATE 2

View of trench facing south, showing depth of overburden (100) and concrete (101)
(scales: 1.0m & 2.0m).

6.1.2 Excavations commenced with the removal of overburden (100), which comprised a mix of loose red ash, loam, brick rubble, broken concrete and some 20th-century domestic refuse. Deposit (100) was 1.70m thick at the eastern end of the trench, increasing to 1.90m thick to the west and lay above two reinforced concrete slab fragments (101) and (102). The first of these, (101) was positioned at the eastern end of the trench and was 0.26m thick. The full extent of (101) was not revealed during the evaluation, but it was at least 3.00m E-W x 2.20m N-S. Partly underlying (101) in the western half of the evaluation trench was a second slab fragment (102), 0.18m thick.

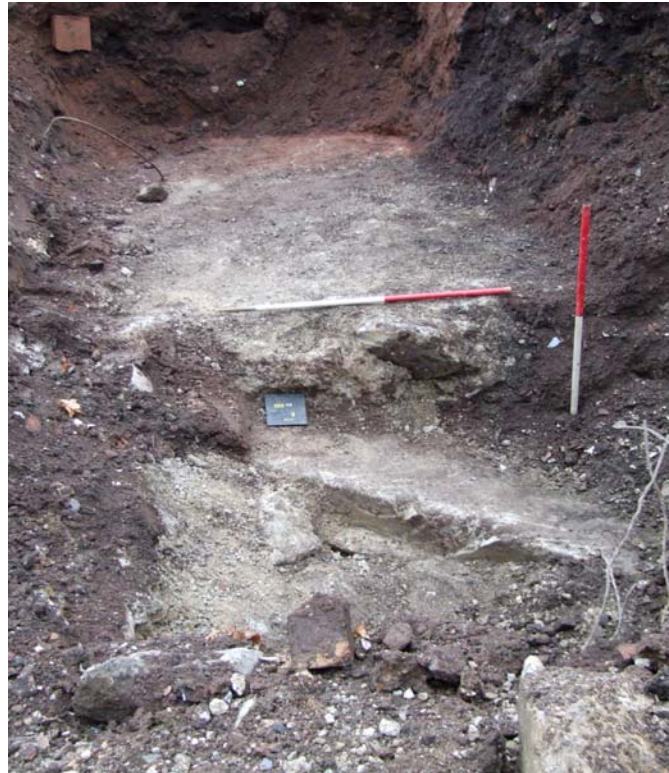
PLATE 3

View of concrete fragments (101) and (102), looking north west (scales: 1.0m).

7.1 The evaluation at Ridgway Road failed to identify any trace of the crate-maker's pond that formerly occupied the trench area. The later development of the electricity works, specifically the water storage tank, had destroyed all evidence of this feature. The pieces of reinforced concrete found within the evaluation trench in all likelihood represent fragments of this water tank. The depth at which the fragments were found seems to support the documentary evidence (Ellis 1925) that this was a partly sunken structure, which, when demolished was seemingly broken up and back-filled into the void that it once occupied. Further landscaping appears to have taken place following the tank's demolition.

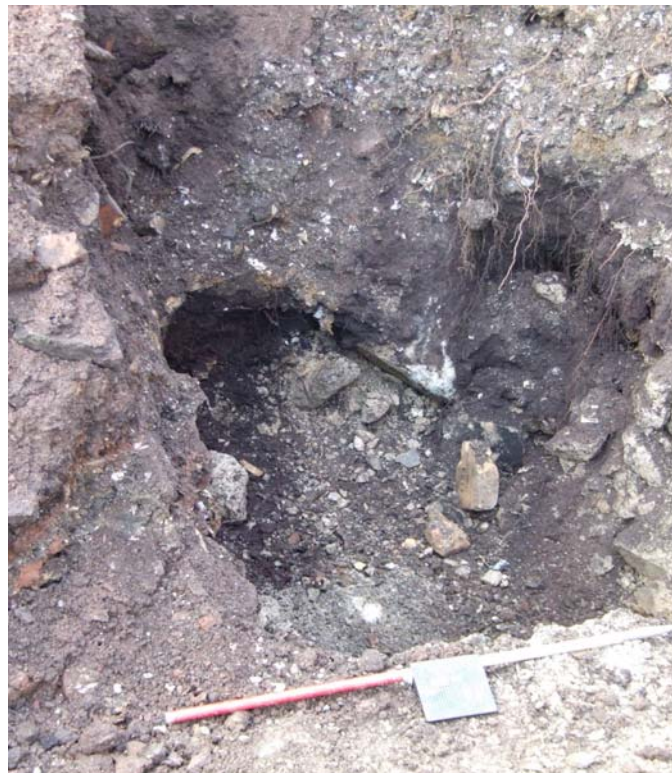
PLATE 4

Concrete fragment (104) at base of sondage on the south side of the trench, looking south west (scale: 1.0m).

6.1.3 In the north-western corner of the trench a loam and rubble made ground deposit (103) was exposed, which was similar in consistency to (100), but appeared to continue beneath (102) and (101) to the east. A sondage was machine excavated through (103) on the southern side of (101), revealing another concrete slab (104) located some 1.30m below (101). At this point the sondage began to flood and excavations were halted. Although the required trenching area had not been achieved at this point, it was decided in consultation with the Planning Archaeologist that, given the significant quantities of overburden, the lack of significant finds and the depth of the trench, the evaluation should cease.
