**Archaeological Building Appraisal at
the former Enson Works & adjacent structures
Chelson Street/Normacot Road
Longton
Stoke-on-Trent
NGR SJ 91470 43050**

Report No. 271

January 2010

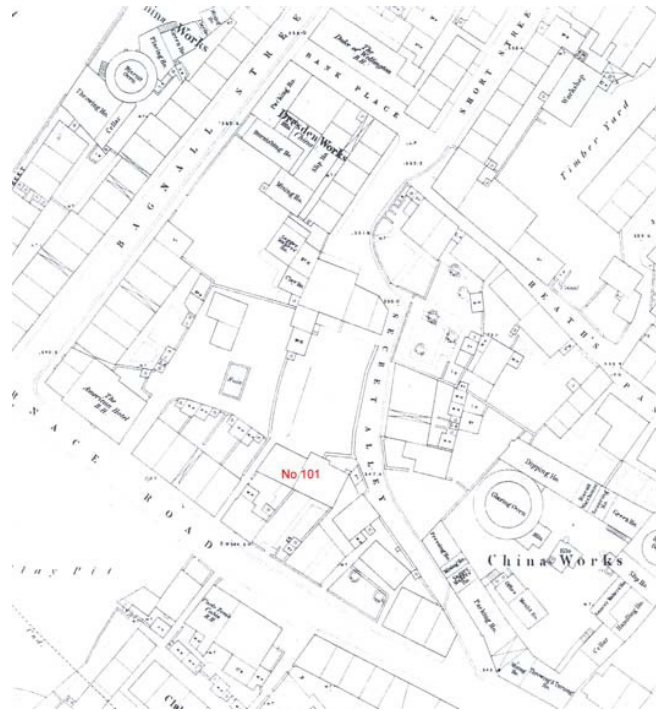
FIG. 3

Extract from the 1856 OS map (1:500) showing the Enson, or Dresden Works and adjacent buildings (no. 101 is marked).

4.1.5 The Dresden Works is first shown on the 1856 Ordnance Survey (OS) map (Fig. 3). The early factory, marked on the map as a china works, appears to have been much smaller than its later incarnation and is sited within the northern half of the area occupied by the present works. The main buildings were located to the north and east of a large yard accessed from Chelson Street (then Bagnall Street) and included units for packing, burnishing, clay preparation and storage, slip preparation and saggar making. Only one kiln is shown within the works and appears to be a rectangular, rather than a circular, structure and may represent a muffle kiln. This, coupled with the factory’s small size, could suggest that the Dresden Works was originally concerned only with elements of the ceramic production process and possibly worked in conjunction with another china manufactory.

4.3.1 The present day number 101 appears to have developed from two adjoining properties, which are first shown on the 1856 OS map (Fig. 3). These buildings overlooked a large yard to the north accessed from Short Street (at this time known as Secret Alley). It is unclear from the map evidence whether these are commercial or domestic properties. Although there is a small yard containing a wash house and privy to the south of the westernmost property, these could actually have belonged to another building within the plot, shown fronting onto Normacot Road in 1856 (Fig. 3). In the yard to the south of the eastern building is a privy and piggery, which implies that it is a residential property. By 1878, these two yards had apparently been combined into a single large space (Fig. 4), with additional reconfiguration and extension of the buildings by 1900 (Fig. 5). Further modification had taken place by 1950 (Fig. 9), by which time the original core of the property had been subsumed within, or indeed replaced by, an L-shaped structure accessed from Normacot Road. The map evidence shows that the element of this building that fronted onto Normacot Road was demolished after 1980, leaving a single unit set back from the road that occupied the footprint of the principal 1856 buildings.

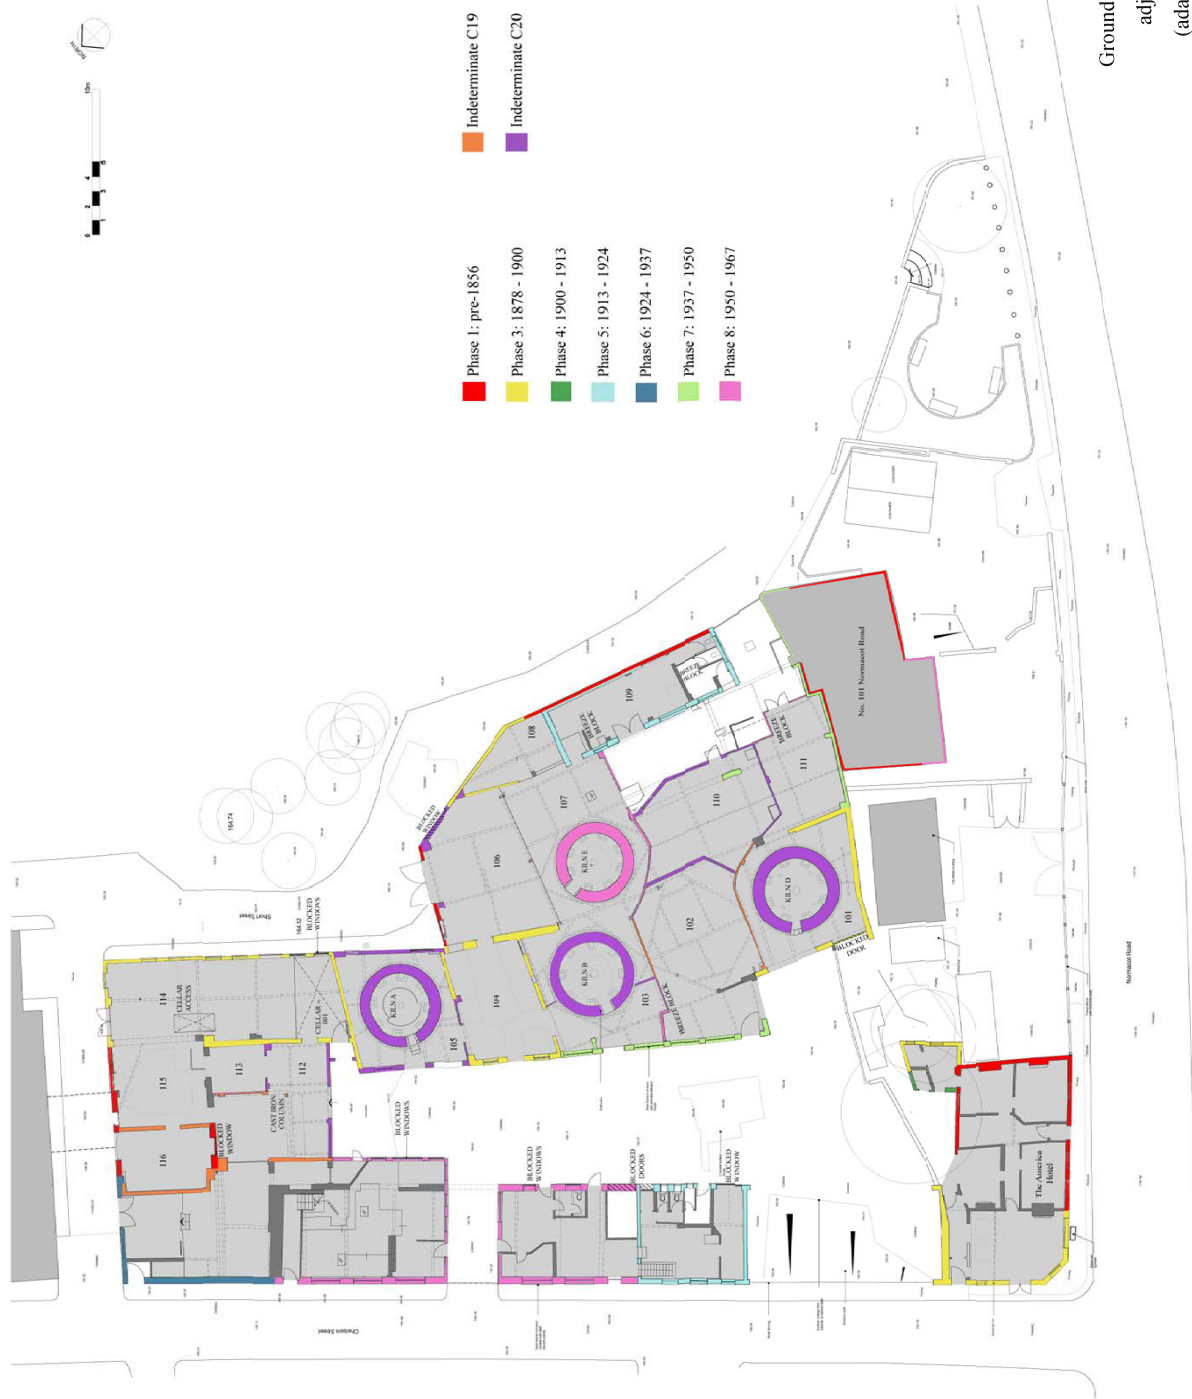
FIG. 12
Ground-floor plan of the Enson Works & adjacent buildings with phasing (adaptation of 2007 plan by Brock Carmichael Architects).

5.1.13 The bottle kilns (A, B and D) are within rooms 101, 103 and 105 (Fig. 12). Brick floors and brick vaulted ceilings remain in rooms 101 and 105, but have been replaced with concrete elsewhere (Plate 10). Circulation around kiln B in room 103 has been curtailed by the insertion of north-south aligned brick walls between the kiln and the north and south walls of the room. A circular scar in the ceiling of room 102 indicates the position of a previous bottle kiln (C). Room 104, in poor state of repair and now missing a roof, seems to have functioned as an access point between the different rooms in the east range. It has been subject to much alteration with two different first-floor levels and the consequent blocking and insertion of both doors and windows (Plate 11).

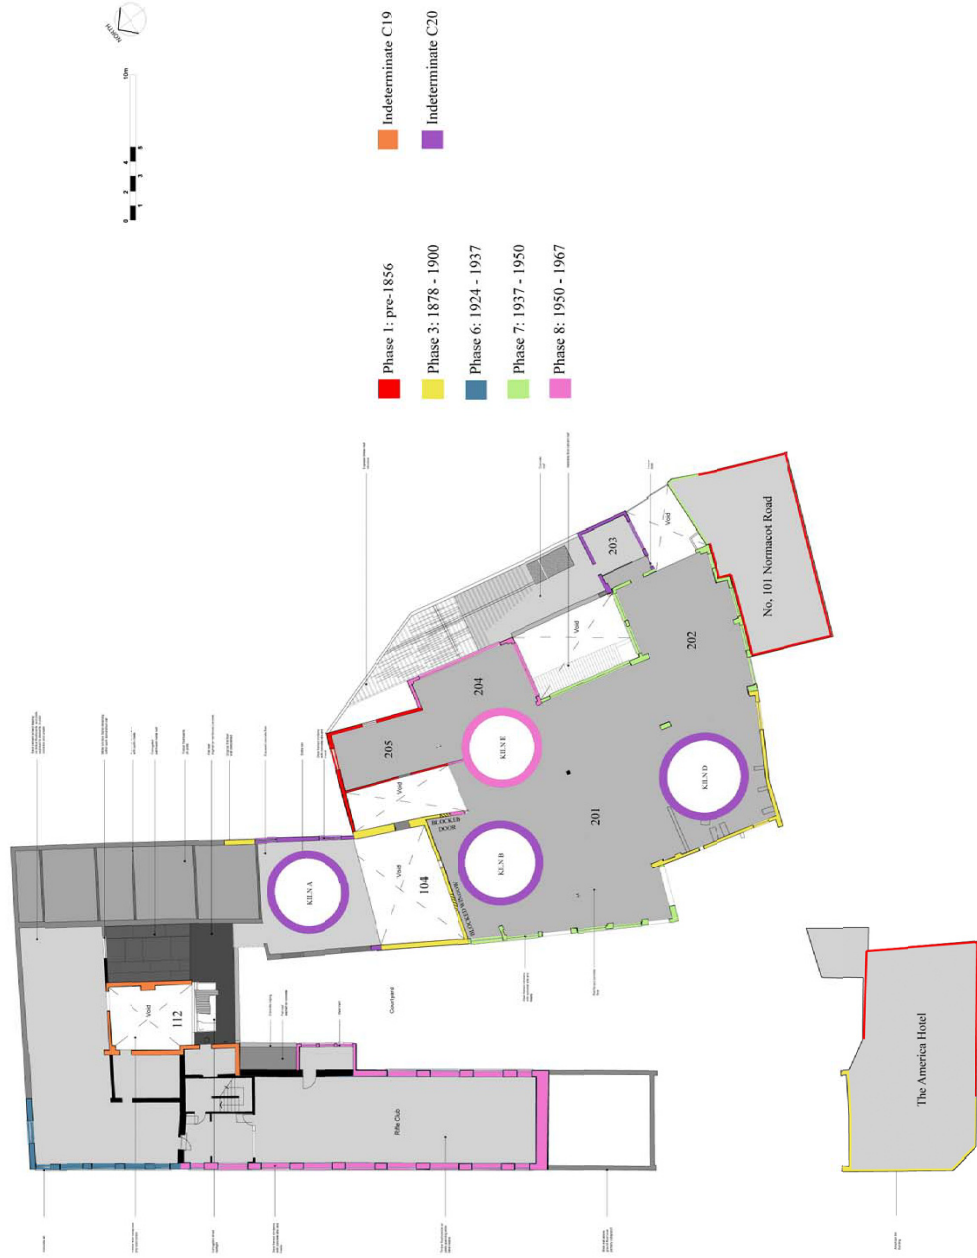
FIG. 13

First-floor plan of the Enson Works & adjacent buildings with phasing (adaptation of 2007 plan by Brock Carmichael Architects).

5.1.14 Further rooms on the east side of this range are accessed through room 104. At the north end of the range, room 106 on the ground floor and room 205 on the first floor represent a 19th-century brick building (Figs. 12 & 13). It is constructed with reddish brown bricks in Flemish bond and has oversailing eaves. An original window with stone lintel, remains in the north wall of room 106 but the first-floor windows have been replaced with metal frames and brick sills (Plate 12). A large gateway has been inserted in the north wall. The building has been opened out on the ground floor and is now incorporated with rooms 107 and 108. The area comprising rooms 107, 110 and 111 on the ground floor and rooms 202 and 204 on the first floor are built in similar style to the extension on the west side of the range. Sections of repaired brick work can be seen on the first floor between rooms 205 and 204, demonstrating that the southern rooms were

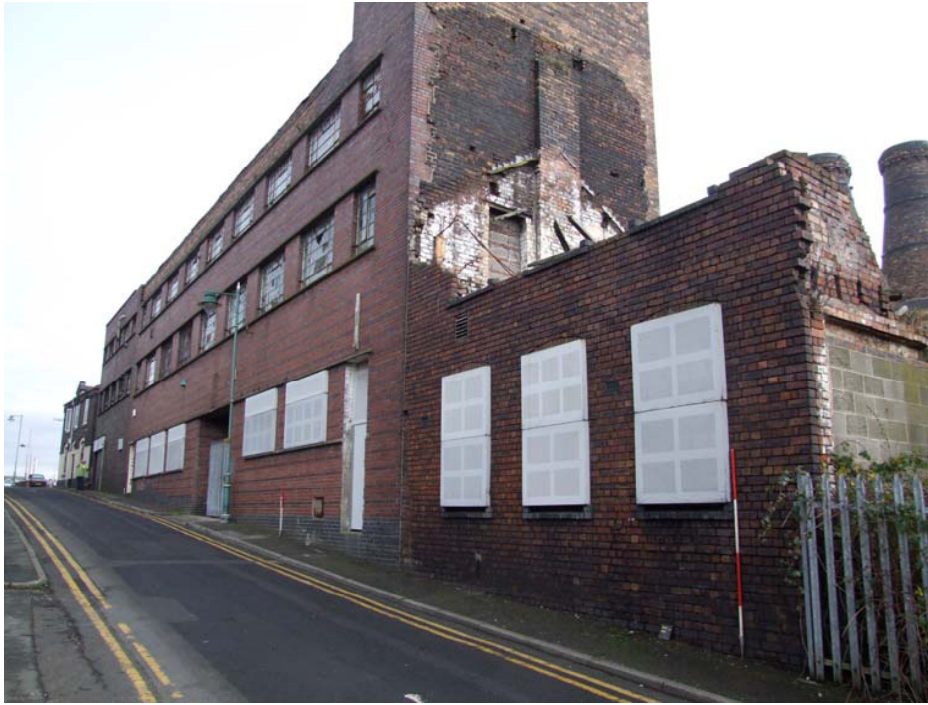
PLATE 1

External view of the west range on Chelson Street, looking north with scarring on the south gable indicative of a previous building (scales: 1.0m, 2.0m).

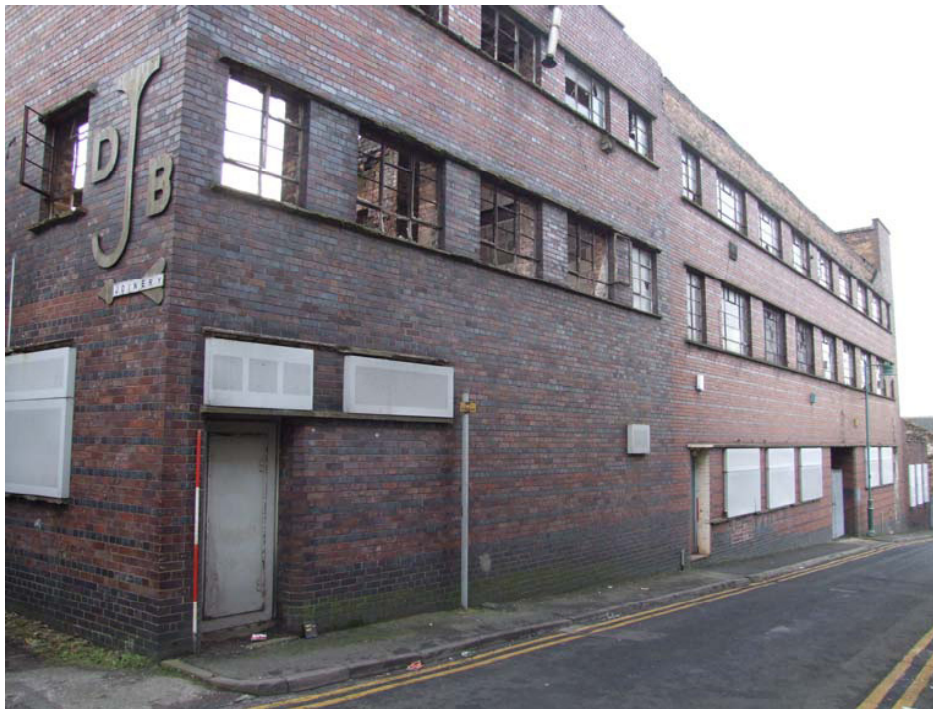
PLATE 2

General view of the west-facing elevation along Chelson Street, looking south, showing the different construction phases of the west range (scale: 2.0m).

5.1.2 Slight variations in brick colour evident towards the northern end of the three-storey building, visible on the Chelson Street elevation, suggests construction in two phases (Plate 2). A ragged join on the northern-elevation indicates that the building was built against, and probably around, existing 19th-century structures at the north end of the works. Darker brickwork at a high level on the south gable suggests that construction of the three-story range incorporated the gable wall of an existing structure, possibly contemporaneous with the extant earlier building to the south (Plate 1). The northern end of the building has suffered fire damage and is now roofless and derelict. The outer skin of brickwork is missing at the top of the Chelson Street elevation.

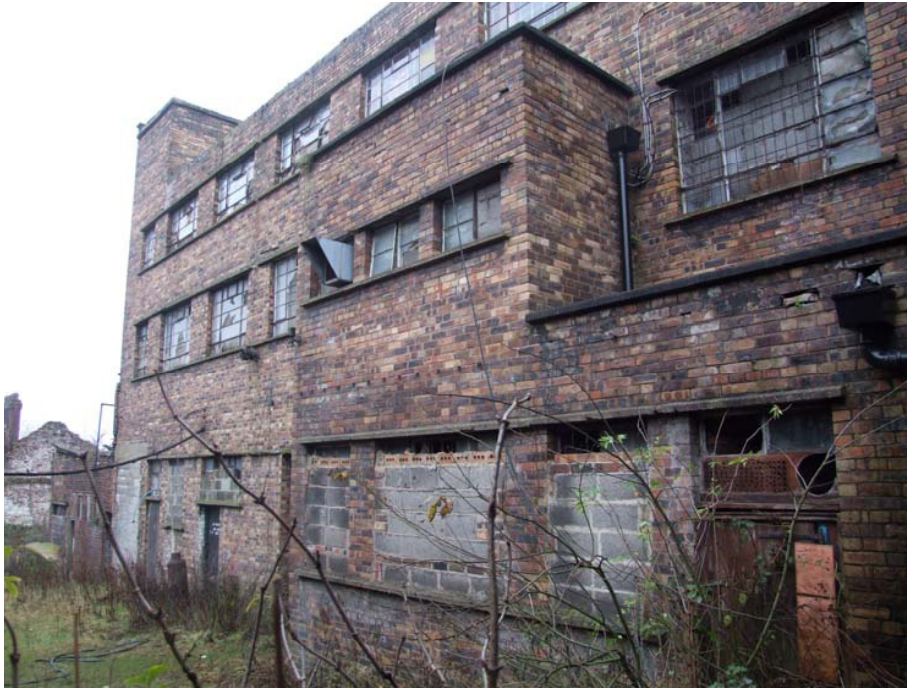
PLATE 3

5.1.3 Internal access to the west range was not possible. It is known, however, that the upper two floors are currently used by the Stoke-on-Trent Rifle and Pistol Club. In the course of its use, the club appears to have lined the walls of these upper floors with breeze blocks, visible externally through the broken windows (Plate 3).

View of Phase 8 (1950-67) section of the west range from within the internal courtyard, looking south west (scale: 2.0m).

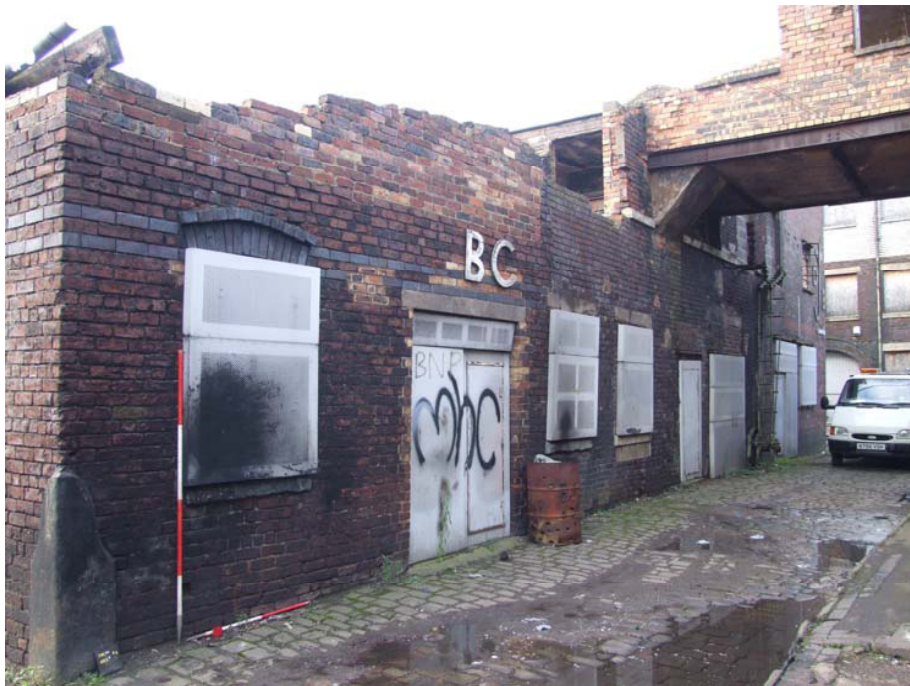
PLATE 4

5.1.5 *The north range.* This part of the works is in a very poor state of repair with the majority of the first floor having collapsed or been demolished. Two distinct phases of construction can be identified on the exterior of the building, both seeming to date stylistically to the 19th century (Plate 4). The earliest of these, seen in the middle section of the northern-elevation and relating internally to rooms 115 and 116, is built with brownish-red bricks in an English bond. Original windows with moulded stone lintels survive on the first floor, but those on the ground floor have concrete lintels and sills, suggesting that they have been modified or are later insertions. The first-floor windows have been closed with breeze blocks. Both doors in this middle part of the northern elevation have more recent brickwork around them indicating that they are later insertions. A crane reaching up to first-floor level is fixed to the wall below the first-floor windows (Plate 5). The second, later 19th-century phase discernible on the exterior of the north range, is identifiable at the north-eastern corner (in the area of room 114), denoted by a change in brick colour and the use of English garden-wall bond.

External view of the north range on Bank Place, looking west (scales: 1.0m, 2.0m).

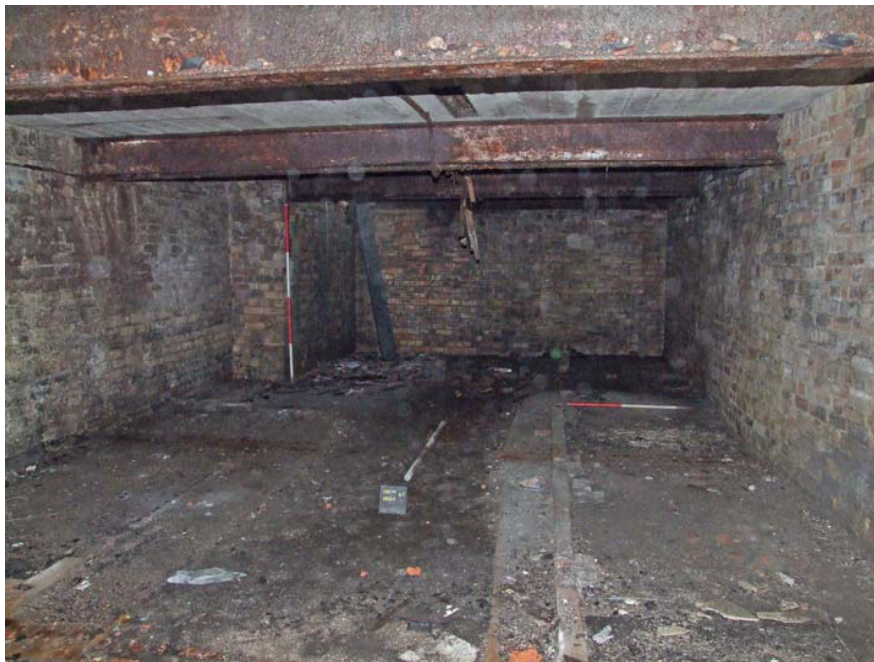
remains at the northern end of the room, elsewhere it is concrete. A rough doorway has been inserted in the western wall to provide access to room 112. Damage to the floor at the southern end of the room has resulted in a large void exposing a cellar (001) below. A somewhat smaller opening in the floor towards the northern end of the room may indicate the original access in to the cellar. The cellar 001 has brick walls and a concrete floor with concrete kerbs or rails extending along either side of the room (Plate 6). A gas-fired 'AGA' heater appears to have provided heat to 001.

PLATE 6
View of cellar 001, looking north.
Note concrete kerbs denoting former shelving extending along either side of the room
(scales: 1.0m, 2.0m).

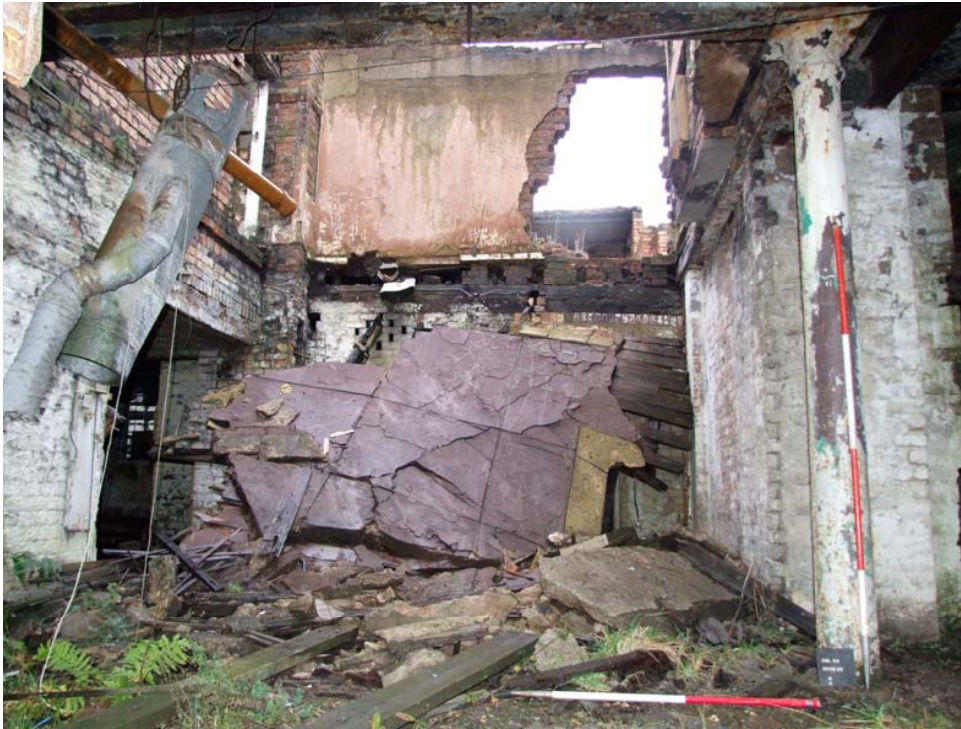
PLATE 7

Interior view of room 112, looking north. Note cast iron column to the right (scales: 1.0m, 2.0m).

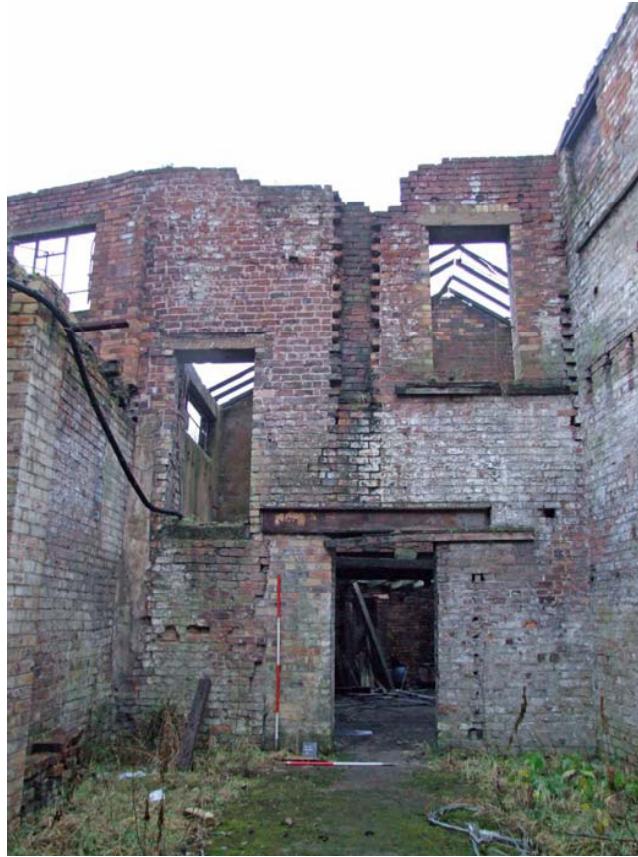
PLATE 11

Room 104, looking east, showing evidence of various alterations (scales: 1.0m, 2.0m).

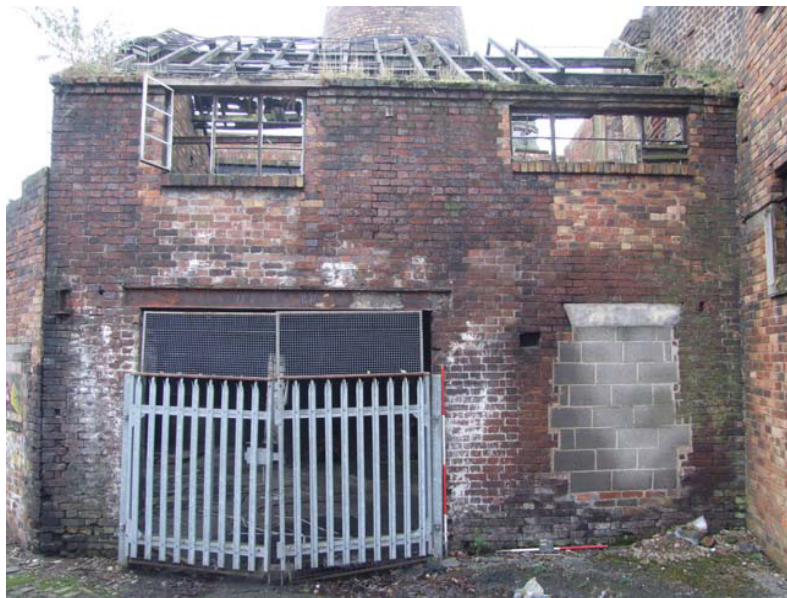
PLATE 12

External view of the north-facing elevation of rooms 106/204,
in the east range (scales: 1.0m, 2.0m).

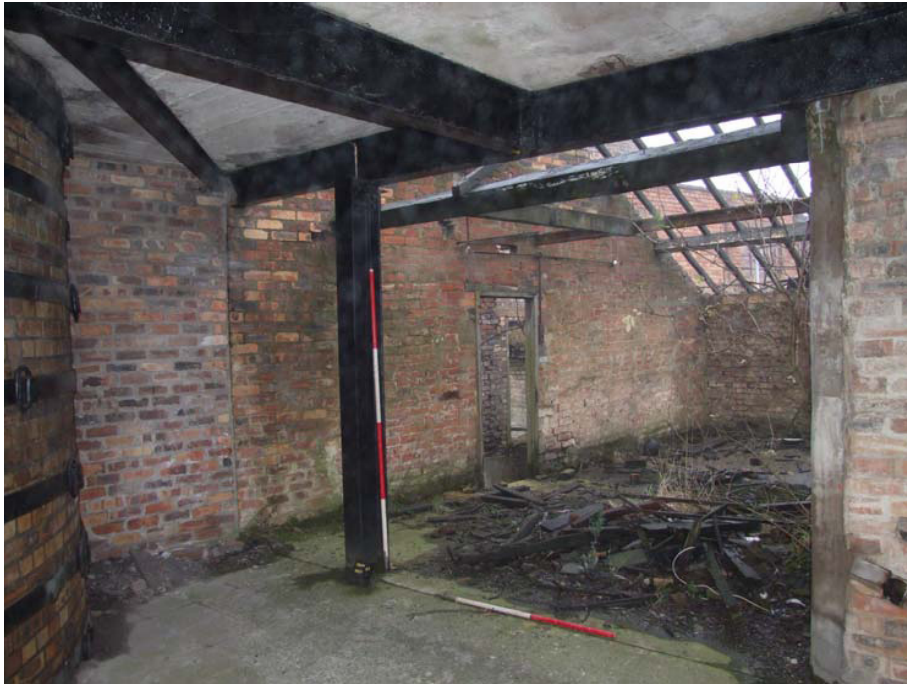
PLATE 13

Room 204 looking north west, showing different phases of development in the brickwork (scales: 1.0m, 2.0m).

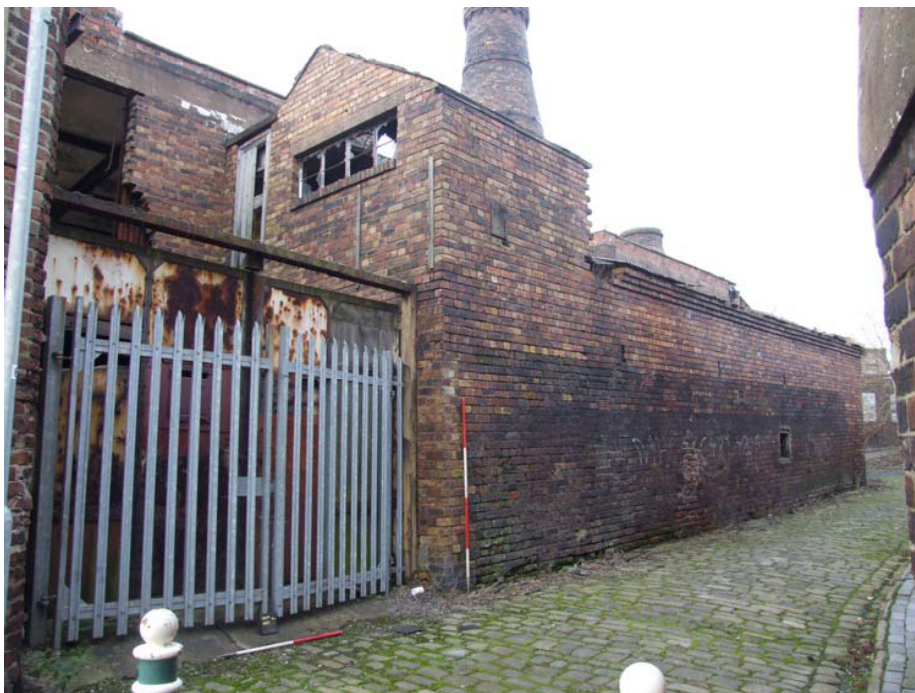
PLATE 14

General view along Short Street, looking north, showing different phases in the east-facing boundary wall (scales: 1.0m, 2.0m).

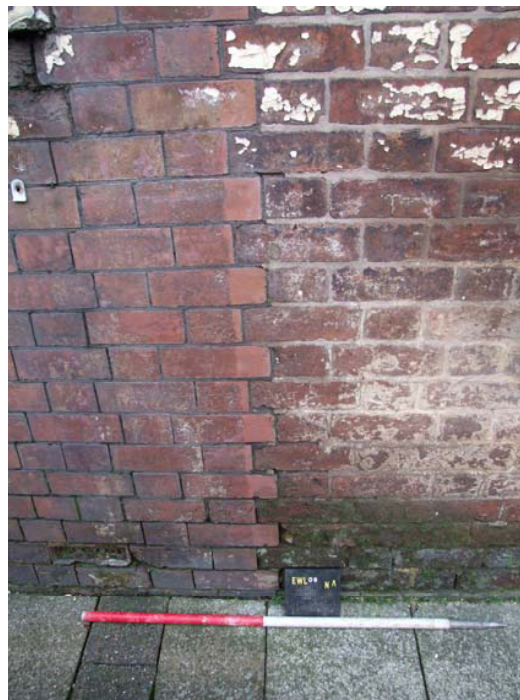
PLATE 16

Change in brickwork jointing on south-facing elevation of the America Hotel (scale: 1.0m).

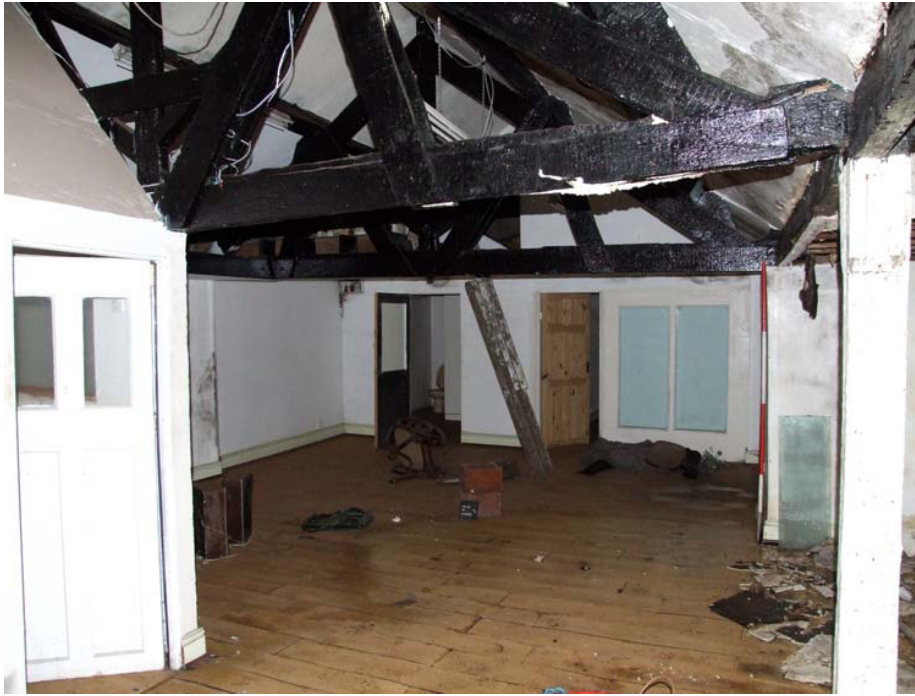
PLATE 19

View of the first floor in number 101 Normacot Road, looking west,
showing roof trusses (scale: 2.0m).
