**Archaeological Watching Brief
on Burslem Branch Canal
Middleport
Stoke-on-Trent
Staffordshire
NGR SJ 8659 4879**

Site Code: BBC 10

Produced for
RENEW North Staffordshire

Report No. 286

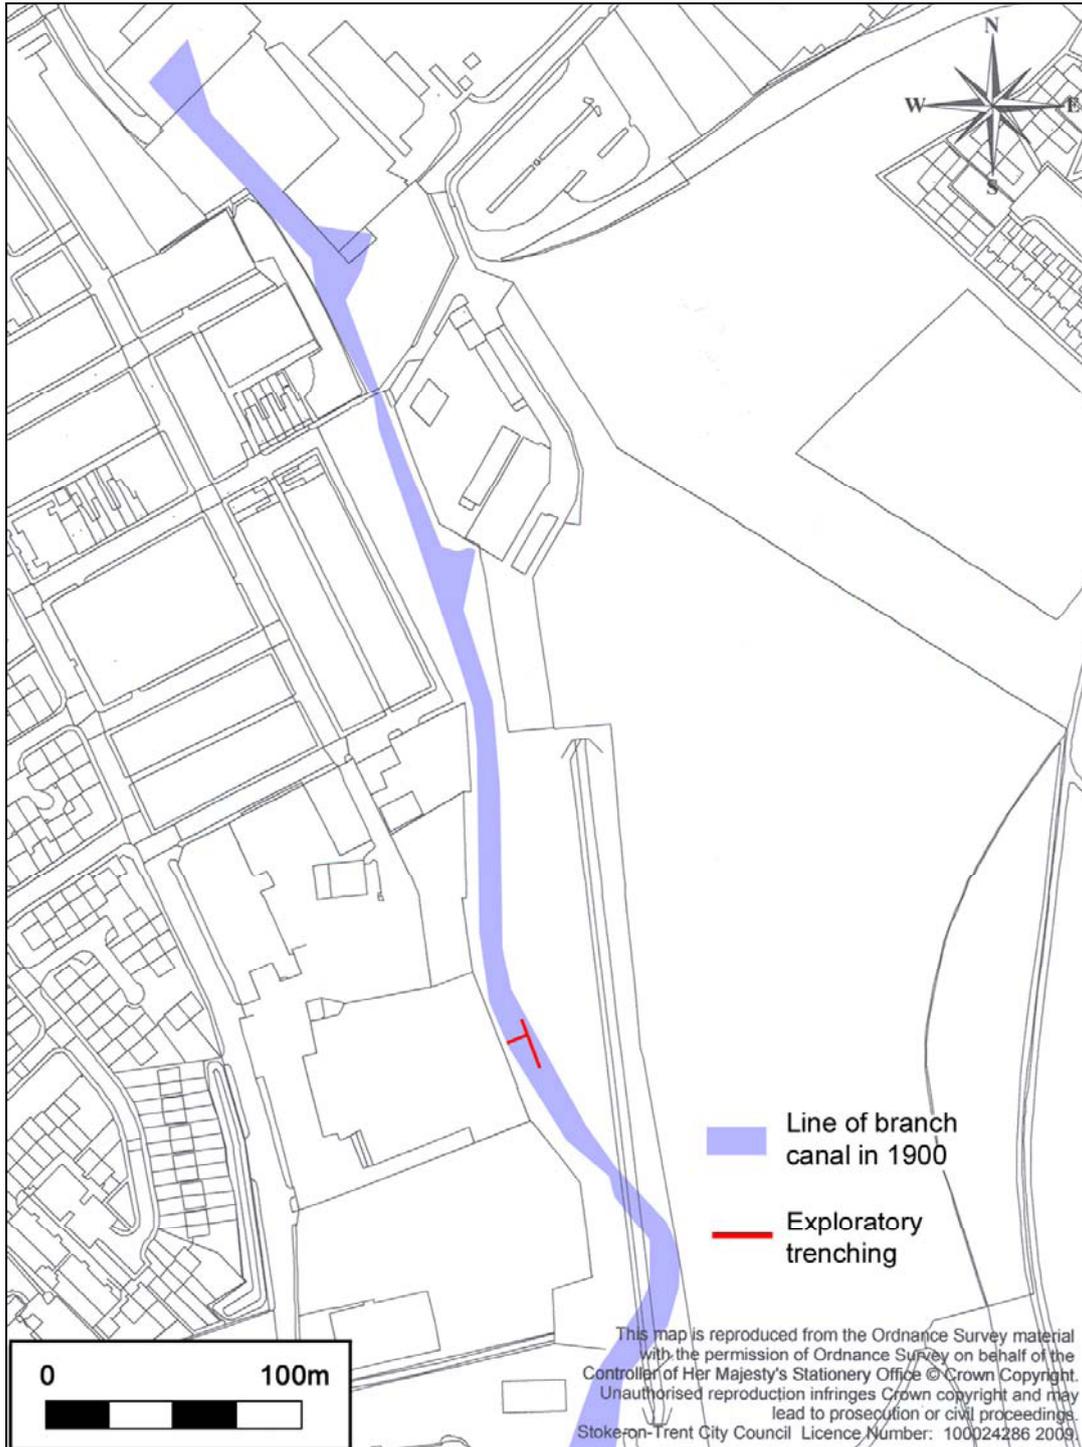
FIG. 2

Modern map showing the location of the exploratory trenching indicated in red on the line of the former canal, highlighted in blue.

6.1 The excavation was carried out by the Waterways Recovery Group who initially opened a 1.30m-wide transverse trench to a depth of c.0.50m below modern ground level (Fig. 2). The trench extended east from the ‘off-side’ flank of the canal adjacent to the redundant Co-op bakery and revealed that underlying a 0.05m-thick covering of turf (100) was a compacted overburden of mixed demolition rubble (101), which included considerable numbers of bricks stamped ‘CBC^o’, probably the Cobridge Brick Company, established by 1893 (Keates, 146) (Plate 1).

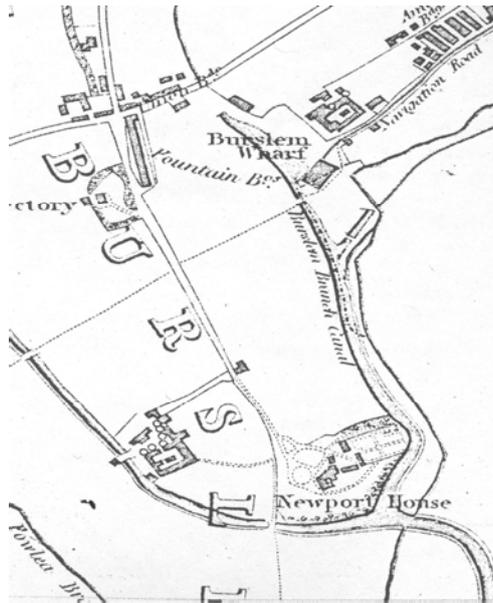
FIG. 3

Hargreaves' map of 1832 depicting the canal winding around Newport House and terminating at Burslem Wharf. The tramway can be seen extending from the warehouse and along Navigation Road.

4.2.1 Historical cartographic evidence reveals the development of the canal. It is first depicted on Hargreaves' map of 1832 (Fig. 3) and is shown as a cutting of approximately 600m in length. The first bend north of its junction with the main navigation curves tightly around the ornamental gardens of Newport House, presumably following topographic contours. The towpath is depicted on the east bank while *c.*370m north of the junction is a 50m-long side cut aligned north east. Another 100m further north is the mooring basin, *c.*120m long and up to 30m wide, labelled as Burslem Wharf. Emerging from a large interchange warehouse is the tramroad leading up Navigation Road.

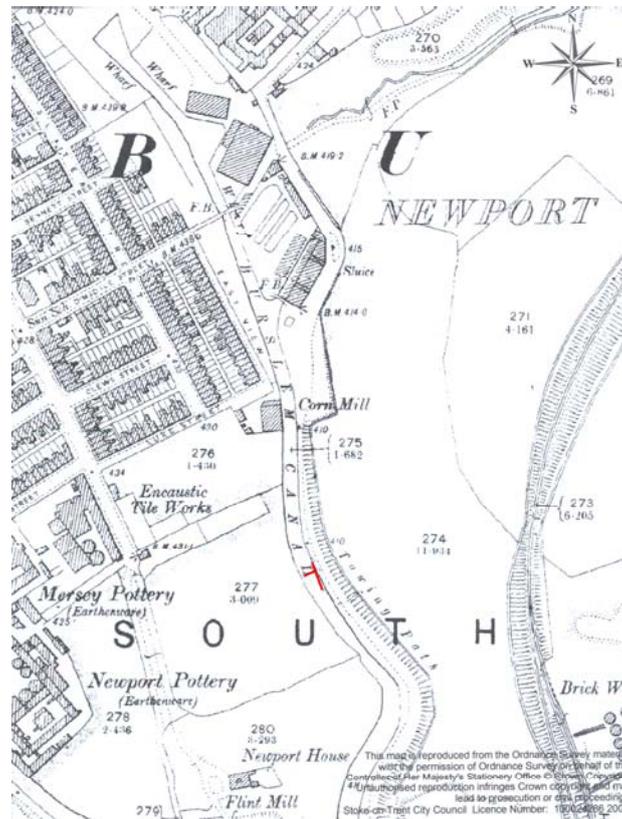
FIG. 4

Extract from the 1900 OS map showing the development of Burslem Wharf, with the location of the exploratory trenching shown in red.

4.2.3 The 1900 OS map (Fig. 4) reveals that only the southern wharf appears to have been further developed; the extensive open structures may again represent storage facilities for raw materials. This edition also shows a corn mill, revealed in 1907 (Staffordshire Sentinel, 51) as Malkin Bros. New Mills on Luke Street, and part of the Malkin encaustic tile works on Newport Lane (Staffordshire Sentinel 1907, 150), have appeared on the west bank, both served by the canal.

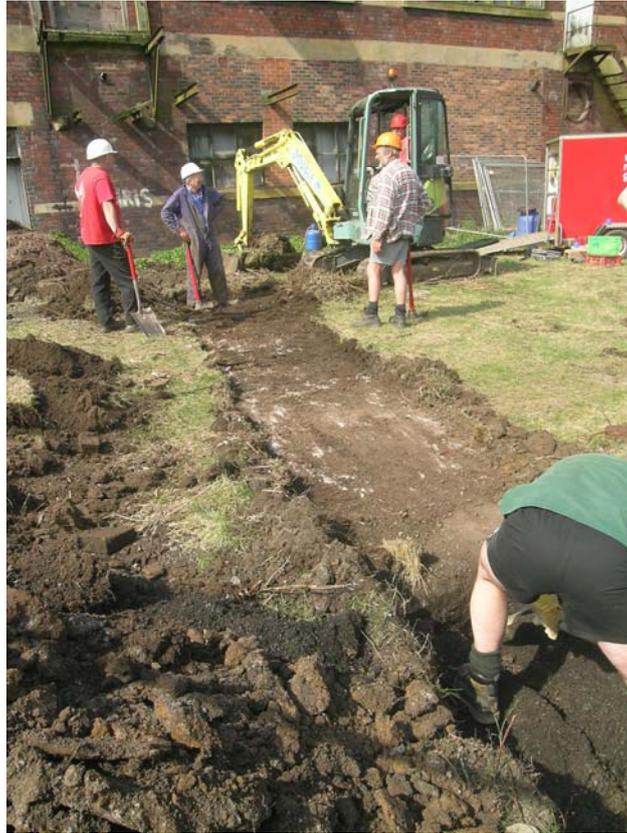
PLATE 1

6.2 Approximately 6.50m east of the bakery wall the trench encountered an extensive deposit of poured concrete (102), about 0.16m thick and extending some 6.0m east-west, while its full extent was not ascertained to the north or south. Excavation on the east side of (102) exposed a north – south aligned rough-cast concrete capping (103), which was interpreted as the top of the canal’s ‘nearside’ washwall. It was therefore decided to discontinue the transverse trench, which was immediately backfilled.

Initial transverse trench across the line of the former canal, looking west, extending from the Co-op bakery and showing topsoil (100) and underlying concrete mass (102).

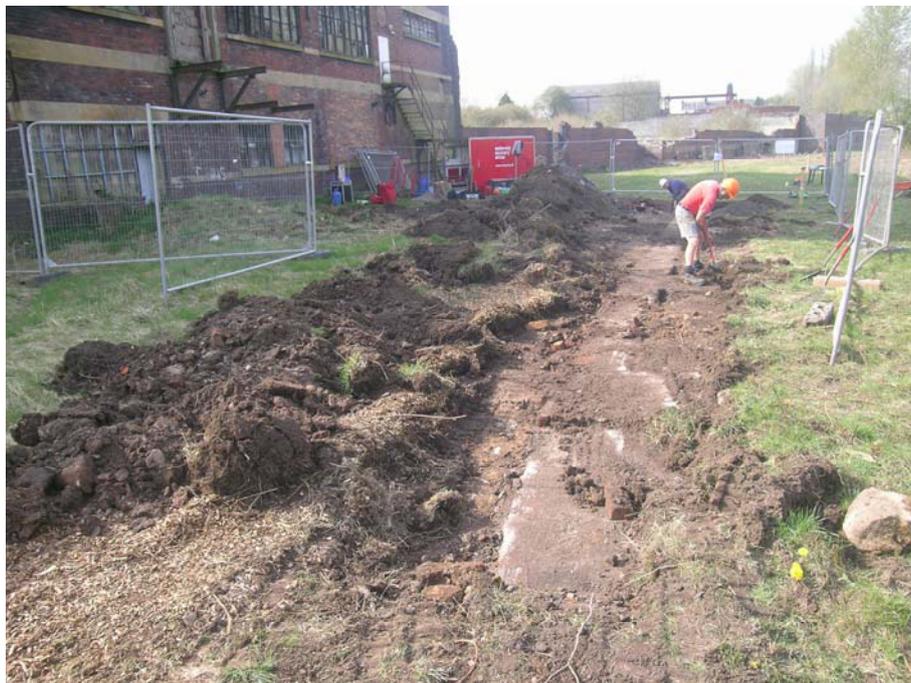
PLATE 2

6.3 Manual removal of the shallow topsoil (100) exposed the top of the washwall for a total distance of 23.65m N-S (Plate 2). The capping (103) was revealed as a blue grey concrete approximately 0.56m wide and 0.20m thick with a 0.02m-wide lip on each side. Approximately every 5.10m along the capping was a triangular feature dovetailing out for a distance of 0.70m, which would have projected into the towpath (Plate 3). Approximately 1.30m south of the northernmost dovetail feature the capping had been raised by approximately 0.16m, although the reason for this step-up was unclear.

Washwall capping (103) exposed by removal of topsoil (100), looking north.

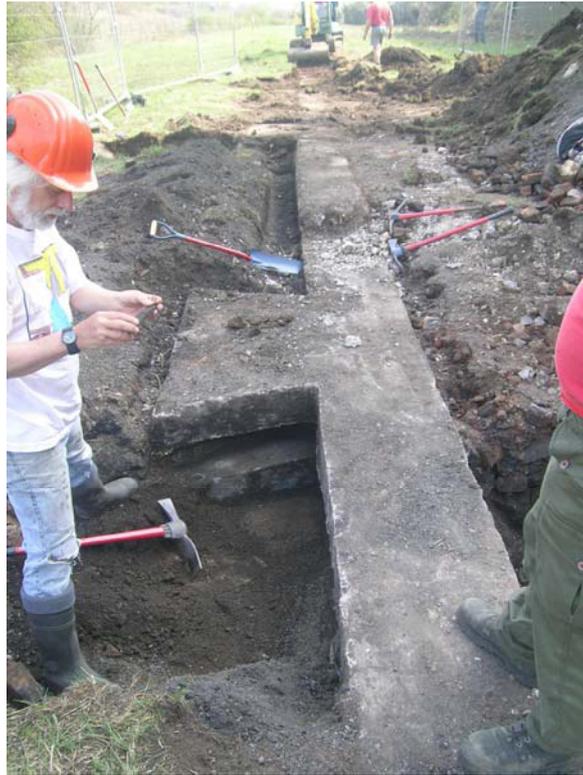
PLATE 3

6.4 Adjacent to this northernmost dovetail feature a small sondage (Sondage 1) was excavated by hand, measuring approximately 1.60m N-S x 0.80m E-W x 0.45m deep. This revealed that (103) appeared to overlie two earlier stone cappings or courses, (104) and (105), both of which also possessed dovetail features, albeit on slightly different alignments. The middle course (104) was approximately 0.12m thick and the lowest one (105) about 0.20m. The base of the latter course corresponded with the bottom of the sondage, which was interpreted as the stone edging defining the top of an early wall-line (106).

7.3 It is unclear, however, from the limited excavation whether stone wall (106) encountered at the bottom of Sondage 1 represents the earliest incarnation of the wall. Its height appears to have been raised at least twice, as represented by masonry courses (104) and (105), before being capped by (103). It is possible that the successive heightening of the wall represents strengthening of weak points in the bank caused by subsidence.

7.4 The dovetail feature, which may have served as a buttress, has been interpreted as being unique (Dumbleton pers. comm.). No evidence for the adjacent towpath, such as gravel deposits, was encountered.

Washwall looking south, showing the dovetail feature in the uppermost concrete capping (103) overlying earlier capping courses (104) and (105).

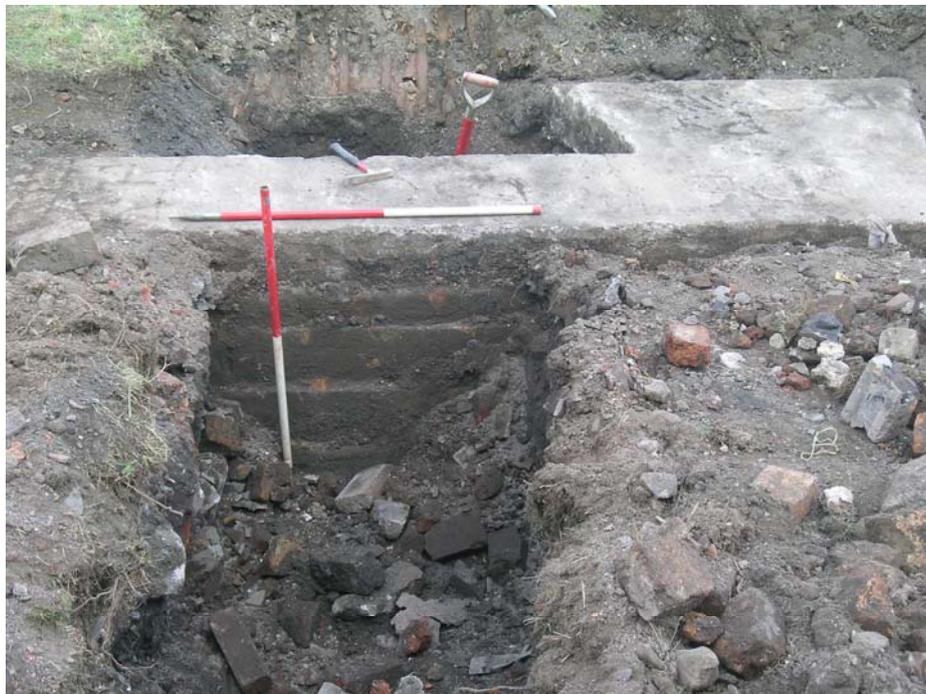
PLATE 4

6.5 A second sondage (Sondage 2) measuring approximately 1.20m N-S x 3.0m E-W x 0.90m deep was excavated through (101) by machine on the west (canal) side of the washwall, which revealed a slightly stepped batter to the masonry (Plate 4).

The west-facing masonry of the washwall in Sondage 2, showing the demolition fill (101) within the canal (scales: 1.0m).
