Castledykes, Dumfries

Archaeological Watching Brief

Data Structure Report

Andrew Nicholson
16 February 2010

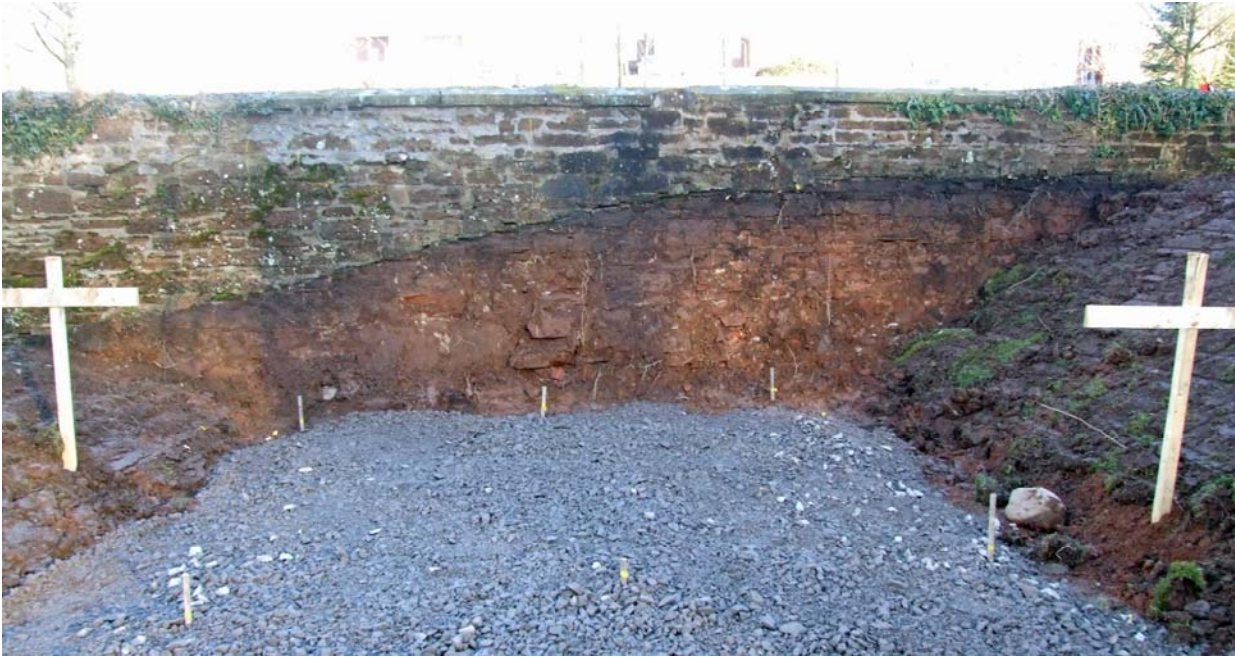
Fig.4 Eastern terminus of excavation, showing profile of soil removed and partially excavated sides

The top 0.2m of the fill were removed across the entirety of the site, to take it down to the depth required to lay the new cycleway. The rest was left in situ, covered by redposited material grading the sides of the cut (Fig.4, on right).

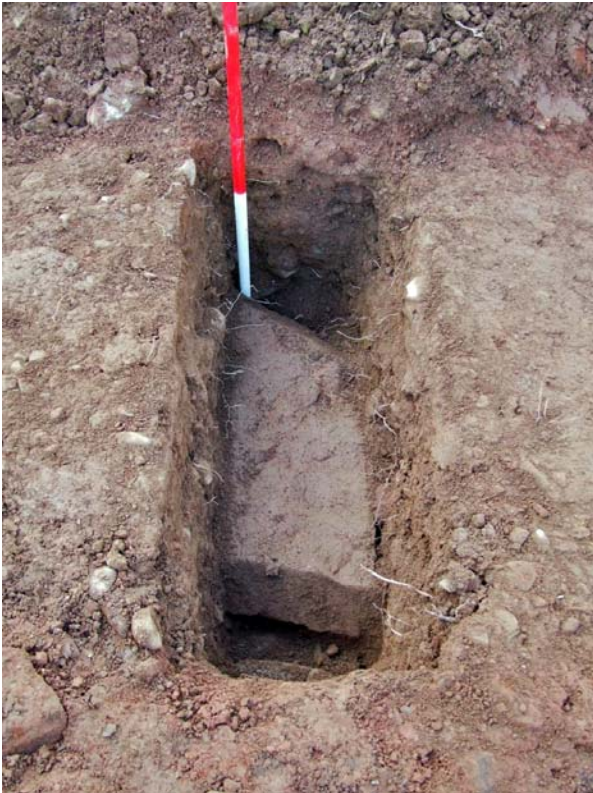
Fig.6 Section through linear cut 5

A section, 0.4m wide, was cut across the linear feature to determine its depth and profile. The sides of the cut were nearly vertical, a feature already noted in the voids to the east. At a depth of 0.52m lay a large sandstone slab, 0.7m wide and 0.2m thick, whose western edge was just visible (Fig.6). Excavation down either side of this was possible for a further 0.2m, beyond which it was not possible to proceed, though the cut obviously continued downwards.

As it was not possible to fully excavate this feature, there are at least two possible interpretations for it. It may be a large field drain, buried below later landscaping, with the sandstone slab representing a capstone. The postulated northwards turn at the western end of the feature would, if it were real, lead it to the later covered culvert. A second possibility is that it is a robber trench from a wall. No finds were recovered from the fill.

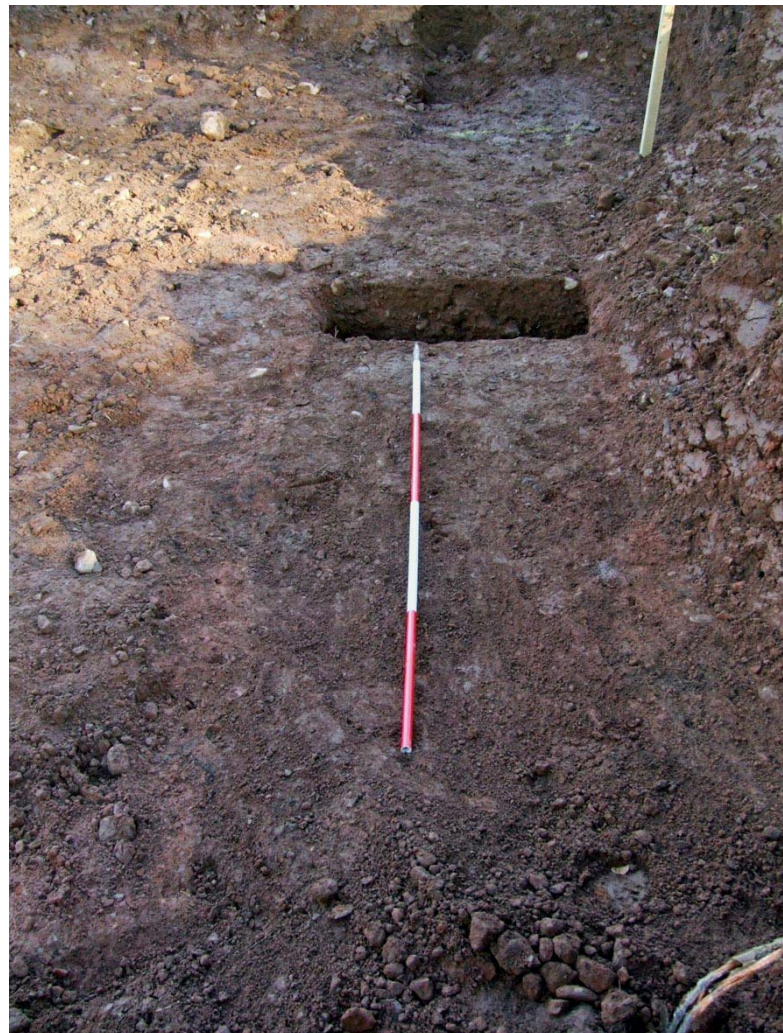
Fig.7 Linear cut 5, looking eastwards (note voiding collapse at eastern end)

In the south-eastern corner of the site, the reddish-pink clay was cut by a trench (5), which became visible as a series of voids along its northern edge. At the extreme eastern end this was filled with a mid grey-brown silty soil, with very few, small stones (6). This silty soil also occurred in two other smaller patches, both around voids on the northern edge of the cut. This silty soil was excavated to a depth of 0.5m, and was still continuing downwards. The presence of the excavation edge, and the fact that it continued well below the level required for the path construction, meant that it was not pursued any deeper. A corresponding southern edge to the cut was located, and traced along the edge of the excavation, revealing a consistent width of close to 1.2m for the feature, which continued westwards for at least 7.6m. There was a slight indication that the northern edge of the cut turned northwards at its western end, but this was obscured by a later cut for an electric cable (9).
