**Historic building recording of a cellar at Bentfield
Green Farmhouse, Bentfield Green, Stansted
Mountfitchet, CM24 8TH**

**commissioned by
David Jones (Alun Design Consultancy)
on behalf of
The homeowner**

CAT Report 1790
March 2022

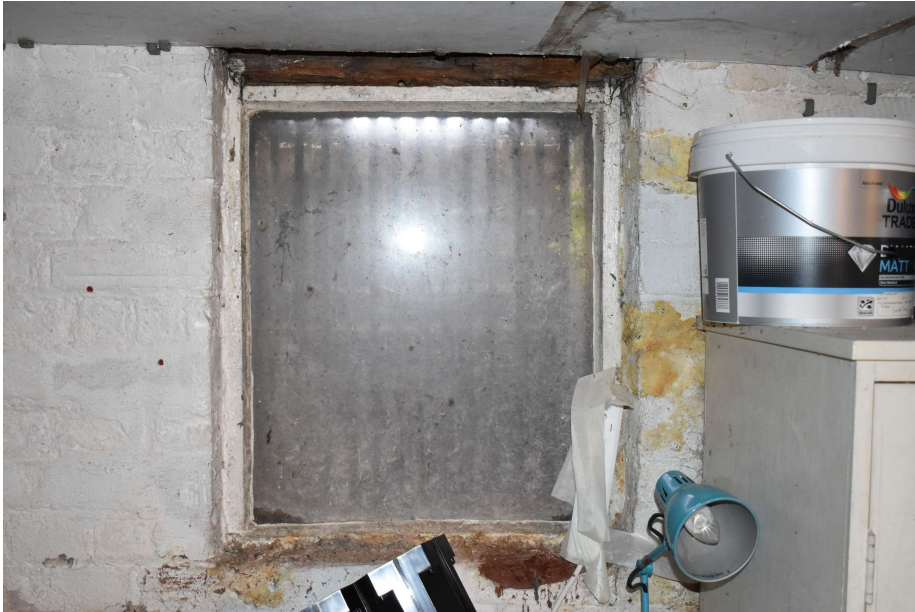
The southern wall has a single-light fixed inserted window with a timber lintel. The majority of the rest of this wall is obscured by modern cupboards. The western wall is a plain brick wall.

Photograph 5 Detail of window. Photograph taken facing south.

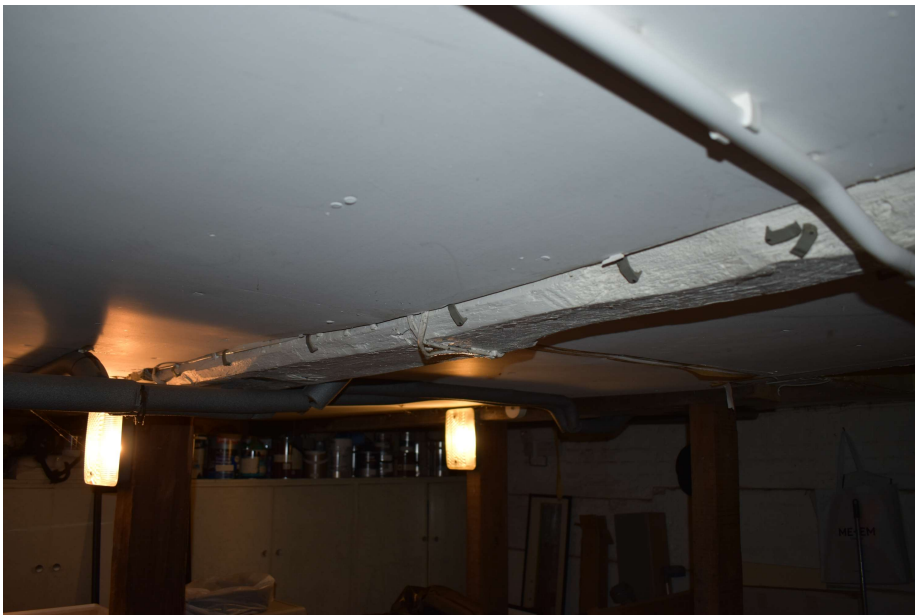
One original north-south bridging beam is present, which is supported by a modern post. A later bridging beam is located to the west of the original beam, and is supported by two modern posts. This beam does not extend to the full width of the room due to the staircase and cellar entrance.

Photograph 6 Detail of original bridging beam. Photograph taken facing south-west.

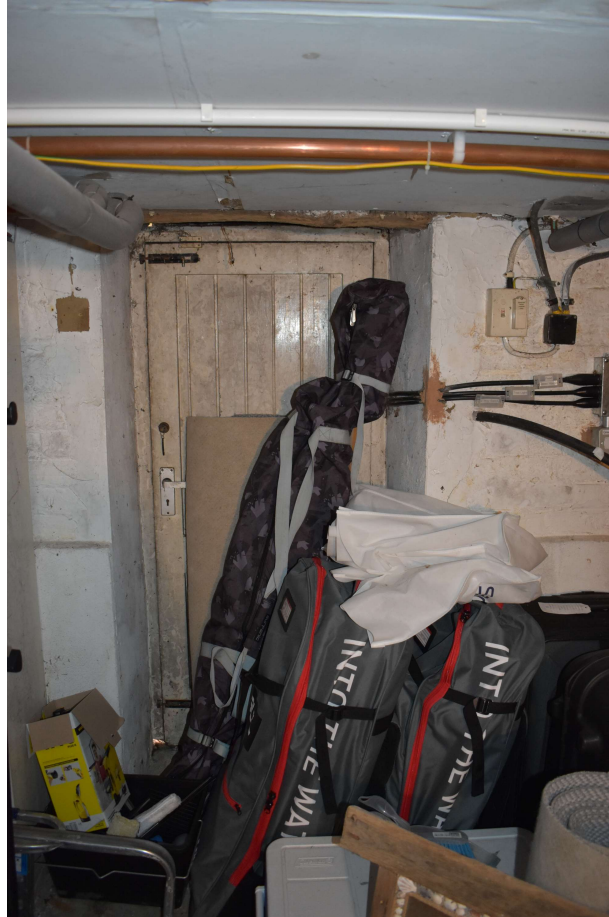
The eastern wall has a single timber door, which opens onto a set of external concrete steps. A modern sump pump is also present the south-west corner.

Photograph 7 Detail of eastern door. Photograph taken facing east.

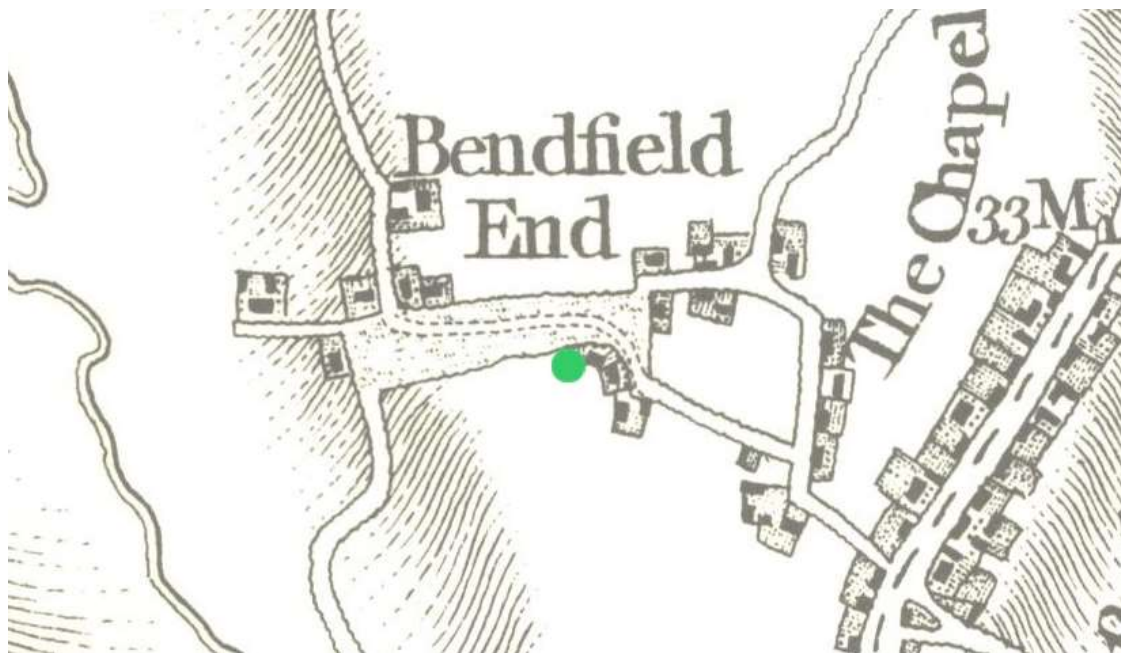
Map 1 Extra of the 1777 Chapman and André map. Site highlighted in green.

While there are buildings present in the sites location on the 1777 Chapman and André map it is unclear whether these represent Bentfield Farmhouse (Map 1). The house is present on the 1875 OS map (Map 2).
